RESIDENTIAL INSPECTION REPORT

2 Regency Point
Conroe TX 77356

Ben Morris & Margaret Morris
JUNE 3, 2021

PROPERTY INSPECTION REPORT

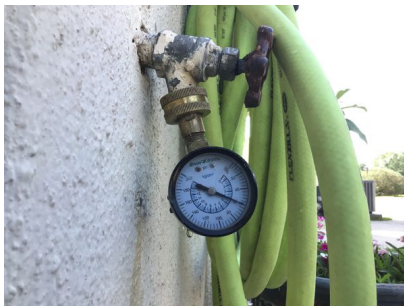
Static water pressure reading: 60 psi
