Lone Star Stucco, LLC

Moisture Assessment Report

1931 Indiana Street

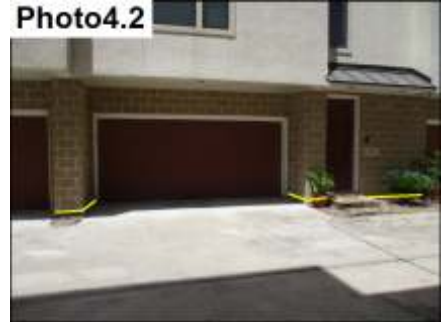
Photo4.2

- CMU appears to be typically detailed at grade for the time of this construction. No visible evidence of moisture intrusion was observed at the time of this inspection at this location. The inspector suggests that this is a positive detail and recommends no modification at this time but to always keep soil away from the structure. Please refer to photos #4.2, #4.3, #4.4, #4.5 and #4.6 for more detail.

Proper Grade Termination With Weep Holes / Positive Detail

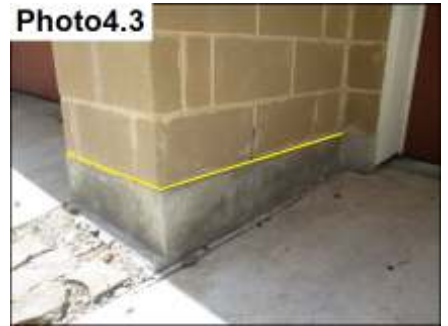
Photo4.3

Proper Grade Termination With Weep Holes / Positive Detail

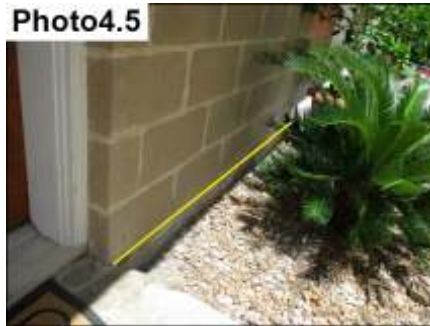
Photo4.5

Proper Grade Termination With Weep Holes / Positive Detail

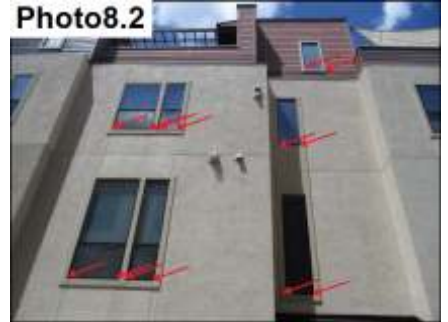
Photo8.2

- The window sealants are separated. The inspector suggests to have a qualified waterproofing contractor further assess and seal this area with a low modulus sealant in an effort to prevent moisture intrusion. These types of sealants are of high quality and compatible with stucco and other termination points. Please refer to photos #8.2, #8.3, #8.4, #8.5 and #8.6 for more detail.

Window Sealants / Seal

Grid Location	Item Description	Moisture Readings	Substrate Condition	Observations
Red Arrows	Windows			The window sealants are separated. The inspector suggests to have a qualified waterproofing contractor further assess and seal this area with a low modulus sealant in an effort to prevent moisture intrusion. These types of sealants are of high quality and compatible with stucco and other termination points. Please refer to photos #8.2, #8.3, #8.4, #8.5 and #8.6 for more detail.

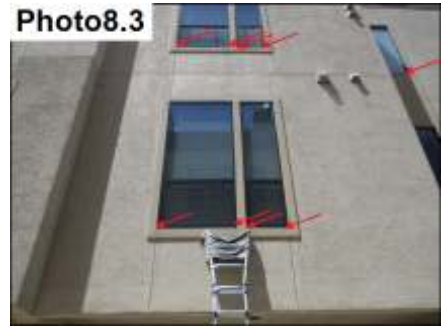
Photo8.3

Window Sealants / Seal

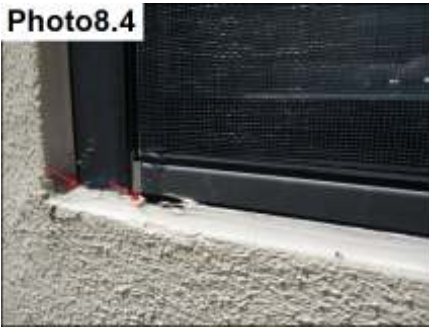
Photo8.4

Window Sealants / Seal

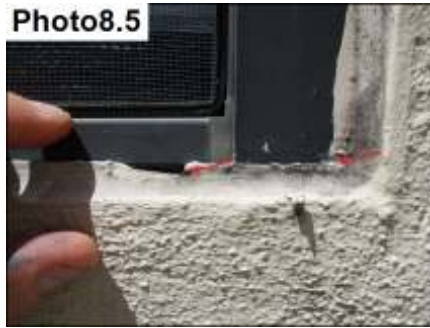
Photo8.5

Window Sealants / Seal

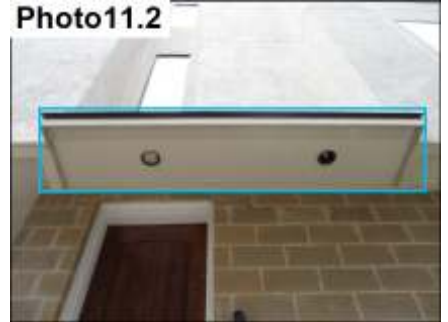
Photo11.2

- The bottom of the wall trim is preventing the potential moisture to properly evacuate the system. The inspector suggests to pull back the trim at this location and provide a 1/4 inch void to create a relief to allow for proper evacuation of moisture from the system. Please refer to photo #11.2, #11.3, #11.4, #11.5 and #11.6 for more detail.

Pull Back Trim To Create A Relief

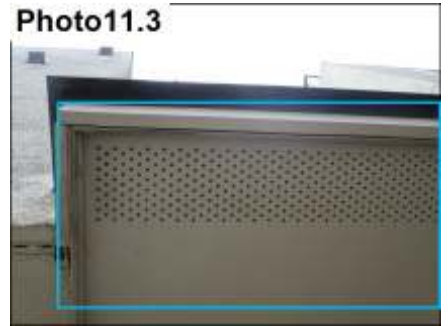
Photo11.3

Pull Back Trim To Create A Relief

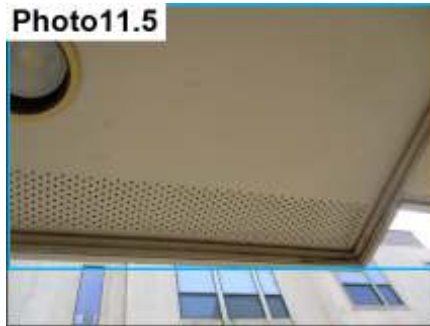
Photo11.5

Pull Back Trim To Create A Relief

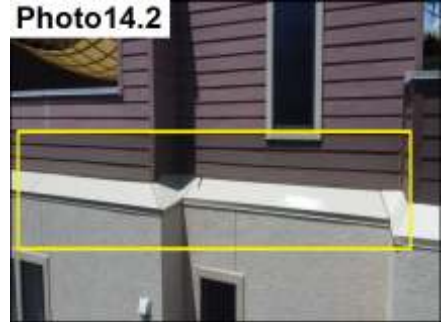
Photo14.2

Metal Cap/Siding Termination / Maintain

Grid Location	Item Description	Moisture Readings	Substrate Condition	Observations
Orange Lines	Metal Cap			The metal cap sealants are present at these locations. The inspector suggests to maintain these sealants in an effort to prevent moisture intrusion. Please refer to photos #14.2, #14.3, #14.4, #14.5 and #14.6 for more detail.

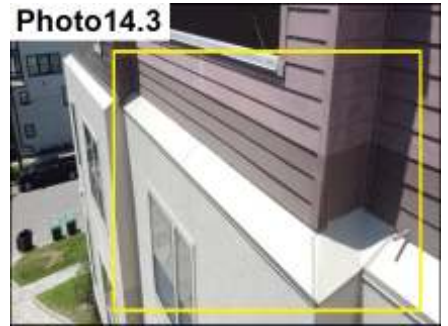
Photo14.3

Metal Cap/Siding Termination / Maintain

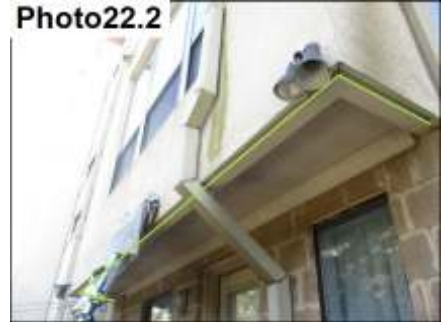
Photo22.2

Reglet Vent Installed / No Modification

Grid Location	Item Description	Moisture Readings	Substrate Condition	Observations
Green Lines	Reglet Vent			The bottom of the bumpout does have a reglet vent with elevated moisture and firm substrate noted. For the time of construction, this was an acceptable detail but it has been realized that it still has the potential to obstruct proper moisture evacuation. The inspector suggests not to modify this area at this point in time but to maintain window sealants above. Please refer to photos #22.2 and #22.3 for more detail.

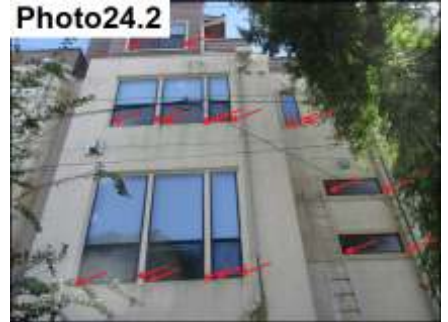
Photo24.2

Window Sealants / Seal

Grid Location	Item Description	Moisture Readings	Substrate Condition	Observations
Red Arrows	Windows			The window sealants are separated. The inspector suggests to have a qualified waterproofing contractor further assess and seal this area with a low modulus sealant in an effort to prevent moisture intrusion. These types of sealants are of high quality and compatible with stucco and other termination points. Please refer to photos #24.2, #24.3, #24.4, #24.5, #24.6, #25.1, #25.2, #25.3 and #25.4 for more detail.

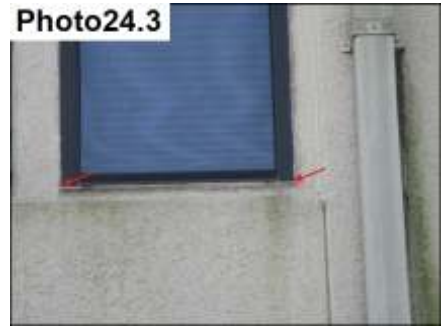
Photo24.3

Window Sealants / Seal

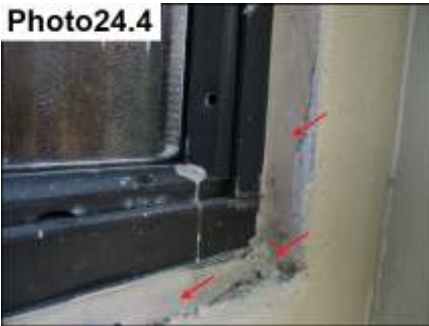
Photo24.4

Window Sealants / Seal

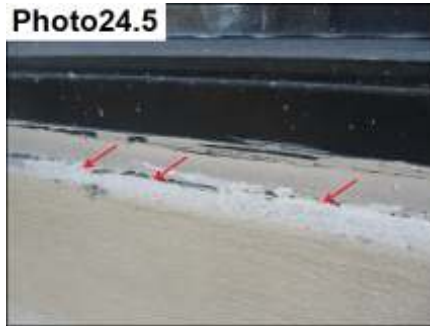
Photo24.5

Window Sealants / Seal

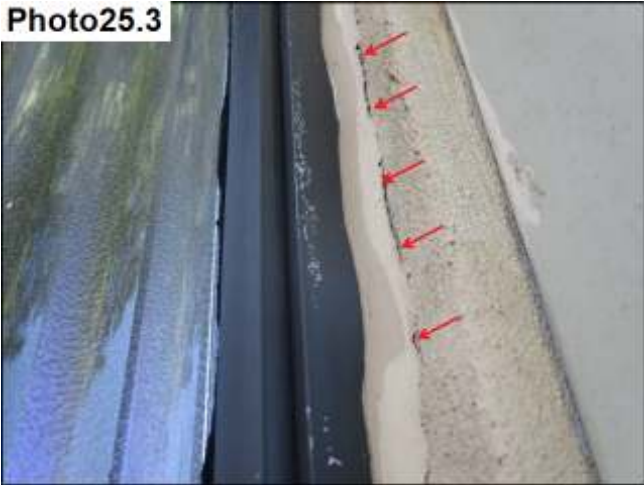
Photo25.3

Window Sealants / Seal

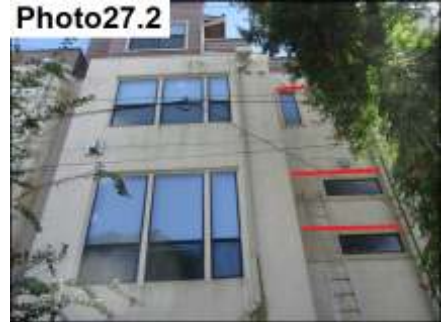
Photo27.2

Window Accent Band/Stucco Termination / Seal

Grid Location	Item Description	Moisture Readings	Substrate Condition	Observations
Green Boxes	Stucco Termination			The window accent band/stucco termination sealants are aged or separated. The inspector suggests to have a qualified waterproofing contractor further assess and repair all cracks then seal the termination with a low modulus sealant in an effort to prevent moisture intrusion. These types of sealants are of high quality and compatible with stucco and other termination points. Please refer to photos #27.2, #27.3, #27.4, #27.5 and #27.6 for more detail.

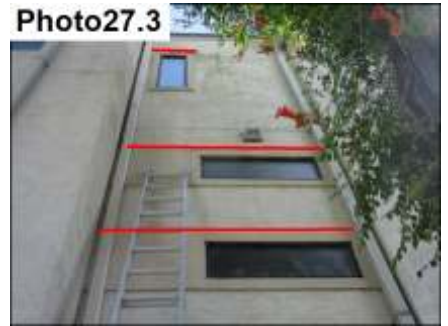
Photo27.3

Window Accent Band/Stucco Termination / Seal

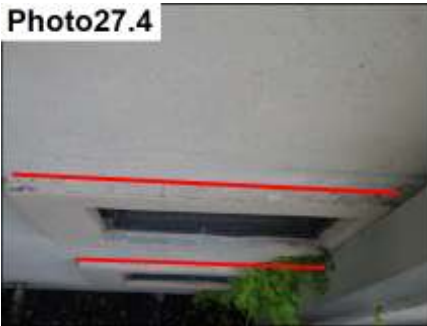
Photo27.4

Window Accent Band/Stucco Termination / Seal

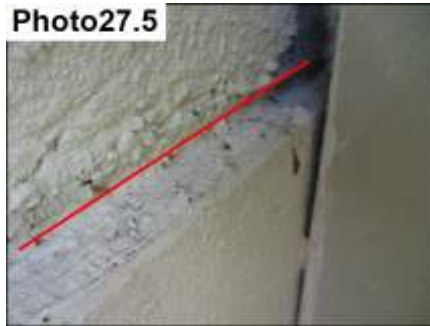
Photo27.5

Window Accent Band/Stucco Termination / Seal

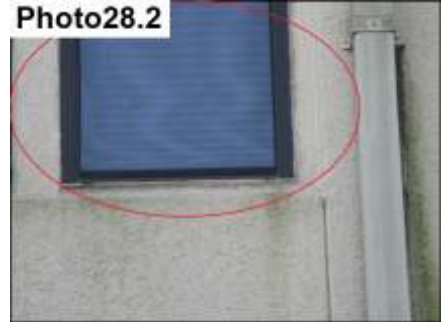
Photo28.2

Refasten & Seal All Screws Then Wet Glaze

Grid Location	Item Description	Moisture Readings	Substrate Condition	Observations
Red Circle	Windows			Fixed windows are noted in these areas with missing and unsealed screws allowing moisture to penetrate the system. The inspector suggests refastening and seal all screws then wet glaze these windows to help decrease the amount of moisture intrusion that can occur at windowpane itself. Glazing the window is using a silicone sealant to seal the glass windowpane to the metal frame. Please refer to photos #28.2, #28.3, #28.4, #28.5 and #28.6 for more detail.

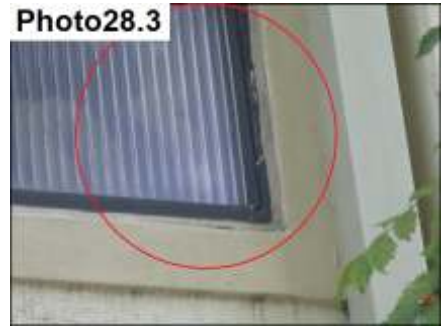
Photo28.3

Refasten & Seal All Screws Then Wet Glaze

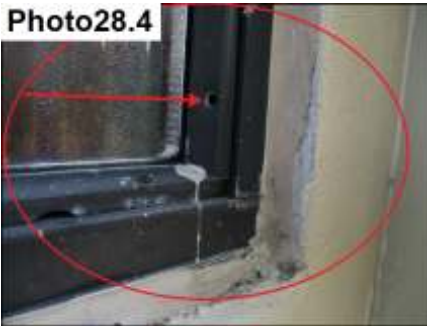
Photo28.4

Refasten & Seal All Screws Then Wet Glaze

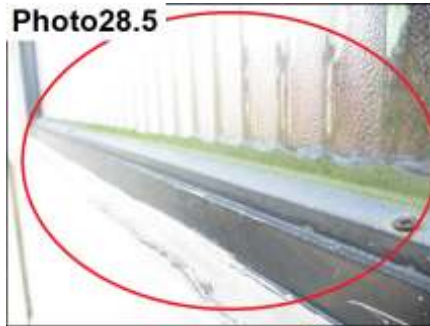
Photo28.5

Refasten & Seal All Screws Then Wet Glaze

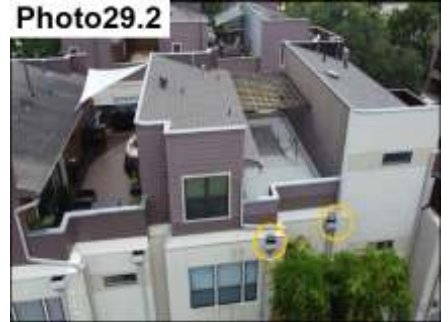
Photo29.2

Scupper Sealants / Seal

Grid Location	Item Description	Moisture Readings	Substrate Condition	Observations
Orange Circle	Scupper			The scupper sealants are aged. The inspector suggests to have a qualified stucco waterproofing contractor seal this area with a low modulus sealant in an effort to prevent moisture intrusion. These types of sealants are of high quality and compatible with stucco and other termination points. Please refer to photos#29.2, #29.3, #29.4, #29.5 and #29.6 for more detail.

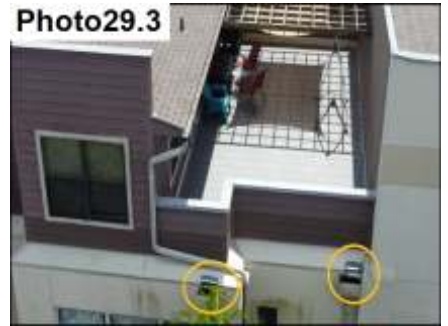
Photo29.3

Scupper Sealants / Seal

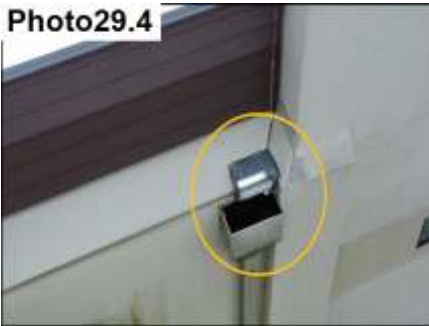
Photo29.4

Scupper Sealants / Seal

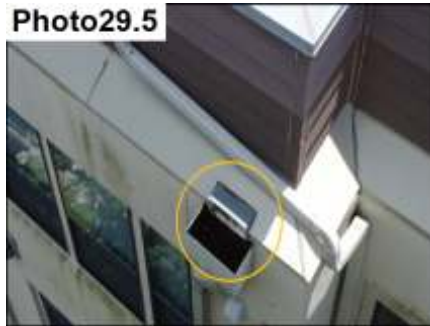
Photo29.5

Scupper Sealants / Seal

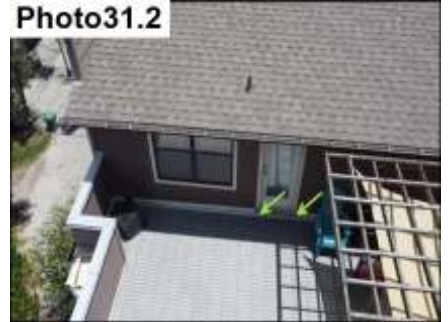
Photo31.2

- The door trim sealants are aged. The inspector suggests to have a qualified waterproofing contractor seal this area in an effort to prevent moisture intrusion. Please refer to photos #31.2 and #31.3 for more detail.

Door Sealant Separation / Seal

Grid Location	Item Description	Moisture Readings	Substrate Condition	Observations
Green Arrows	Doors			The door trim sealants are aged. The inspector suggests to have a qualified waterproofing contractor seal this area in an effort to prevent moisture intrusion. Please refer to photos #31.2 and #31.3 for more detail.

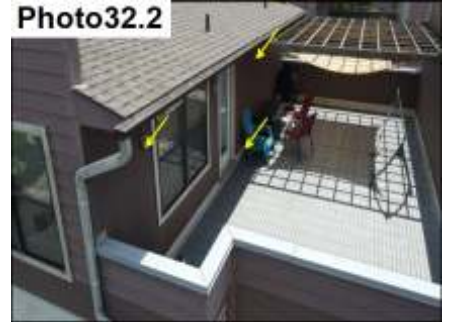
Photo32.2

- The penetration sealants are aged and separated. The inspector suggests to have a qualified waterproofing contractor seal this area in an effort to prevent moisture intrusion. Please refer to photos #32.2 and #32.3 for more detail.

Penetration Sealants / Seal

Grid Location	Item Description	Moisture Readings	Substrate Condition	Observations
Yellow Arrows	Penetrations			The penetration sealants are aged and separated. The inspector suggests to have a qualified waterproofing contractor seal this area in an effort to prevent moisture intrusion. Please refer to photos #32.2 and #32.3 for more detail.

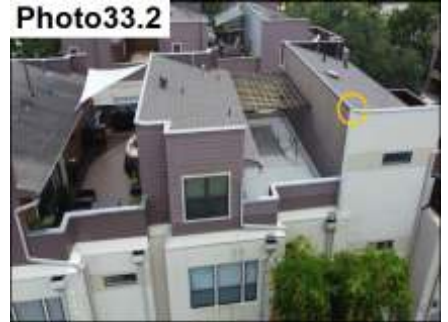
Photo33.2

- The metal cap sealants are aged at these locations. The inspector suggests to have a qualified waterproofing contractor further assess and seal in an effort to prevent moisture intrusion. Please refer to photos #33.2 and #33.3 for more detail.

Metal Cap/Siding Termination / Seal

Grid Location	Item Description	Moisture Readings	Substrate Condition	Observations
Orange Lines	Metal Cap			The metal cap sealants are aged at these locations. The inspector suggests to have a qualified waterproofing contractor further assess and seal in an effort to prevent moisture intrusion. Please refer to photos #33.2 and #33.3 for more detail.
