PROPERTY INSPECTION REPORT

Concerning: 7 Craven Park Court, The Woodlands, TX 77354

By: Todd Goodwin : TREC# 21218

10/16/2019

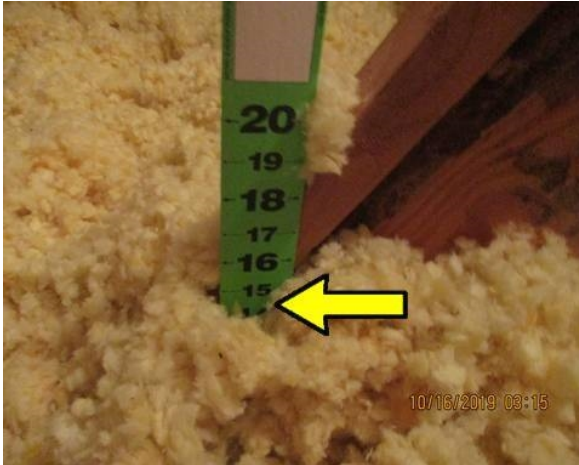
Insulation levels

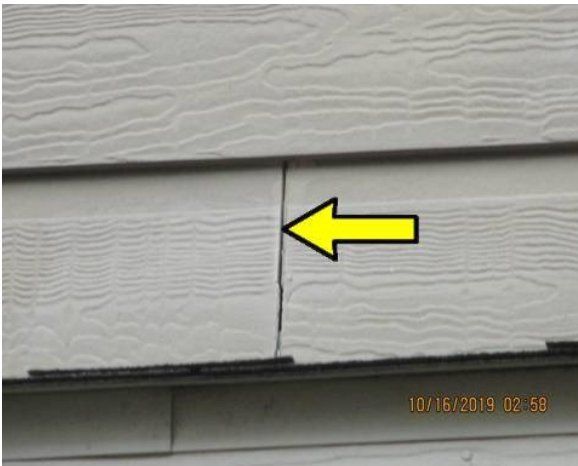
Seal where siding meets

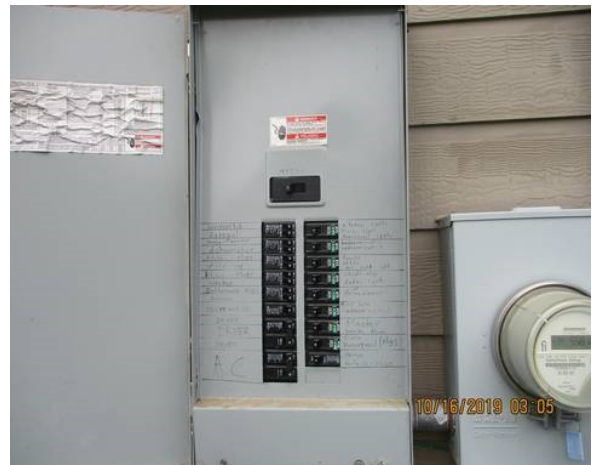
Panel is labeled

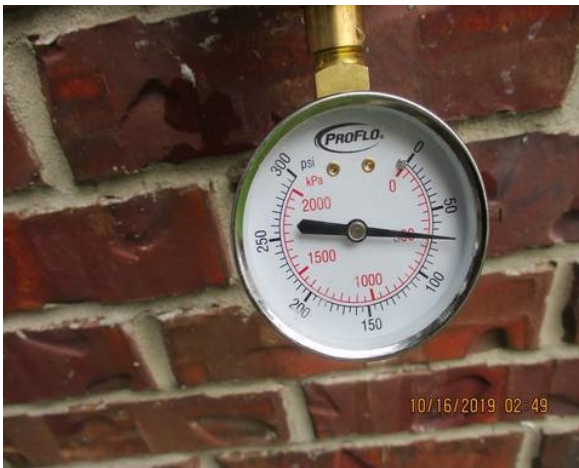
70 psi

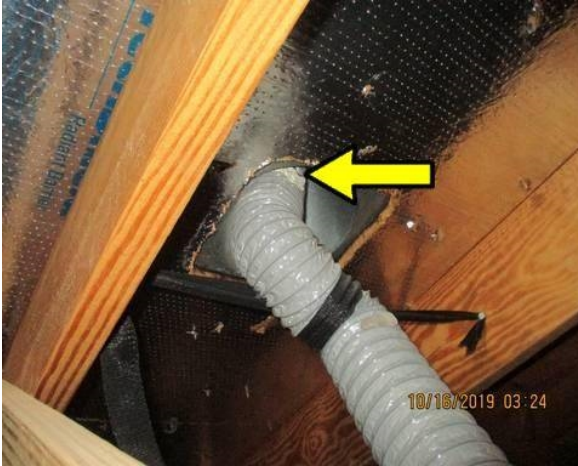
Vents outside as required

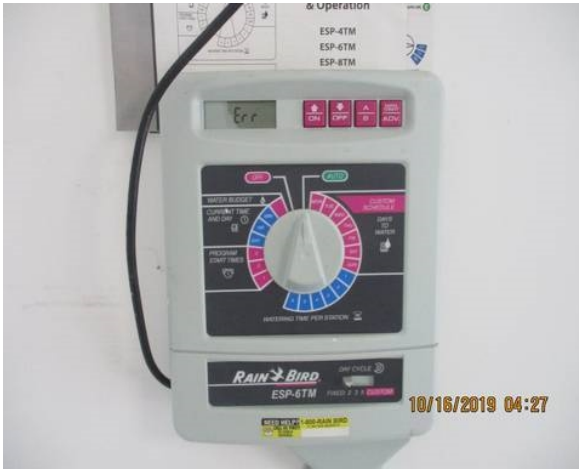
Rain Bird ESP-6TM controller
