Lone Star Stucco, LLC

Moisture Assessment Report

2815 Newman St

2/27/2020

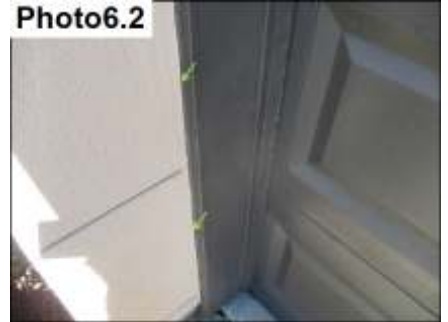
Photo6.2

Door Trim Aged / Seal

- The door sealants are aged and separated. The inspector suggests to have a qualified stucco waterproofing contractor seal this area with a low modulus sealant in an effort to prevent moisture intrusion. These types of sealants are of high quality and compatible with stucco and other termination points. Please refer to photos #6.2 and #6.3 for more detail.

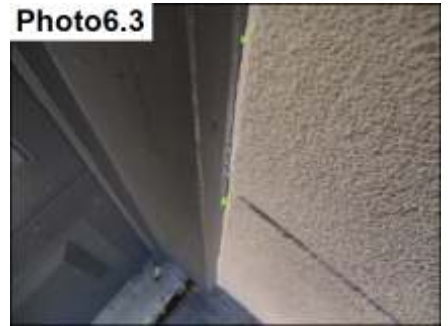
Photo6.3

Door Trim Aged / Seal

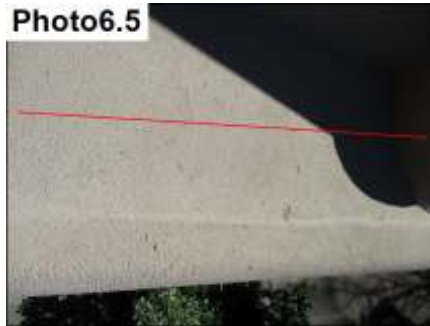
Photo6.5

Angled Accent / Elastomeric Paint

- The angled accent wall paint is deteriorated with hairline cracks. The inspector suggests to have a qualified stucco waterproofing contractor paint this area with elastomeric paint in an effort to prevent moisture intrusion. Please refer to photos #6.4, #6.5 and #6.6 for more detail.

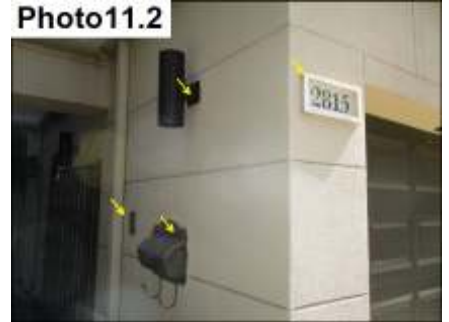
Photo11.2

Penetrations / Seal

- The penetration sealants are aged. The inspector suggests to have a qualified stucco waterproofing contractor seal this area with a low modulus sealant in an effort to prevent moisture intrusion. These types of sealants are of high quality and compatible with stucco and other termination points. Please refer to photos #11.2, #11.3, #11.4, #11.5 and #11.6 for more detail.

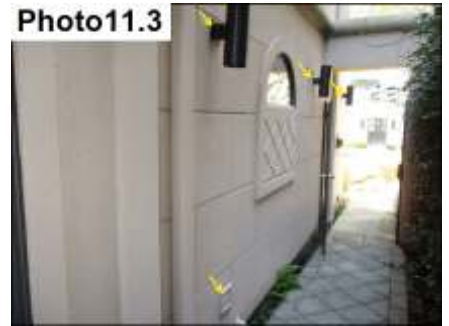
Photo11.3

Penetrations / Seal

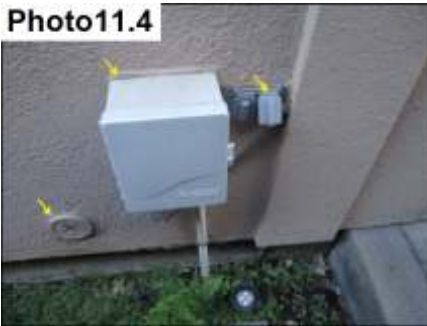
Photo11.4

Penetrations / Seal

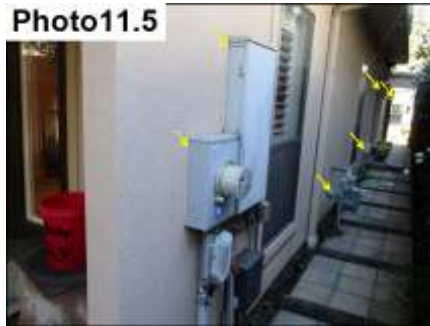
Photo11.5

Penetrations / Seal

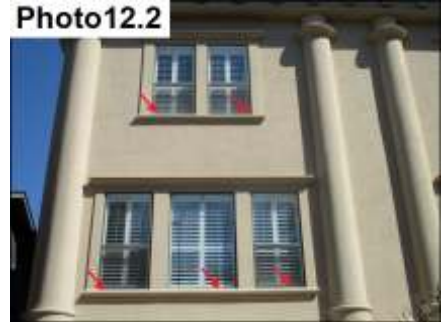
Photo12.2

Windows / Seal

- The window sealants are thin and aged. The inspector suggests to have a qualified stucco waterproofing contractor seal this area with a low modulus sealant in an effort to prevent moisture intrusion. These types of sealants are of high quality and compatible with stucco and other termination points. Please refer to photos #12.2, #12.3, #12.4 #12.5 and #12.6 for more detail.

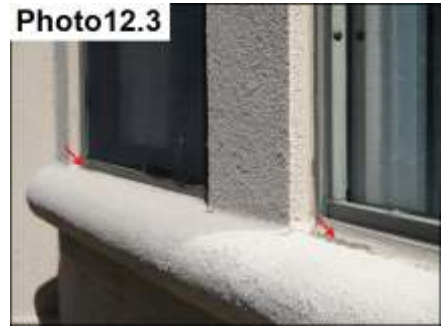
Photo12.3

Windows / Seal

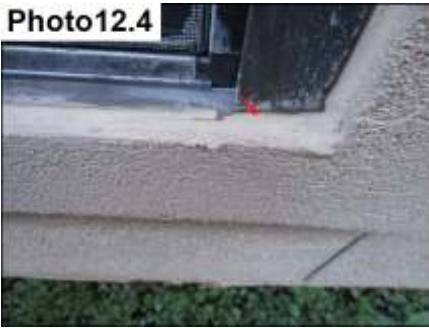
Photo12.4

Windows / Seal

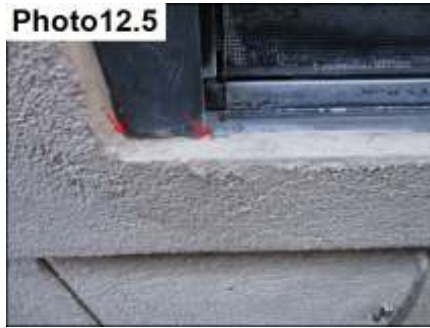
Photo12.5

Windows / Seal

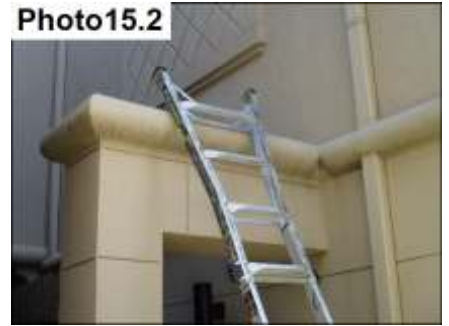
Photo15.2

Flat Accent / Elastomeric Paint Or A Metal Cap

- The entryway has a flat accent. It is recommended that a qualified waterproofing contractor further assess and either apply elastomeric paint or install a metal cap to prevent moisture intrusion. Please refer to photos #15.2, #15.3 and #15.4 for more detail.

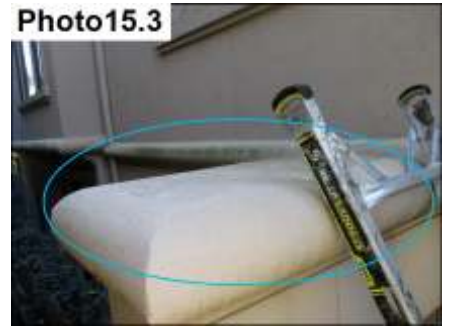
Photo15.3

Flat Accent / Elastomeric Paint Or A Metal Cap

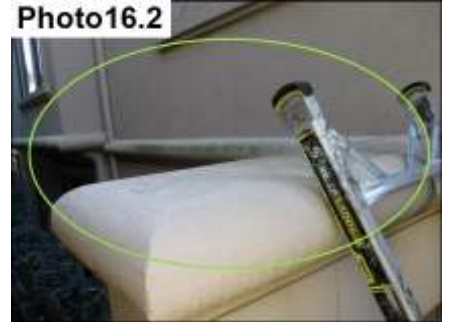
Photo16.2

Mildew / Clean

- Mildew is noted at this location. The inspector suggests to have a qualified stucco waterproofing contractor clean this area. Please refer to photos #16.2, #16.3 and #16.4 for more detail.

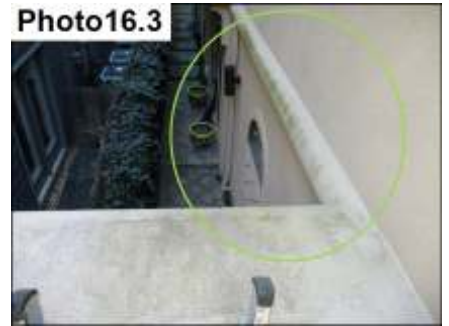
Photo16.3

Mildew / Clean

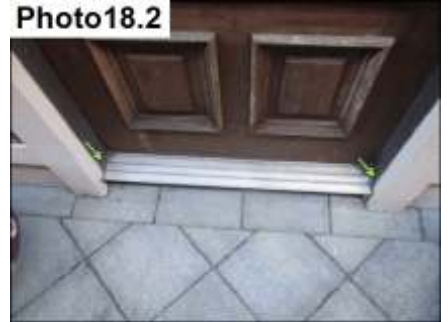
Photo18.2

Door Trim / Seal

- The door sealants are aged and separated. The inspector suggests to have a qualified stucco waterproofing contractor seal this area with a low modulus sealant in an effort to prevent moisture intrusion. These types of sealants are of high quality and compatible with stucco and other termination points. Please refer to photos #18.2, #18.3 and #18.4 for more detail.

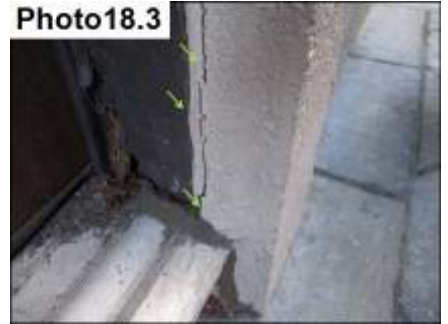
Photo18.3

Door Trim / Seal

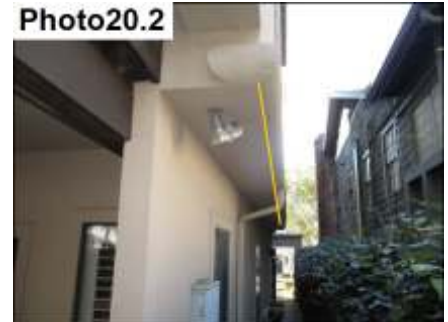
Photo20.2
Bumpout Wall / No Modification

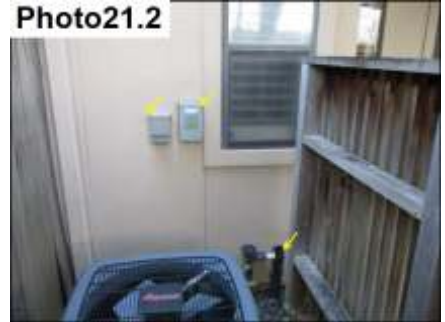
Photo21.2

Penetrations / Seal

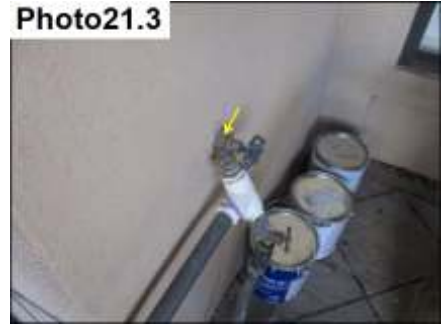
Photo21.3

Penetrations / Seal
