RedFish Inspections

Property Inspection Report

4327 Croft Creek Dr, Spring, TX 77386
Inspection prepared for: Harold Andrew
Real Estate Agent: -

Date of Inspection: 12/12/2018 Time: 11:00 AM - 1:00 PM
Age of Home: New Size: 2738 sqft
Weather: Sunny

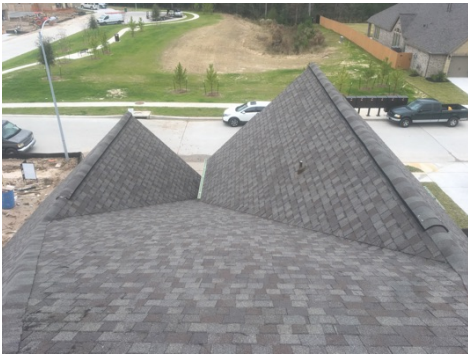
Front

Debris was noted on the roof in the rear and should be removed. All nails should be removed. As the sun heats the shingles, the nail heads will sink into the roof covering which will leave indentations. We recommend cleaning to prevent damaging the shingles.

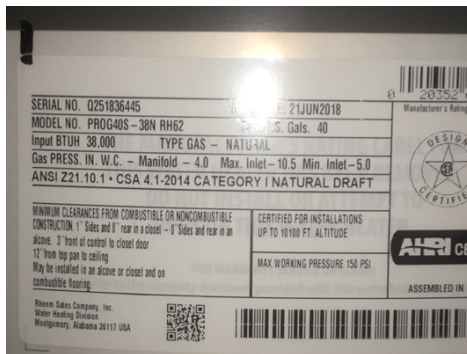
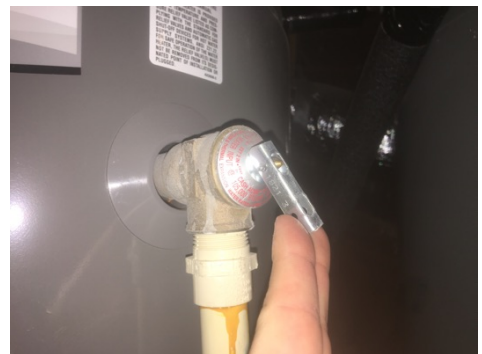
Unit 1: Model and Serial numbers Unit 2: Model and Serial numbers

The unit 1 (rear) water was missing the shield/cover at the burn chamber opening. We recommend having this replaced.

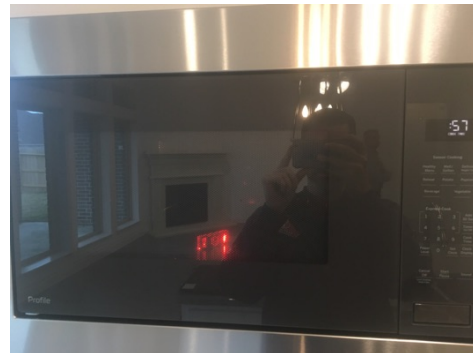
Microwave on
