NationSpec Home Inspection

23615 San Servero Dr, Katy, TX 77493

Date of Inspection: 4/13/2022 Time: 2:00 PM

PROPERTY INSPECTION REPORT

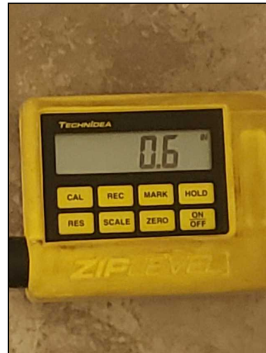
Front door 0.6

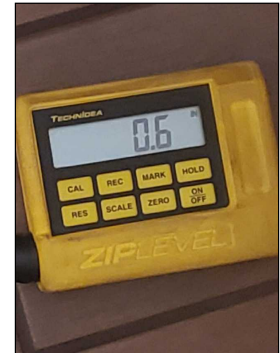
Front left bedroom, front left corner 0.6

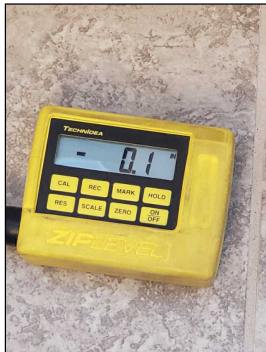
Dining room window -0.1

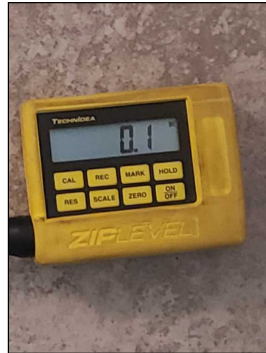
Back door 0.1

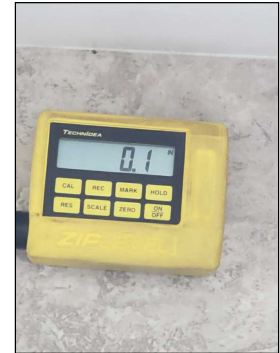
Primary bathroom near tub 0.1

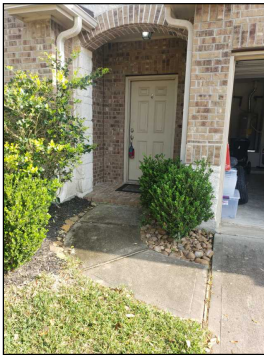
K.1. Cracking was observed in the concrete garage or patio surface

Front entry and walkway

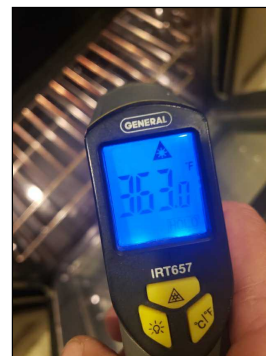
Oven operated within the 350 +/- 25 degrees F range
