Inspection for Property located at 22311 Rolling Meadow Ln
08/04/2021
Prepared for : Cathal and Ina Quinn

PROPERTY INSPECTION REPORT

Concerning: 22311 Rolling Meadow Ln, Katy, TX 77450
(Address or Other Identification of Inspected Property)

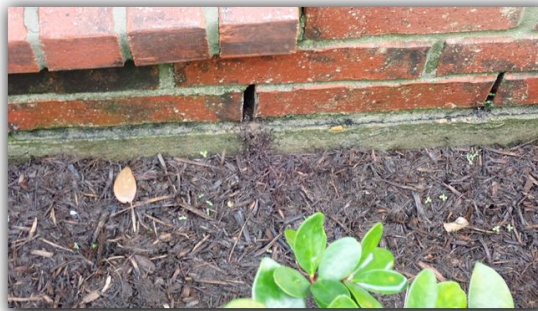
Ants entering house at masonry weep holes, use insecticide treatment, do not seal up weep holes.

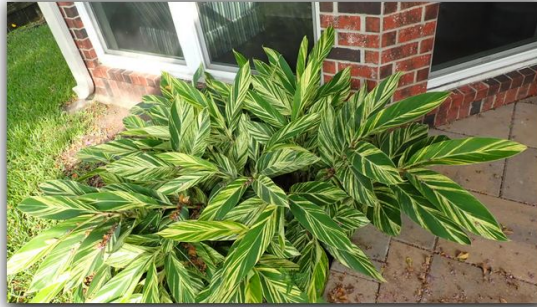
Heavy foliage next to house make it difficult to inspect the foundation and is considered a conducive condition to wood destroying insects such as termites.

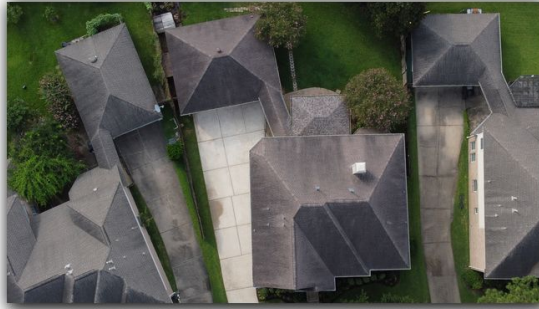
Comments: Missing shingles observed at one or more locations.

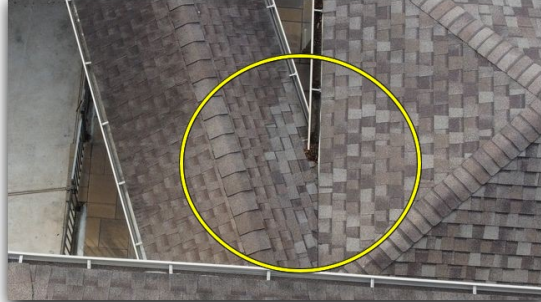
Observed spot repairs to roof surface. Recommend asking the seller about the reason and circumstances requiring repair.

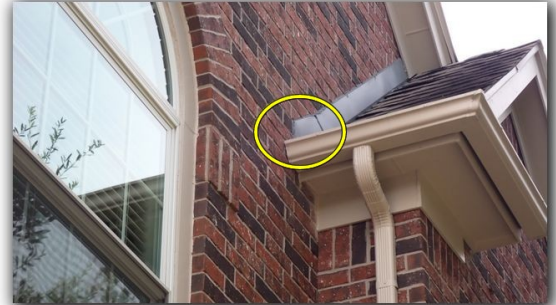
Did not observe "kick out" flashing where a roof terminates along a vertical wall. Kick out flashing encourages rain water running down roof to be diverted / "kicked out" away from vertical wall and reduce water running down vertical wall. IRC R905.2.8.3

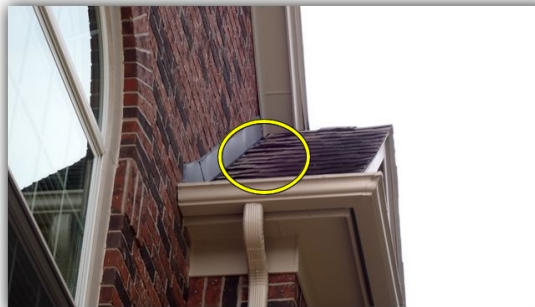
One or more areas of raised shingle tabs from fasteners not secured down properly or nail heads popping up through shingles.

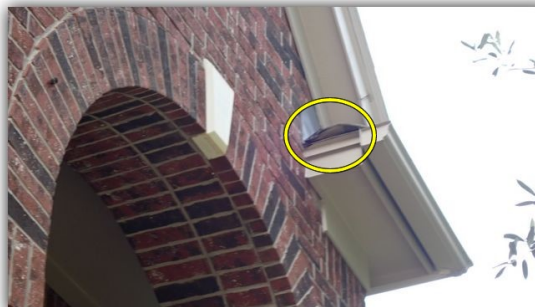
Lower side of flashing is not sealed down, wind driven rains can cause water penetration.

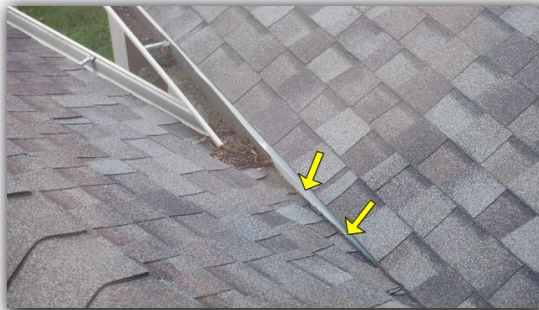
Section of valley with questionable flashing configuration.

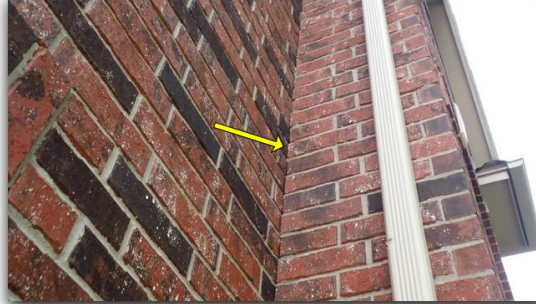
Expansion joint(s) and / or inside corners in brick veneer need caulking. Ensure any mortar present in expansion joint is first removed before sealing.

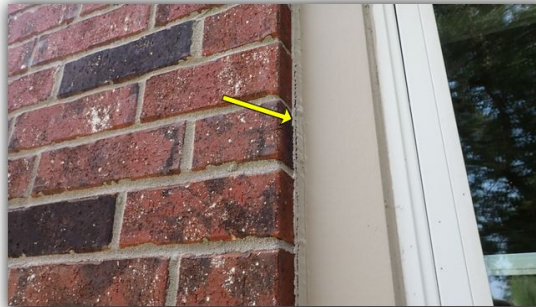
Caulking missing and/or deficient around trim boards may allow wind driven rain entry.

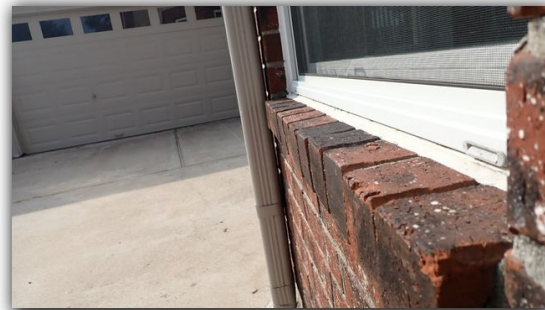
Window brick ledge should have a positive slope to shed water. The slope should be a minimum 15 degrees.

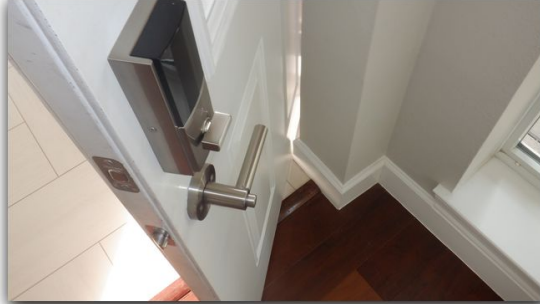
Missing or non-functioning door stop behind one or more doors needed to prevent damage to sheetrock and/or other surfaces.

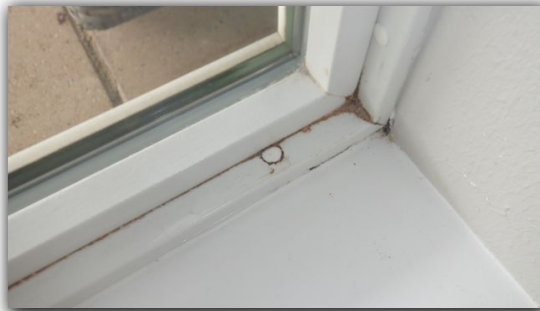
Comments: Evidence of previous condensation on some window frames. Dry at the time of inspection.

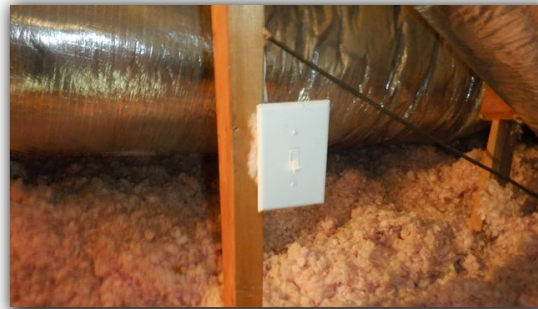
Unknown switch operation; attic.

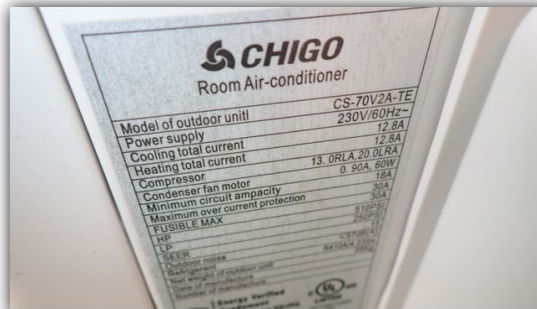
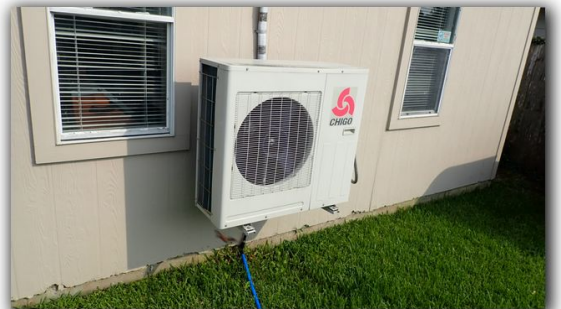
The garage min-split condenser was manufactured by Chigo.

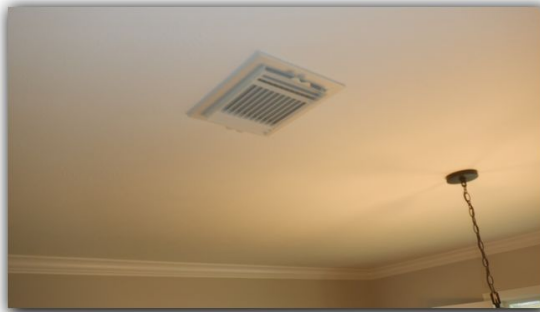
Comments: One or more air registers are facing a direction that may not promote good airflow and temperature comfort. Consider facing the primary flow of the registers towards the outer walls if the room feels uncomfortable.

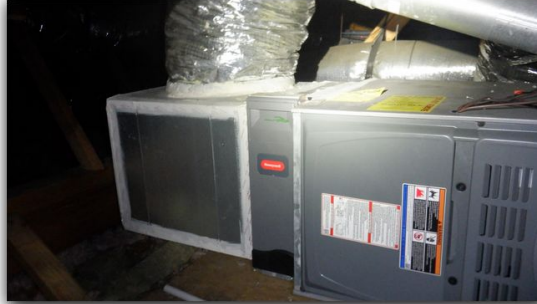
Media air filter(s) located in attic that requires changing/cleaning every 6 months, recommend checking guide for proper maintenance information.

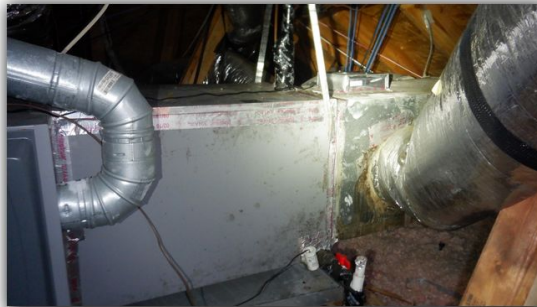
Some staining and possible mold on plenum box/joints. Recommend cleaning.

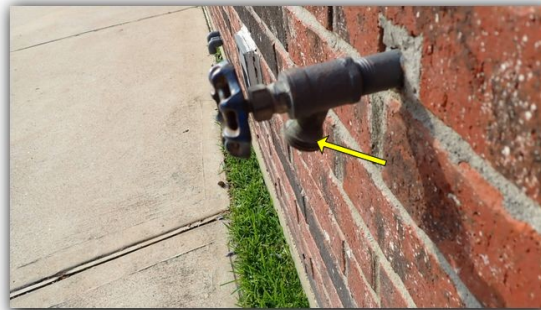
Comments: Exterior hose spigot(s) do not have code approved anti-back flow devices installed.

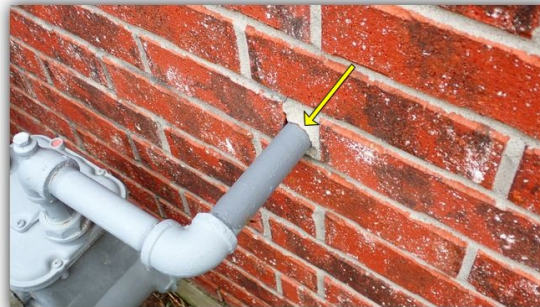
Gas piping not sleeved as it passes through masonry wall as required by Code [CABO 2608.3] IRC 2603.3.

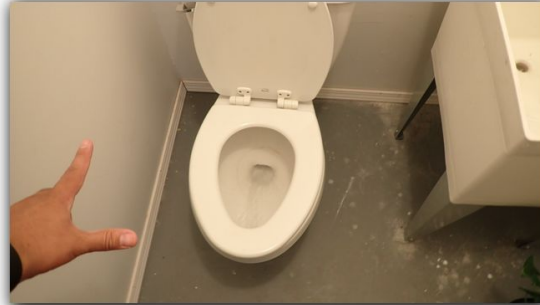
Commode not secured to floor, This condition will leak sewer gas and may also leak water/moisture. Recommend removal of commode, inspection of flange serviceability, install new wax ring and new securing bolts.

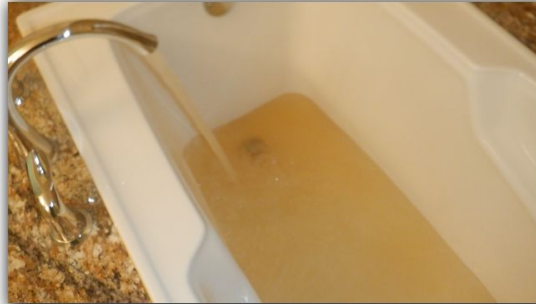
Some rusty water observed when tub was ran, cleared up over time.

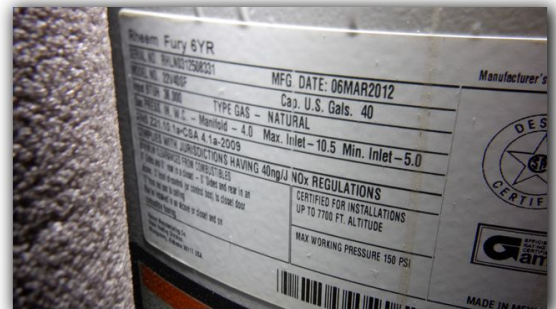
Comments: The water heater data-plates indicate that both units were manufactured in 2012

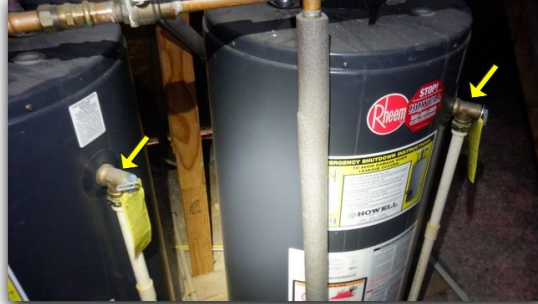
Did not check operation of T&P relief valve since valve is over 3 years old. Most manufacturers recommend replacement of T&P valves over 3 years of age.

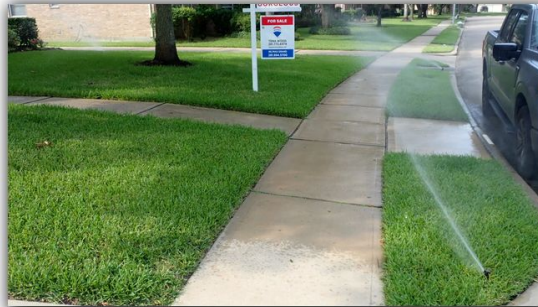
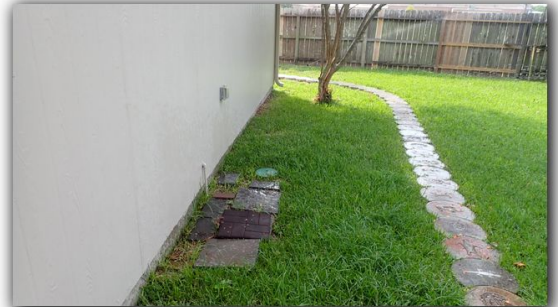
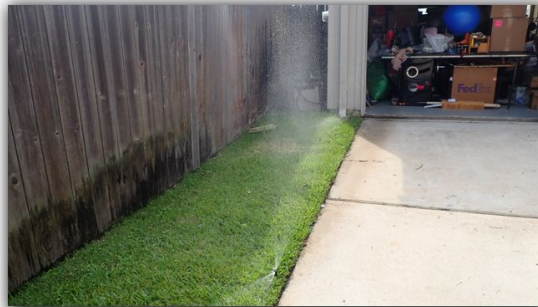
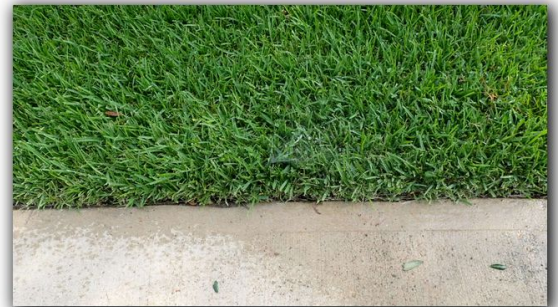
Heads in one or more locations require adjustment due to spray covering areas not needing water (driveways, streets, pools, etc.). Or Heads do not "pop-up" correctly.
