# Your Inspection Report

7109 Delesandri Dr  
Hitchcock, TX 77563

Wednesday, May 11, 2022

# PROPERTY INSPECTION REPORT FORM

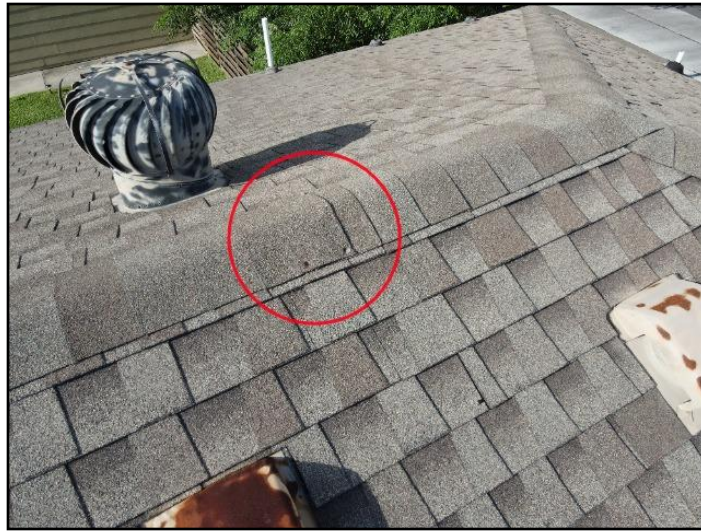
6. Exposed fasteners

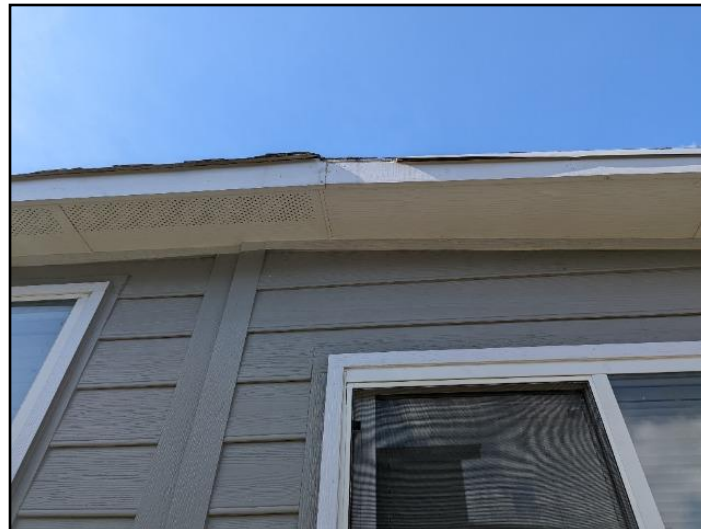
11. Missing

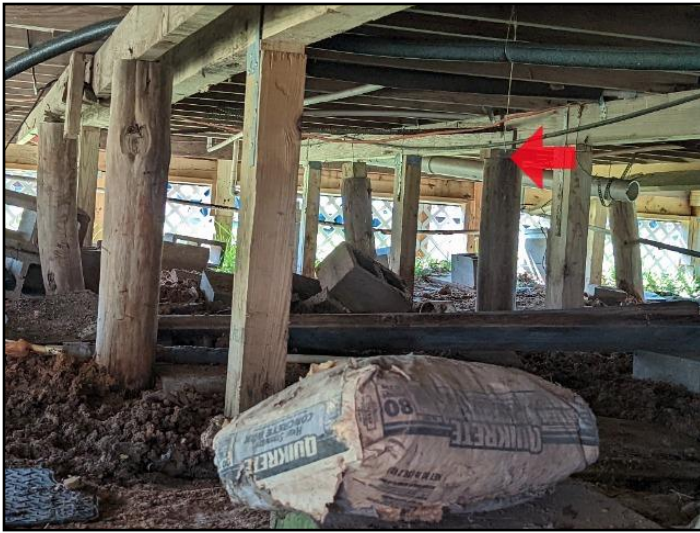
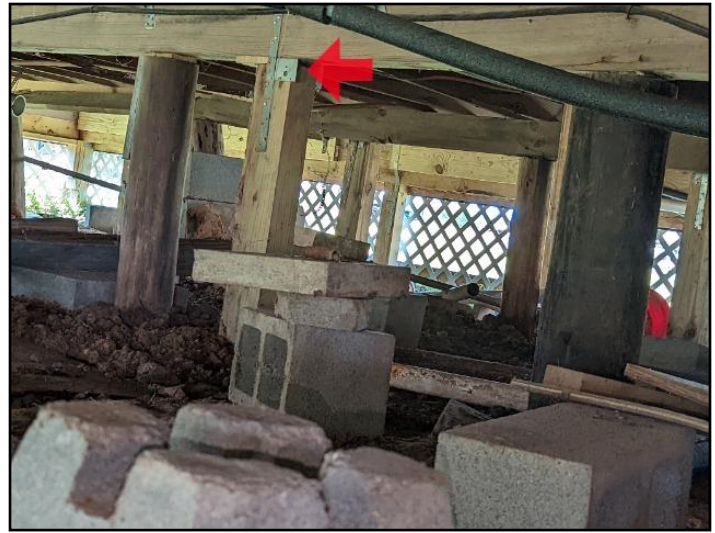
22. Poorly secured at top or bottom

23. Poorly secured at top or bottom

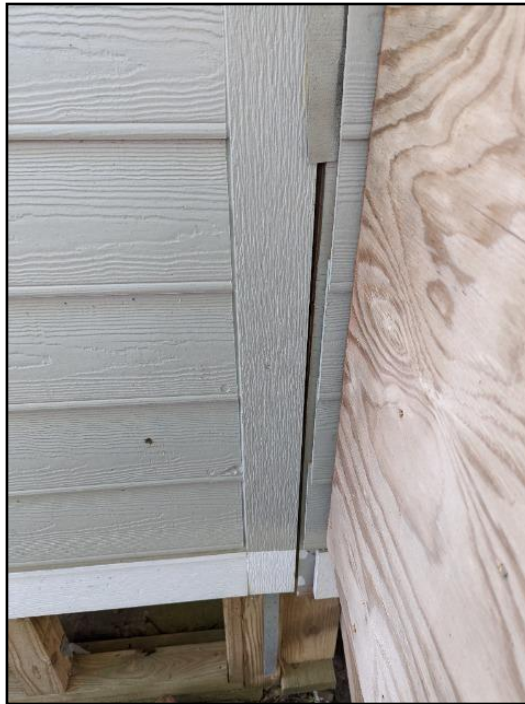
**26.** *Offset excessive*

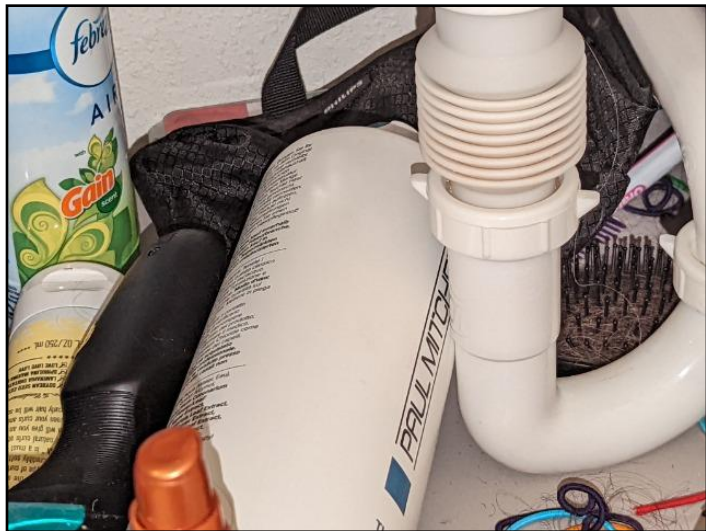
57. Nonstandard shape or material

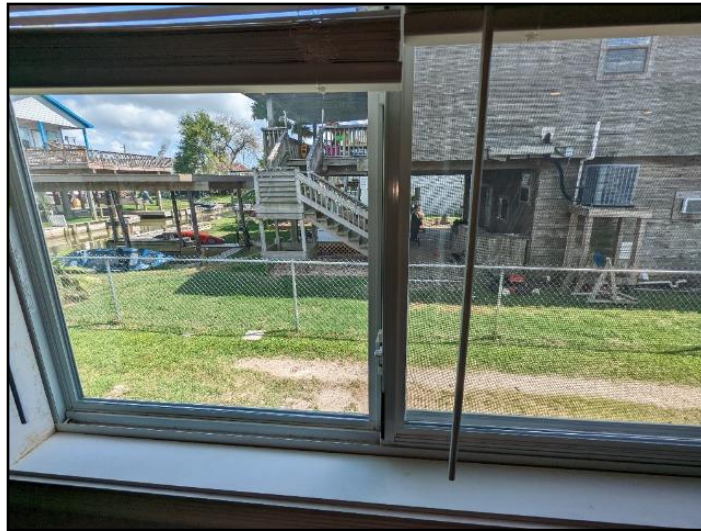
**55. Condition:** • Inoperative

69. Inoperative

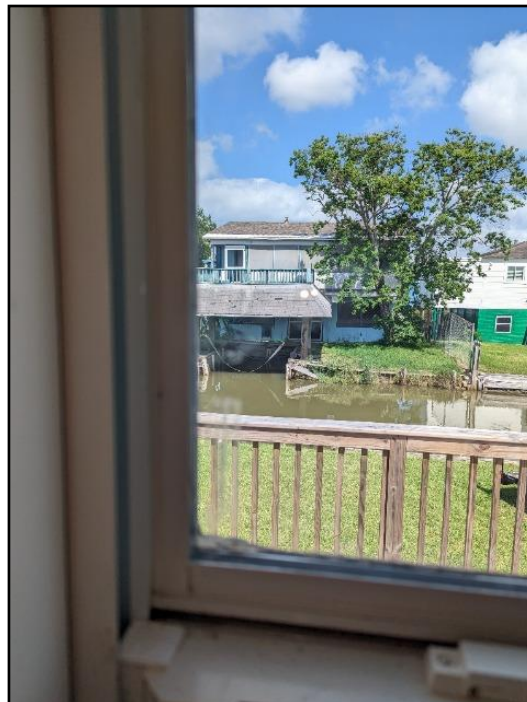
56. Condition: • [Lost seal on double or triple glazing](#)

Implication(s): Shortened life expectancy of material

Location: Rear Family Room

70. Lost seal on double or triple glazing

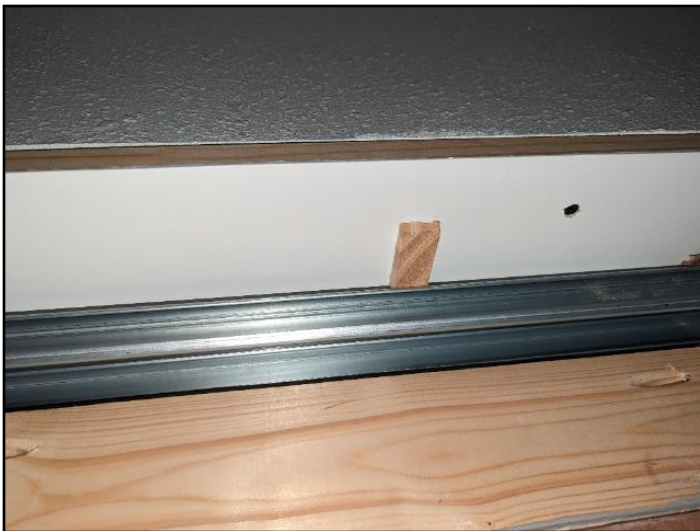
58. Condition: • [Ineffective](#)

**Implication(s):** Equipment ineffective

**Location:** Various Closet

72. Ineffective

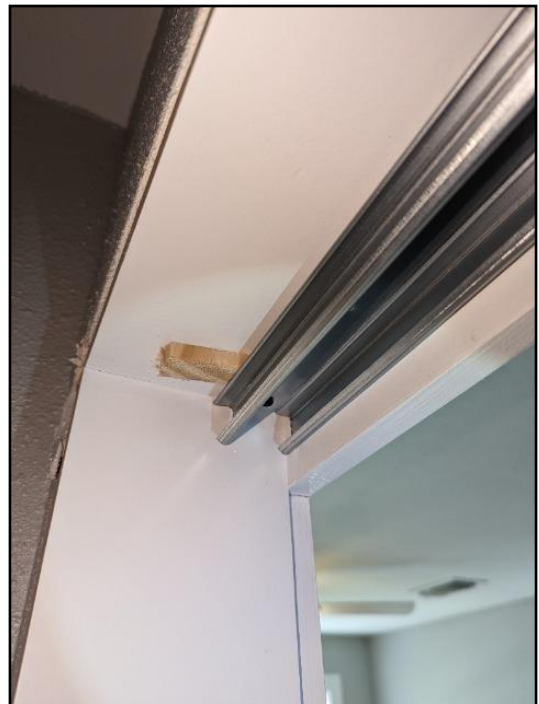
73. Ineffective

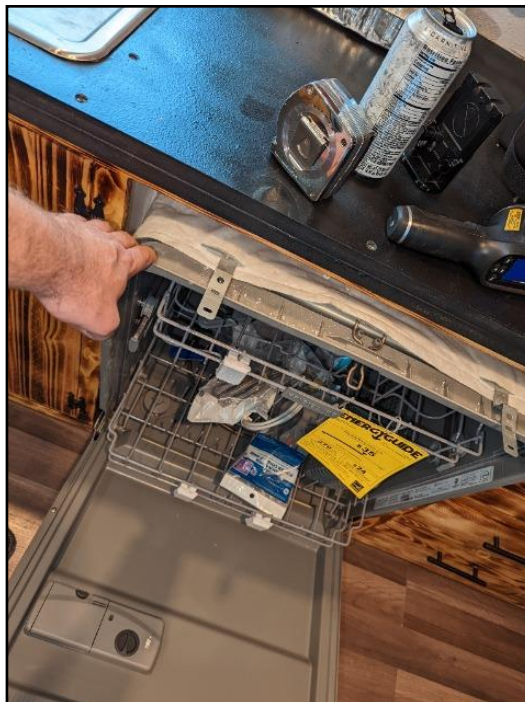
69. Condition: • Inoperative

Implication(s): Equipment inoperative

Location: Kitchen

84. Inoperative
