RESIDENTIAL INSPECTION REPORT

5021 Doolittle Blvd
Houston TX 77033

Jennelle Shaw
SEPTEMBER 2, 2020

PROPERTY INSPECTION REPORT

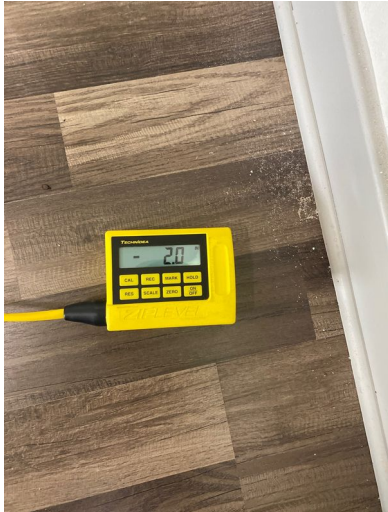
Possible prior repairs:

Note: There was evidence of possible previous foundation repairs. All available repair documentation and possible warranty documentation should be provided by seller/property owner.

1: Evidence of Foundation Settlement Present

Recommendation: Contact a qualified structural engineer.

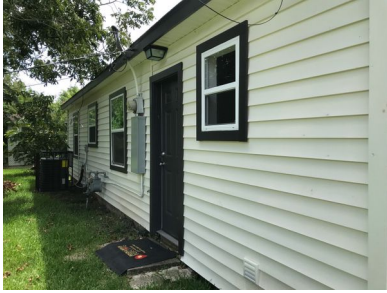
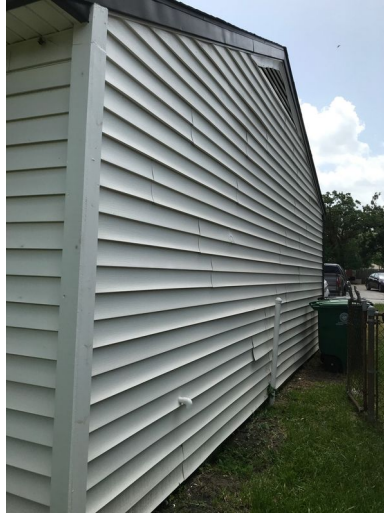
Vinyl/Metal Siding can hide defects:

Vinyl/metal siding can hide defects behind the wall. The inspector cannot verify the presence of other siding materials or their condition behind the siding. If further evaluation is desired, consult with a qualified contractor.

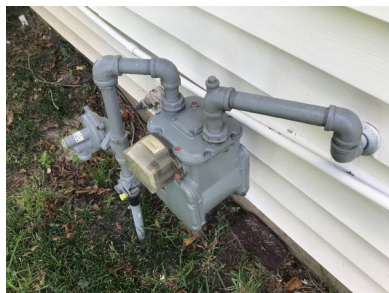
Unable to Verify Gas Line Bonding:

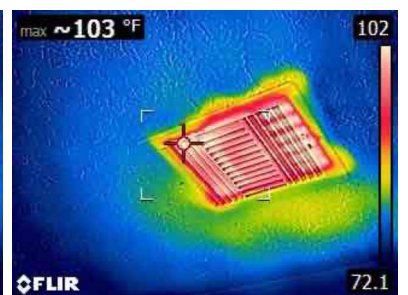
Heating System was Functioning:

The Heating System was functioning at the time of inspection. Refer to the Inspection Report for any further recommendations.

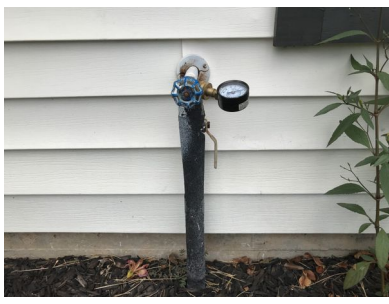
Location of water meter: Front yard near street
Location of main water supply valve: Exterior Wall - Rear

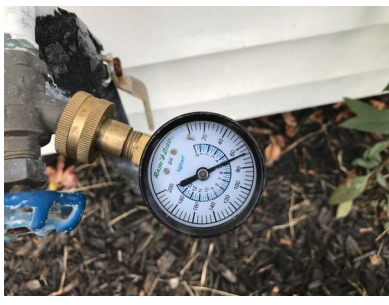
Static water pressure reading: 65 psi
