Your Inspection Report

404 South Beauregard Street
Alvin, TX 77511

INSPECTION DATE:
Thursday, March 16, 2023

PROPERTY INSPECTION REPORT FORM

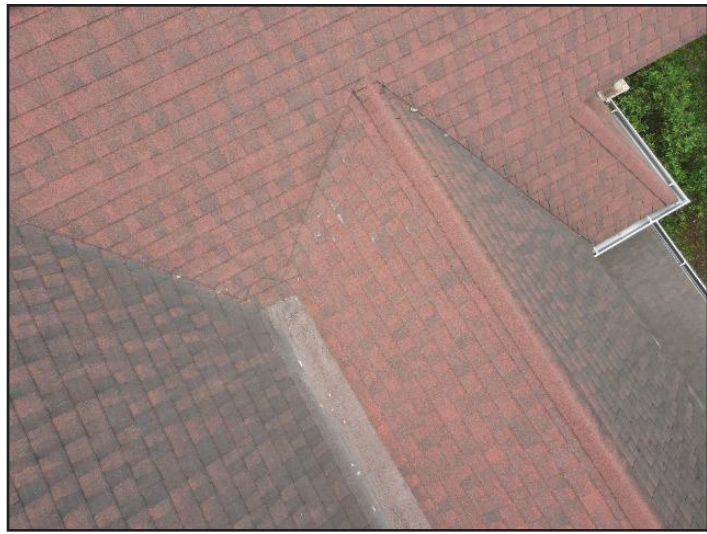
5. Vulnerable areas

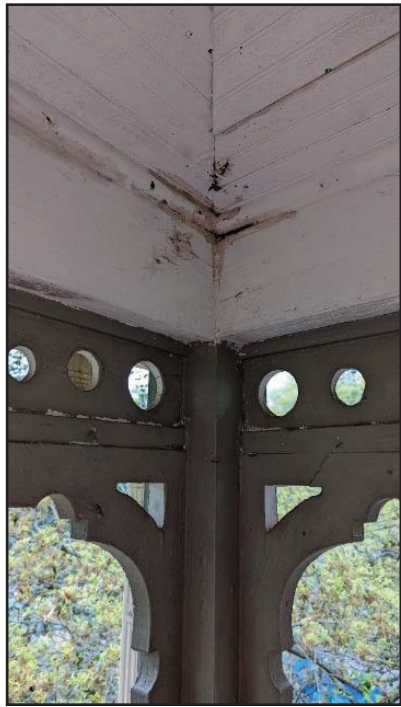
13. Rot or insect damage

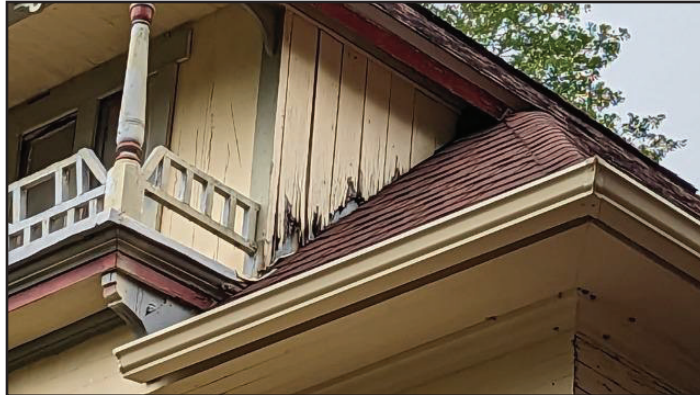
16. Rot

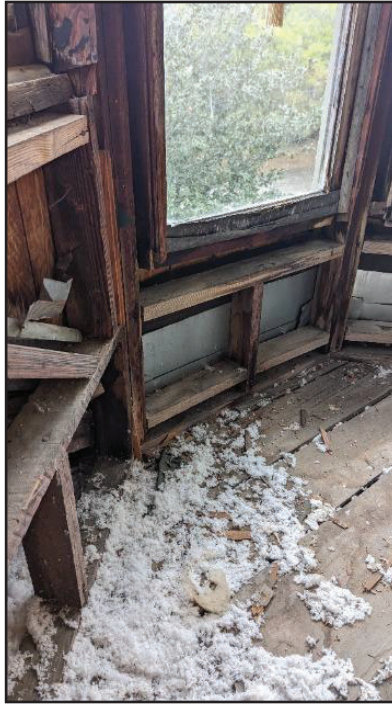
18. Water damage

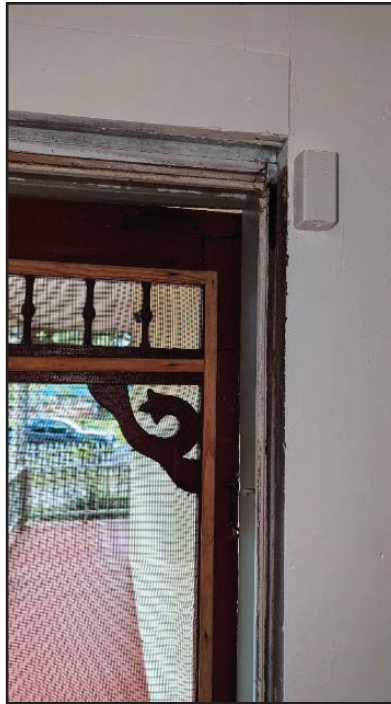
Implication(s): Chance of damage to finishes and structure | Reduced operability

Location: Various Exterior

20. Racked

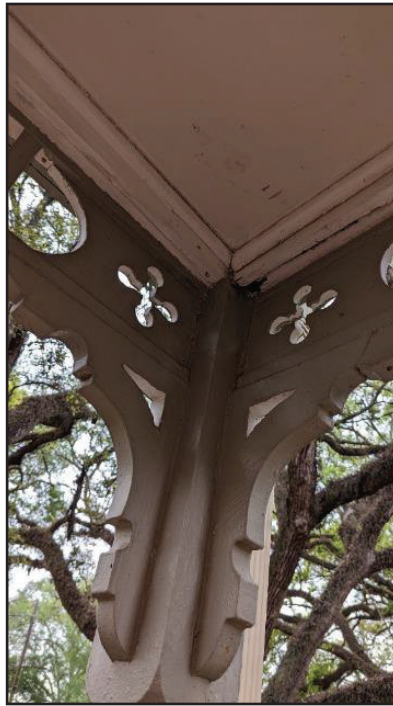
21. Rot or insect damage

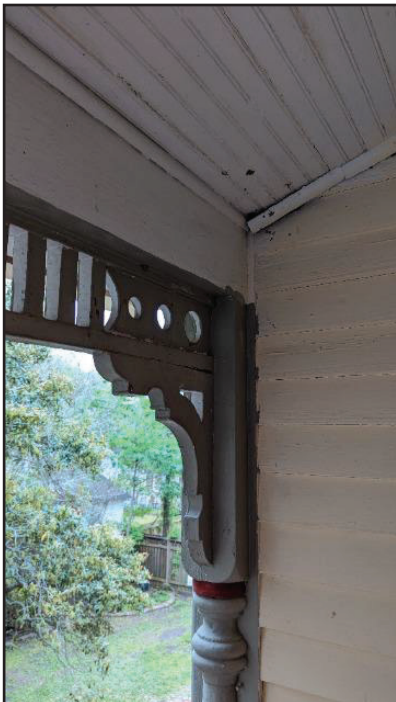
20. Condition: • [Settled](#)

Implication(s): Weakened structure | Chance of movement

Location: Various Porch

22. Settled

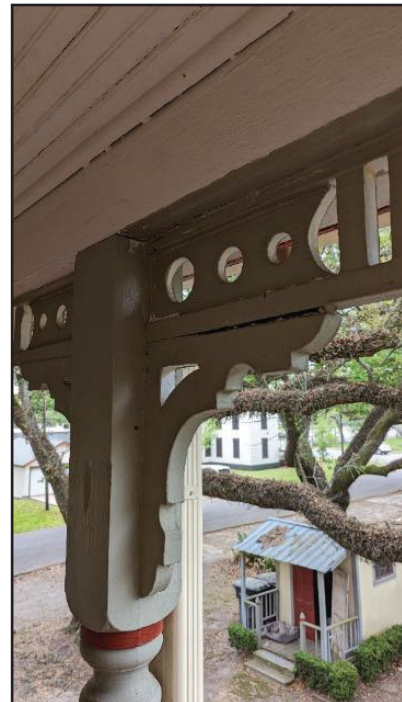
23. Settled

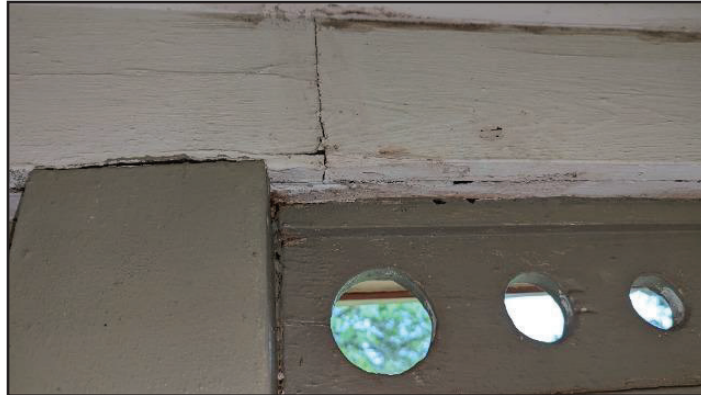
25. Rot or insect damage

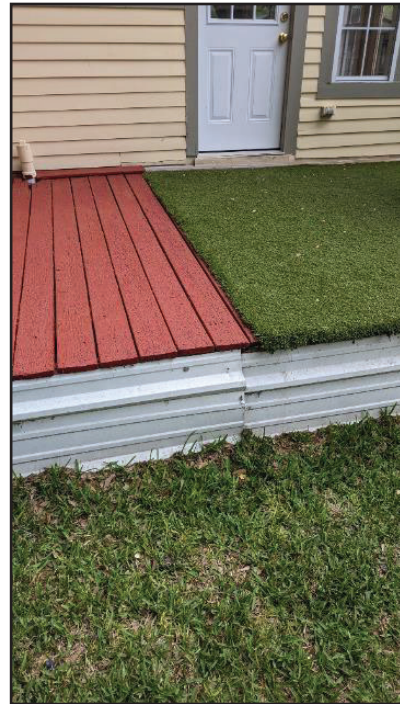
30. Wood/soil contact

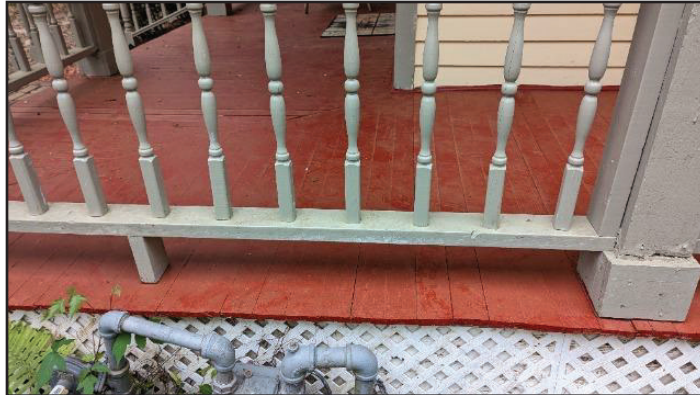
34. Spindles (balusters) climbable

30. Condition: • [Spindles \(balusters\) climbable](#)

Implication(s): Fall hazard

Location: Various Throughout

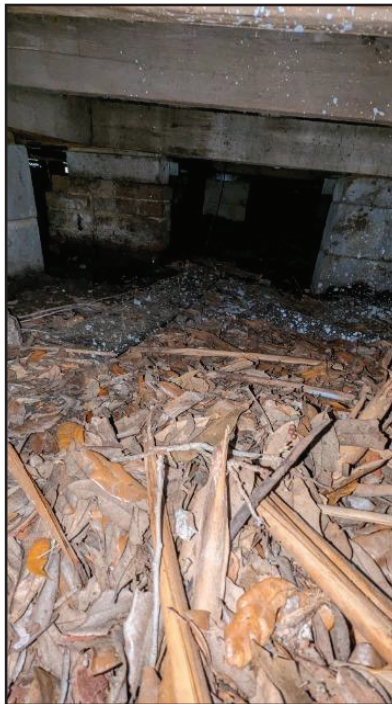
35. Disturbed ground

31. Condition: • [Disturbed ground](#)

Implication(s): Loss of proper slope for drainage

Location: Various Crawl Space

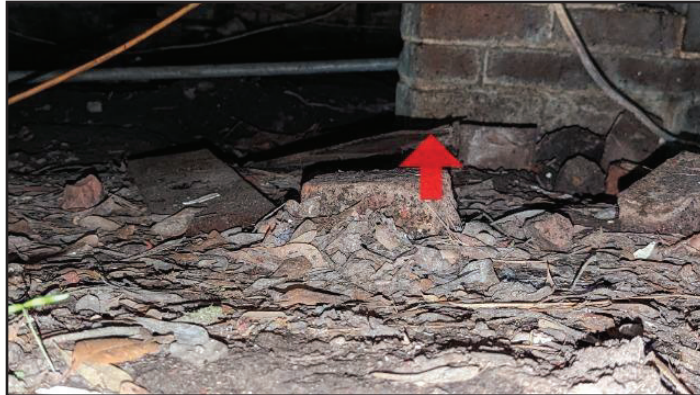
42. Settled

34. Condition: • Foundation appears to have been repaired previously with new masonry columns, flashing, and shims to level out the major beams. This appears to have caused major fireplace footings to be damaged and caused some racking in the windows and doorways. Monitor the foundation for possible future movement. No cross bridging or joist bracing was noted at the time of the inspection and can cause springy flooring.

35. Condition: • [Settled](#)

Implication(s): Weakened structure | Chance of structural movement

Location: Various Crawl Space

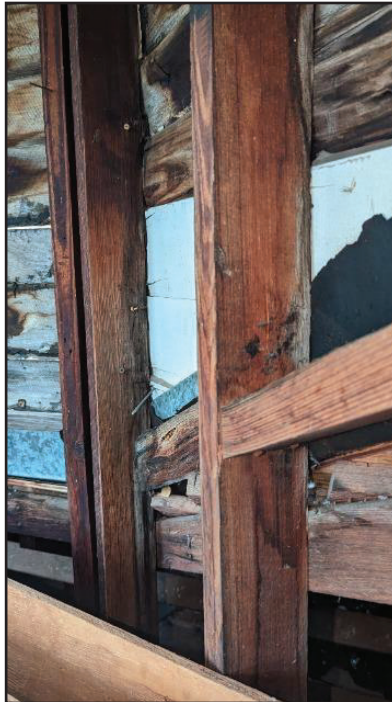
46. Rot

39. Condition: • [Rot](#)

Implication(s): Weakened structure

Location: Various Attic Turret

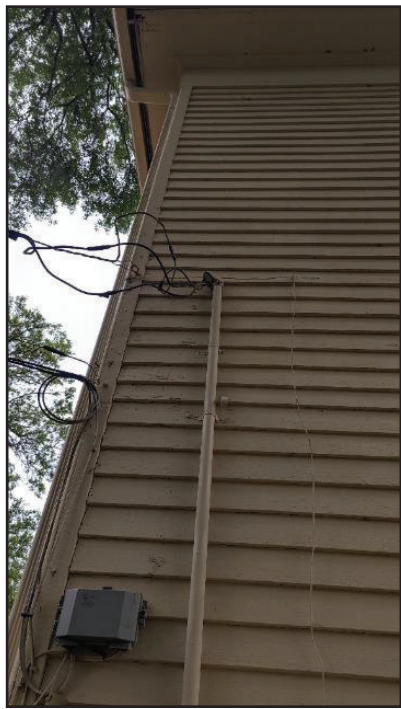
53. No drip loop

44. Condition: • [No drip loop](#)

Implication(s): Shock hazard or interruption of electrical service

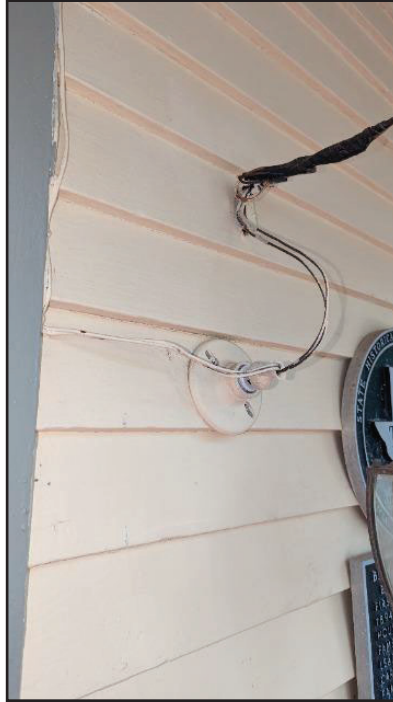
60. Not suitable for use

51. Condition: • [Not suitable for use](#)

Implication(s): Shortened life expectancy of material | Electric shock

Location: Front Exterior Wall

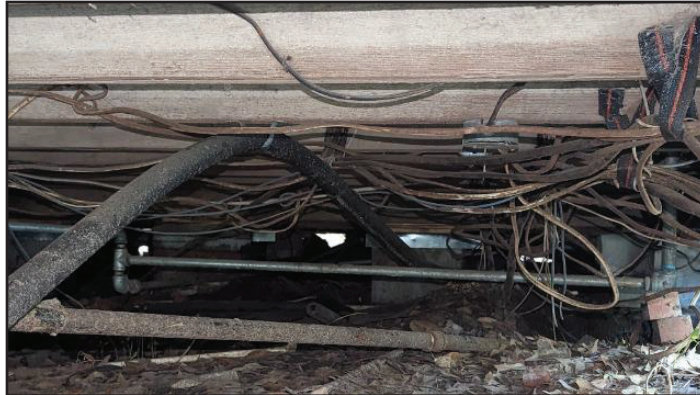
62. Missing

53. Condition: • [Missing](#)

Implication(s): Electric shock | Fire hazard

Location: Various Crawl Space

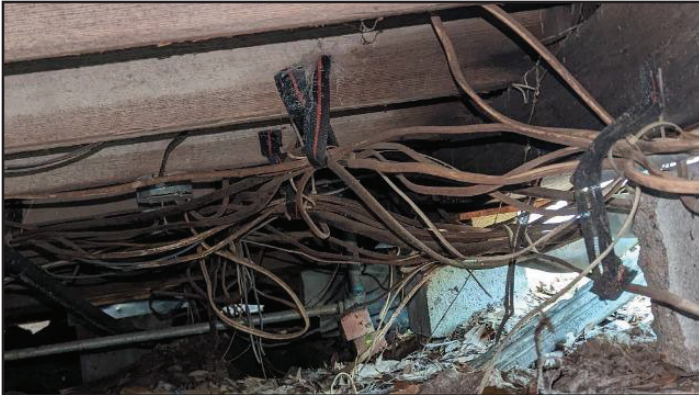
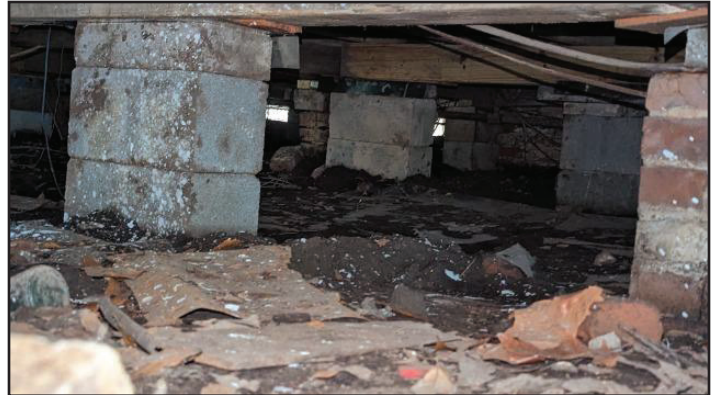
64. Overcrowded

55. Condition: • [Overcrowded](#)

Implication(s): Electric shock | Fire hazard

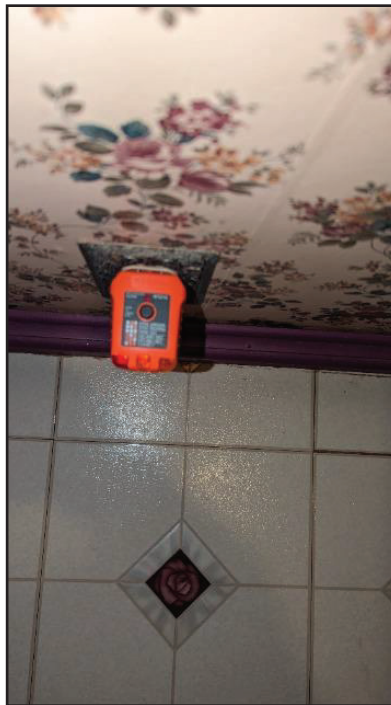
66. Open hot

56. Condition: • [Open hot](#)

Implication(s): Electric shock

Location: Middle Kitchen

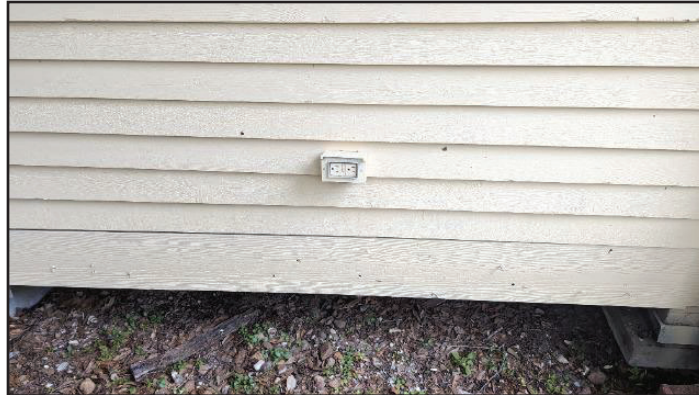
57. Condition: • Not suitable for outdoor (exterior) use

Implication(s): Shock hazard or interruption of electrical service

67. Not suitable for outdoor (exterior) use

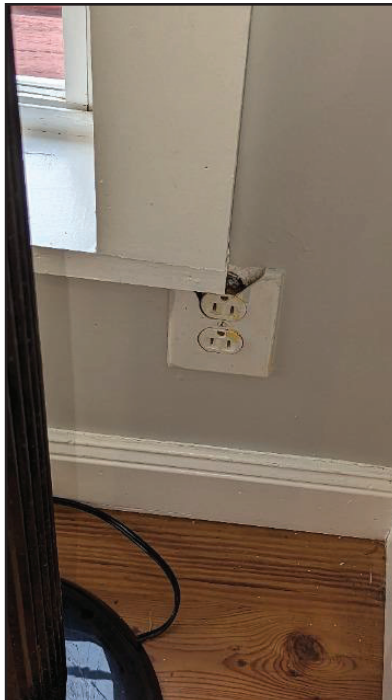
62. Condition: • [Damaged](#)

Implication(s): Electric shock

Location: Rear Right Dining Room Kitchen

72. Damaged

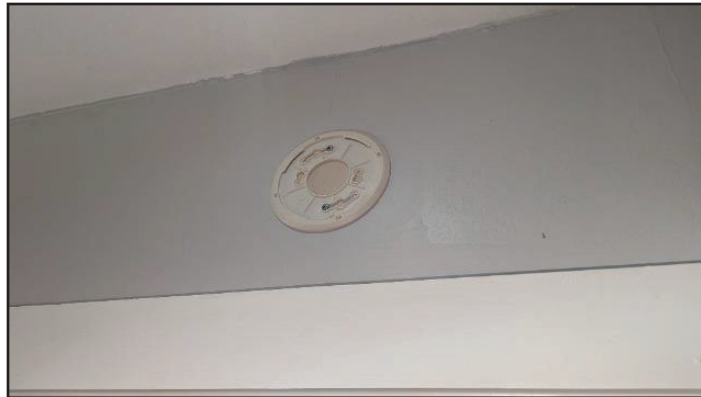
65. Condition: • Missing

75. Missing

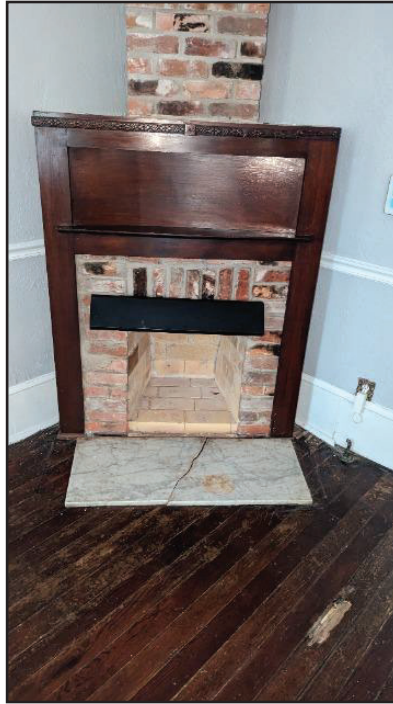
67. Condition: • Not functional

77. Not functional

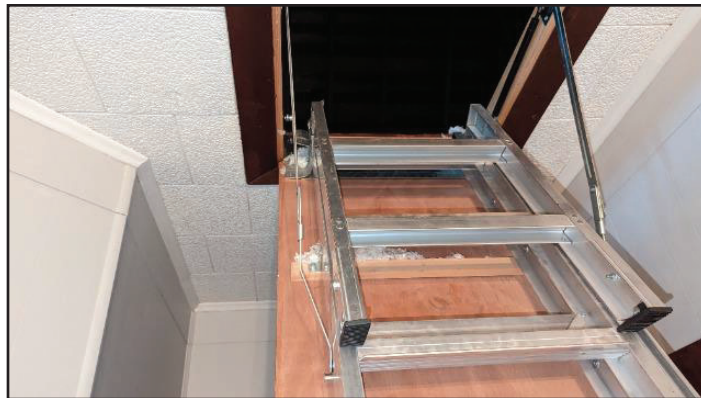
72. Condition: • [Not insulated](#)

85. Not weatherstripped

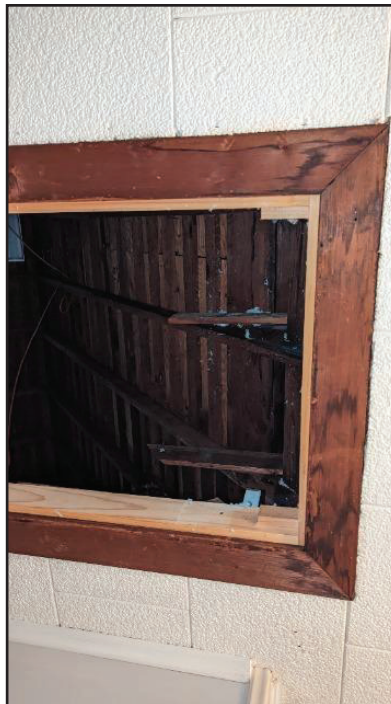
73. Condition: • [Not weatherstripped](#)

Implication(s): Chance of condensation damage to finishes and/or structure | Increased heating and cooling costs | Reduced comfort

86. Not weatherstripped

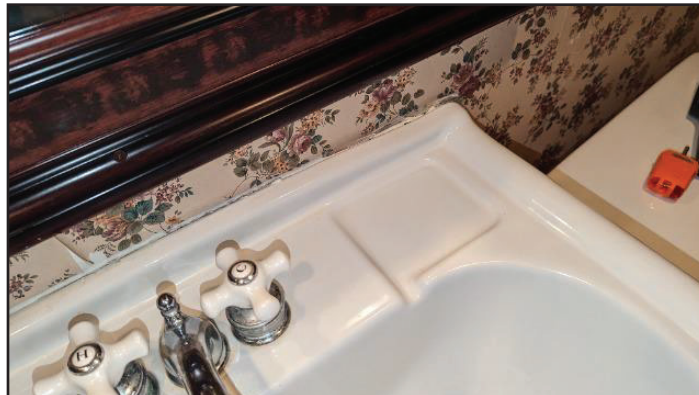
82. Condition: • [Loose](#)

Implication(s): Chance of water damage to structure, finishes and contents | Damage or physical injury due to falling materials | Sewage entering the building

Location: First Floor Hallway Bathroom

101. Loose

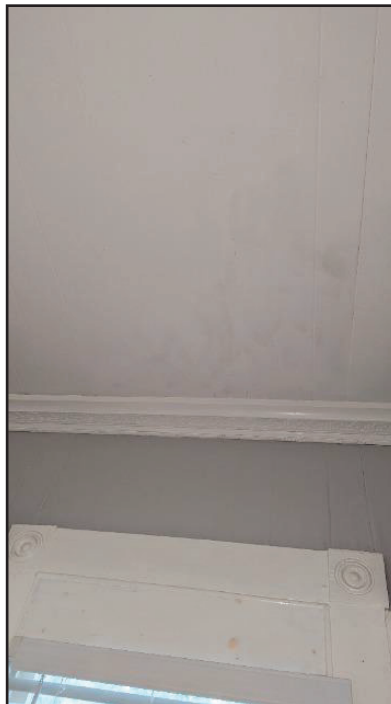
110. Water damage

89. Condition: • [Water damage](#)

Implication(s): Chance of movement | Rot | Leakage

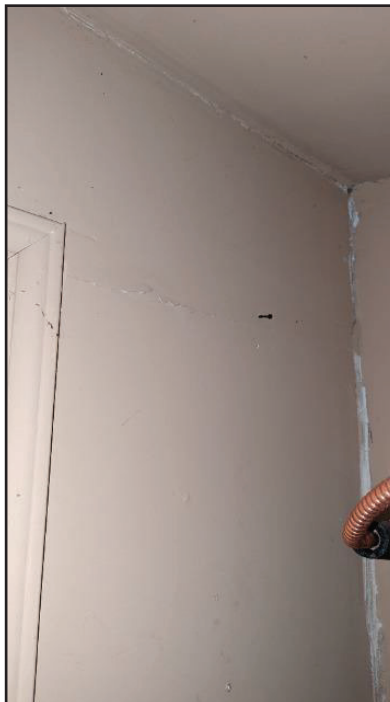
112. Cracks

91. Condition: • Cracks

Implication(s): Chance of structural movement | Damage or physical injury due to falling materials

Location: Front Laundry Area

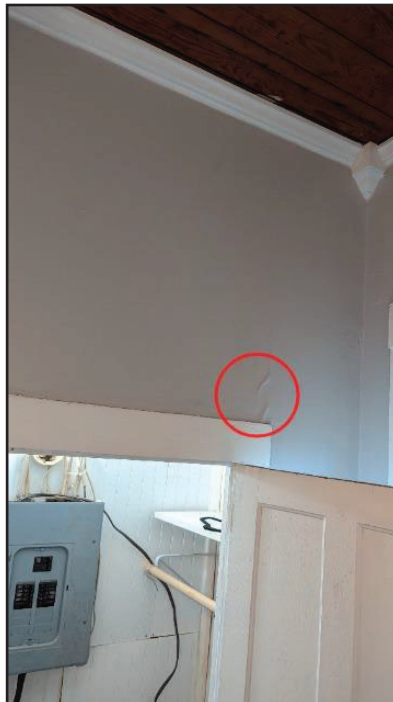
114. Poor joints

93. Condition: • [Poor joints](#)

Location: Various

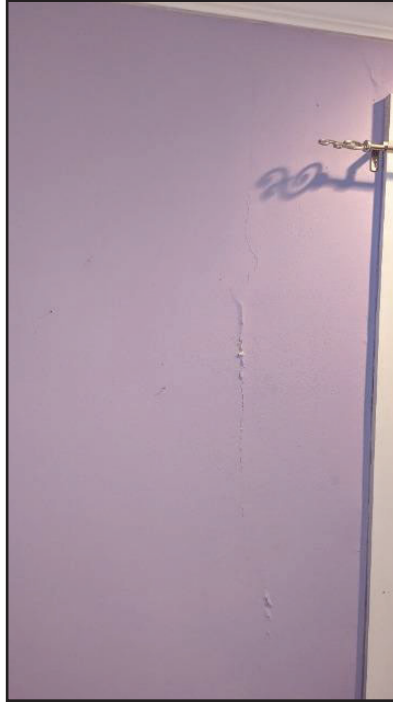
115. Cracked

94. Condition: • [Cracked](#)

Location: Various Rear Second Floor Master Bedroom

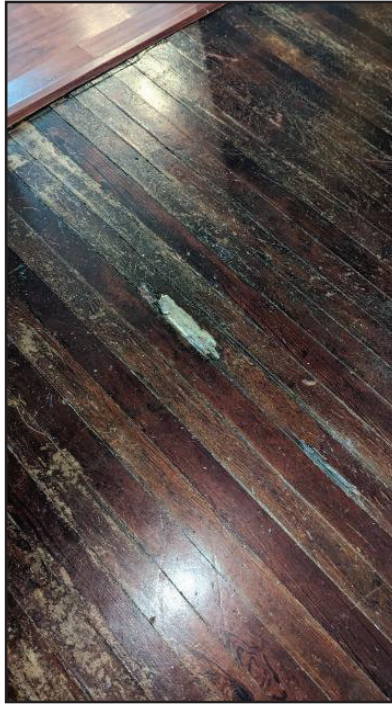
116. Mechanical damage

95. Condition: • [Mechanical damage](#)

Implication(s): Trip or fall hazard

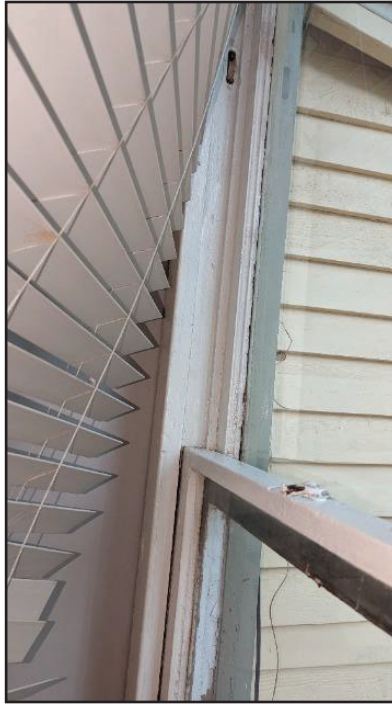
118. Original lower quality units

97. Condition: • [Original lower quality units](#)

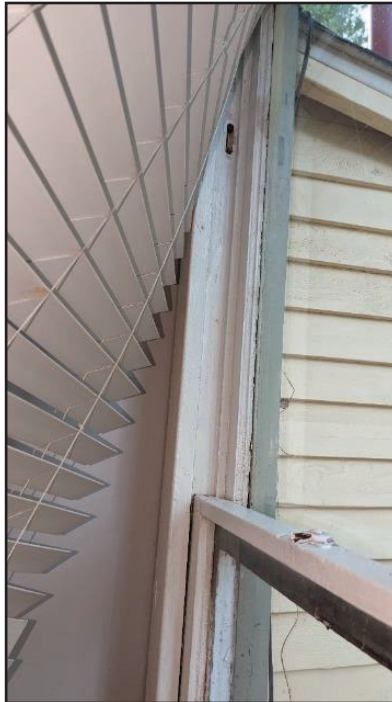
119. Painted shut

98. Condition: • Painted shut

Implication(s): Nuisance | Equipment inoperative

Location: Various

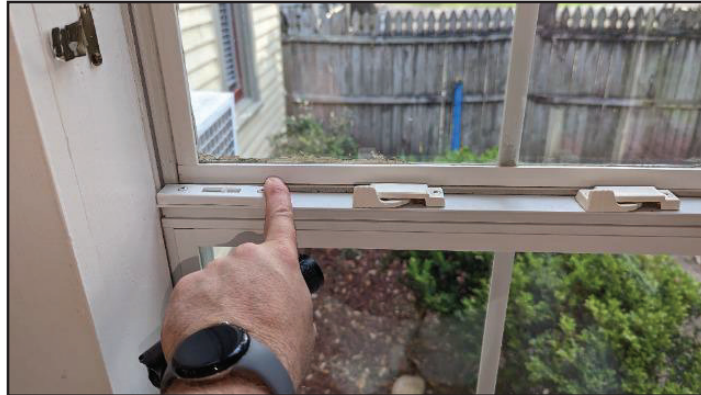
122. Lost seal on double or triple glazing

101. Condition: • [Lost seal on double or triple glazing](#)**Implication(s):** Shortened life expectancy of material**Location:** Left Side Dining Room Kitchen

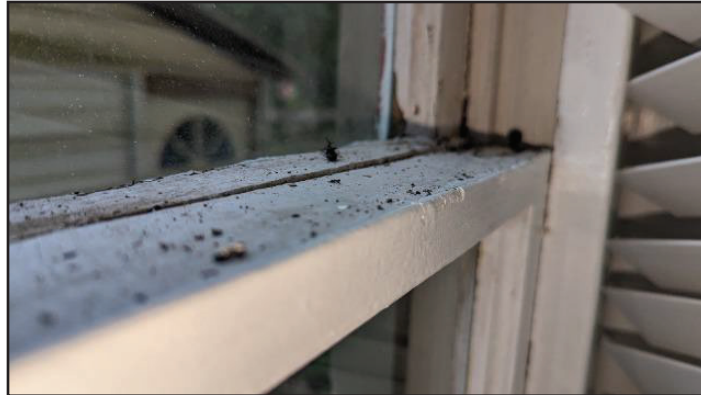
123. Stiff

102. Condition: • [Stiff](#)

Implication(s): Reduced operability

Location: Various

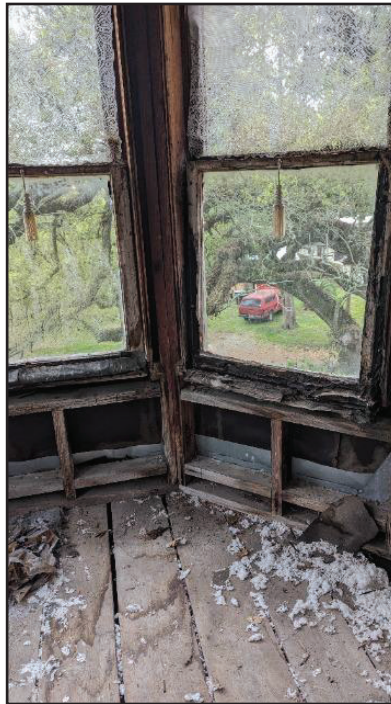
124. Rot

103. Condition: • [Rot](#)

Implication(s): Chance of damage to structure | Material deterioration

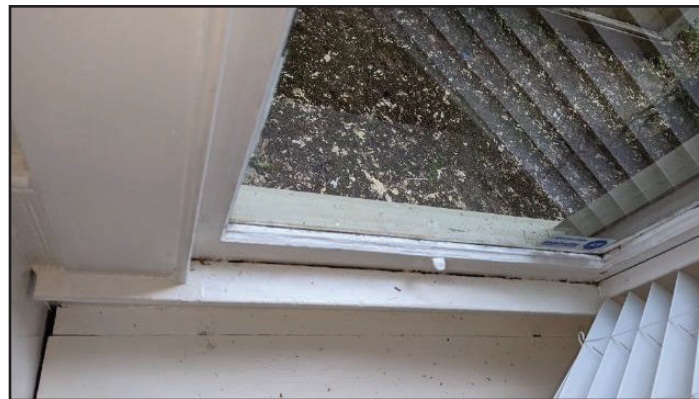
125. Inoperative

104. Condition: • [Inoperative](#)

Implication(s): System inoperative or difficult to operate

Location: Various Throughout

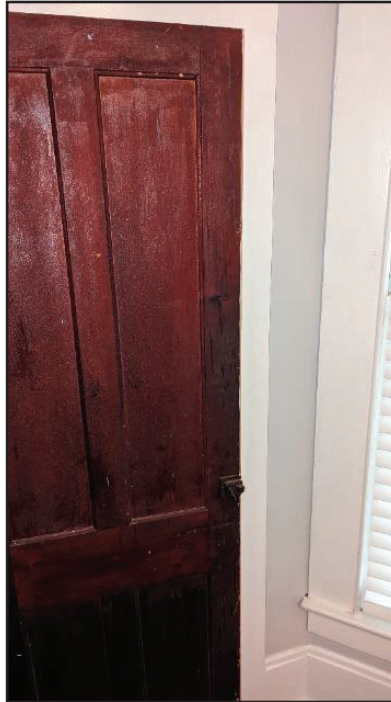
129. Swings open or closed by itself

108. Condition: • [Swings open or closed by itself](#)

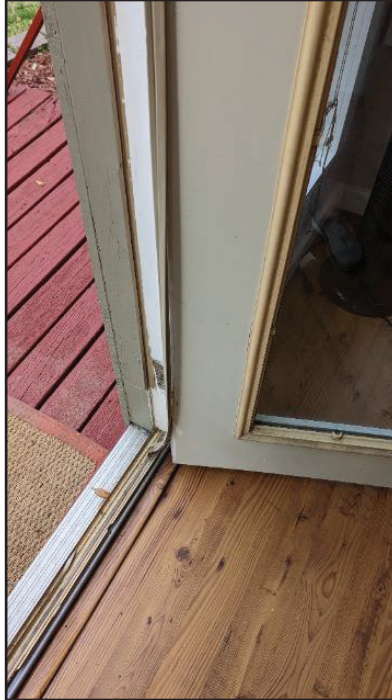
131. *Binds*

110. Condition: • Binds

Implication(s): System inoperative or difficult to operate

Location: Rear Dining Room Kitchen

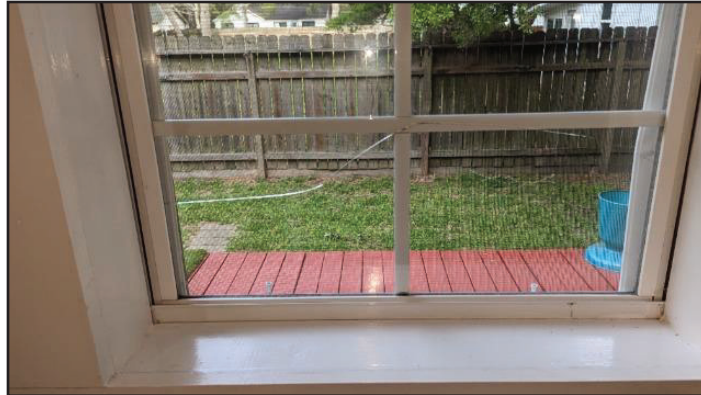
133. Cracked

112. Condition: • [Cracked](#)

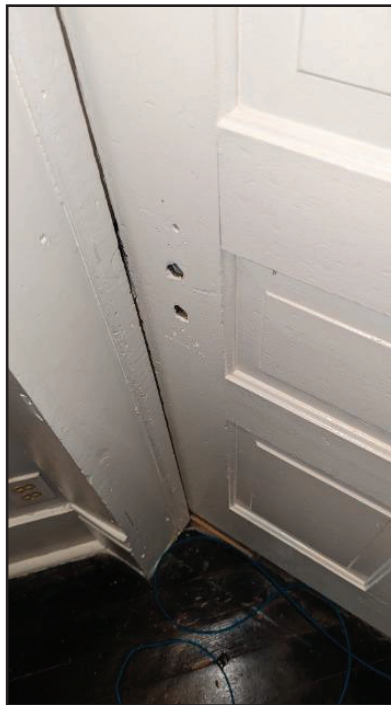
134. Missing

113. Condition: • [Missing](#)

Implication(s): System inoperative or difficult to operate

Location: Middle First Floor Hall

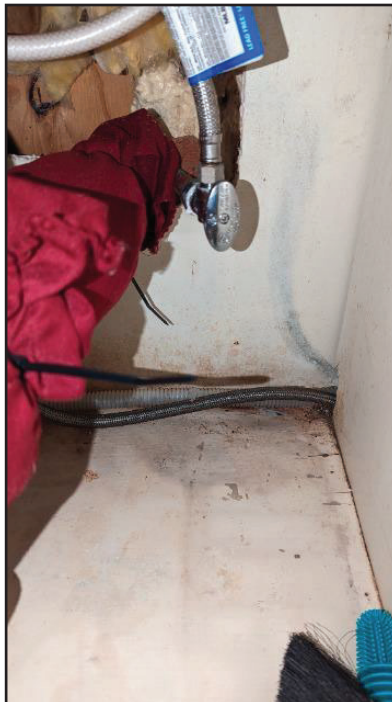
138. Water damage

117. Condition: • [Water damage](#)
Implication(s): Material deterioration
Location: Kitchen

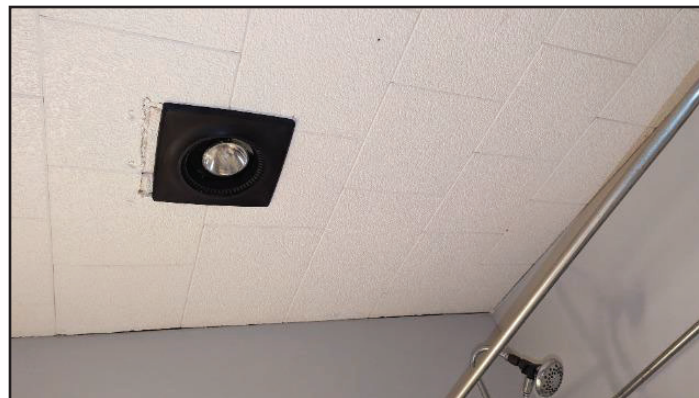
140. Missing

119. Condition: • [Missing](#)

Implication(s): Chance of condensation damage to finishes and/or structure

Location: Second Floor Hallway Bathroom

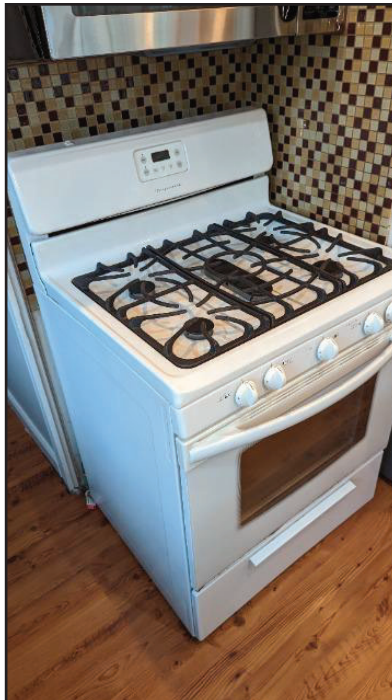
142. Inoperative

121. Condition: • Inoperative

Implication(s): System inoperative

Location: Kitchen

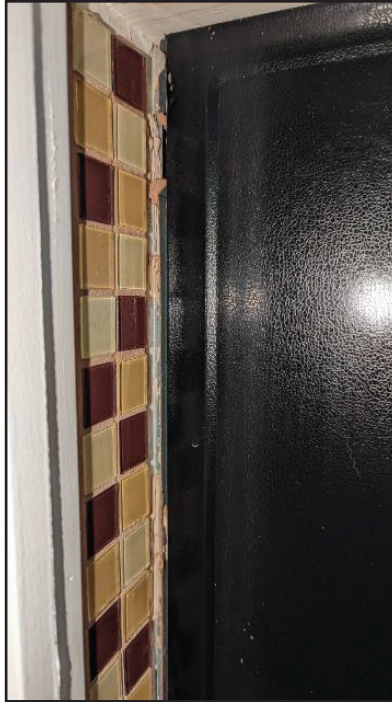
143. Loose

122. Condition: • Loose

Implication(s): Water Penetration

Location: Kitchen

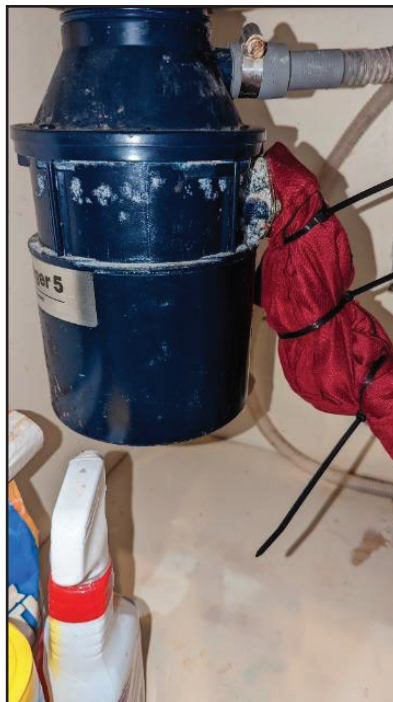
145. Jammed

124. Condition: • Jammed

Implication(s): Equipment inoperative

Location: Kitchen
