PROPERTY INSPECTION REPORT

Concerning: 807 Valley Ranch Dr, Katy, TX 77450
(Address or Other Identification of Inspected Property)

By: Scott Osborne, Lic #20555 11/09/2019
(Name and License Number of Inspector) (Date)

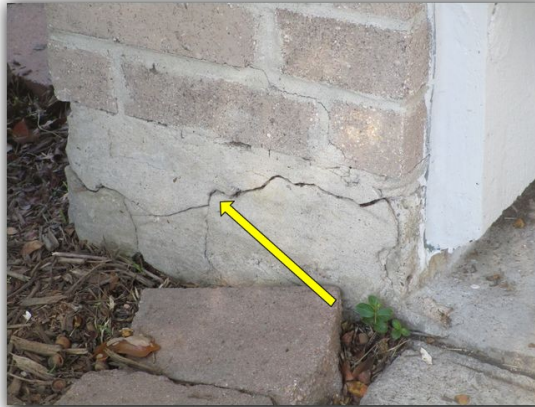
There are large trees in close proximity to the foundation. I recommend monitoring this area of the home for any signs of movement. Underground roots can cause slab movement.

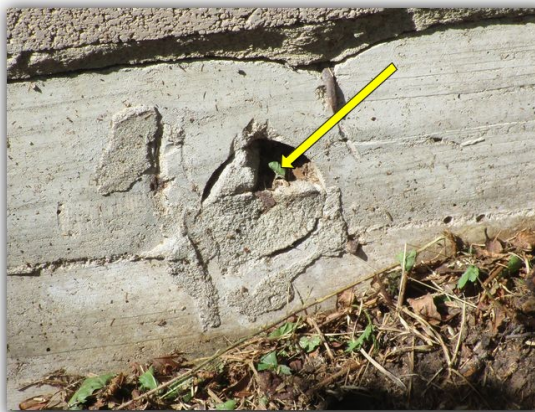
There are exposed cable ends on the right side of the home. These cable ends should be sealed to help prevent oxidation/rusting of the cable into the foundation.

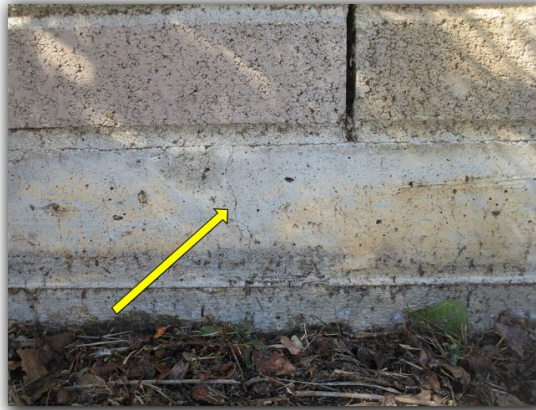
There is a hairline crack in the foundation on the right side of the home below the hose bib.

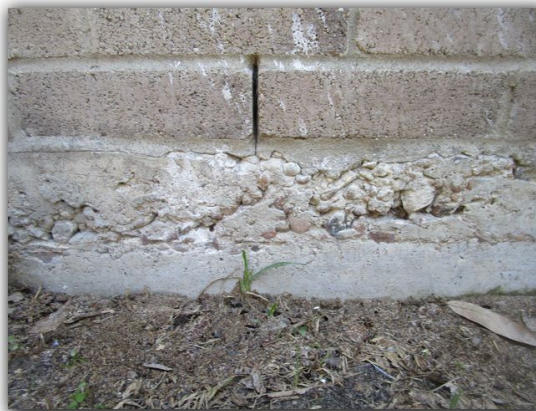
There is exposed aggregate on the left side of the home near the main water supply line.

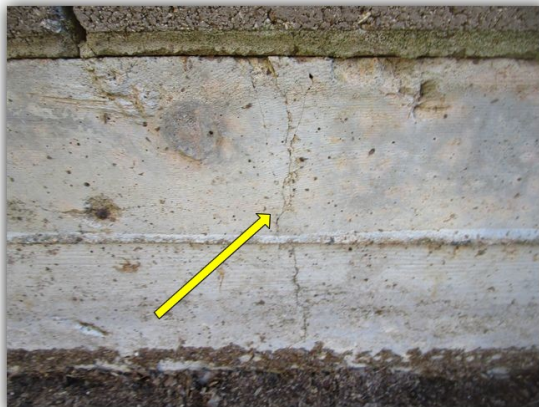
There is a hairline crack in the foundation on the left side of the home near the second window and near the fence / gate.

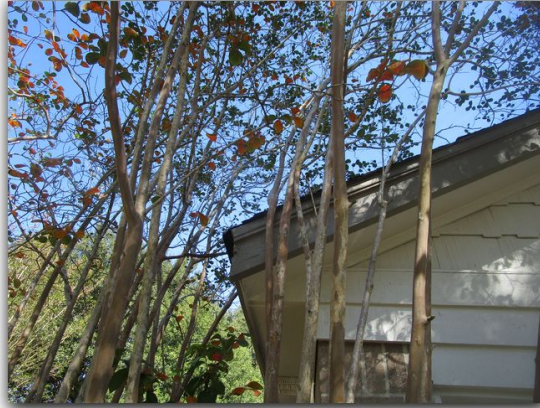
There are tree branches touching the roof at the front left corner with evidence of damage to the shingles at the eave. I recommend trimming the branches away from the roof.

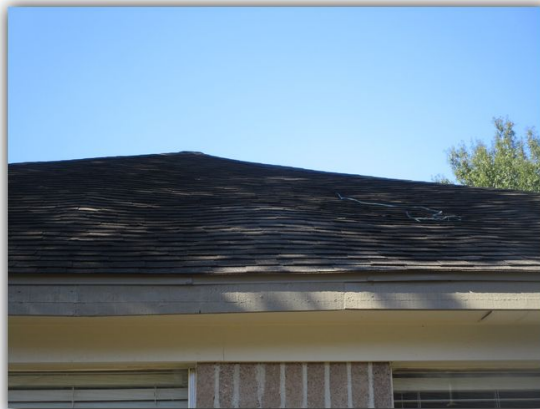
The roof sags at the right side of the roof at more than one location.

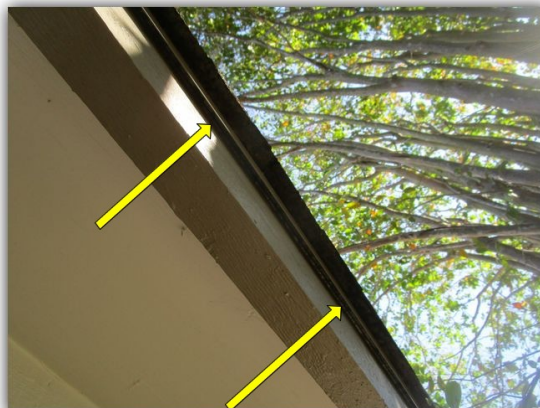
There is a gap at the drip edge flashing at the front right corner. The flashing appears to have pulled away from the edge of the roof.

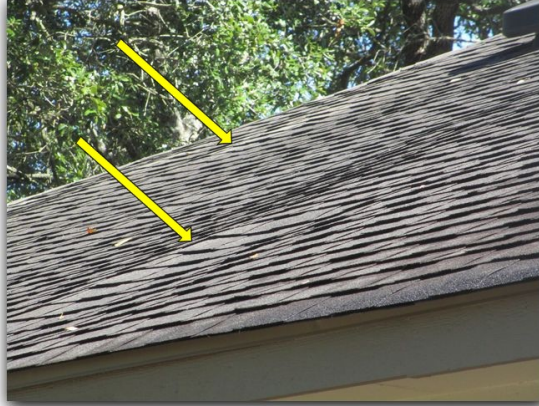
There are sags / deflections along the left side of the roof at more than one location.

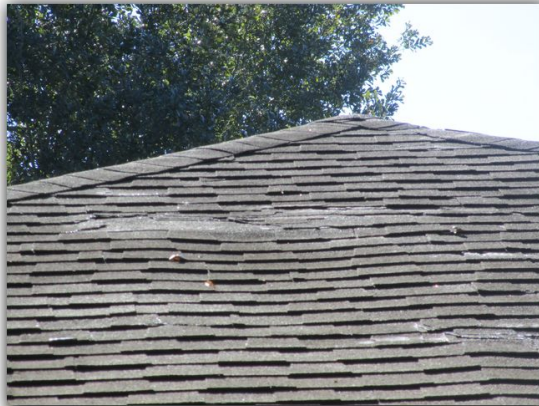
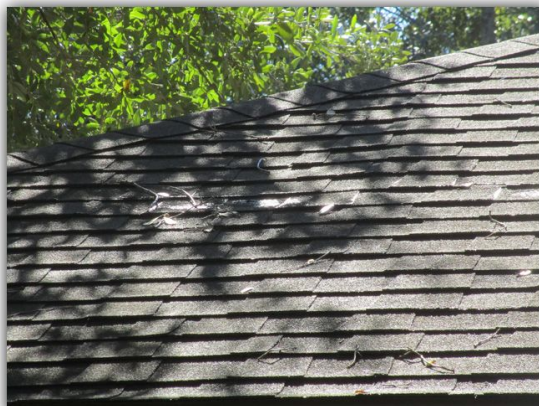
There is extensive damage to the roof at the rear of the home above the rear right bedroom and master bathroom areas.

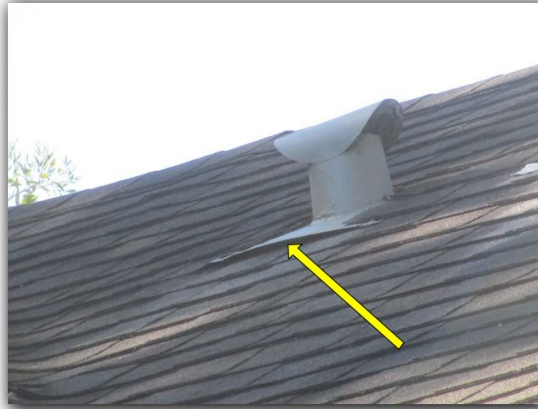
The bottom edge of the roof vents are lifted, creating potential moisture penetration points.

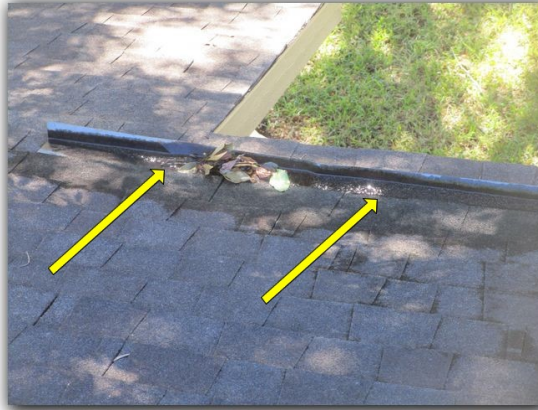
The rain guard along the front of the roof line is holding water and debris. This may lead to moisture penetration.

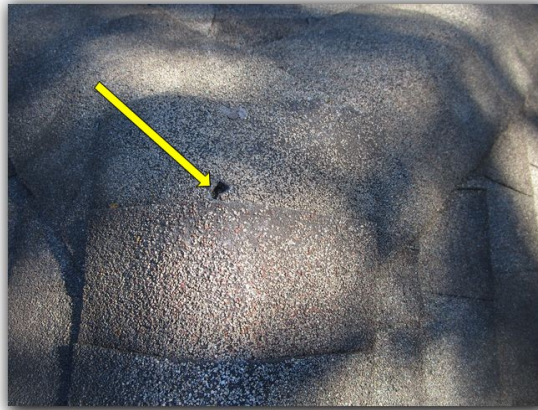
The shingles are showing signs of age with damage and wear, including loss of granular material.

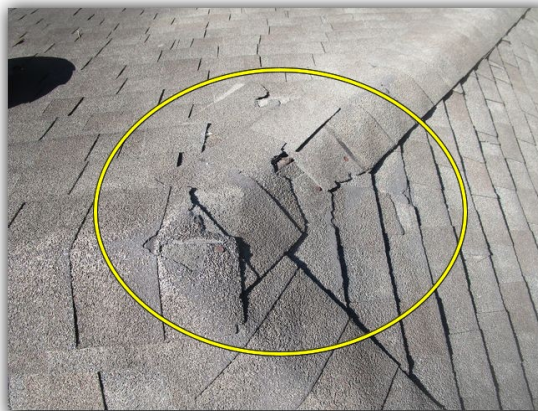
There is evidence of damage to the shingles at the ridge above the rear left corner of the home.

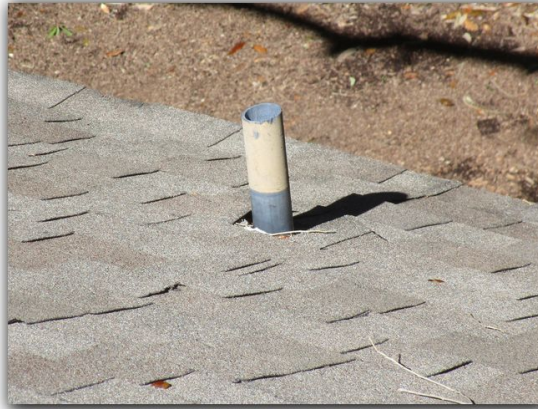
The roof jack is missing / damaged above the rear master bathroom.

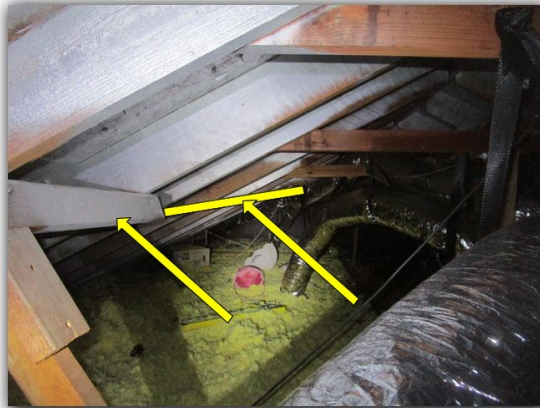
There are no "H" clips between the roof decking. Purlin braces are designed to provide additional support to the roofing structure and are required every four feet. There are purlins and purlin braces missing in the attic above the master bedroom / bathroom area as well as near the furnace.

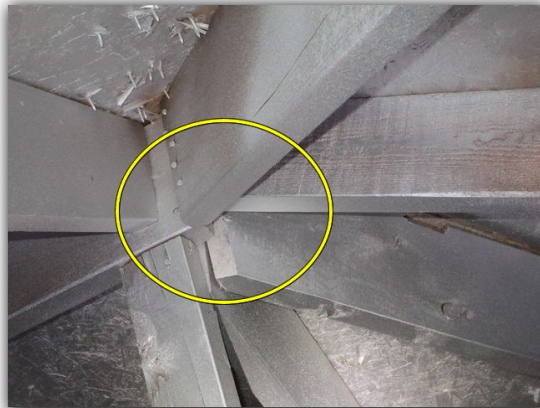
There is no palm bracing where the rafters meet the end of the ridge beam.

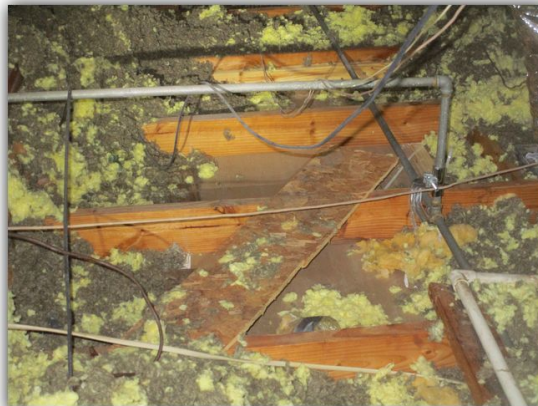
There is missing insulation in the attic above the rear right spare bedroom. Additional insulation may be needed.

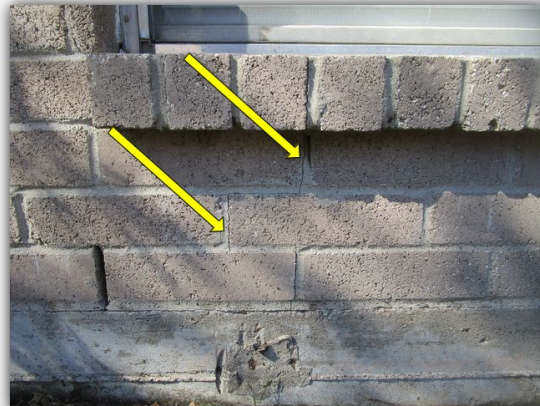
There are cracks in the brick on the right wall at the first and second windows.

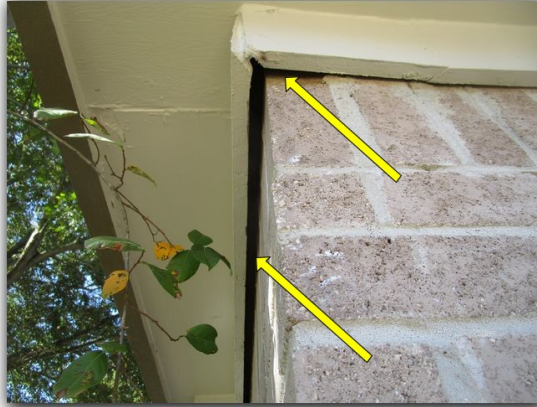
There is a gap at the frieze trim at the top of the front wall at the right and left sides of the kitchen box window frame. The trim appears to have shifted forward, creating an exposed opening into the wall cavity.

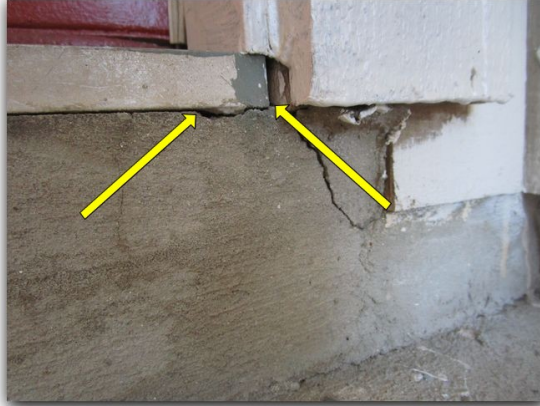
There is a gap at the base of the trim and threshold at the front entry door.

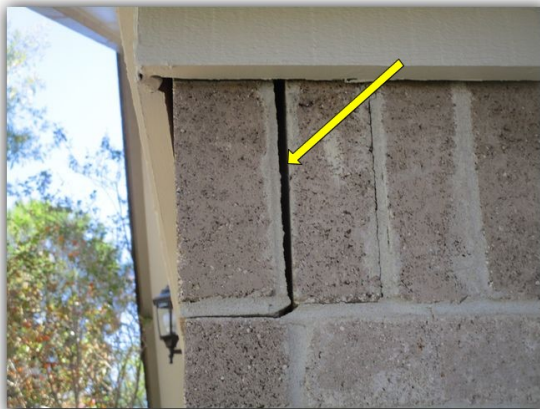
There is a mortar joint crack with loose bricks at the top front right corner of the garage.

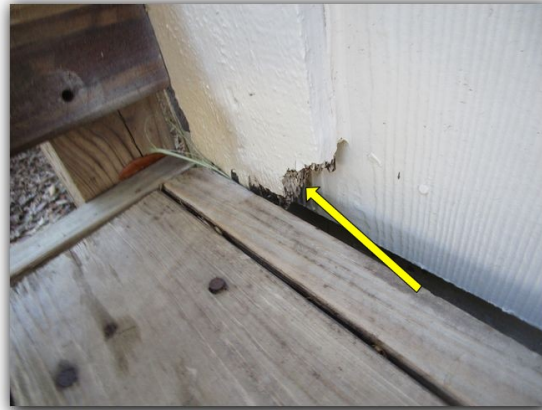
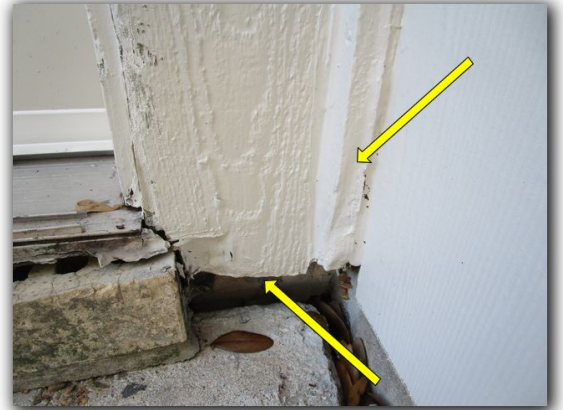
There is evidence of rotting wood at the base of the trim at the rear right corner and at the rear entry door trim.

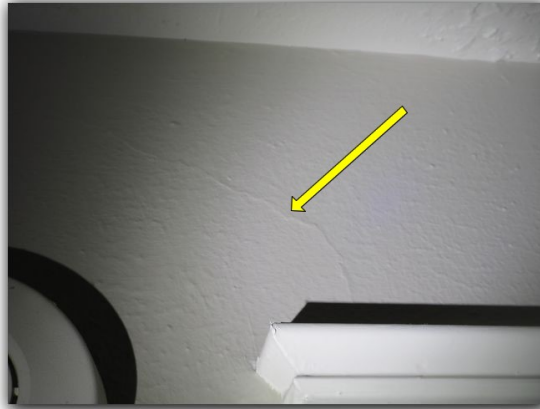
There is a crack on the wall in the hall above the door to the front right bedroom.

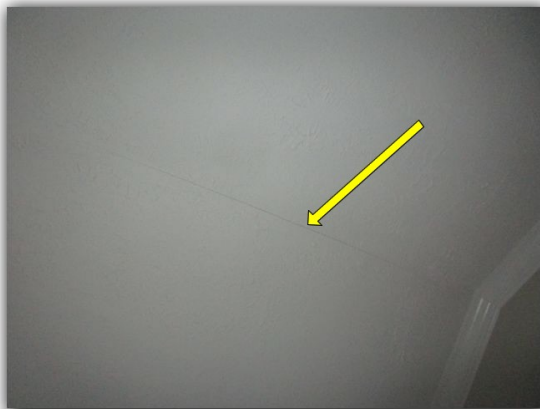
There are cracks at the angled ceiling intersections at more than one location including the living room.

NOTE: There are signs of prior repair to the ceilings throughout the home, including sheet rock, texture, and paint. This may conceal prior signs of damage or movement.

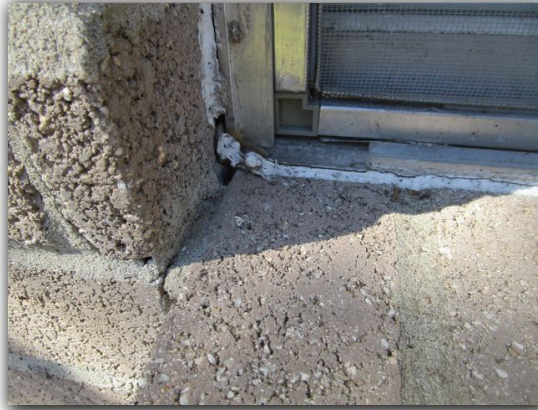
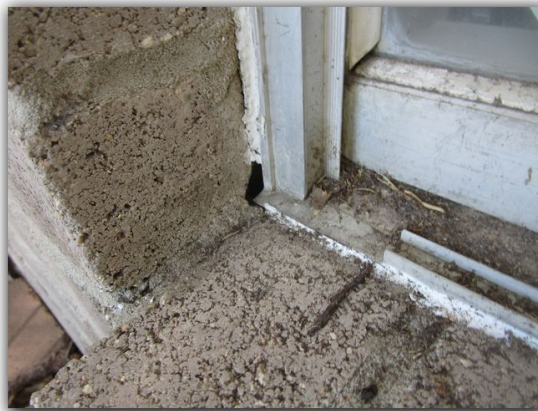
The caulking and glazing beads around the windows are showing signs of deterioration and may need to be replaced.

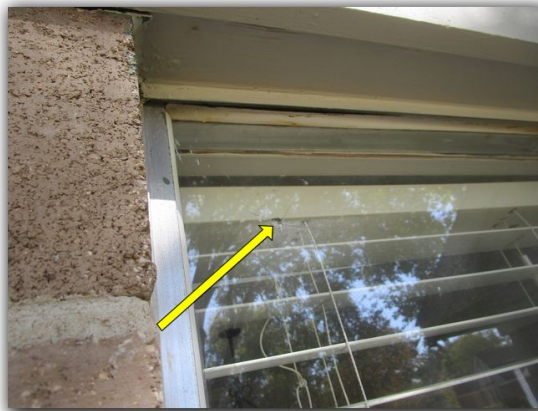
There are missing window screens.
There is a chip in the middle and left dining room windows.

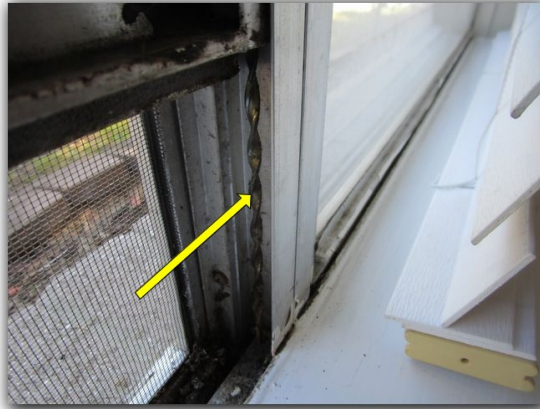
The springs have popped in the window frames inside the left breakfast room window.

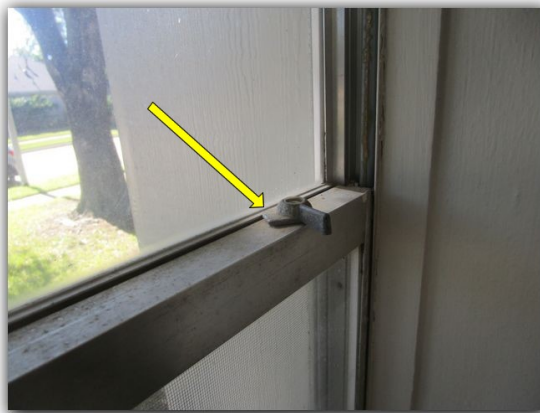
The kitchen window is not square in the frame, and the right latch does not fit into the frame properly.

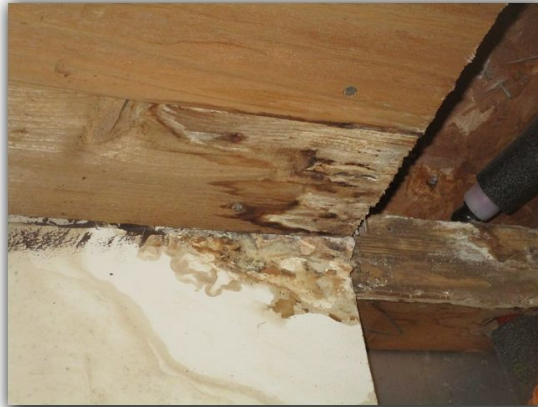
There are signs of moisture stains and damage, with evidence of prior wood destroying insect damage, in the garage above the water heater area at the exterior wall. I recommend asking the seller for any additional information.

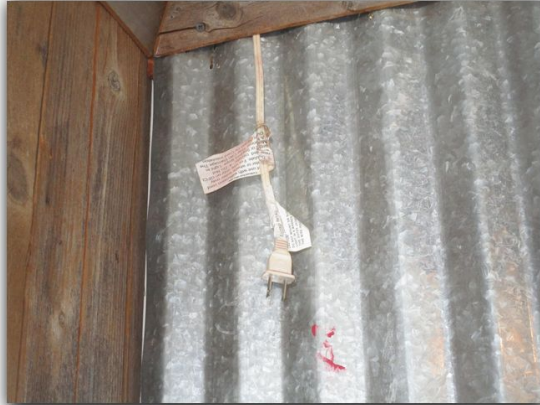
There is an extension cord protruding from the garage ceiling at the rear left corner. I am not able to determine the source or purpose of this cord. I recommend asking the seller for any additional information.

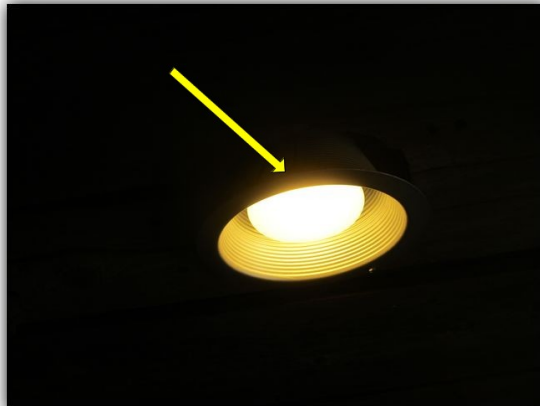
The recessed light fixture is loose in the ceiling in the garage and in the living room.

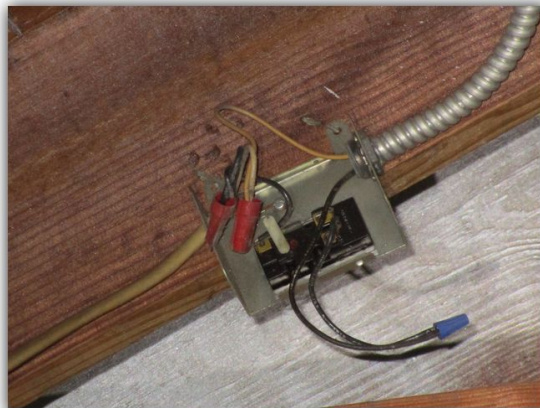
There are spliced wires that are not fully or properly contained inside a junction box in the attic.

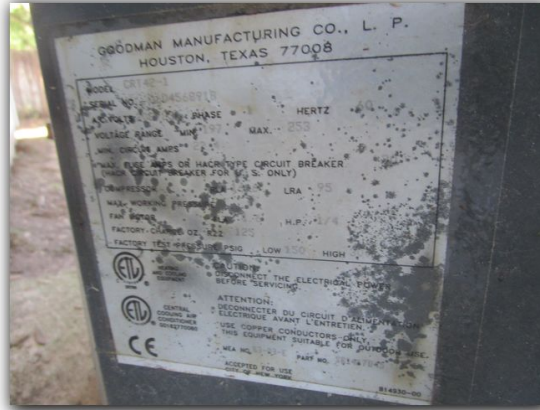
The information label is worn on the exterior condenser unit. The insulation on the copper lines at the exterior condenser unit is deteriorated and may need to be replaced or repaired.

NOTE: Due to the age of the unit, I recommend having the unit serviced by a licensed HVAC technician.

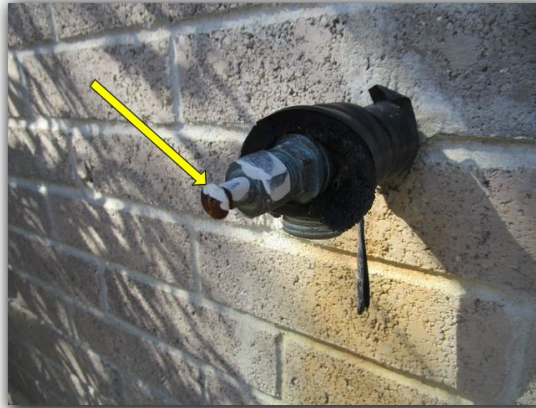
There is a missing control valve handle on the hose bib on the right wall, with evidence of a leak onto the wall.

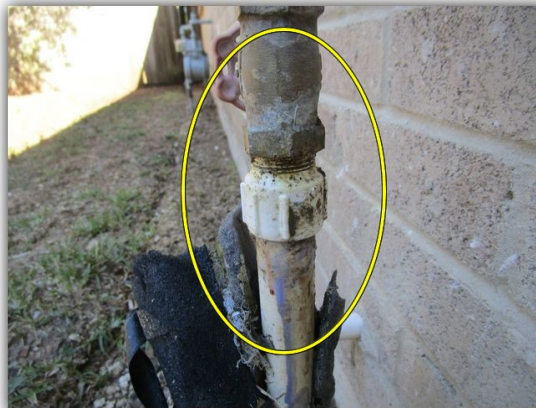
The main water supply line is not fully / properly insulated, with evidence of a leak at the main line.

Due to the age of the home, the galvanized plumbing and the signs of foundation movement, I recommend a complete review of the plumbing system, including scoping the underground lines for any damage, leaks or other deficiencies by a licensed plumber. I recommend asking the seller if the underground plumbing has already been reviewed / scoped (including any optional hydrostatic pressure test). If so, ask for a copy of the report.

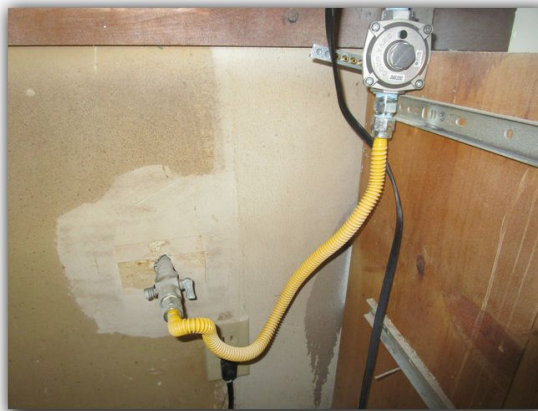
The gas supply shut off valve is located behind the drawers under the cook top. The gas supply shutoff valve should be readily accessible in case of an emergency. The gas supply valve is off. I could not test the cook top.

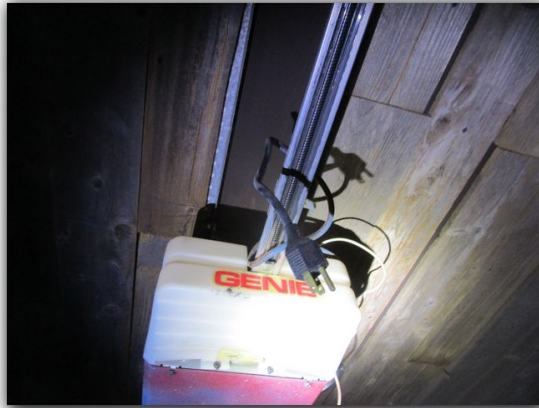
The garage door opener is not connected and could not be tested.
