Saji # Spections LLC

21611 Live Oaks Spring Dr, Katy, TX 77450
Inspection prepared for: Mike Rothchild
Date of Inspection: 2/28/2022 Time: 11:00 AM
Age of Home: 1993 Size: 2434 Sq Ft
Weather: Clear & Cool
Order ID: 194

PROPERTY INSPECTION REPORT

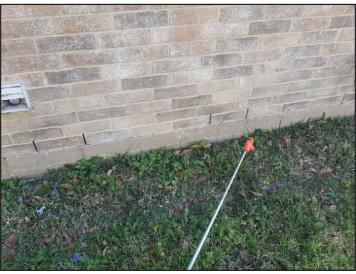
EXPOSED ANCHOR BOLTS

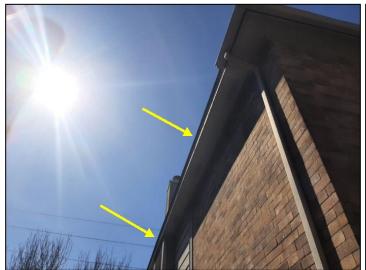
NO GUTTER SECTIONS

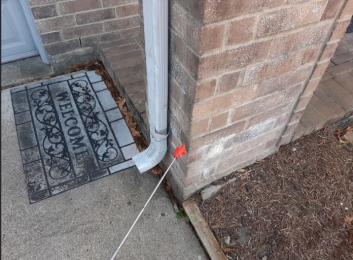
LOOSE GUTTER SECTION

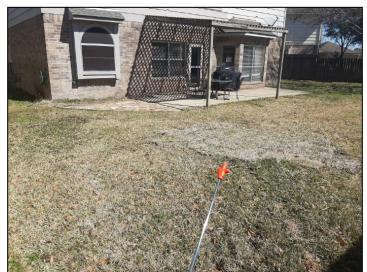
UNEVEN AREA

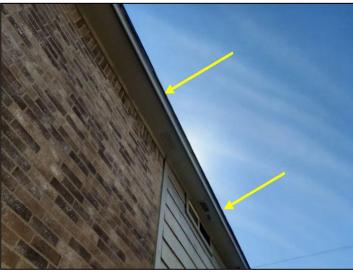
NO GUTTER SECTIONS

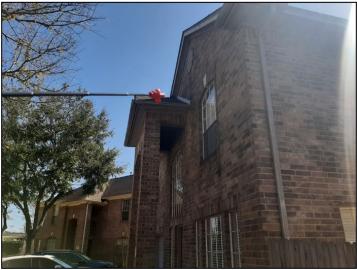
OPENING TO ATTIC AREA DUE TO VERMIN ACTIVITY

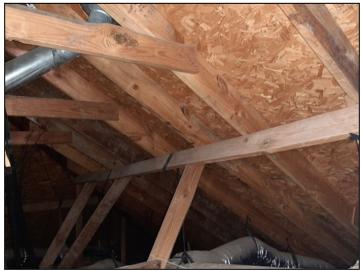
ATTIC STRUCTURE OK; NO RADIANT BARRIER

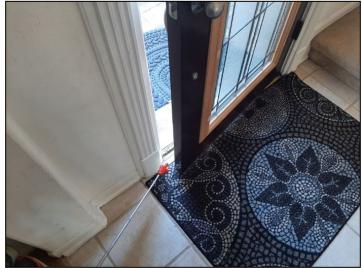
DOOR RUBBING ON FRAME

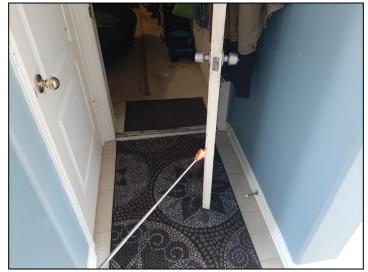
DOOR RUBBING ON FRAME

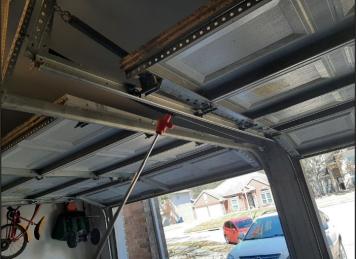
LUBRICATION NEEDED

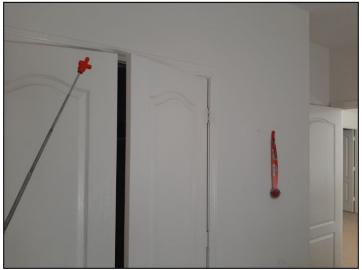
INOPERABLE HARDWARE

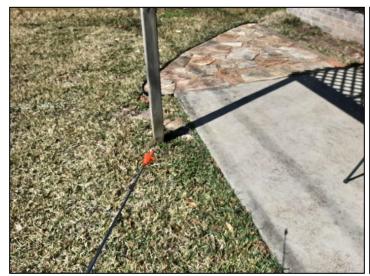
POST IN CONTACT WITH SOIL

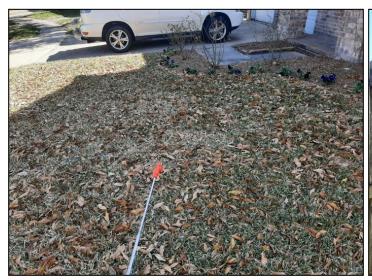
EXPOSED TREE ROOTS

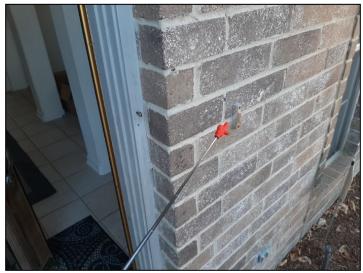
INOPERABLE DOOR BELL

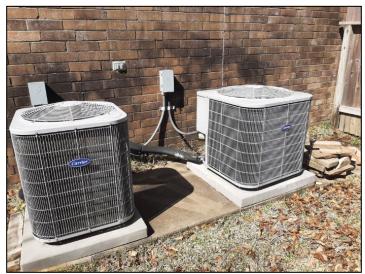
CONDENSING UNIT OK

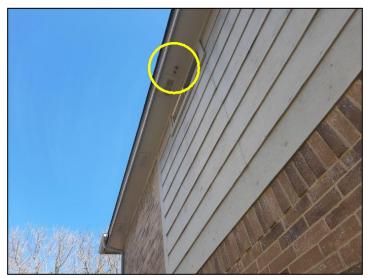
EVAPORATOR SECONDARY DRAIN PIPE ROUTED HERE

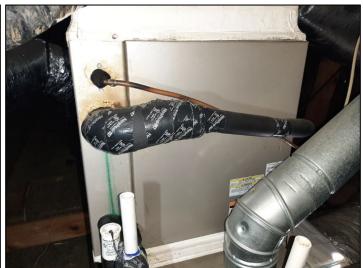
EVAPORATOR 1 OK

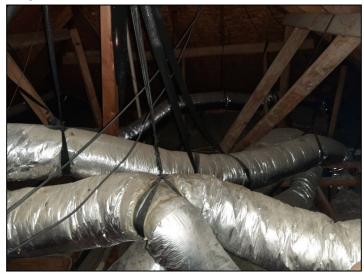
DUCTING OK

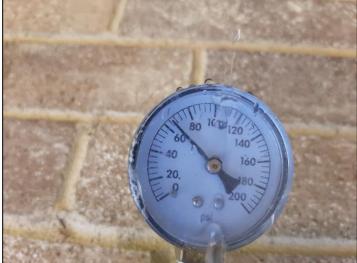
WATER PRESSURE OK

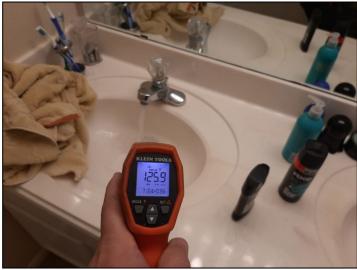
HOT WATER OK

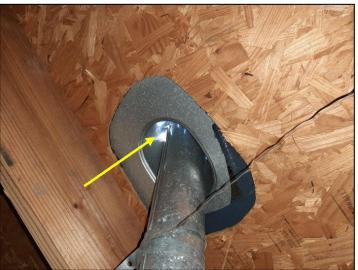
- All deficiencies noted in red OR captioned in the pictures should be further evaluated by a qualified professional.
- Current signs of water intrusion and / or unsealed areas was noted around the roof jack that secures the exhaust vent pipe for the heater.

UNSEALED AREA

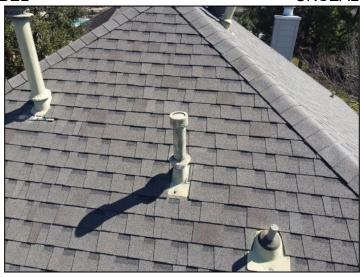
VENTING OK

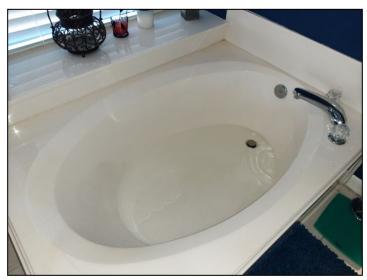
REGULAR TUB OK

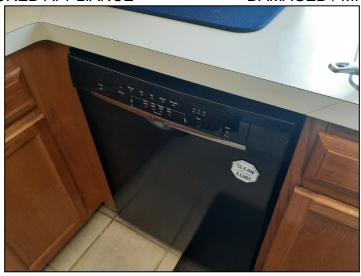
DISHWASHER OK

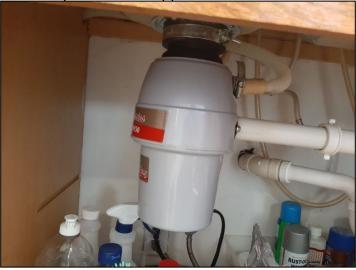
DISPOSAL OK

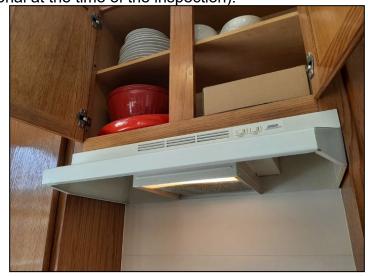
VENT HOOD OK

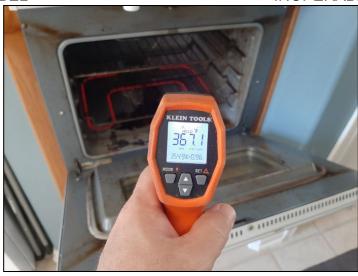
OVEN TEMPERATURE OK

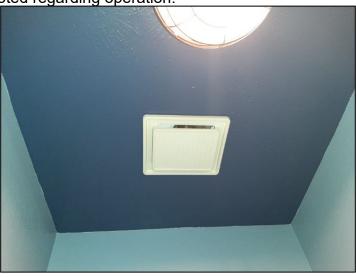
VENT FANS OK

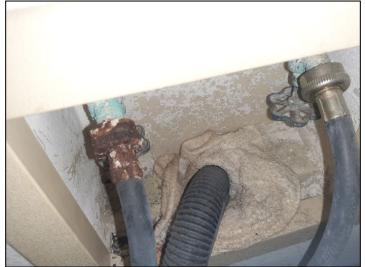
CONNECTION OK

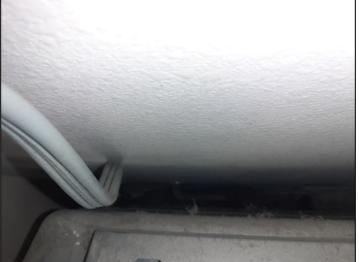
BOTH GAS AND ELECTRIC DRYER CONNECTIONS

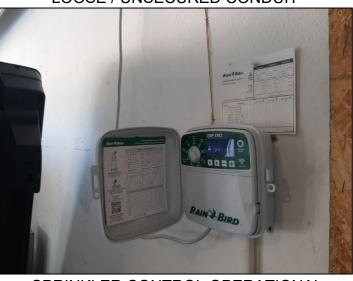
SPRINKLER CONTROL OPERATIONAL

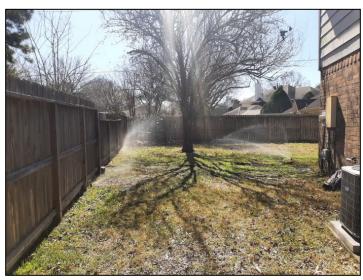
SPRINKLER ZONES OK
