PROPERTY INSPECTION REPORT

Prepared For: Jeff Mitchell
(Name of Client)

Concerning: 5421 Verdome Lane, Houston, TX 77092
(Address of Inspected Property)

By: Steven Gibson, TREC PI: 20994 03/25/2021
(Name and License Number of Inspector) (Date)

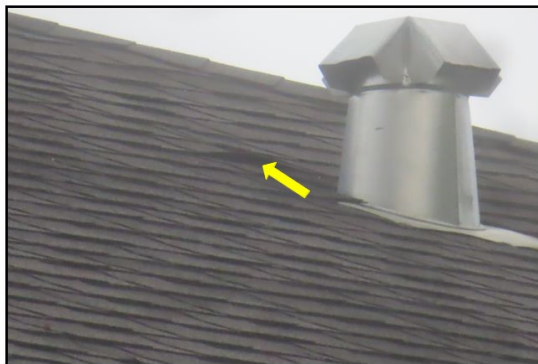
ROOF SURFACE:

One or more areas of raised shingle tabs from fasteners not secured down properly or nail heads popping up through shingles.

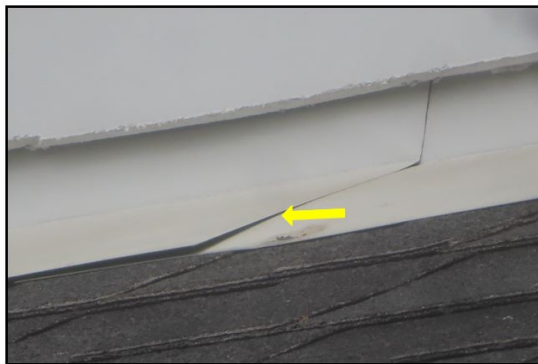
Flashing not sealed at seam.

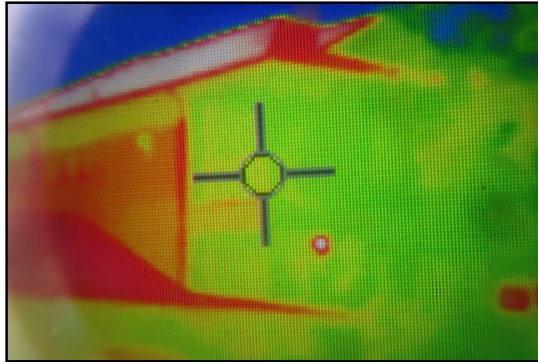
This inspection consisted of using a FLIR or similar infrared camera and walking the interior of the property looking for anomalies that would warrant further investigation using a pin type moisture meter and areas of deficient insulation. Be advised that a thermal scan is not a substitute for indoor air quality testing (IAQ), testing for pollutants and other bio-hazards. If client is concerned about the quality of indoor air or presence of bio-hazards or pollutants, a qualified IAQ specialist should be consulted.

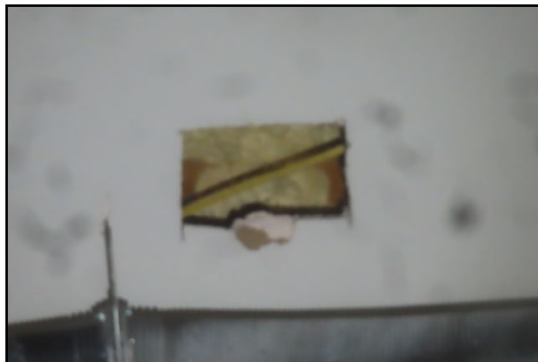
CEILINGS:

Hole cut in garage ceiling sheetrock.

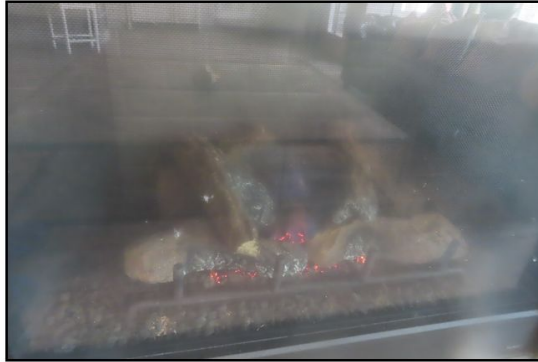
FAMILY ROOM:

No significant deficiencies or anomalies observed at the time of inspection.

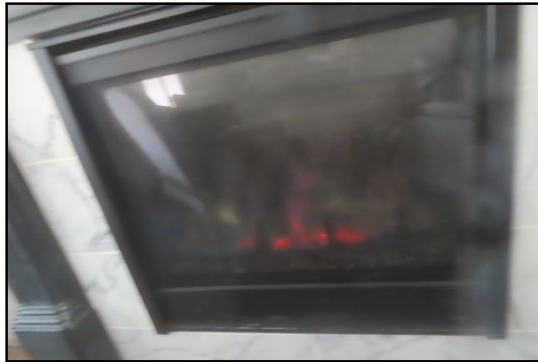
MASTER BEDROOM:

No significant deficiencies or anomalies observed at the time of inspection.

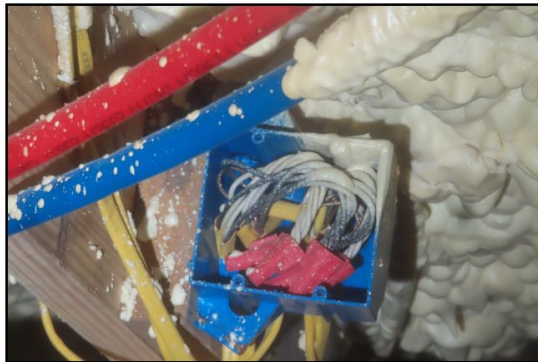
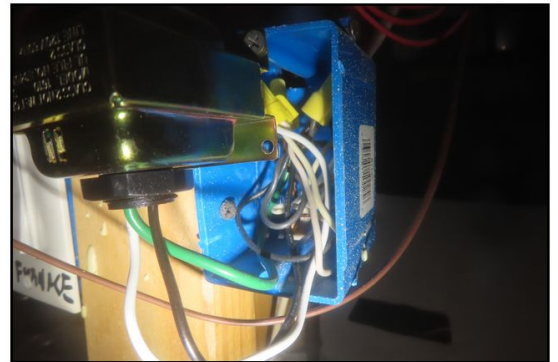
Wire connections are not enclosed in proper electrical junction box(s), or electrical junction box(s) do not have covers in place, including but not limited to the following location;(Master bedroom at fireplace inside gas starter compartment, Attic, Under house)

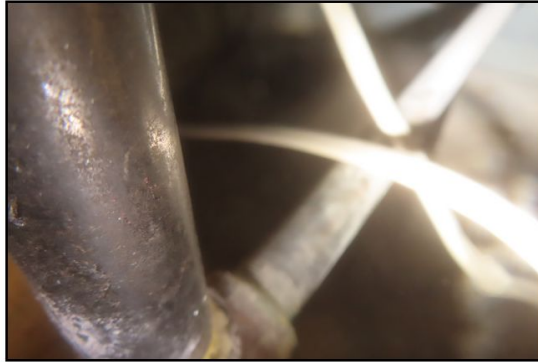
Electrical wiring in contact with gas line inside master bedroom fireplace gas starter compartment.

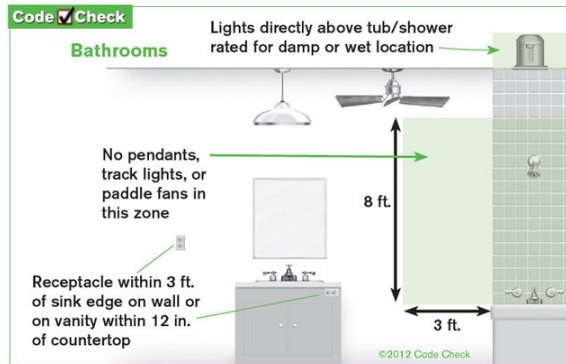
FIXTURES:

Light fixture over bath not rated for wet/damp locations. Per IRC 3903.8: "All fixtures installed in wet/damp shall be marked SUITABLE FOR WET/DAMP LOCATIONS." Bare light bulbs are not to be installed over a bath /shower location.(Master bathroom over tub.)

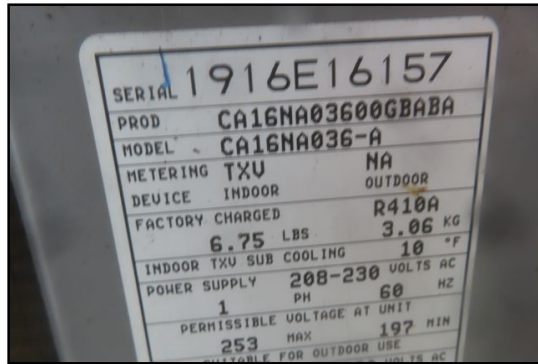
CONDENSING UNIT: FIRST FLOOR 2016 3 TON CARRIER

No significant deficiencies or anomalies observed at the time of inspection.

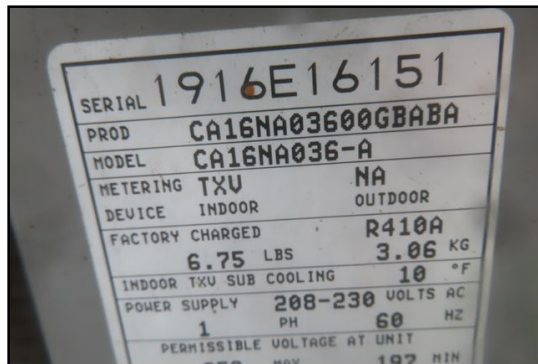
CONDENSING UNIT: SECOND FLOOR 2016 3 TON CARRIER

No significant deficiencies or anomalies observed at the time of inspection.

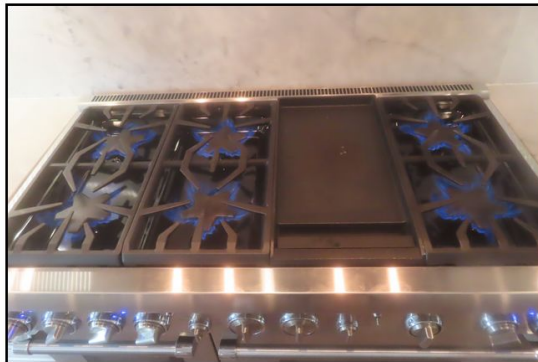
GAS RANGE/COOKTOP:

No significant deficiencies or anomalies observed at the time of inspection.

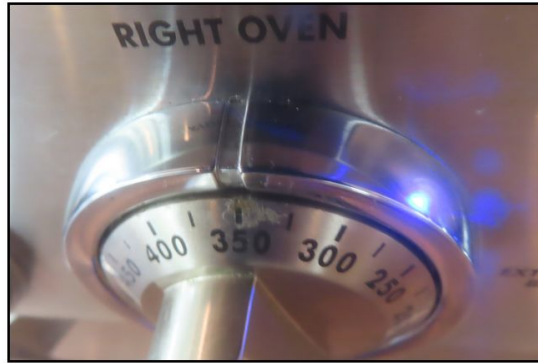
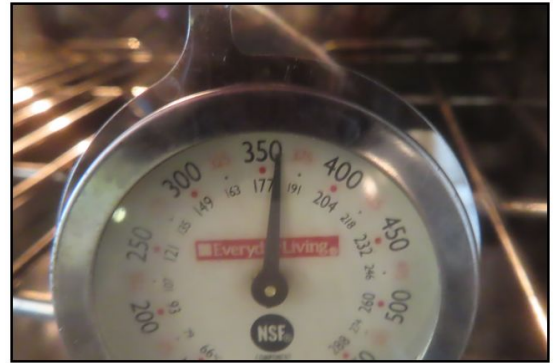
GAS RIGHT OVEN:

No significant deficiencies or anomalies observed at the time of inspection.

Timer and cleaning cycles not checked.

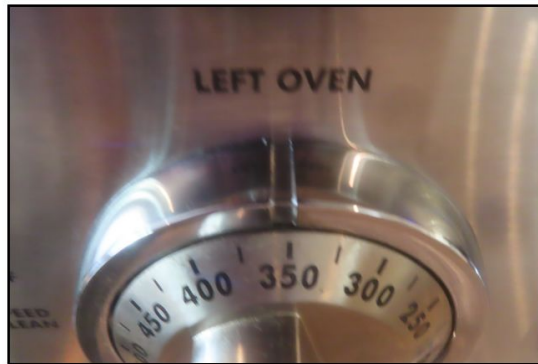
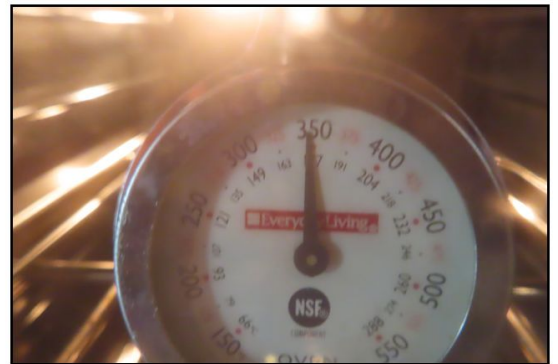
GAS LEFT OVEN:

No significant deficiencies or anomalies observed at the time of inspection.

Timer and cleaning cycles not checked.

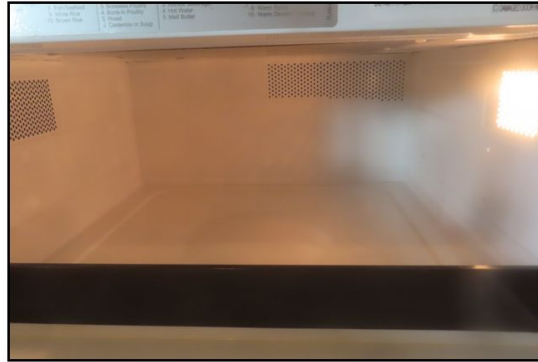
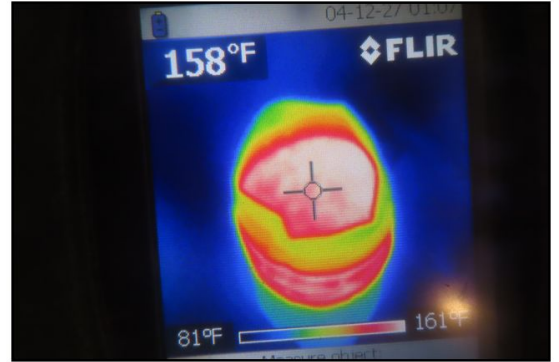
E. Microwave Ovens

No significant deficiencies or anomalies observed at the time of inspection.

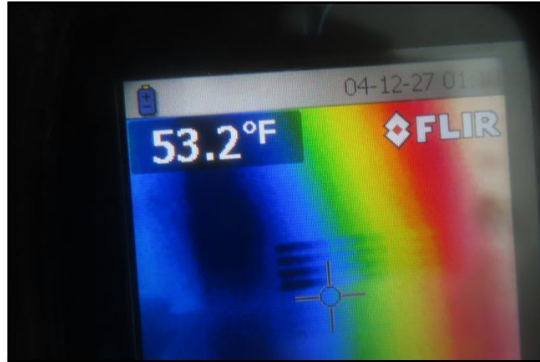
MINI FRIDGE:

No significant deficiencies or anomalies observed at the time of inspection.

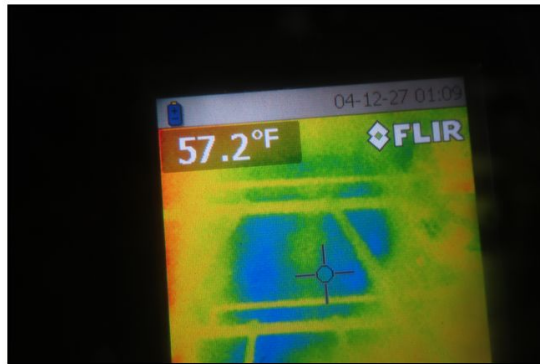
WINE COOLER:

No significant deficiencies or anomalies observed at the time of inspection.

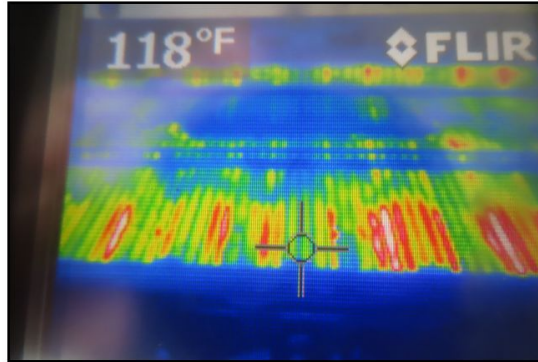
OUTDOOR COOKING EQUIPMENT

No significant deficiencies or anomalies observed at the time of inspection.
