PROPERTY INSPECTION REPORT

Concerning: 374 CR 4151, Woodville, TX 75979
(Address or Other Identification of Inspected Property)

By: Herbert Lee Johnson III, Lic #22058 08/16/2019
(Name and License Number of Inspector) (Date)

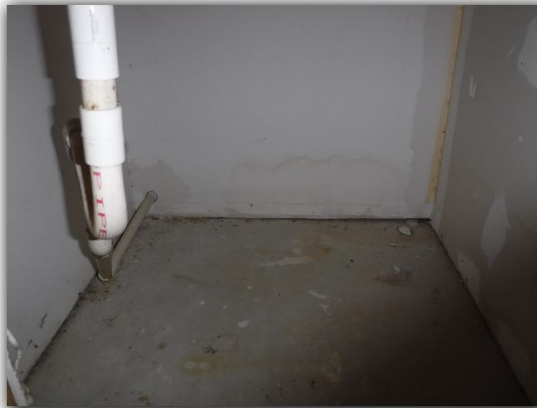
- Minor cracking above front left bedroom door
- Water stains on walls and/or ceilings

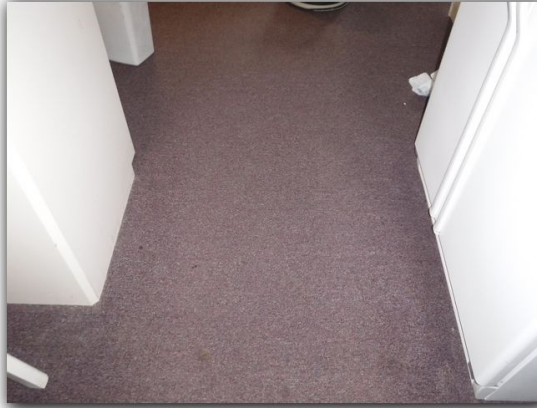
- Carpet older/stained
- Vinyl flooring damaged in bathroom.

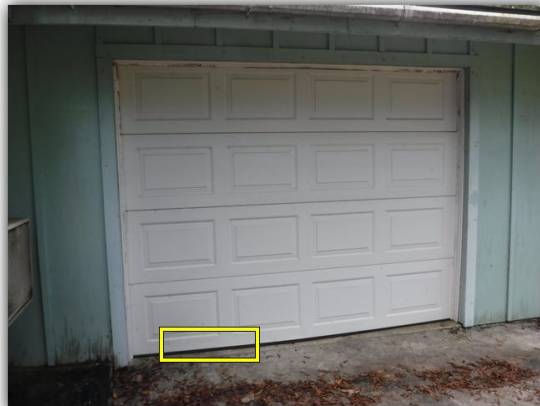
Type: Metal Wood Fiberglass Damaged panels

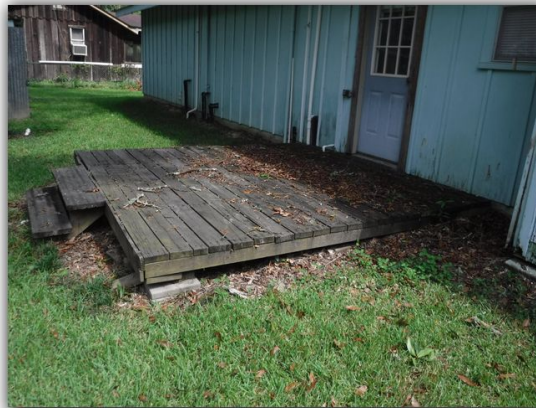
Structural deficiencies, old, deteriorated deck with wood on soil contact and split or damaged wood supports, I recommend repair or replacement of this deck.

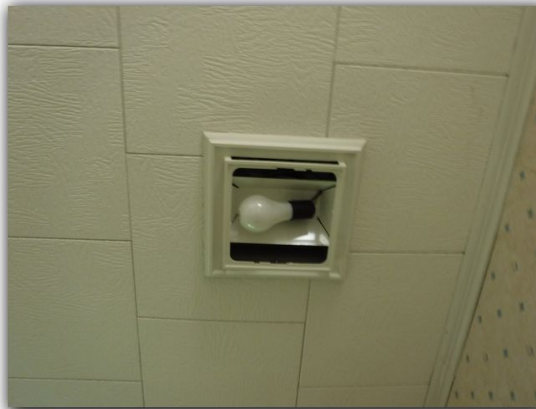
- Light is larger bathroom inoperable at time of this inspection

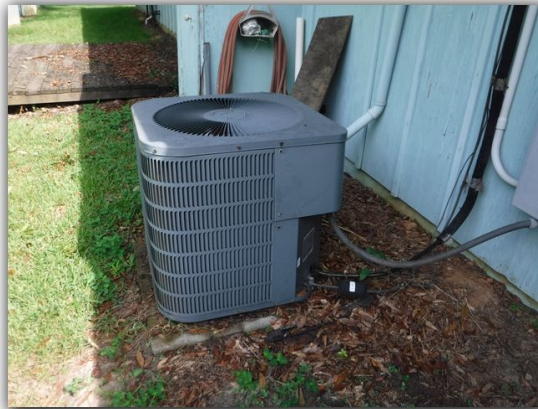
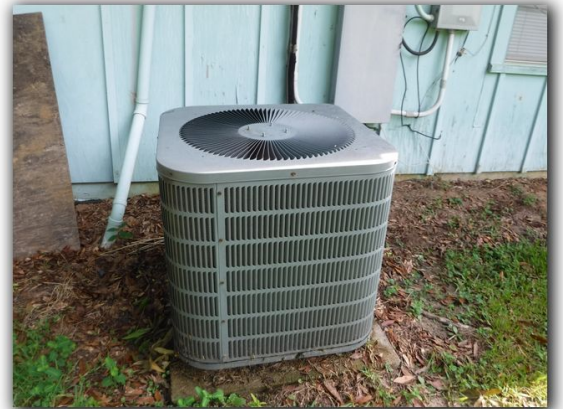
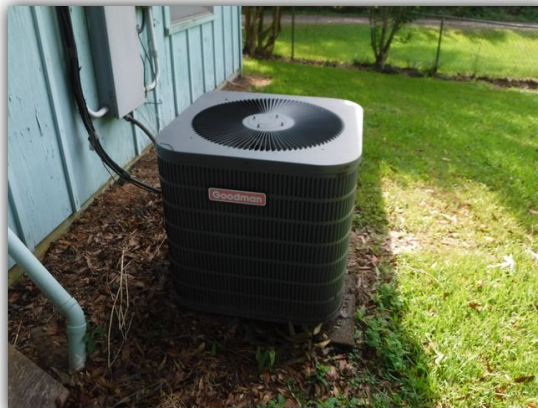
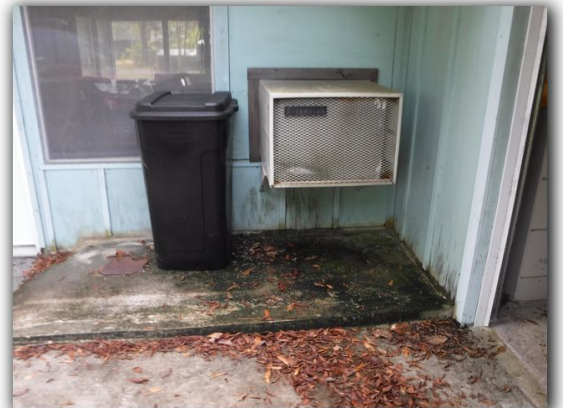
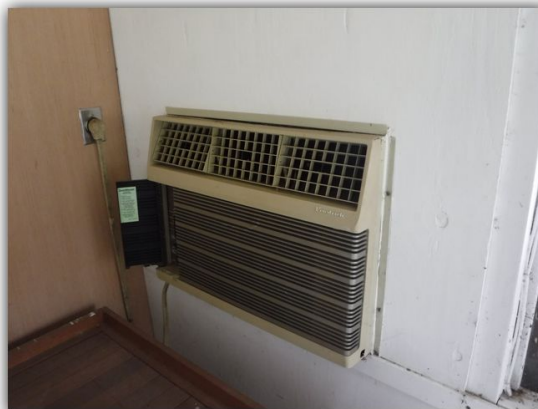
- No blower door switch installed on unit
- Condenser unit not level or 3" above grade
- Lack of GFCI near unit for technician
- Condensate line termination point was not determined

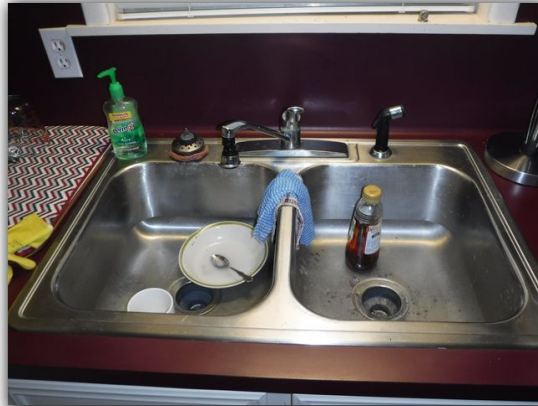
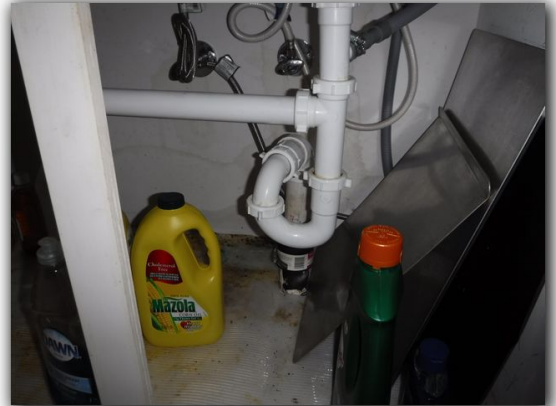
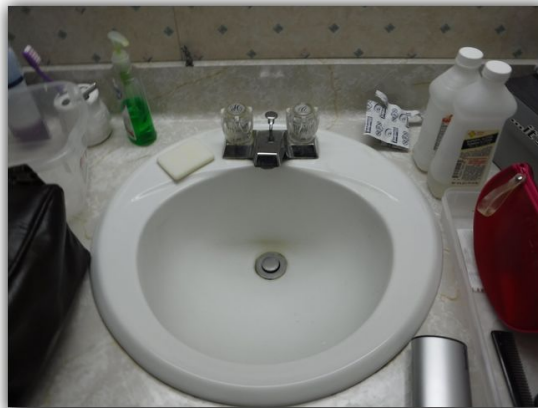
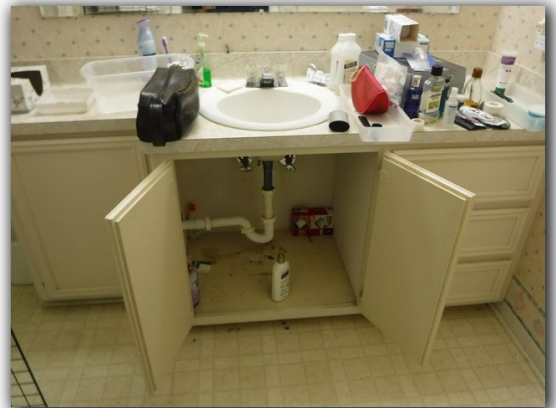
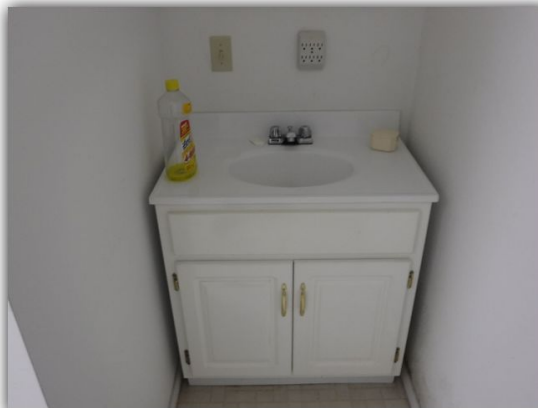
Sinks

Comments: Visual Inspection only.

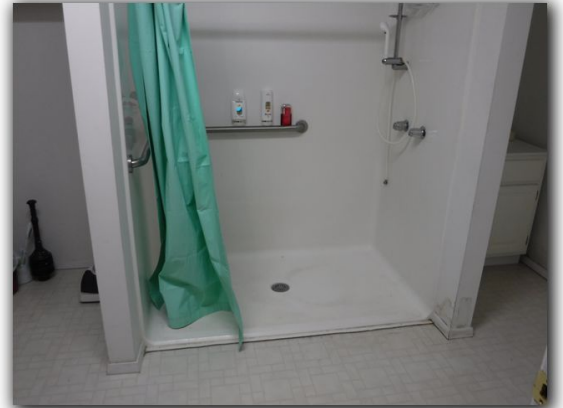
Bathtubs and Showers

Comments: Large handicapped bathroom was the only portion of the home with water, shower was operable.

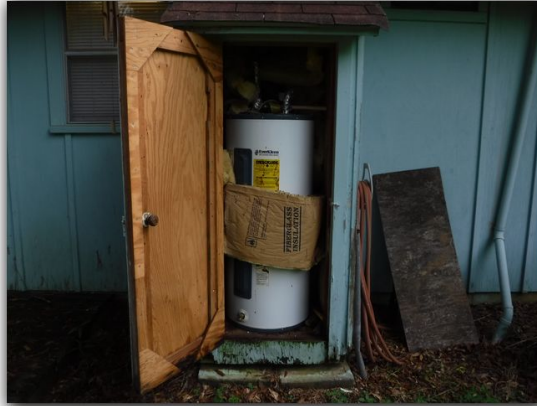
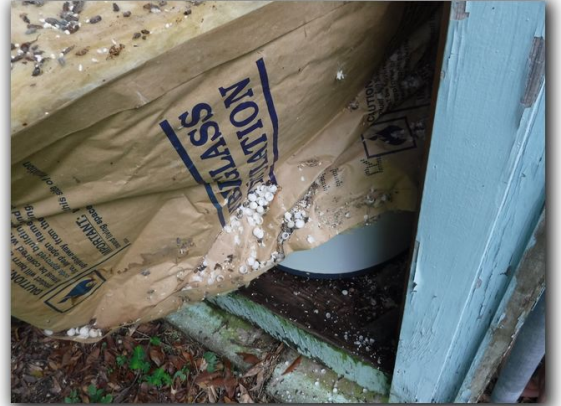
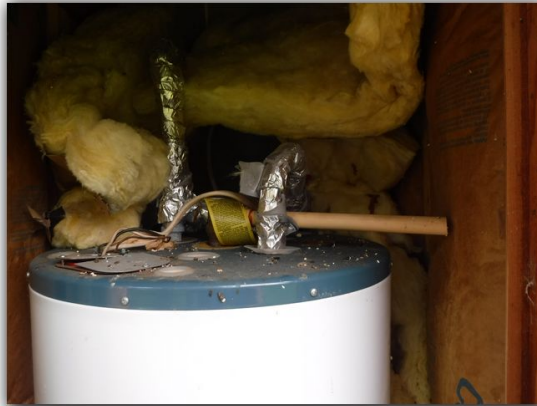
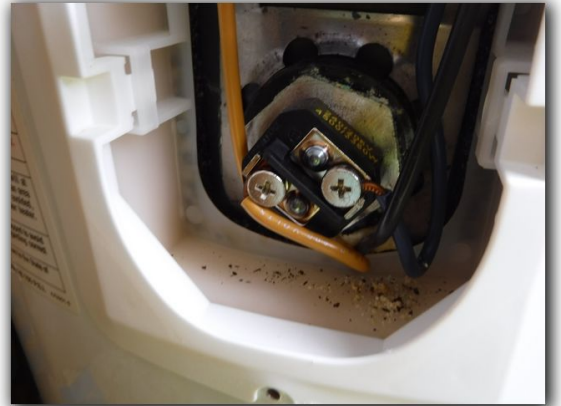
Electrical disconnect missing/inadequate clearance

Water damage at bottom of exterior closet housing unit

- T/P valve inspected / verified, but NOT TESTED
- Drain line is not plumbed to the exterior

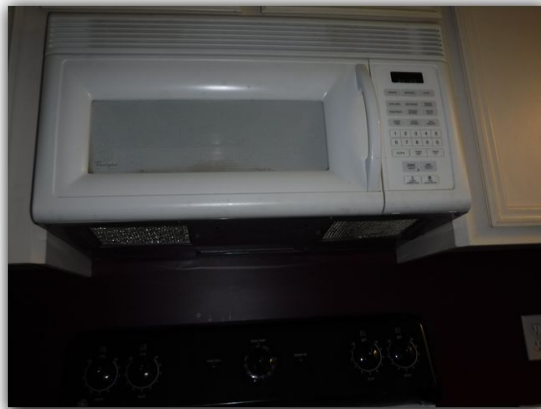
Unit vents to kitchen space

Light not functional at time of this inspection

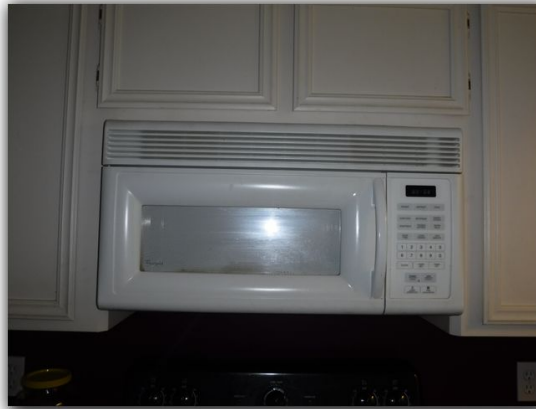
Comments: Whirlpool MicroVent

Vent light inoperable
