RedFish Inspections

Property Inspection Report

16118 Arborlea Dr, Friendswood, TX 77546
Inspection prepared for: Del Whittington
Real Estate Agent: Cindy Kipling - Realty Associates

Date of Inspection: 5/4/2022 Time: 2:30 PM - 6:00 PM
Age of Home: 30 years old Size: 2228 sqft
Weather: Mostly Cloudy

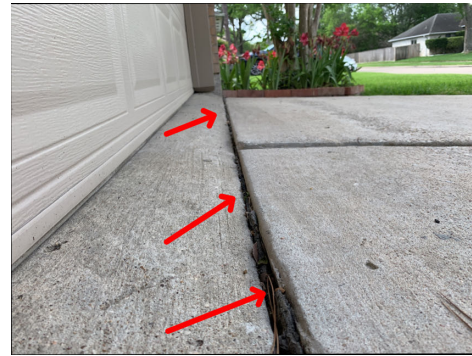
Driveway upheaved

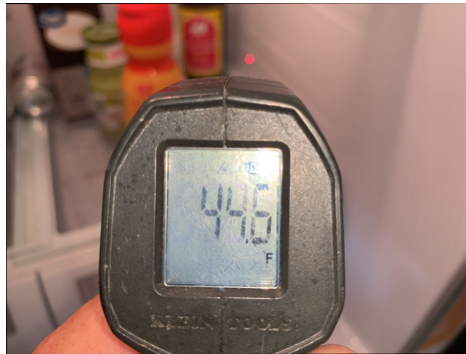
Refrigerator cool temperature

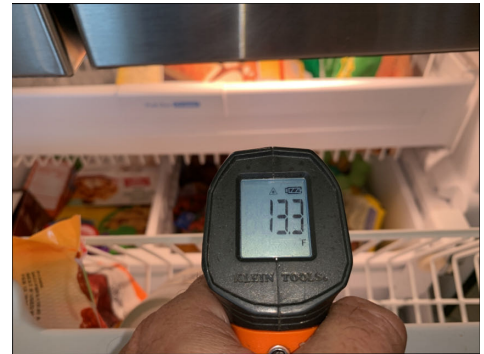
Freezer cool temperature
