# Your Inspection Report

12128 Ostermeyer Road  
Galveston, TX 77554

**INSPECTION DATE:**  
Tuesday, November 15, 2022

**PREPARED BY:**  
Charles Lehnhoff, 23070

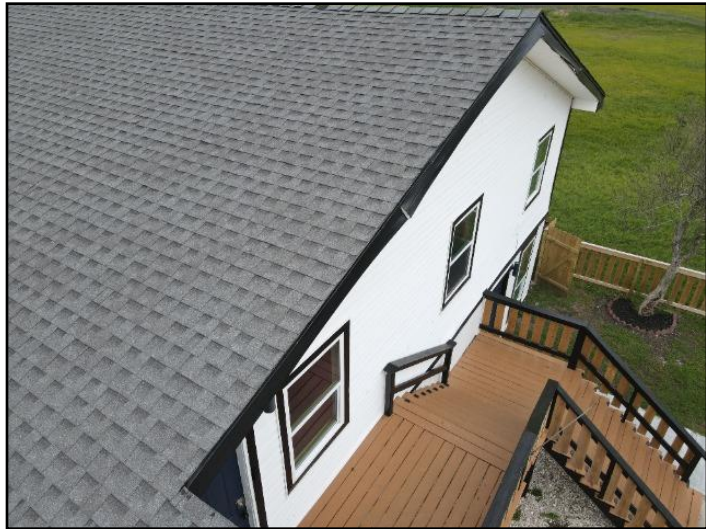
2. Aging

2. Condition: • [Missing, loose or torn](#)

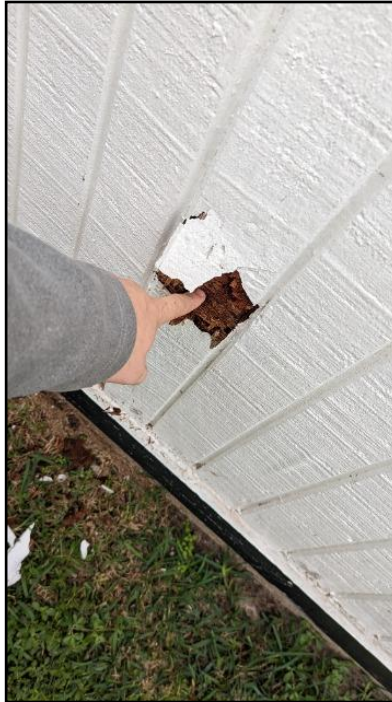
11. Rot or insect damage

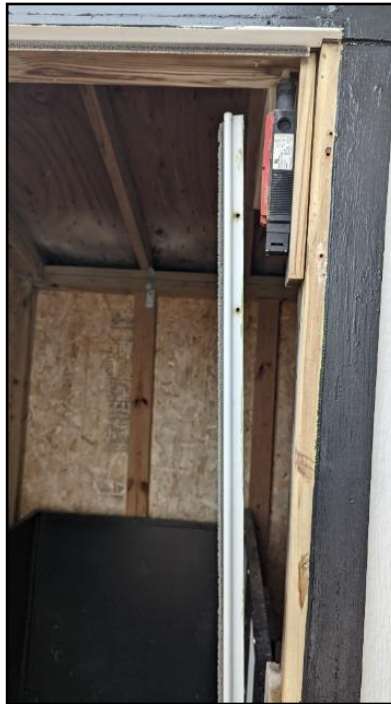
13. Damage

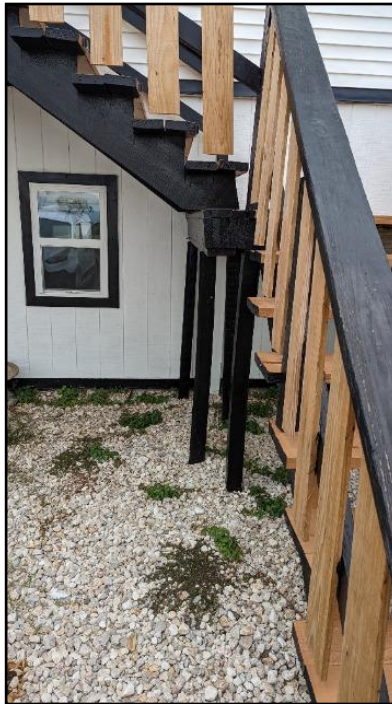
15. *Poorly built*

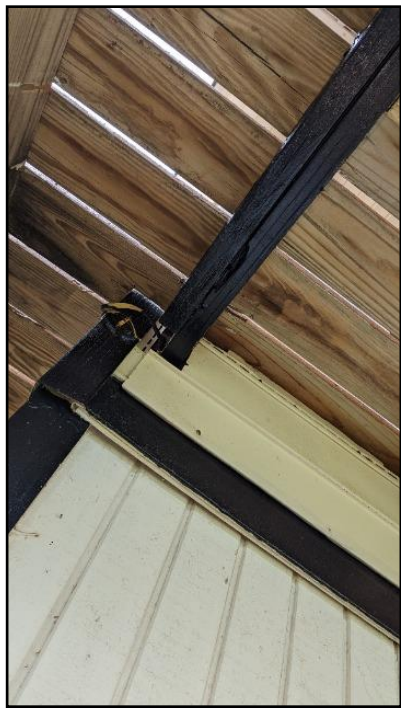
**Implication(s):** Weakened structure | Chance of movement

**Location:** Various Rear Second Floor Deck

19. Sag

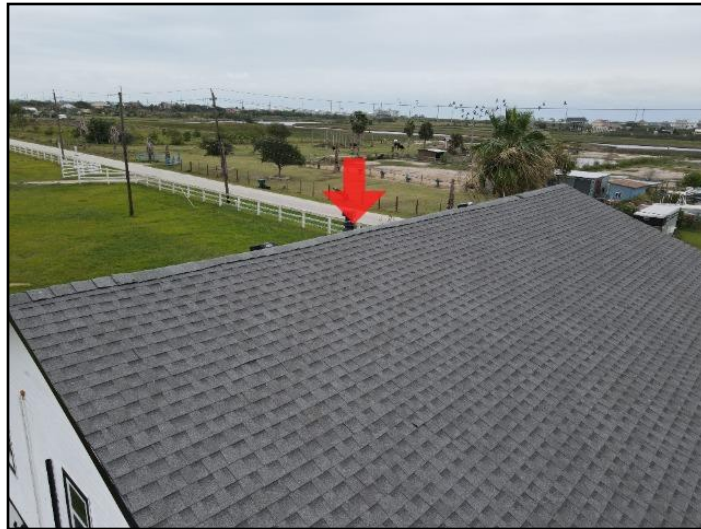
Implication(s): Weakened structure | Chance of structural movement

Location: Middle Roof

28. Ridge sagging

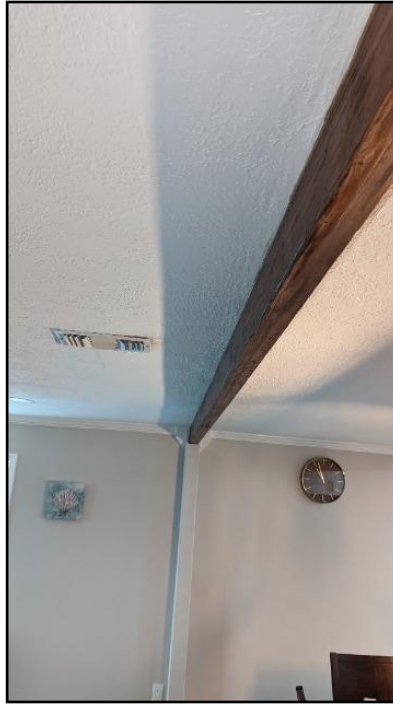
Implication(s): Weakened structure | Chance of structural movement

Location: Middle Living Room

29. Sag

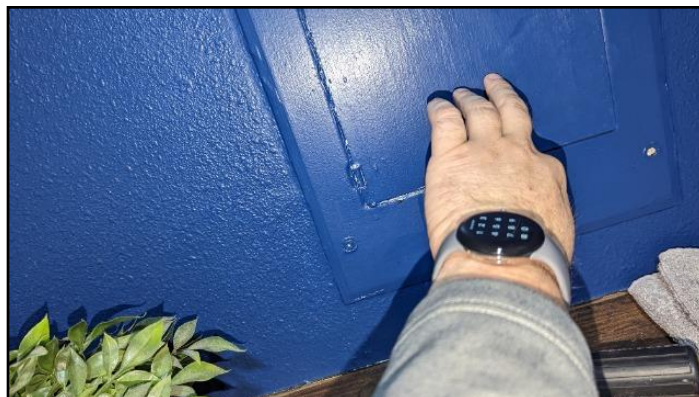
- Restricted access  
Painted Shut in Laundry Area

32. Restricted access

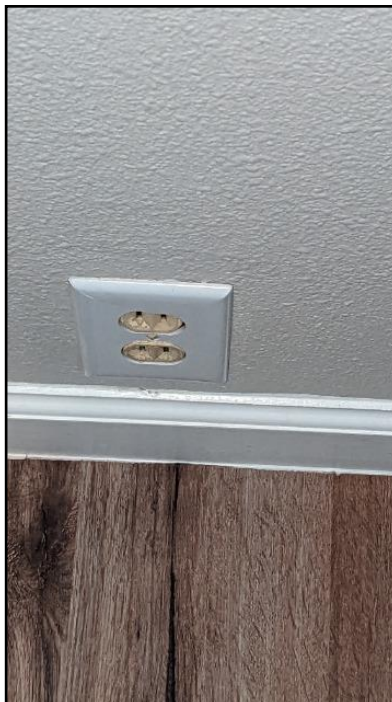
Implication(s): Electric shock

Location: Various Throughout

43. Ungrounded

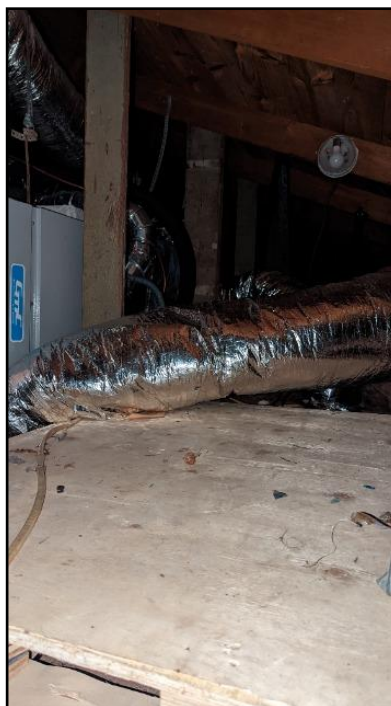
Implication(s): Increased cooling costs | Reduced comfort

Location: Throughout Attic

55. Poor support

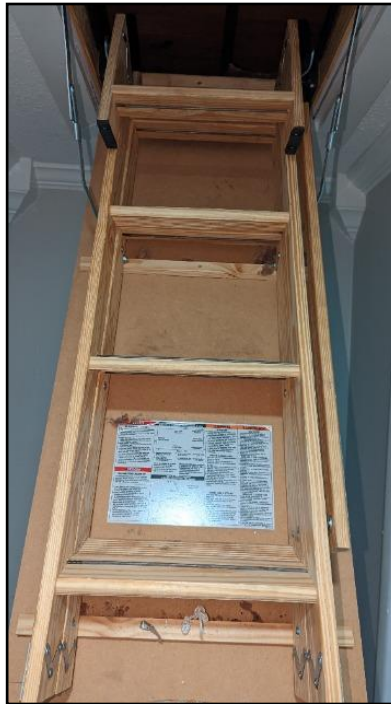
60. *Not insulated*

55. Condition: • [Not insulated](#)

Implication(s): Increased heating and cooling costs | Reduced comfort

Location: Middle Hall

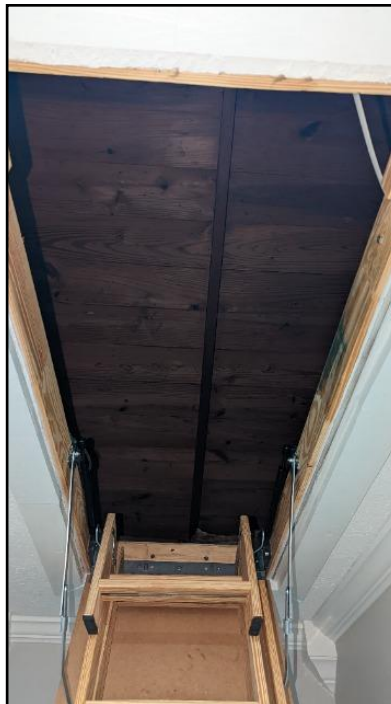
61. Not weatherstripped

56. **Condition:** • [Not weatherstripped](#)

**Implication(s):** Chance of condensation damage to finishes and/or structure | Increased heating and cooling costs | Reduced comfort

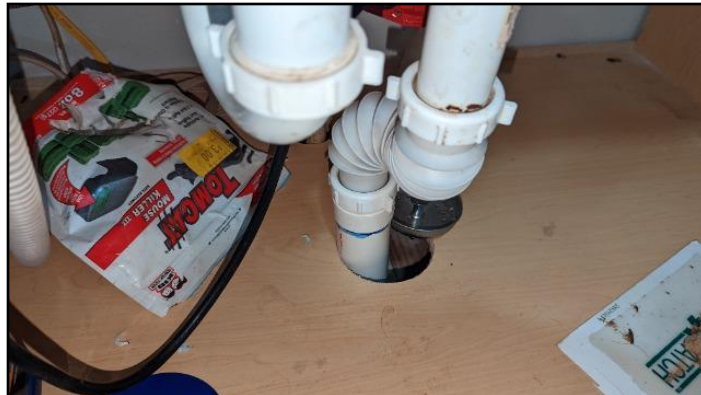
76. Wrong type

63. Condition: • [Wrong type](#)

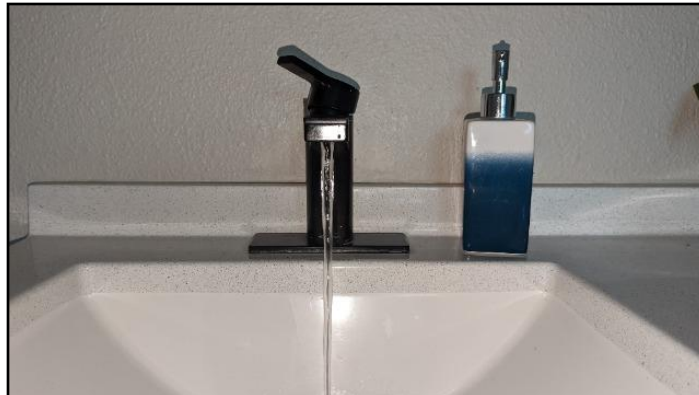
78. Aerator - obstructed

65. Condition: • [Aerator - obstructed](#)

Implication(s): Reduced water pressure and volume

Location: Second Floor Master Bathroom

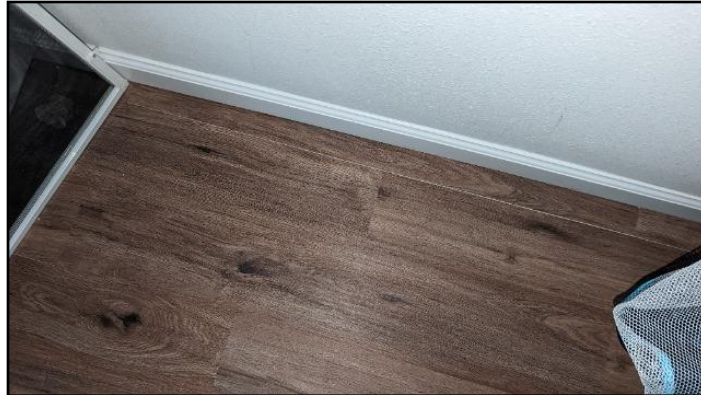
92. Exposed tongues

74. Condition: • [Exposed tongues](#)

Location: Various Closets
