PROPERTY INSPECTION REPORT

Date of Inspection: 9/26/2022

Joseph Killion <i>Name of Client</i>	9/26/2022 <i>Date of Inspection</i>
3349 Jan Ct Katy, TX 77493 <i>Address of Inspected Property</i>	
Syed Waqif (Aj) <i>Name of Inspector</i>	TREC # 22011 <i>TREC License #</i>
<i>Name of Sponsor (if applicable)</i>	<i>TREC License #</i>

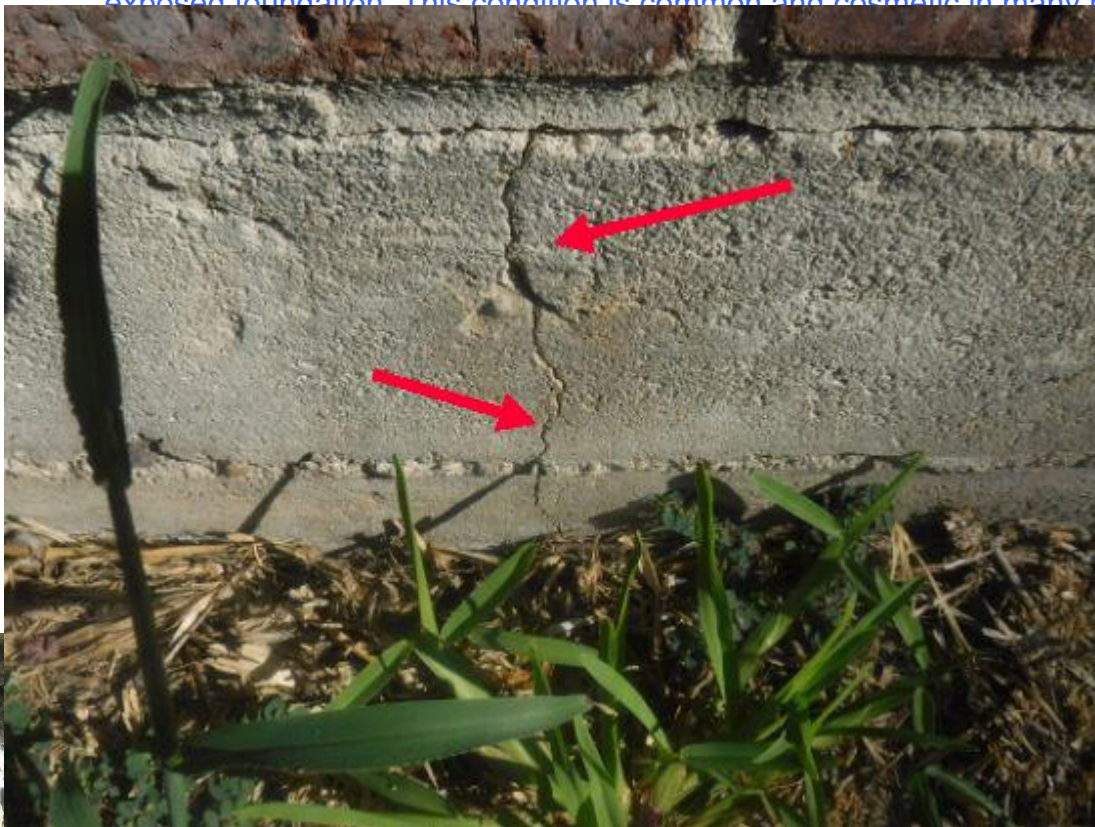
- Surface deterioration (known as spalling) was observed on the exterior of the exposed foundation. This condition is common and cosmetic in many homes and

Spalling on the south side

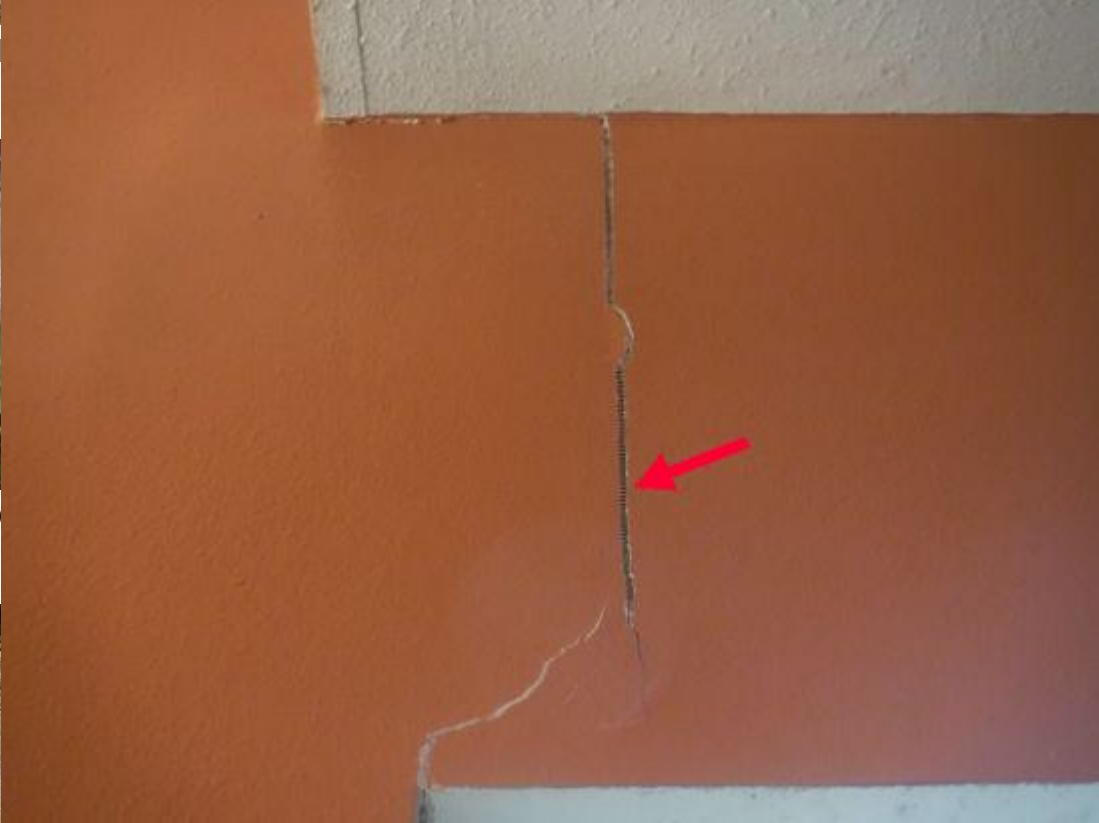
Vertical shrinkage crack

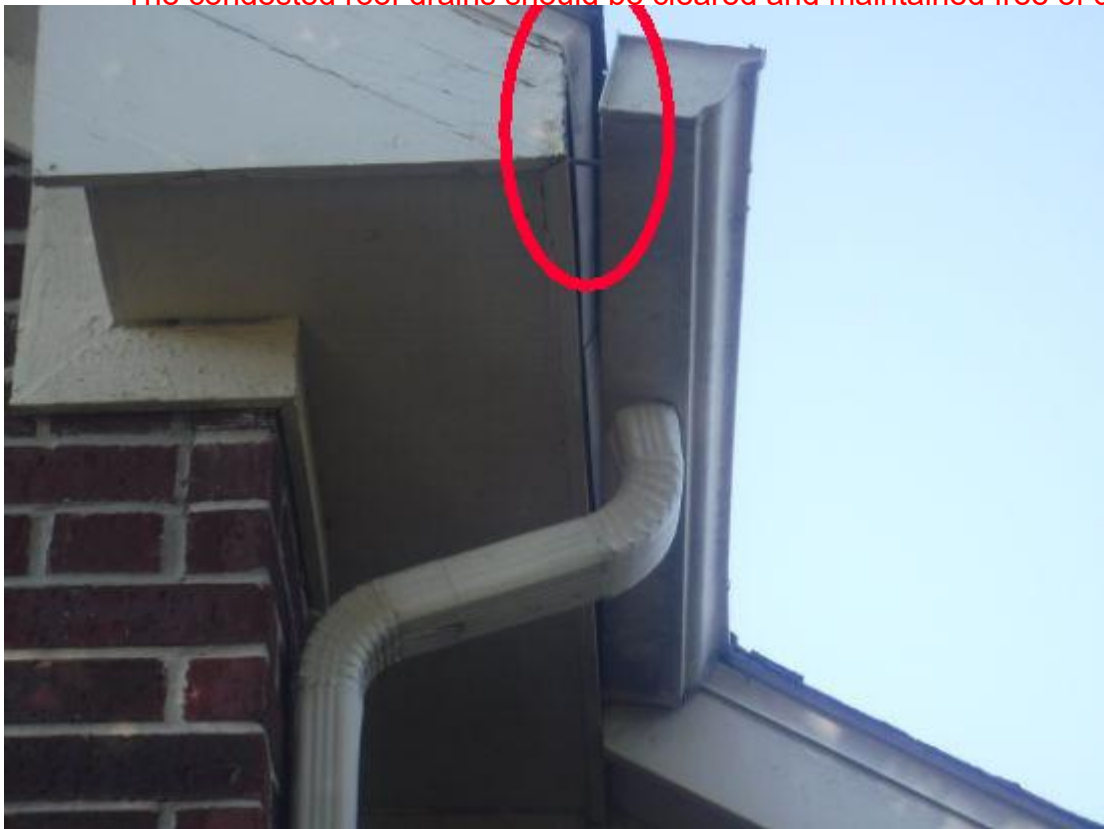
• The congested roof drains should be cleared and maintained free of debris.

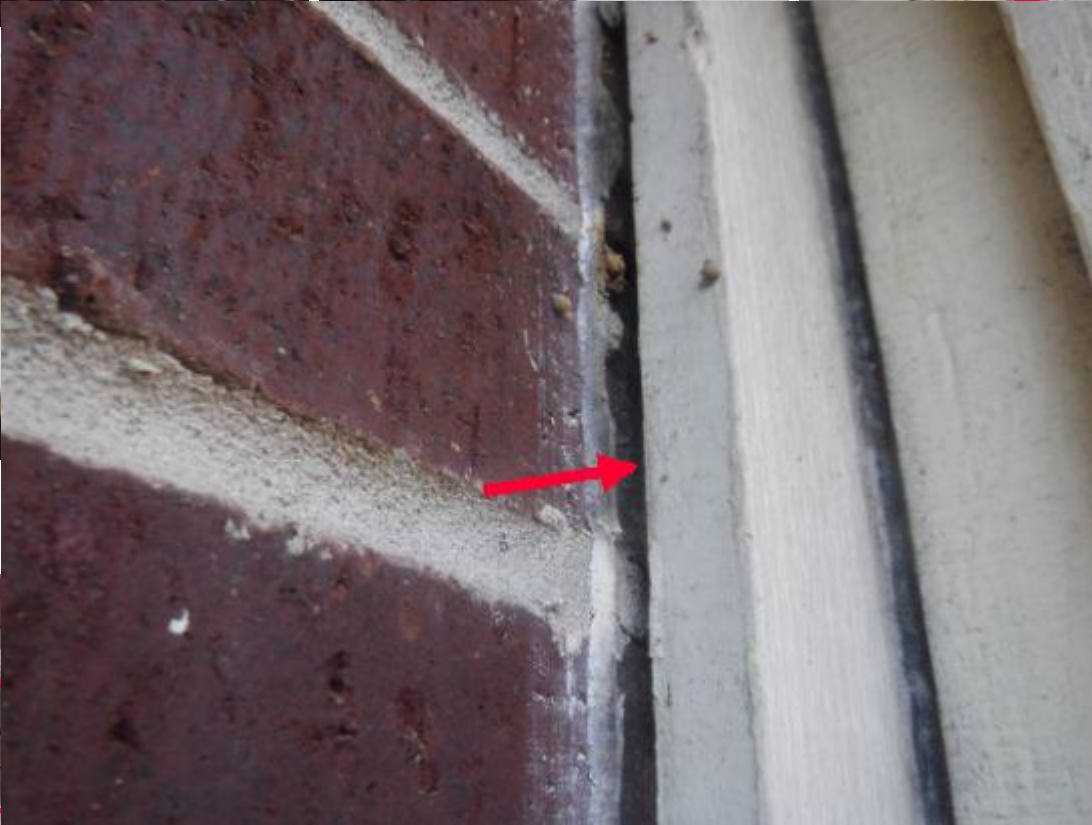
Settlement/movement crack

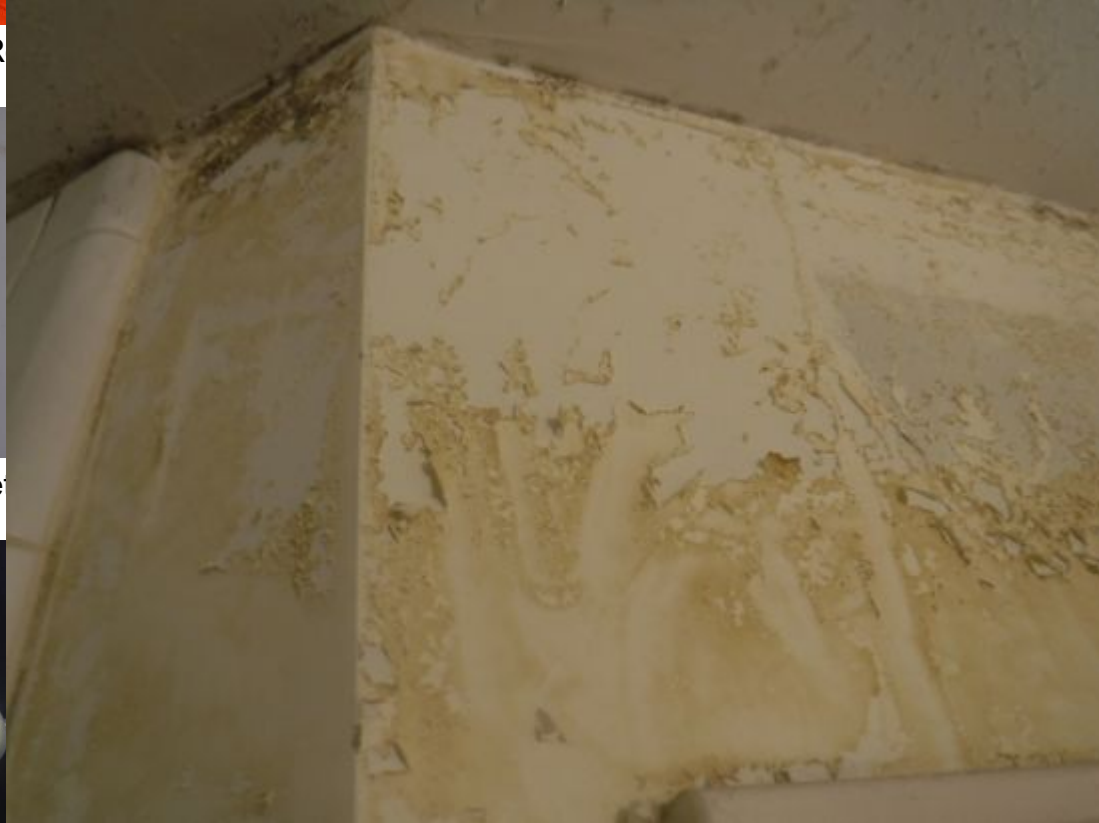
Damaged wall

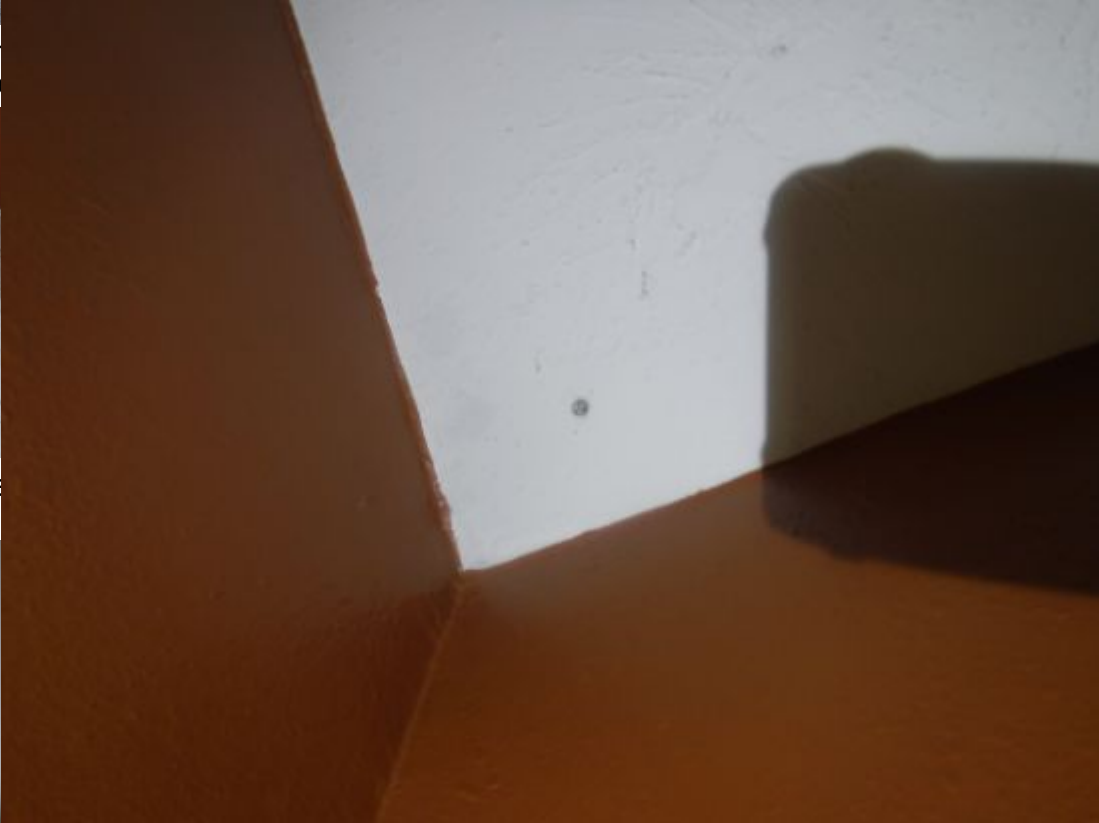
Damaged ceiling

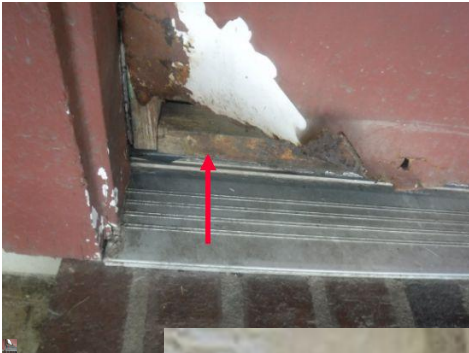
Damaged

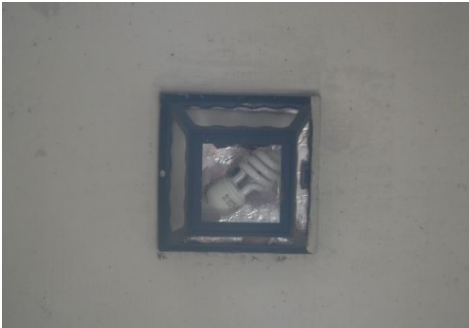
Damaged

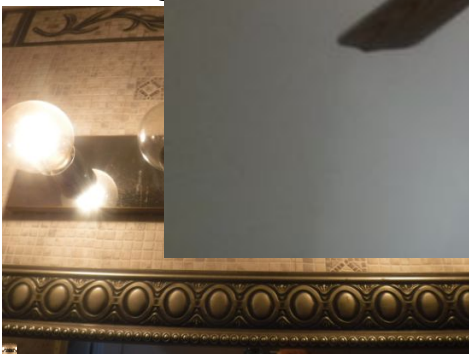
Inoperative light

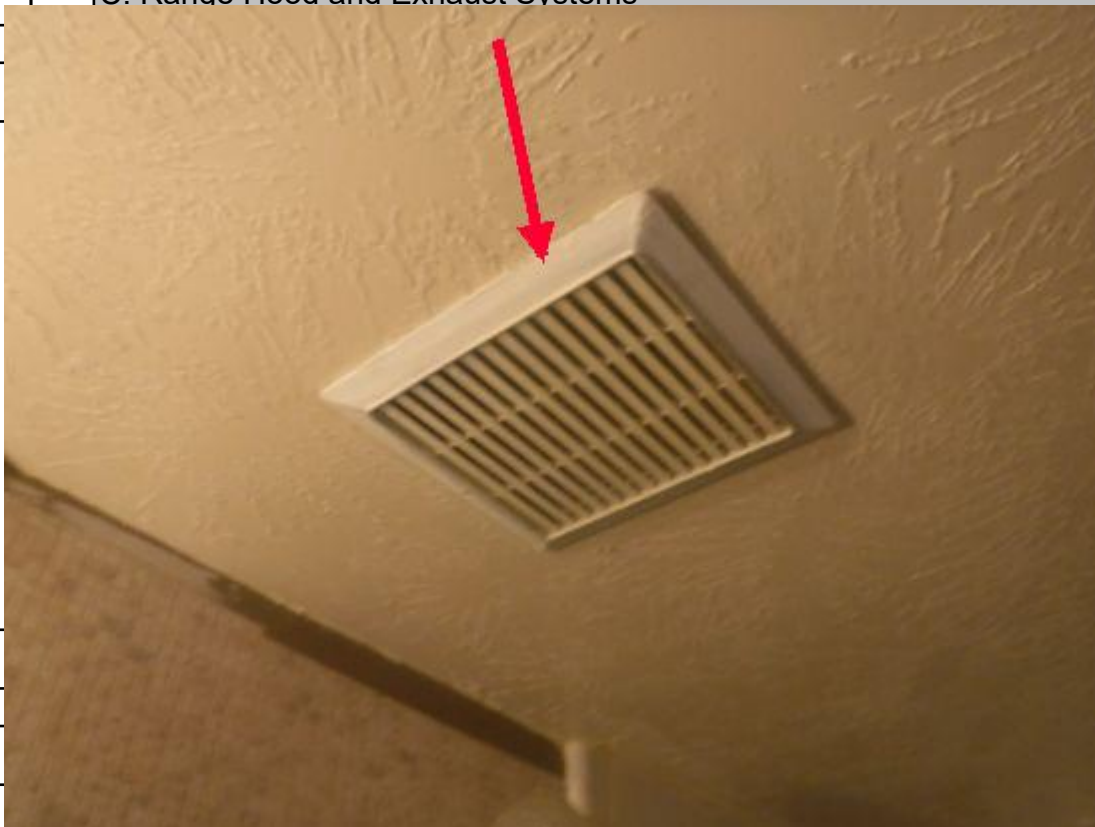
• The bathroom exhaust fan exhibits excessive vibration when running. This condition should be repaired.

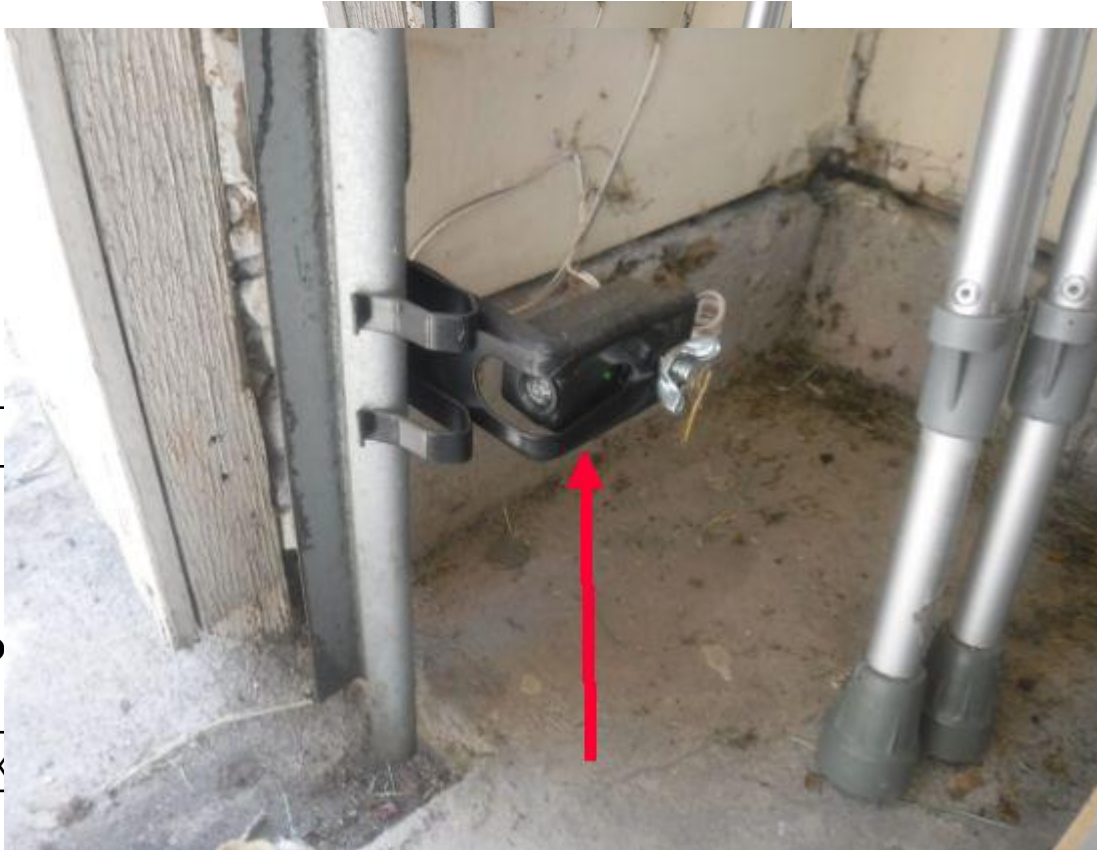
- The electronic sensor for the garage door opener was found to be installed at an improper height (should be 6" or below) from the garage floor. This should be repaired as it poses a safety concern.
