PROPERTY INSPECTION REPORT

22430 Smokey Hill Dr. , Katy, TX 77450
Inspection prepared for: Matt Messer
Real Estate Agent: Open House - Open House

Date of Inspection: 10/8/2022 Time: 8:30 AM
Age of Home: 1977 Size: 1,812
Weather: Clear 75 Degs F
Structure Type: Structure is a wood framed structure
on a concrete slab foundation.

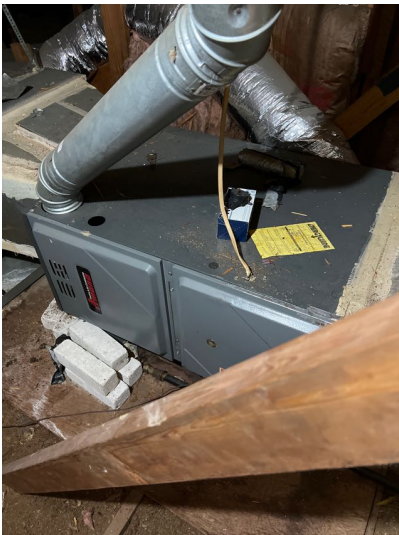
- The gas supply line was not equipped with a required sediment trap just before the appliance connector. This condition does not meet current mechanical standards and should be corrected.

Picture of Furnace

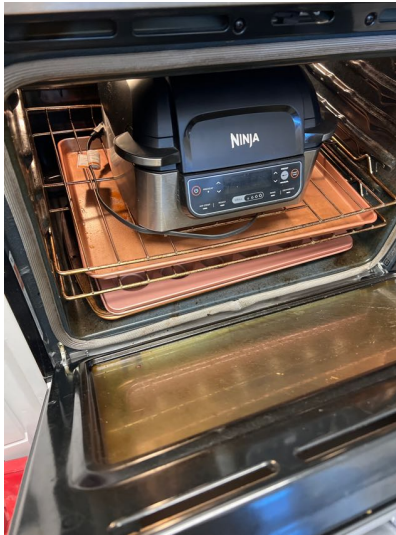
Oven used for storage
