Property Inspection Report

3616 1/2 Avenue M, Galveston, TX 77550
Inspection prepared for: Victor Orellana
Date of Inspection: 4/28/2023 Time: 9:00 AM
Age of Home: 1975 Size: 1544
Weather: Sunny 78 Degrees
Property Vacant

Inspector: Travis Morrow
TREC 22042
P.O. Box 6816, Katy, TX 77491
Phone: 2817796431
Email: travis@morrowinspections.com
www.morrowinspections.com

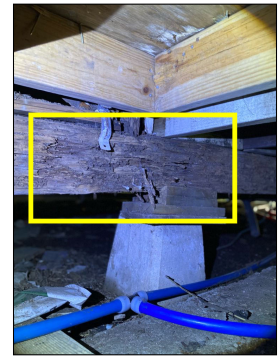
Rot/deterioration/damage beams.

F.13. Damaged/rotten/deteriorated floor joists/framing observed. A qualified contract should be engaged for further review/repair. (crawlspcace, laundry room)

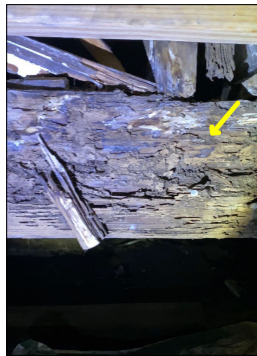
Rot/deterioration/damage beams.

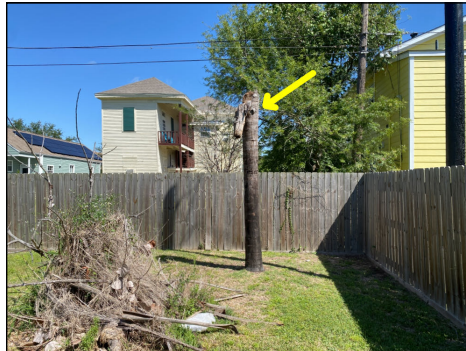
Dead tree rear of home.

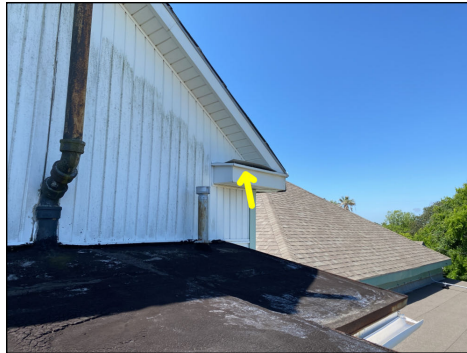
Lifted flashing.

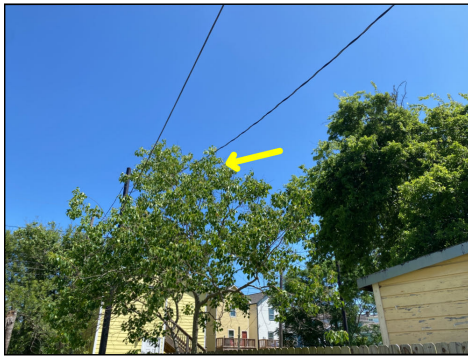
A.11. Tree limbs should be cut back away from service lines.

Tree contacts service drop.

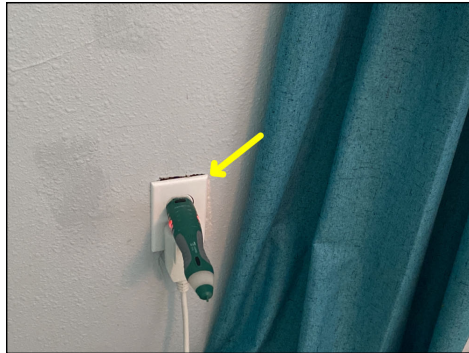
B.14. Reversed polarity (wired backwards) was observed and requires repair. (front first floor bedroom)

Reversed polarity front first floor bedroom.

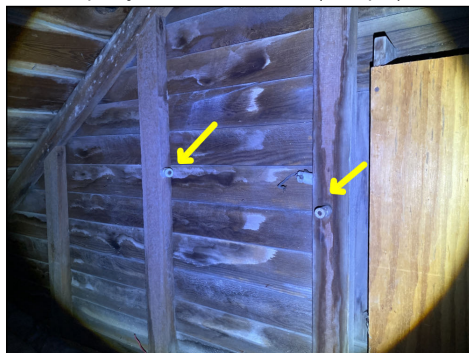
B.21. Note: The home in question is advertised as being built in 1975. What appears to be old knob and tube wiring was observed in the attic. This style wiring was generally not installed past the 1940s.

Evidence of prior knob and tube.
