# PROPERTY INSPECTION REPORT

Concerning: 2215 Briarstead Drive , Houston, TX 77057  
(Address or Other Identification of Inspected Property)

By: Bob Avery Lic.#: TREC #20559 MAT #1059 04/15/2021  
(Name and License Number of Inspector) (Date)

DATE OF INSPECTION: 04/15/2021

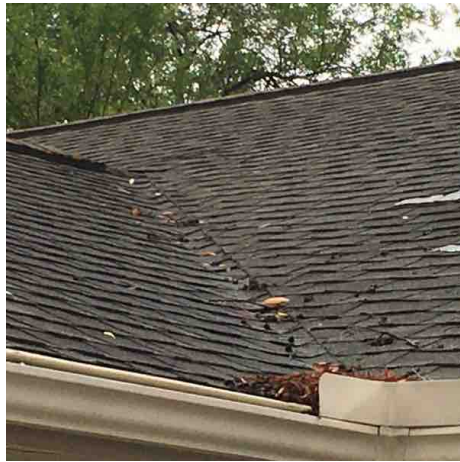
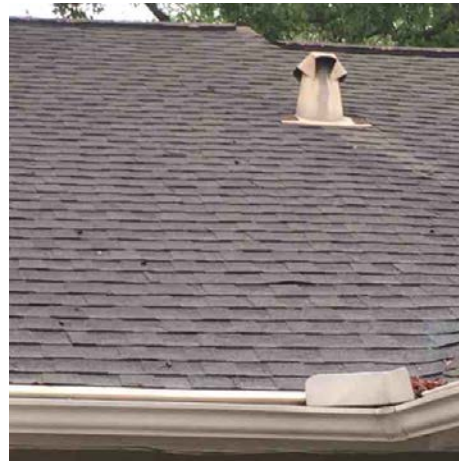
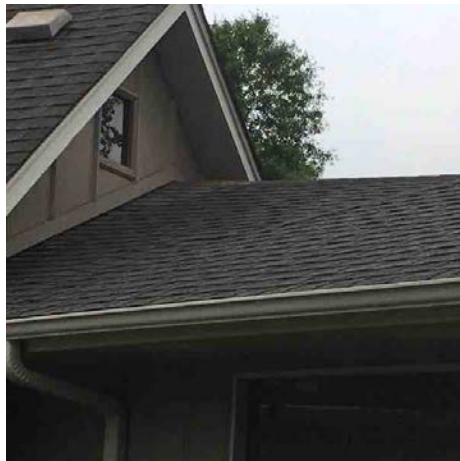
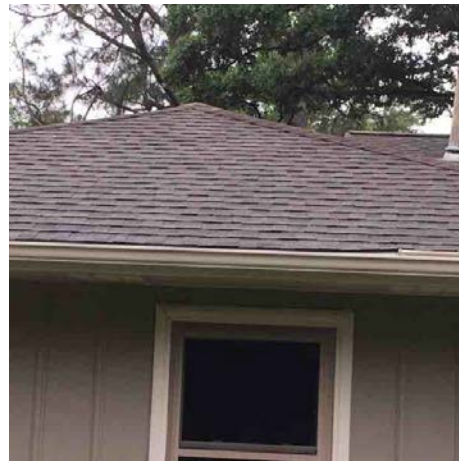
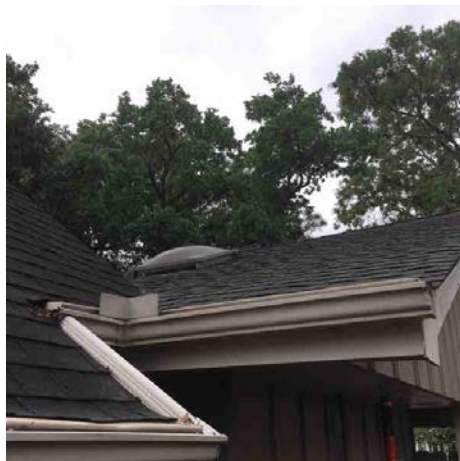
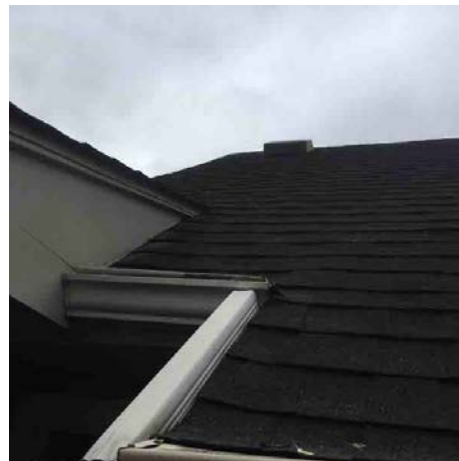
- Roof appears to be in good condition except where noted.

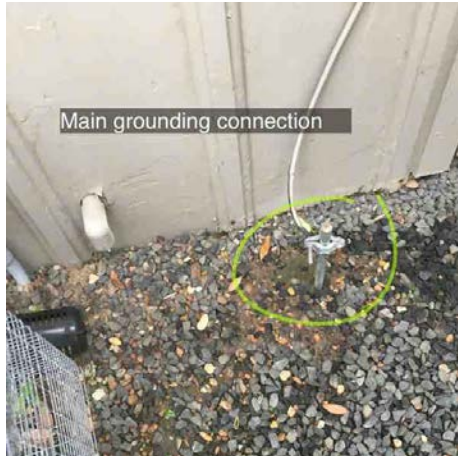
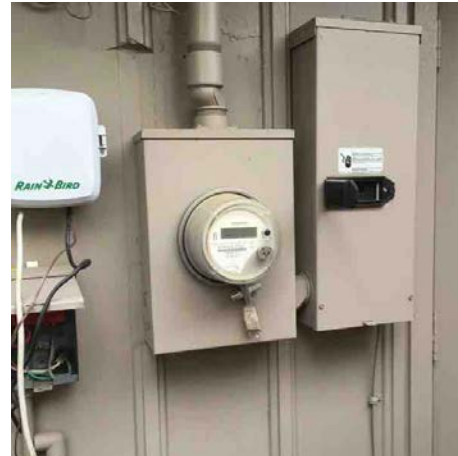
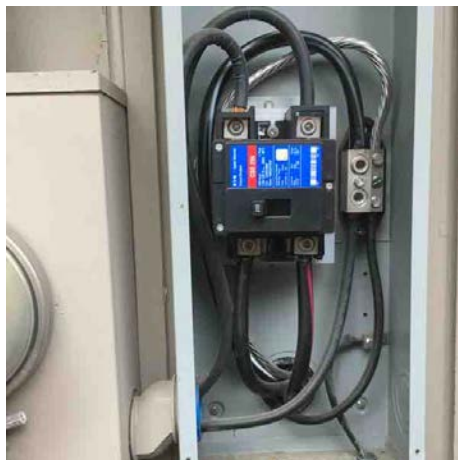
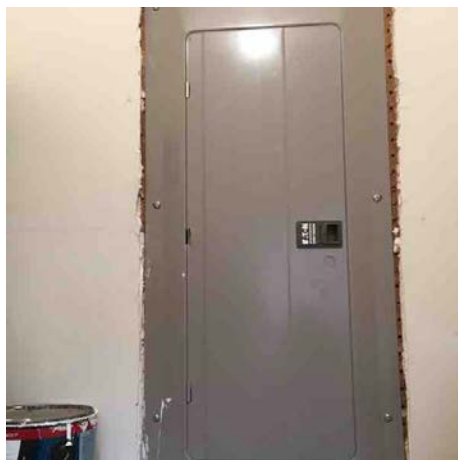
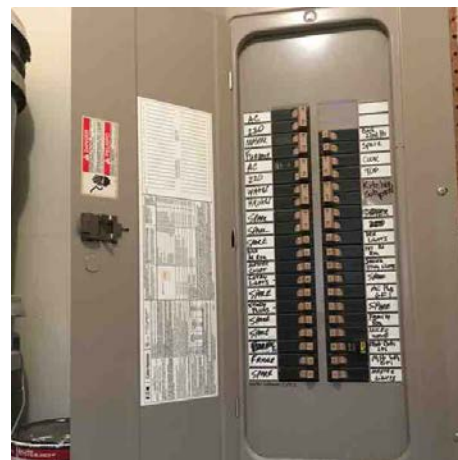
- Main distribution panel is 200 amp service; underground, 120/240 volt, copper leads and uses breakers. Romex type wiring is noted. All bondings and groundings were not visible and could not be verified.

50 amp sub panel present

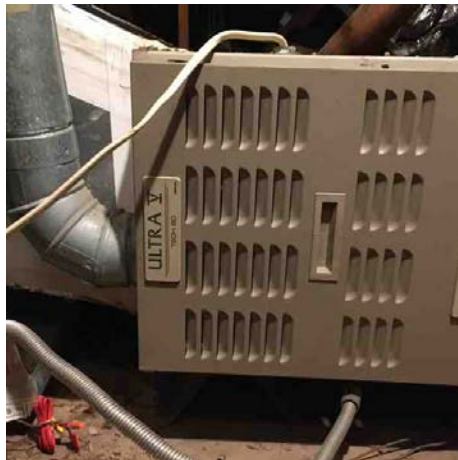
- Heating system was run for more than 30 minutes. System met accepted standard differentials of 35 to 50 degrees between supply and return registers. Reading ranged between 37 - 40 degrees.

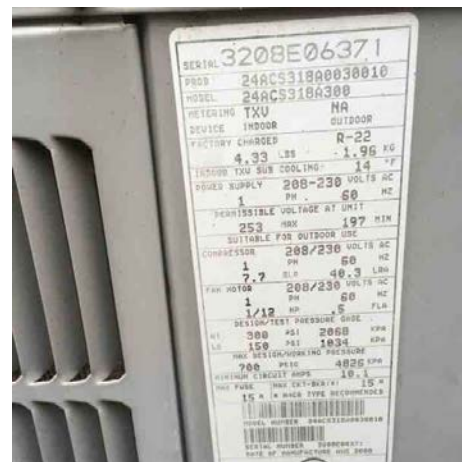
- Cooling system was run for more than 30 minutes. System meet accepted standard differentials of 15 to 20 degrees between supply and return registers. Reading ranged between 15 - 20 degrees.

2020 A-410. Max breaker 40 amps  
 2008 R-22. Max breaker 15 amps

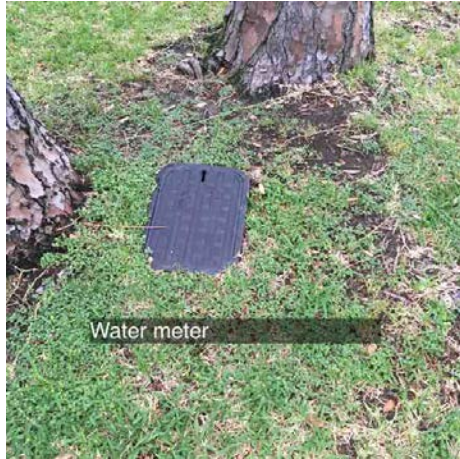
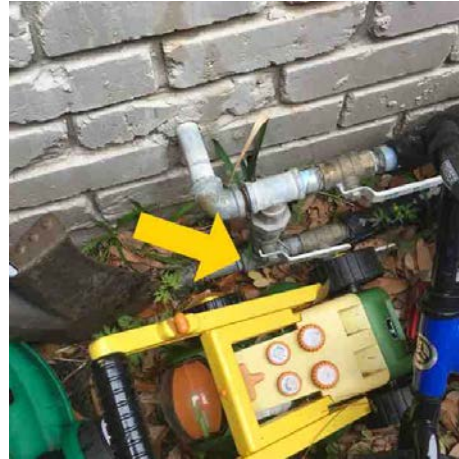
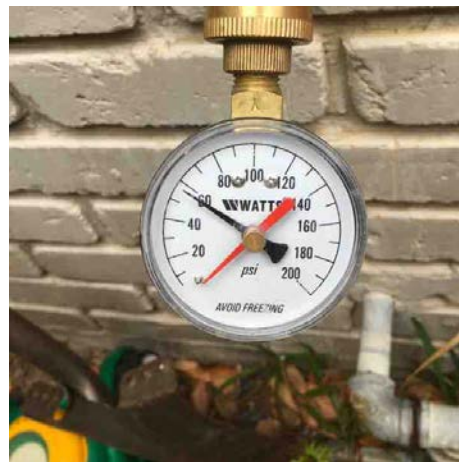
- Appears to have two water shut offs one on the exterior right side and one on the back exterior wall of the addition. Investigate with seller o Li sensed plumber. **(Right Exterior)**

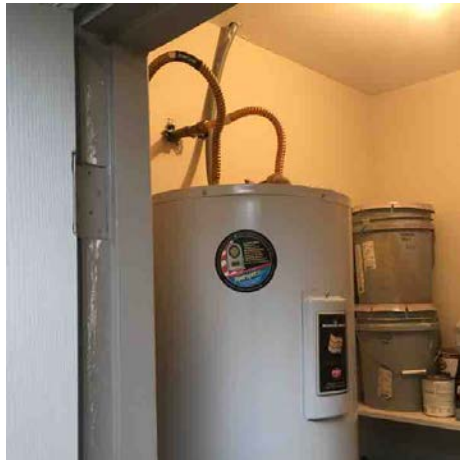
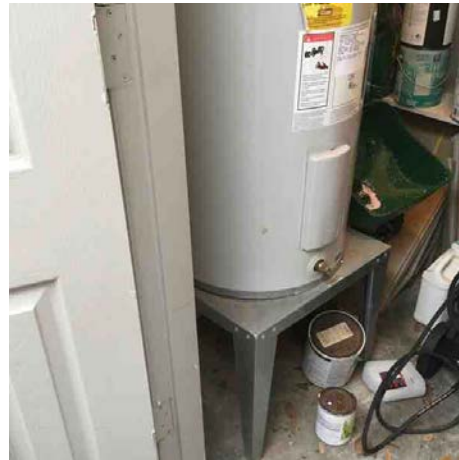
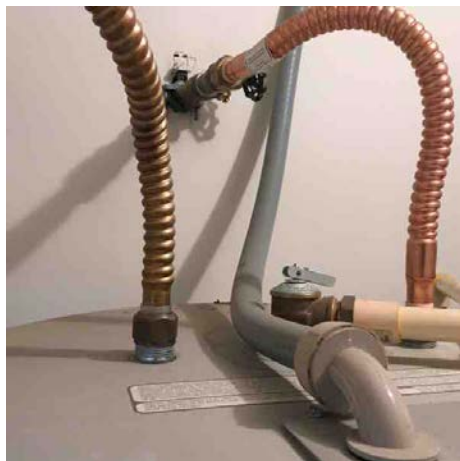
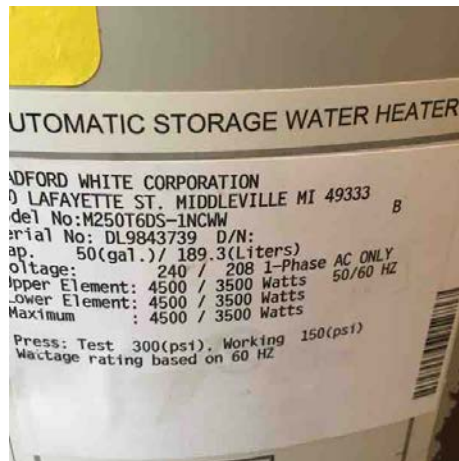
- Water heater in exterior closet of addition. 2007

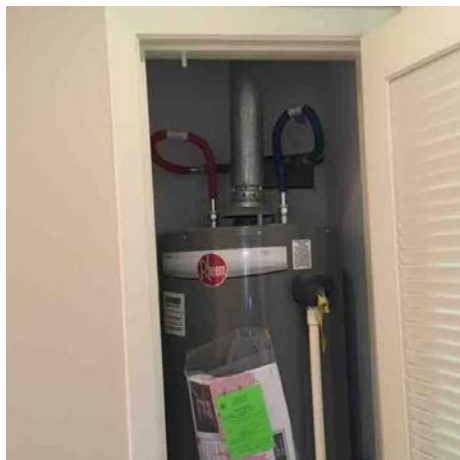
- 2019

Water heater in closet in hall.

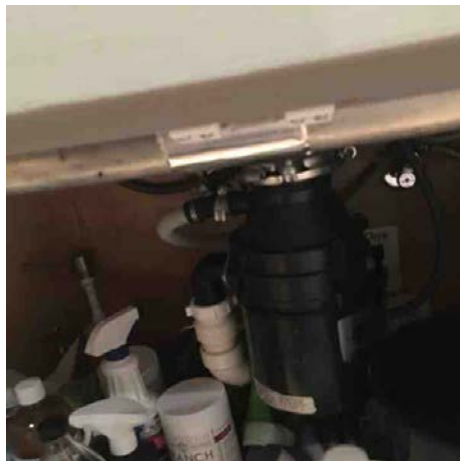
- Functioned properly

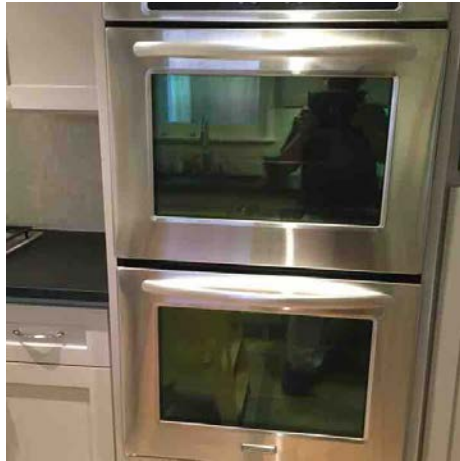
- Temperature for Top and bottom ovens was 295 and 297 when set at 350. Outline the 25 degree range.

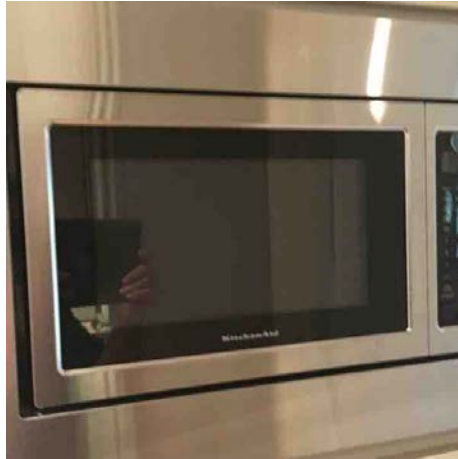
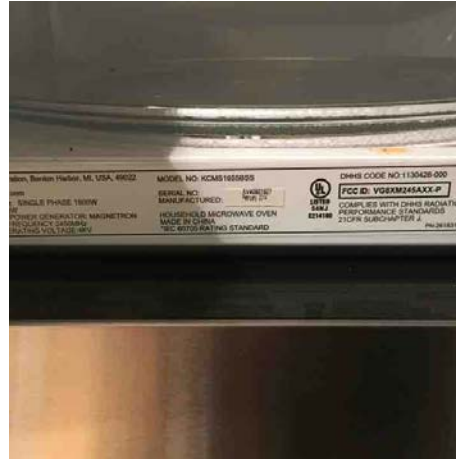
- Not functioning. No power

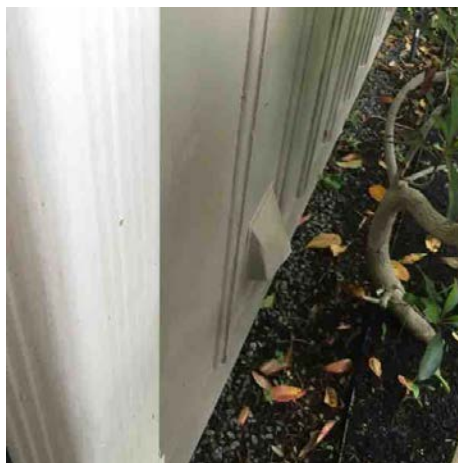
- Appears to be installed properly (**Back Exterior**)

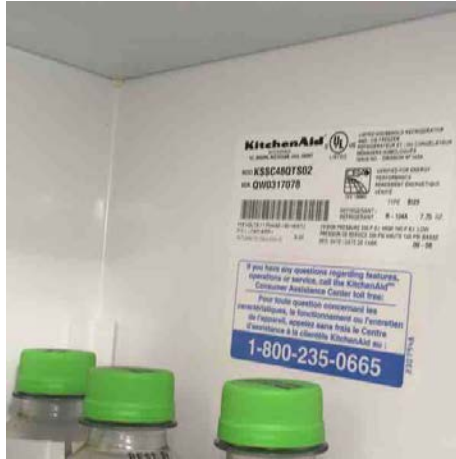
- Refrigerator data plate
