# 2607 Bisontine Street Friendswood, Texas 77546

## Your Home Inspection Report

Client:	Jacqueline Garner
Type:	Home inspection
Inspected by:	Double Checked Home Inspections
Scheduled:	April 7, 2022, 7:00 PM
Completed:	April 8, 2022, 12:55 AM

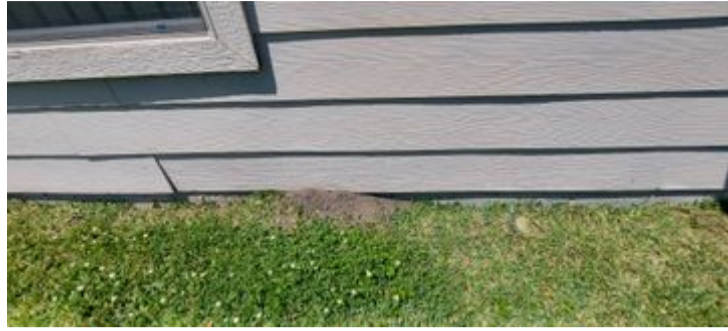
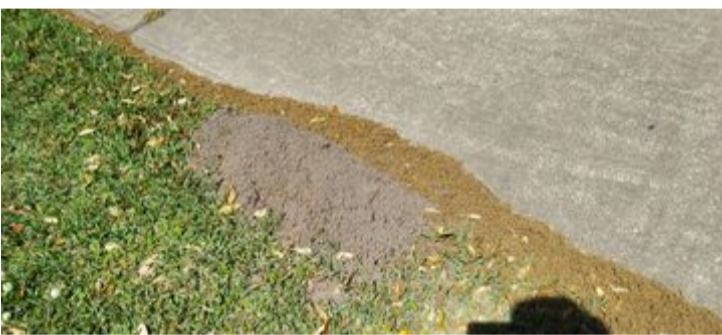
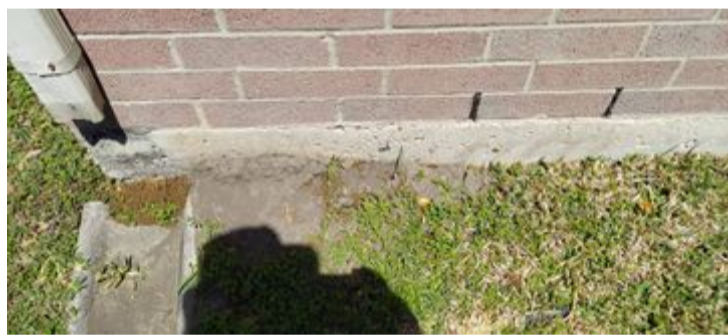
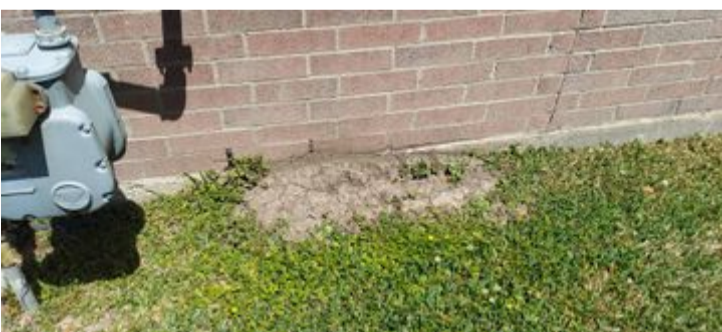
### Ant piles observed

I observed large ant piles next to the foundation in the backyard.

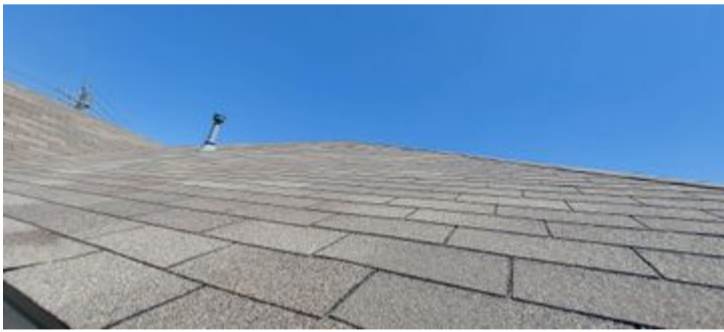
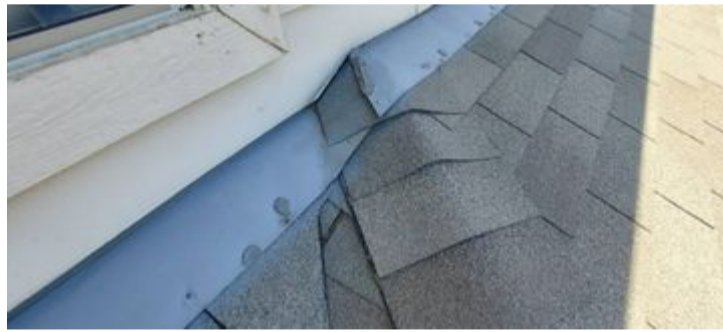
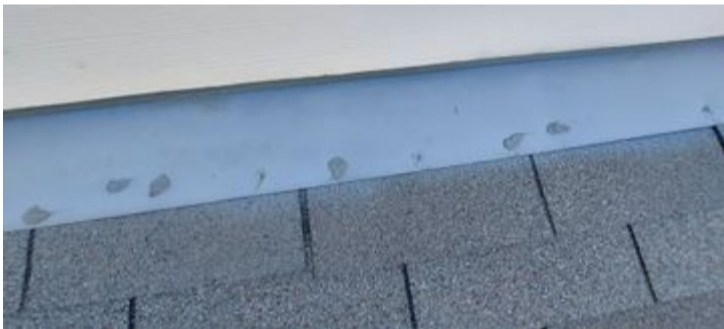
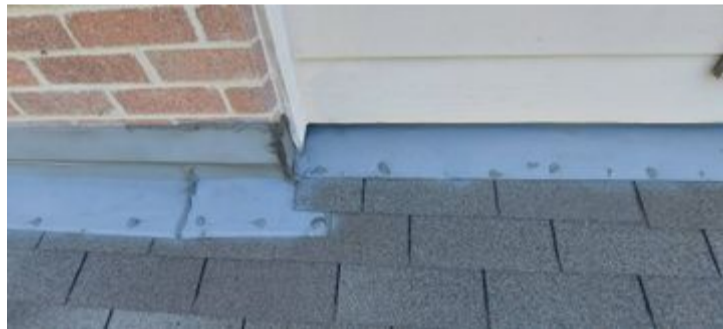
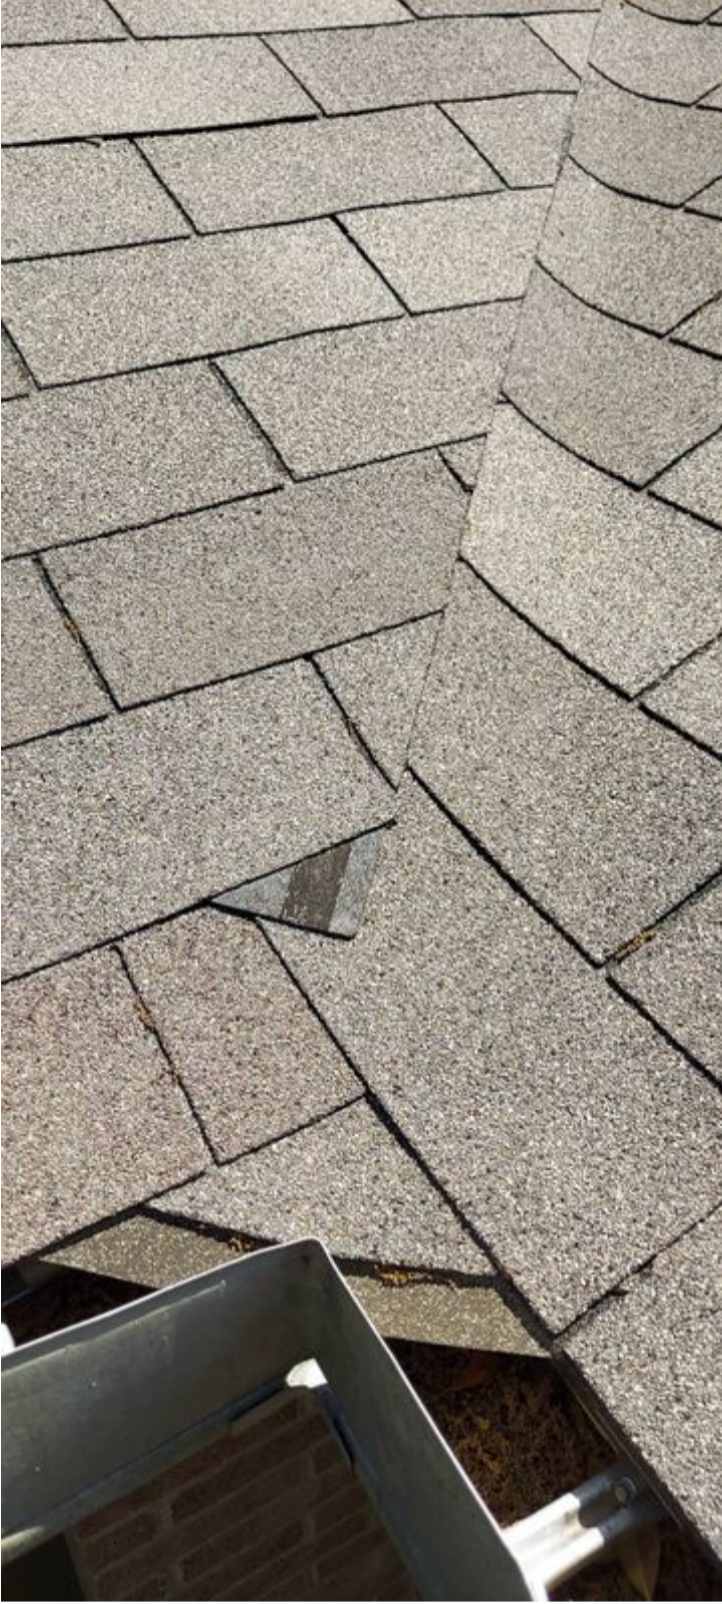
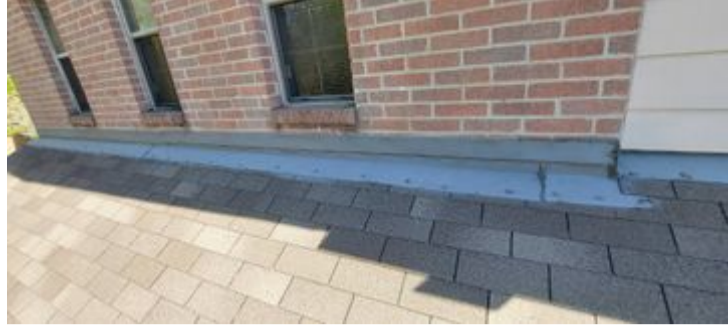
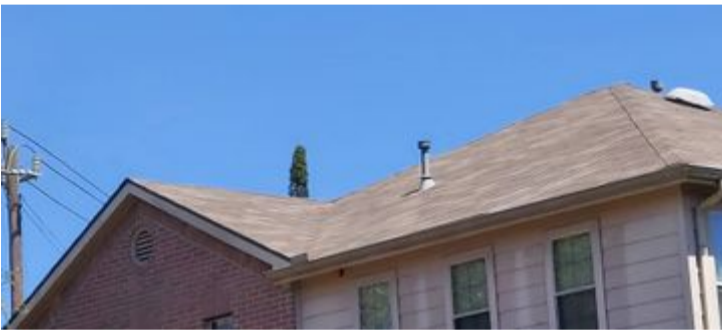
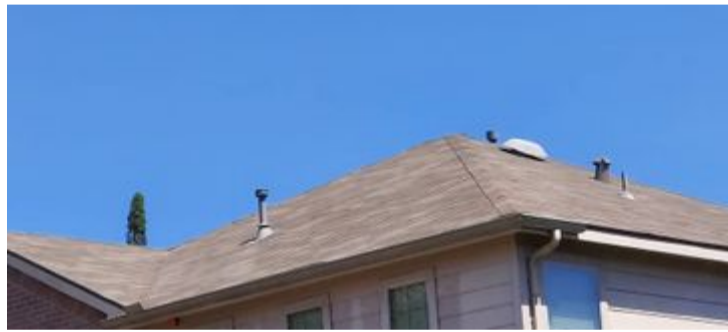
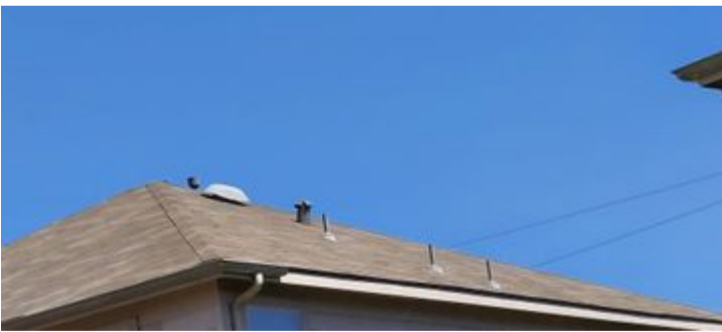
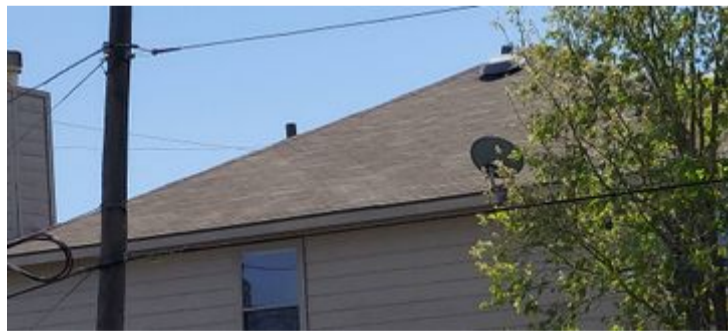
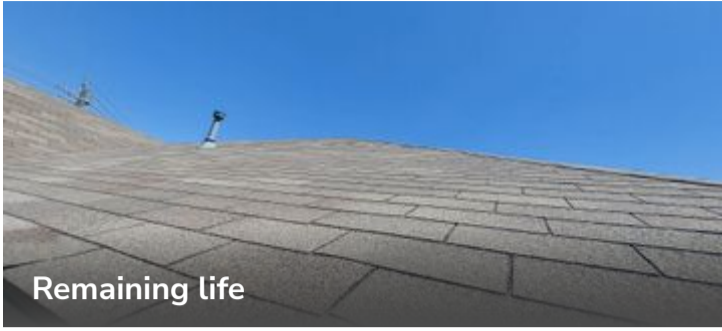
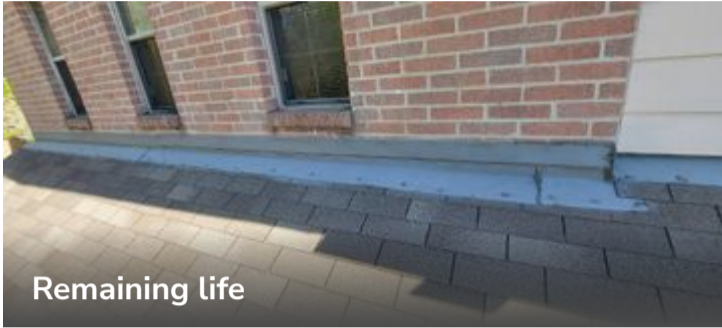
**While I was not able to walk the entirety of the roof, the roof is less than a year old. It was in really good condition.**

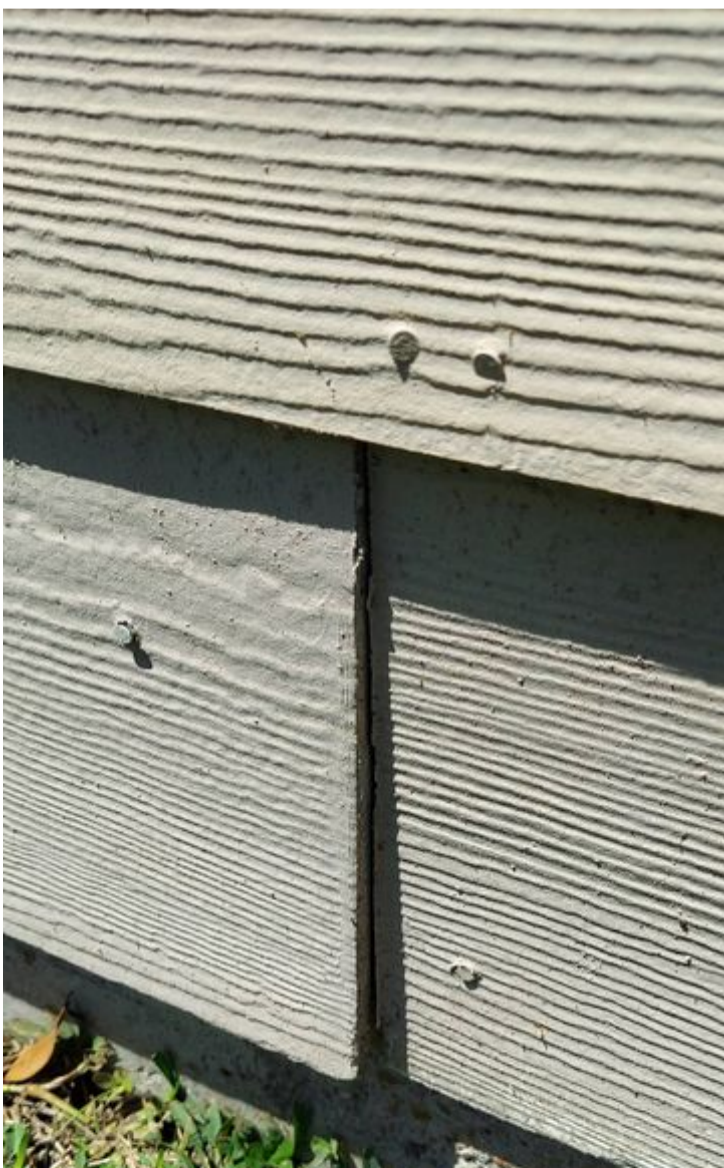
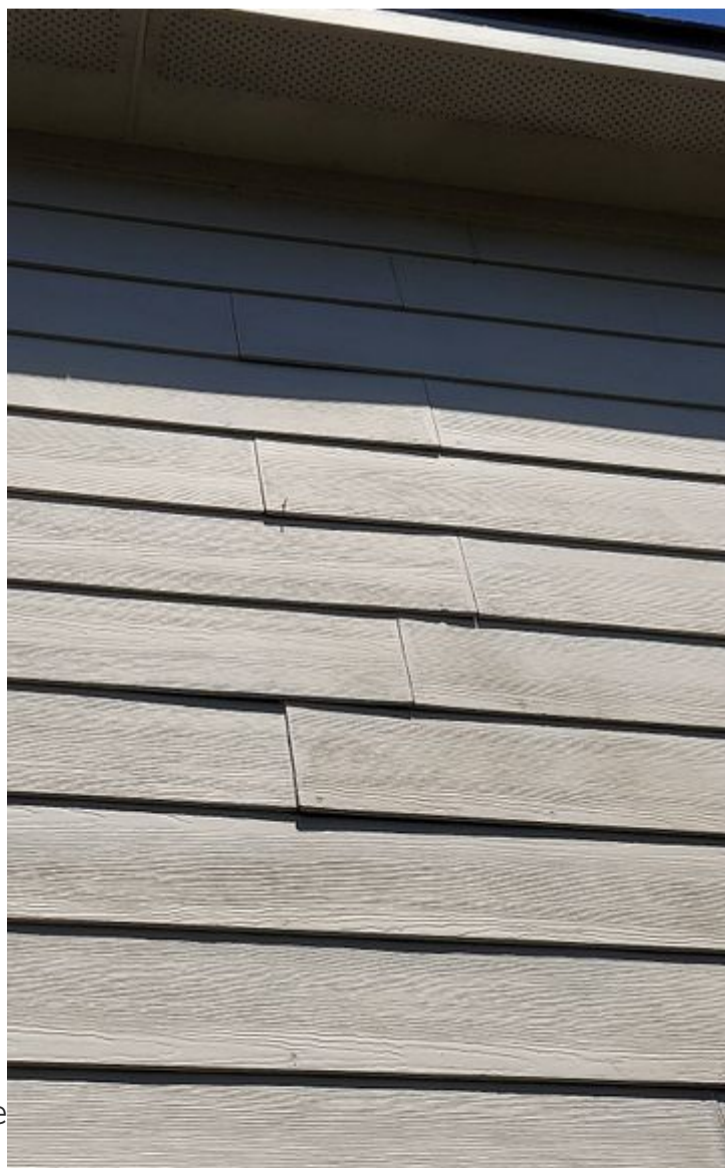
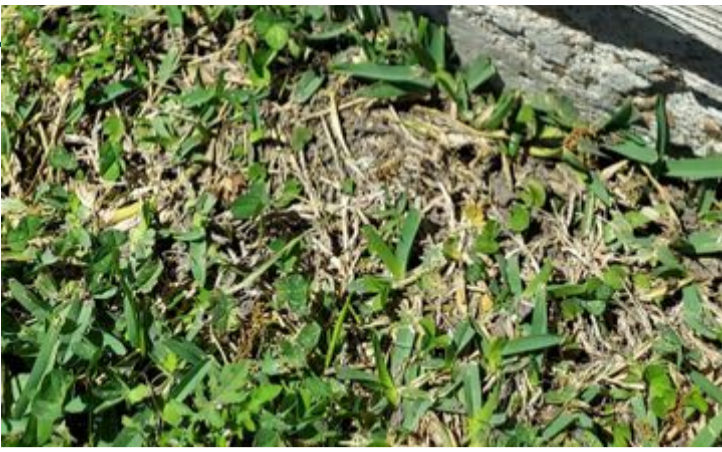
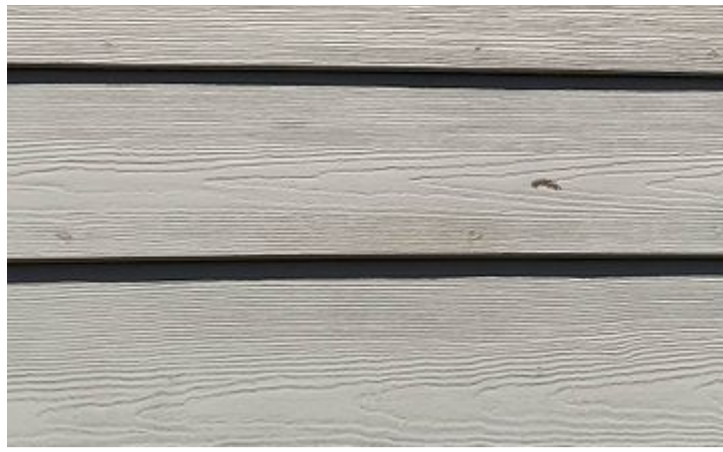
## Siding butts not sealed

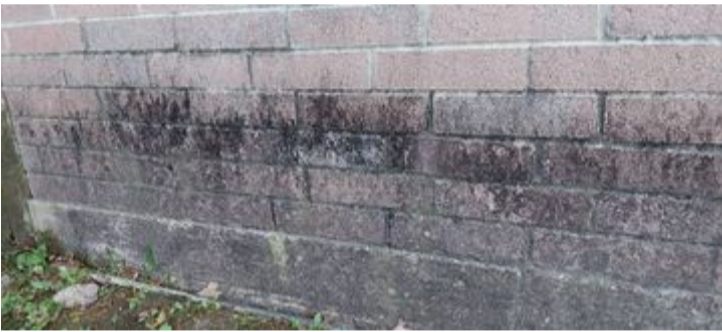
### Stains on brick cladding observed

I observe some blackish type of staining on the brick cladding.

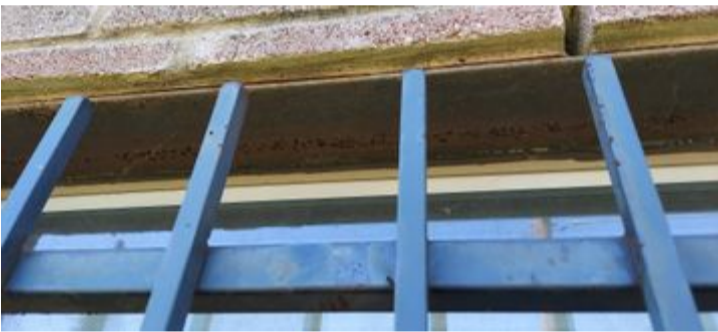
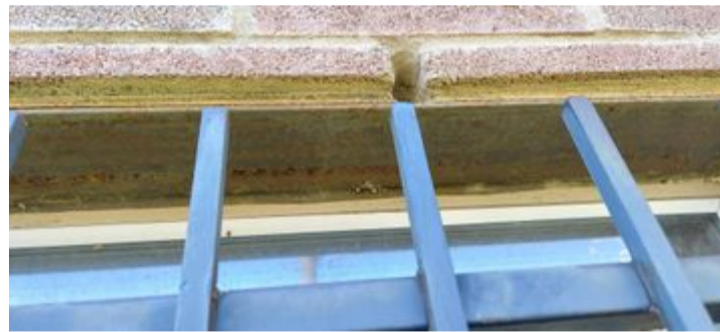
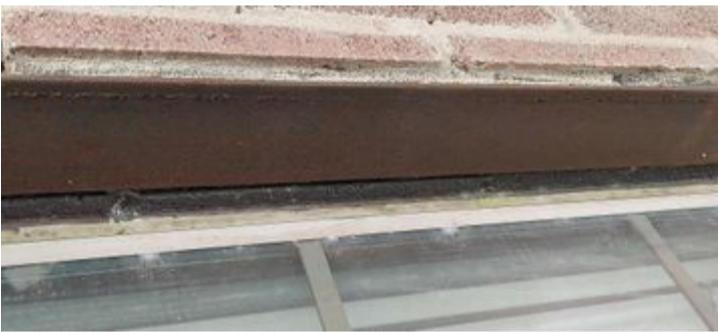
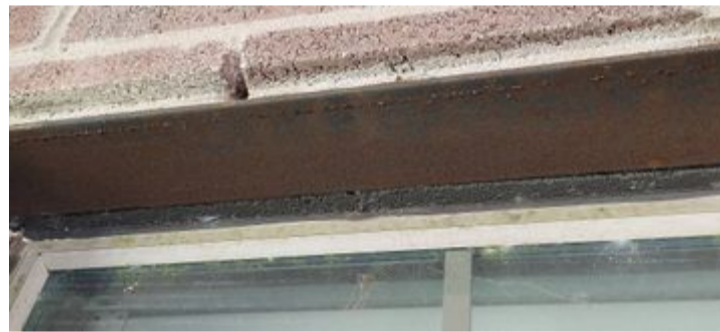
## Window Lintel Rust

The window lintel was rusted, recommend cleaning and paint.

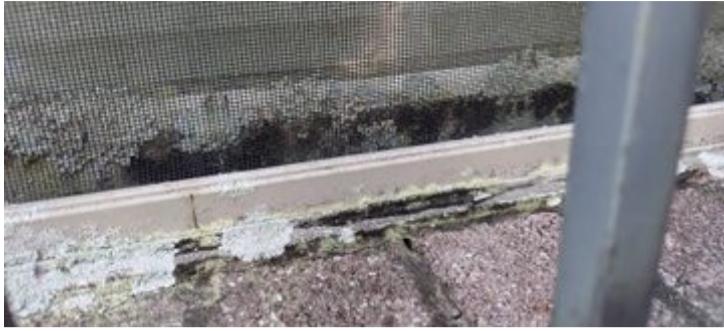
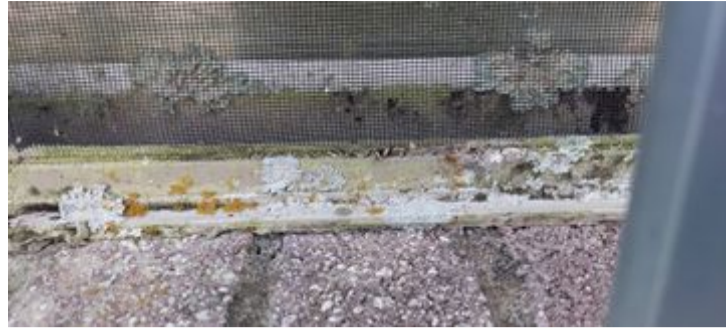
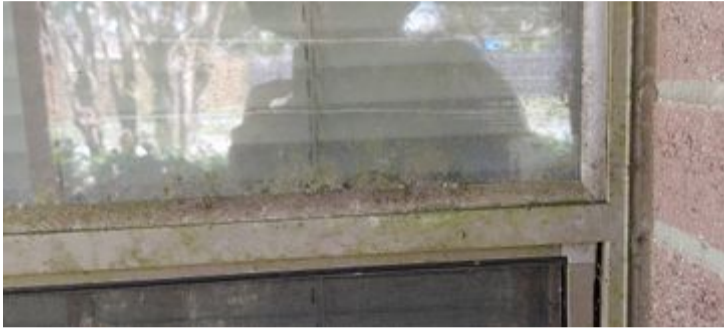
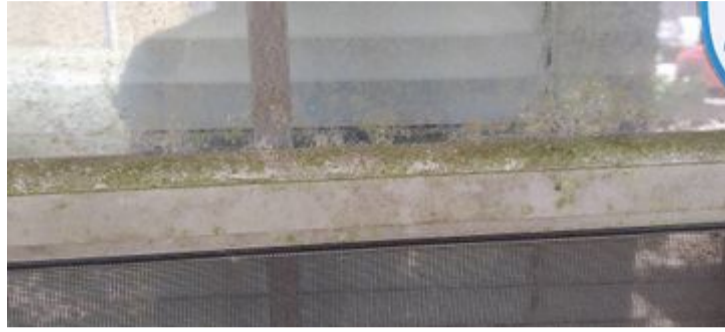
## Mildew observed on windows

I observed mildew on the exterior portion of windows.

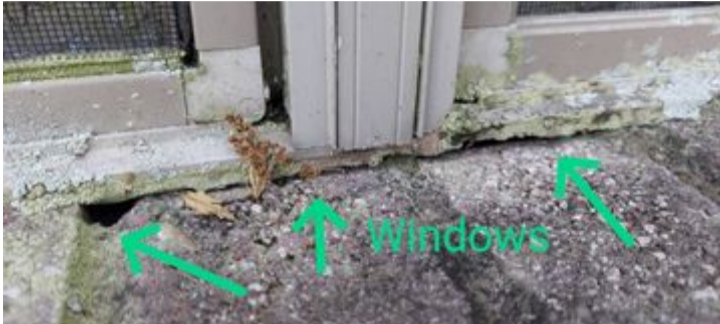
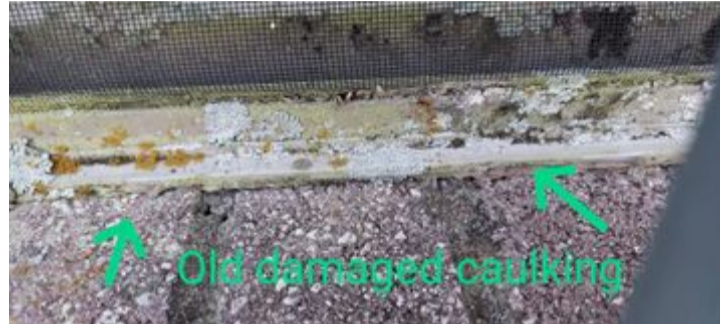
## One or more areas need caulk

One or more exterior areas need caulking.

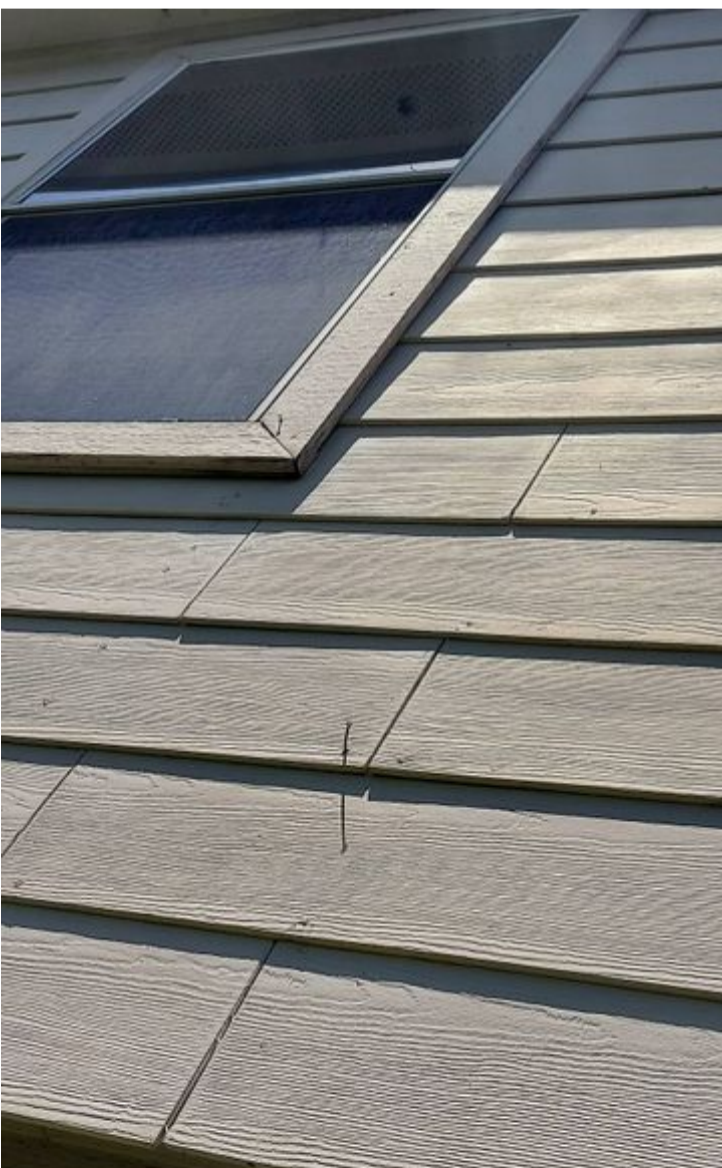
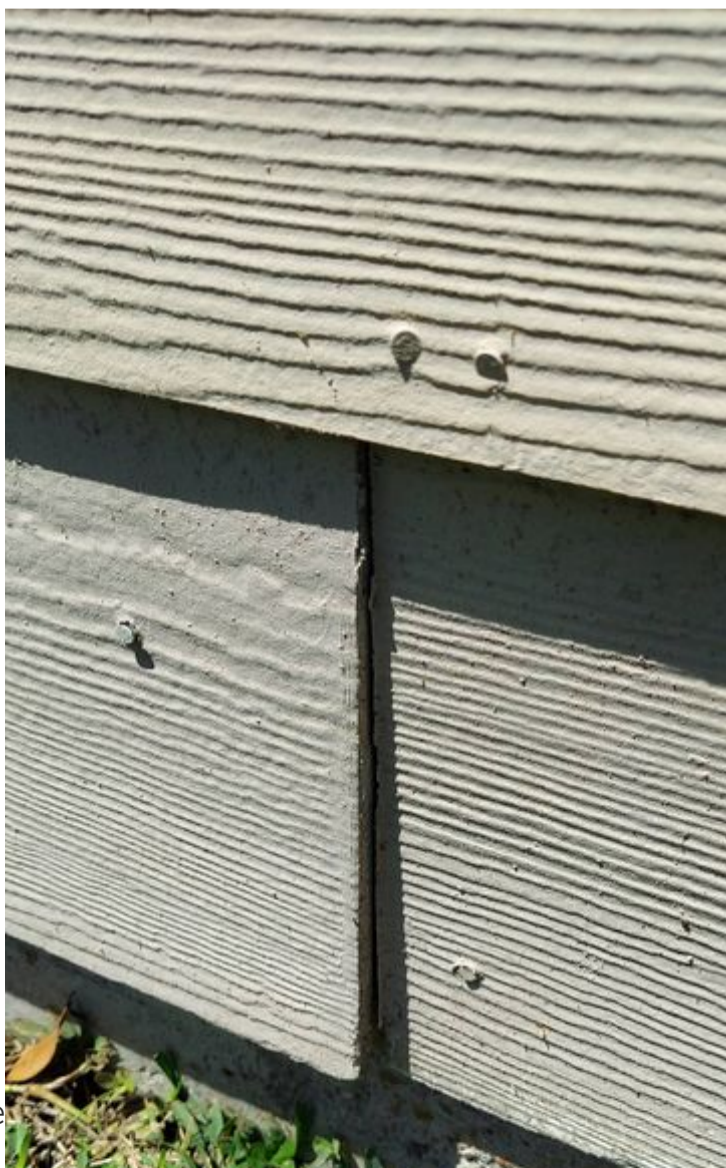
## Nails sticking out of siding observed

At the time of the inspection, I observed one or more nails protruding from the siding.

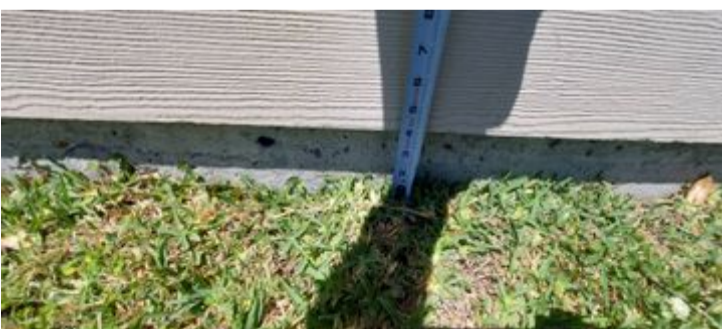
## Hardy plank siding too close to grade level

Hardy plank siding should be 6" above grade level.

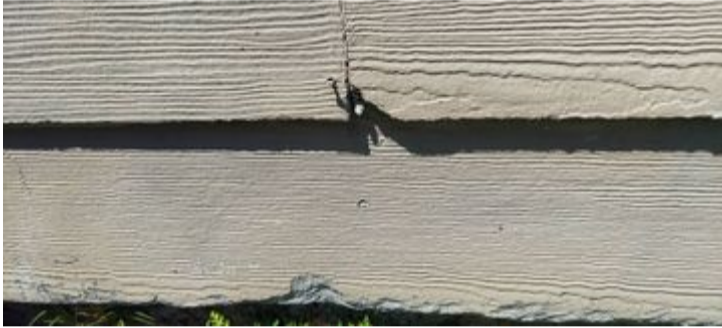
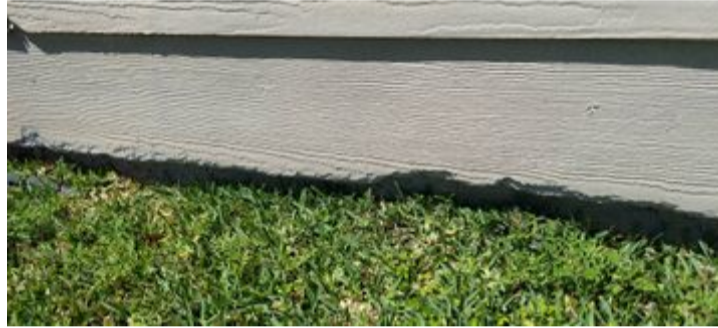
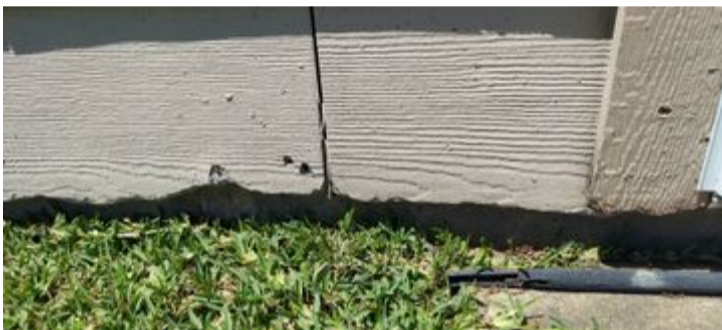
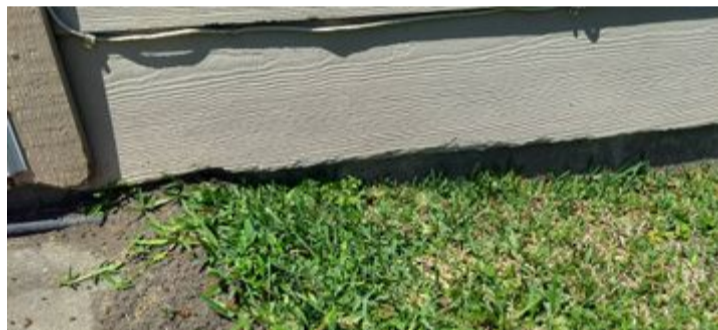
## Damaged siding observed

I observed citing damage along the bottoms of the house.

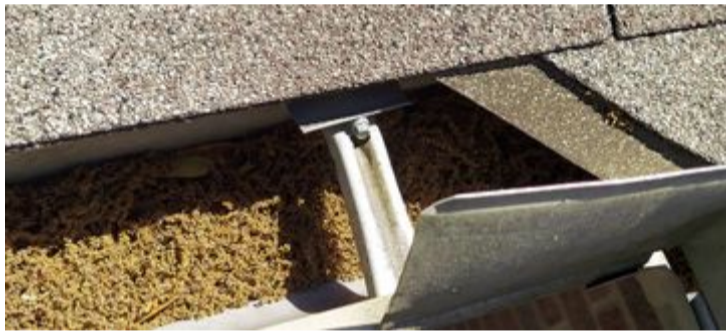
## Gutters are full of debris

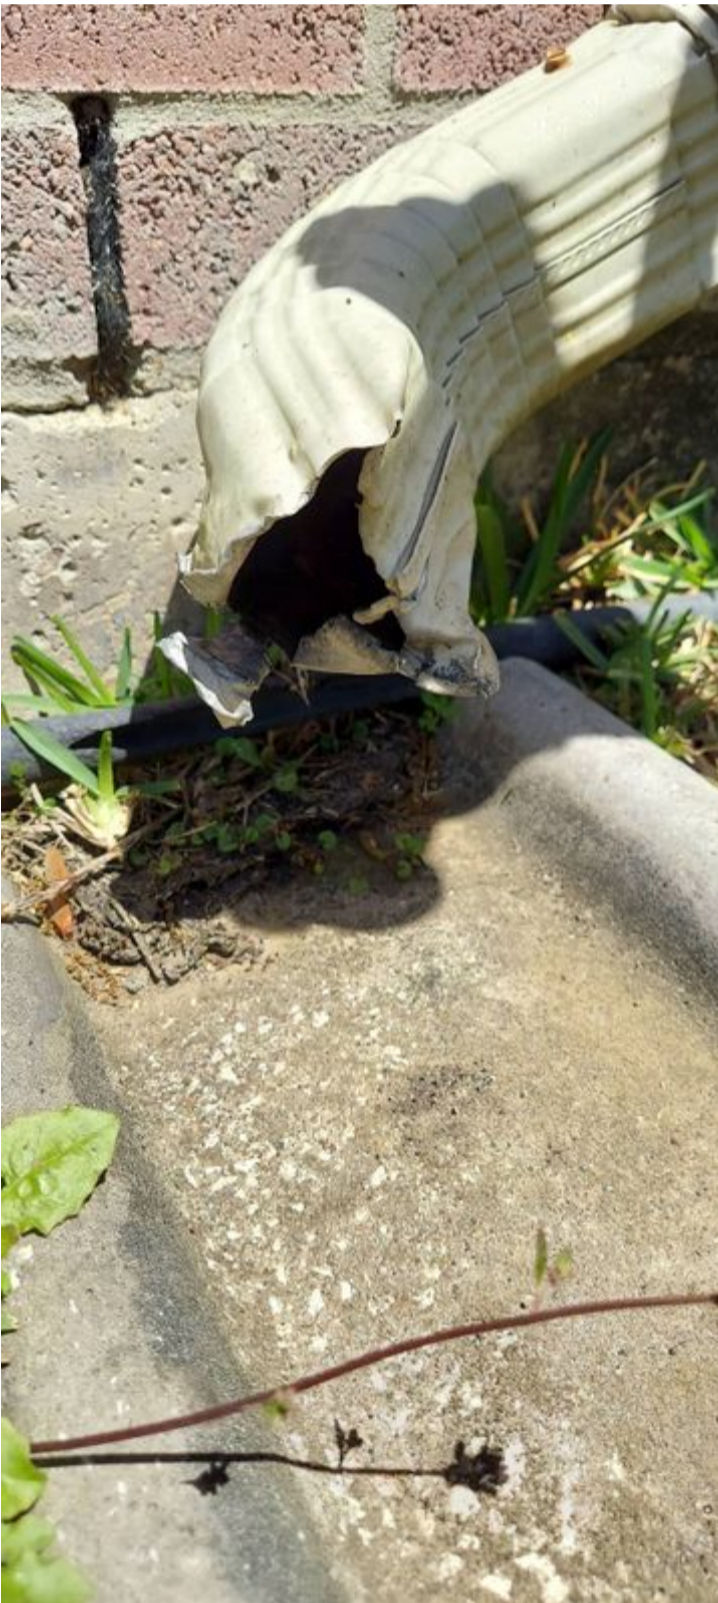
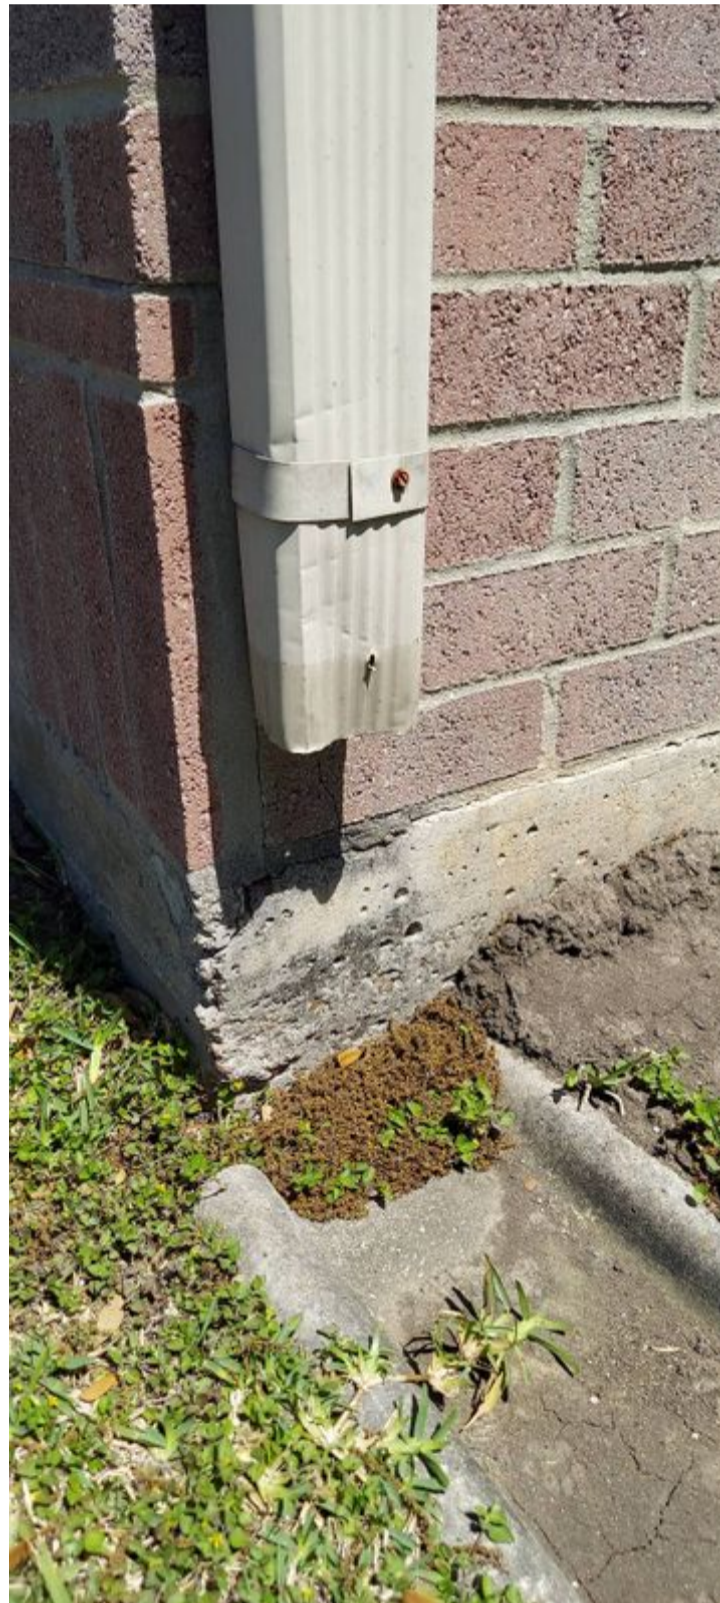
Damaged downspout observed

Damage down spots should be repaired to make sure the rain getters work efficiently.

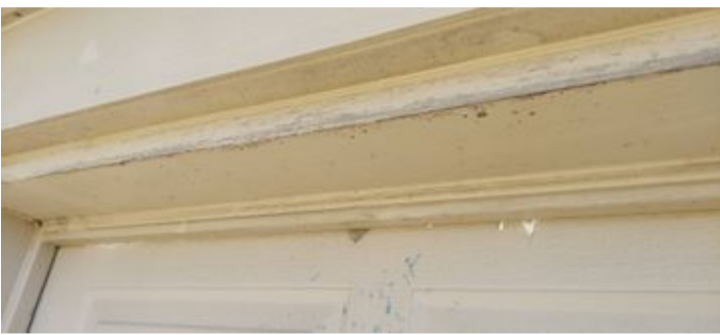
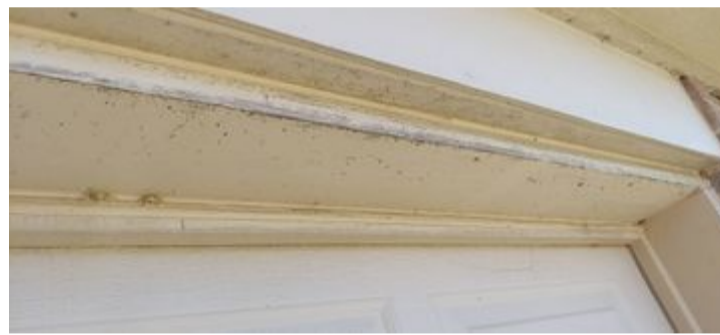
## Exterior trim weathered/damaged

Trim surrounding garage door has been damaged or weathered.

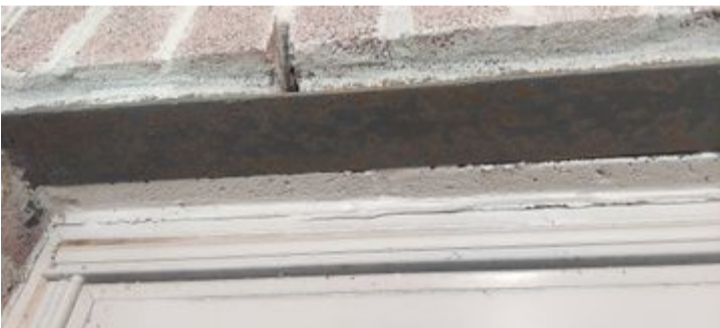
## Door lintel rust observed

The lintel above the front door is beginning to rust.

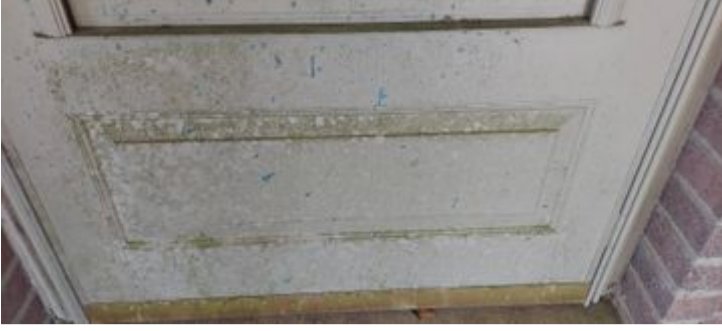
## Mildew observed on exterior door

The front door had mildew along the bottom of it.

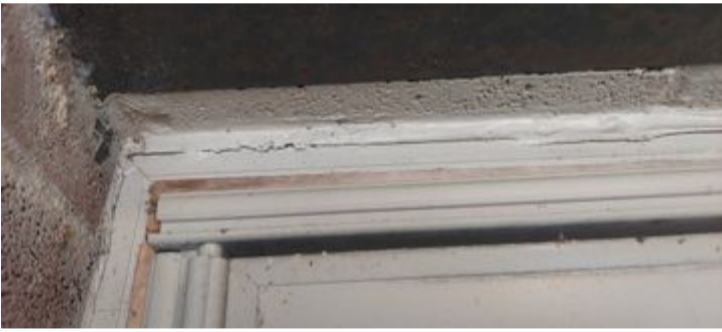
## Weather seals damaged or missing

The weather seals around the front door were old and worn and need to be repaired.

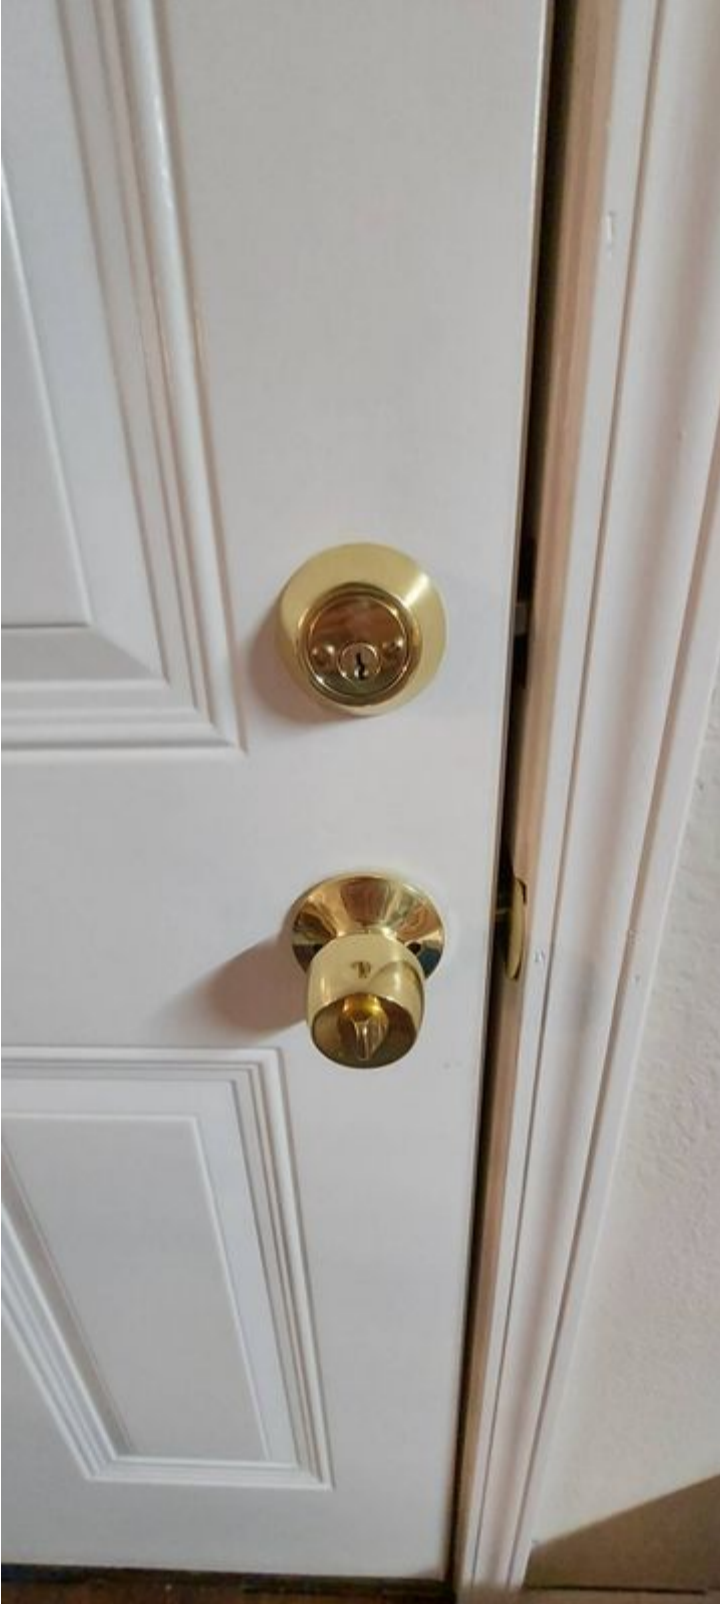
## Double Keyed Lock

Safety hazard.

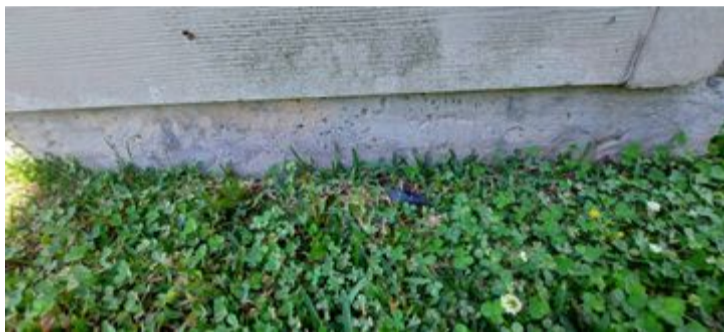
### Exposed snap ties observed on foundation

The snap ties that were holding the forms together together should be removed after the forms are pulled off. I do observe one or more areas where the snap ties were still exposed. If these rust they will swell and make cracks in the foundation.

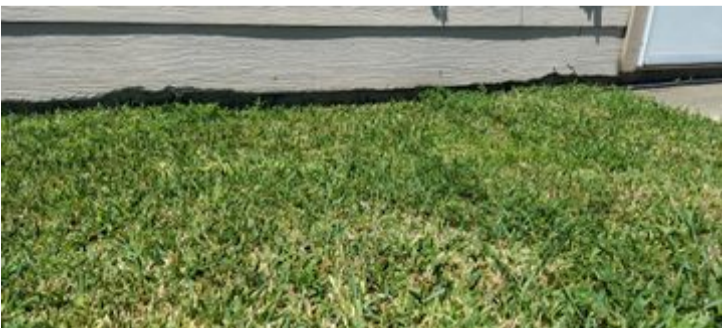
### Limited foundation inspection

Portions of the foundation were obscured by grade level or vegetation.

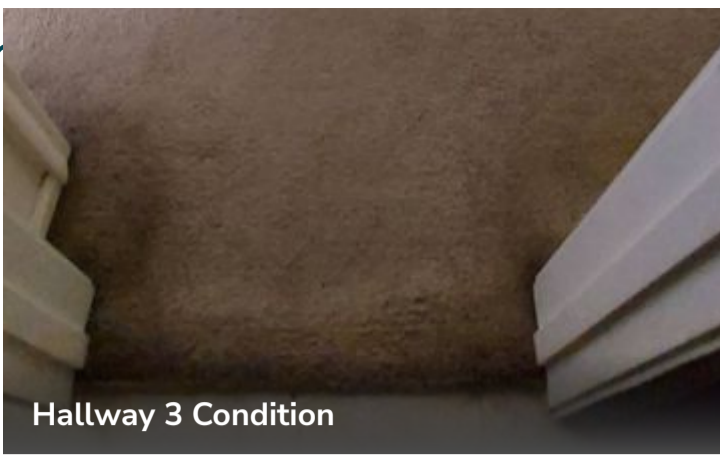
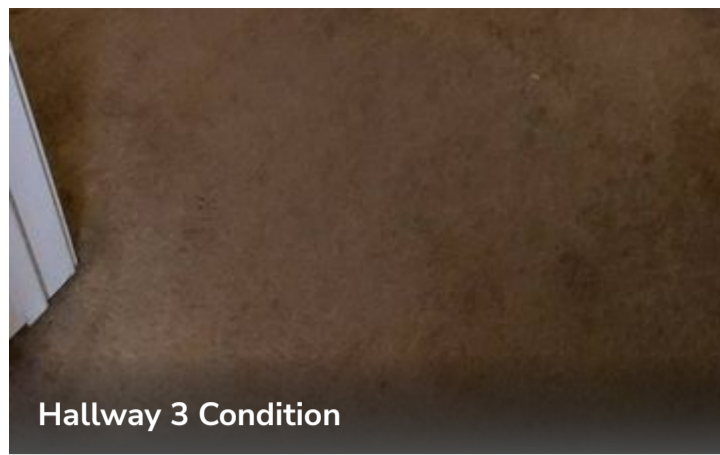
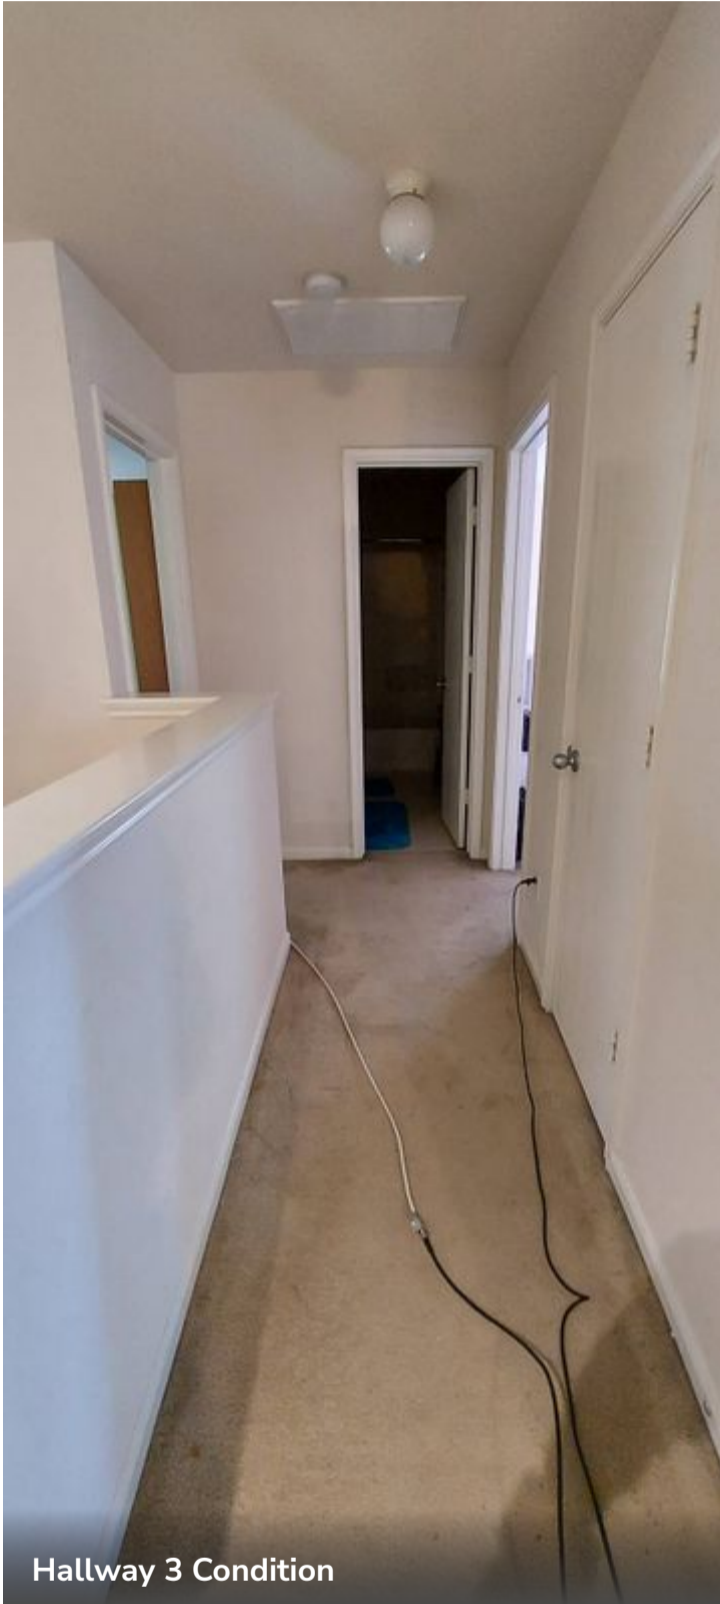
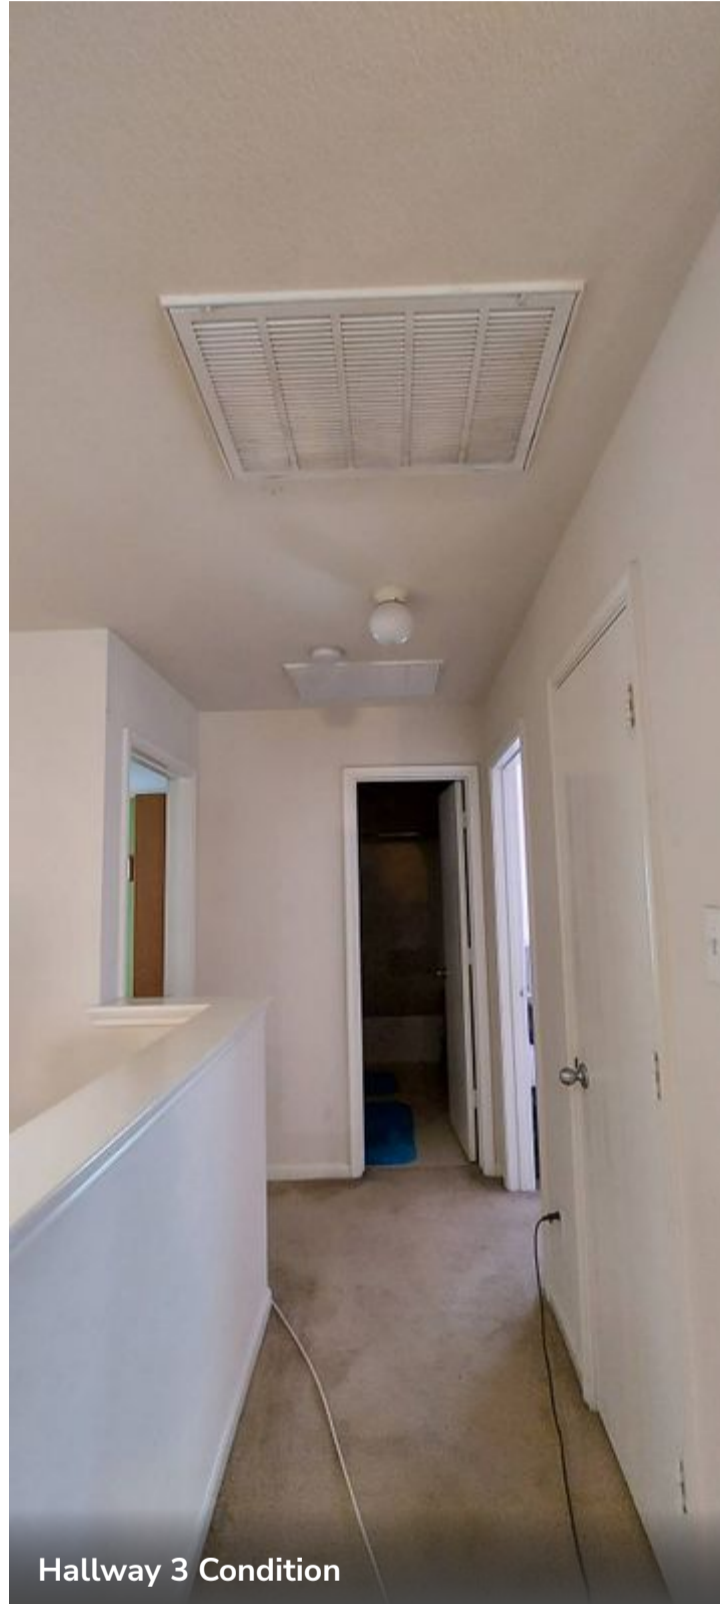
**B - Good (Moderate Repairs)**

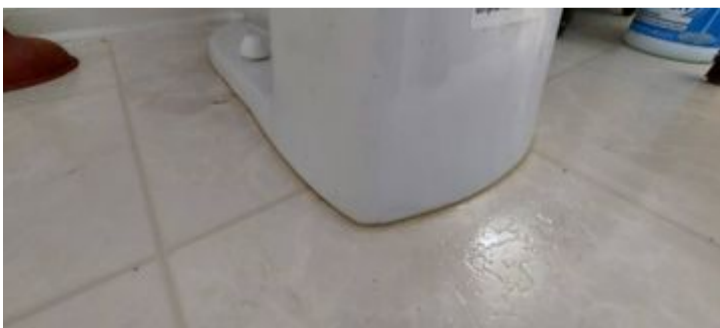
**Needs caulking**

The toilet needs caulking at the base.

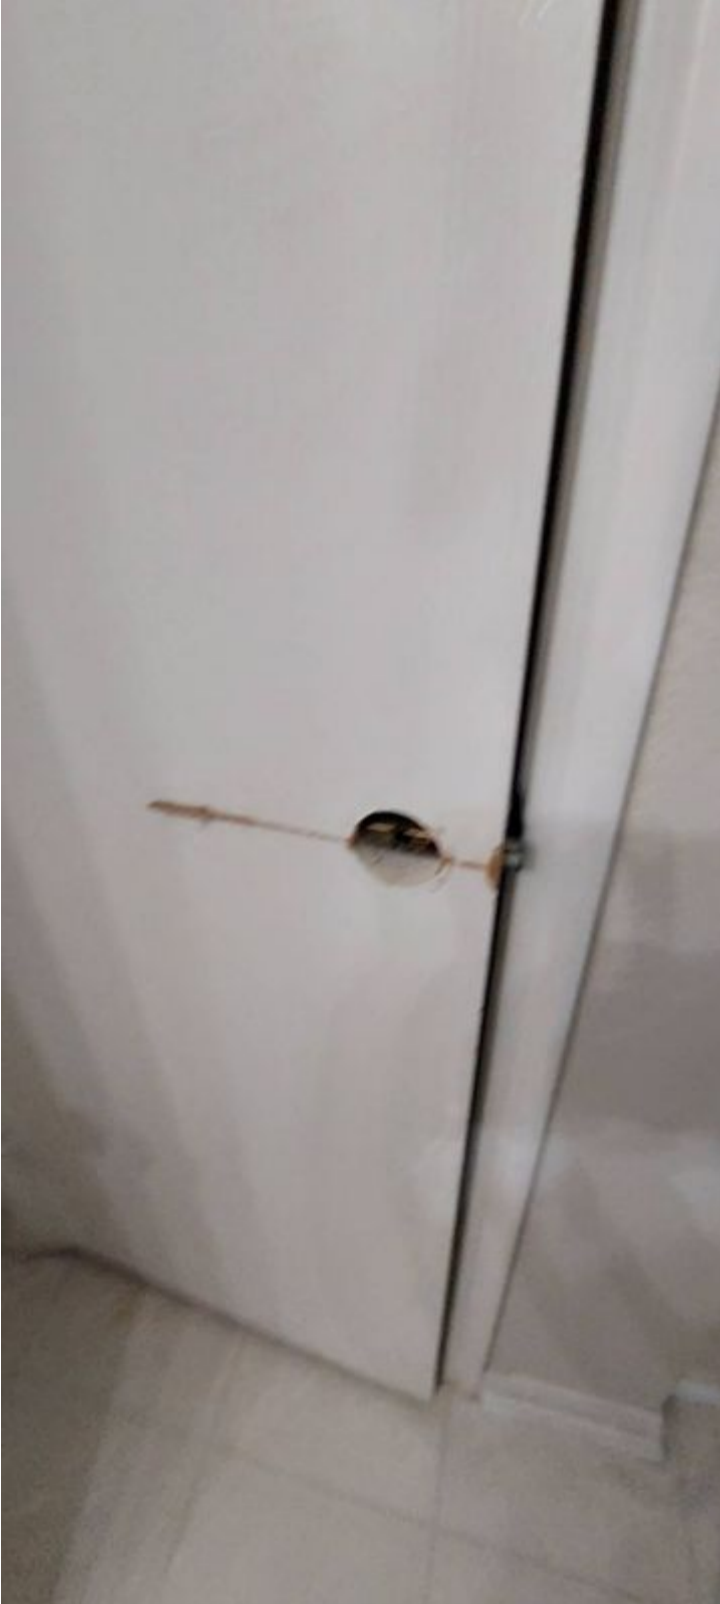
## Missing door handle

The bathroom closet was missing a door handle.

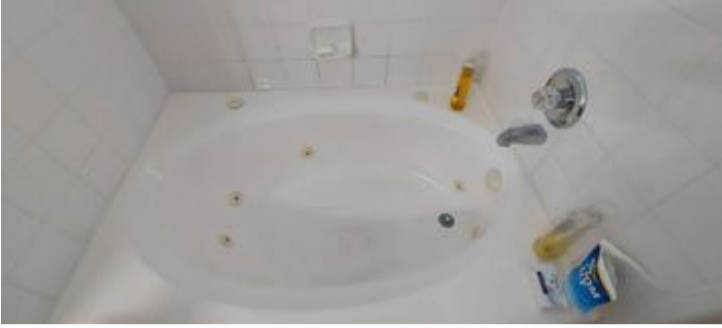
The jets in the bathtub were not working.

**The owner informed me that there is no electricity to the jet tub any longer.**
