# 2607 Bisontine Street Friendswood, Texas 77546

## Your Home Inspection Report

Client:	Jacqueline Garner
Type:	Home inspection
Inspected by:	Double Checked Home Inspections
Scheduled:	April 7, 2022, 7:00 PM
Completed:	April 8, 2022, 12:55 AM

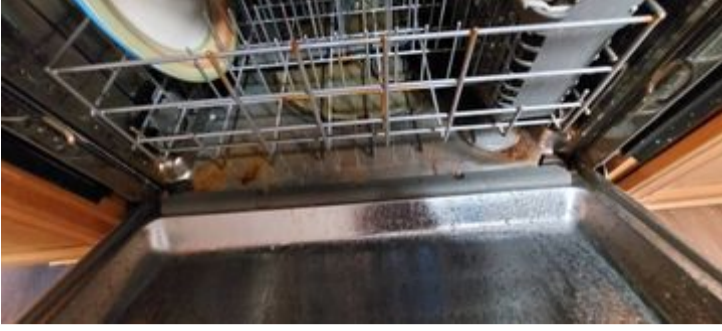
**At the time of the inspection, I was told by the owner the dishwasher cannot be run or there will be water all over the floor. The inside had water still in the bottom and everything was rusting, even the silverware.**

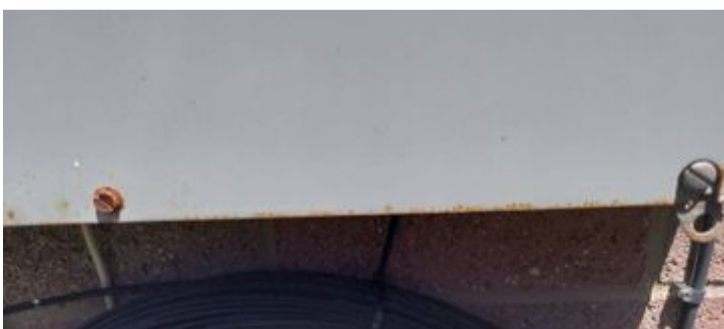
### Minor rust on service panel

I observe some very minor rust resting on the bottom of the service panel.

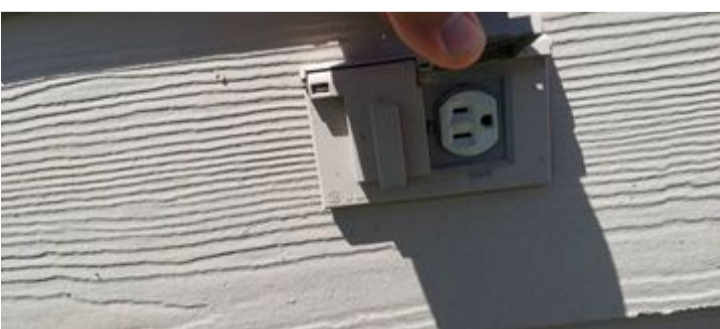
One or more exterior outlets are not weather rated.

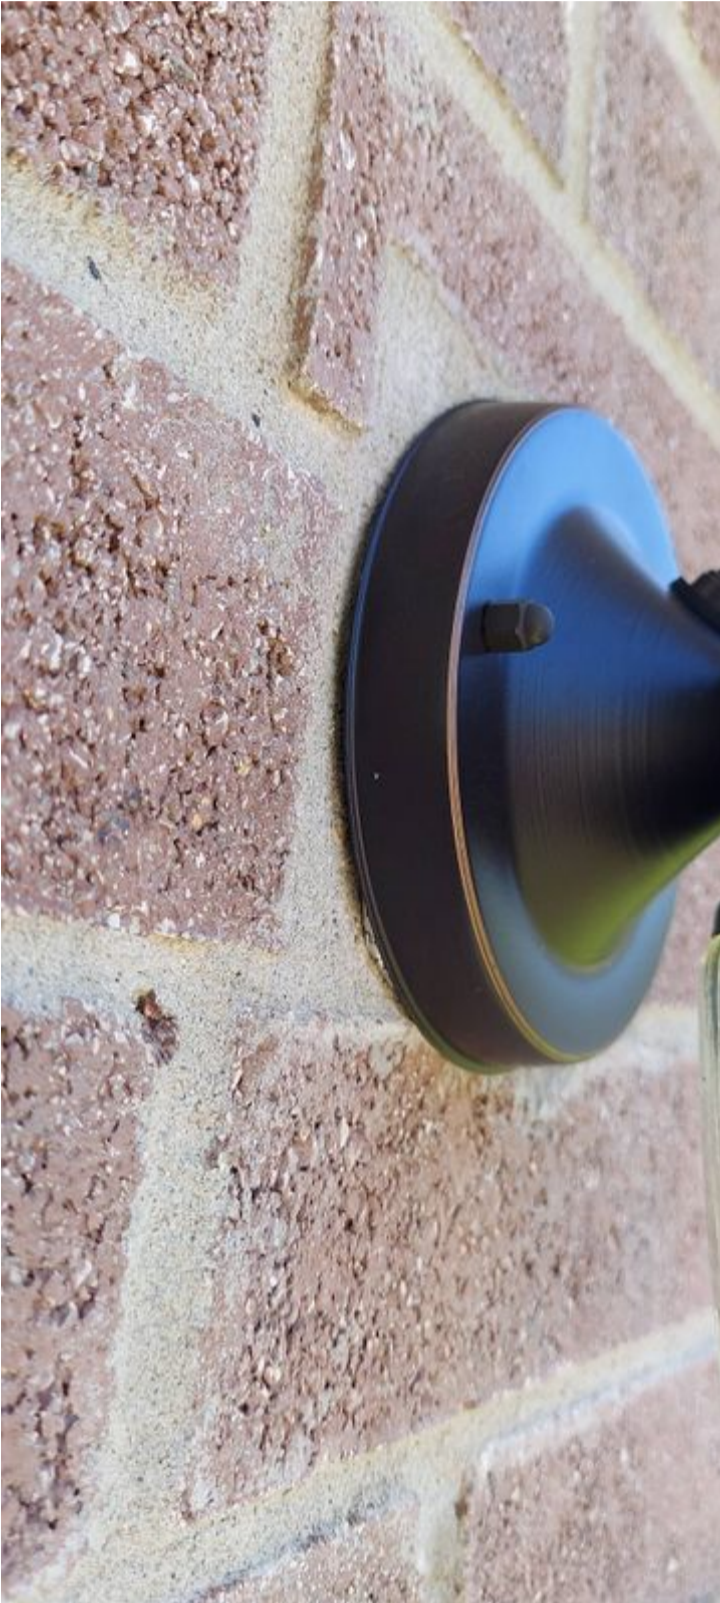
## Exterior Fixture - needs caulking

There is no sealant around exterior light fixture.

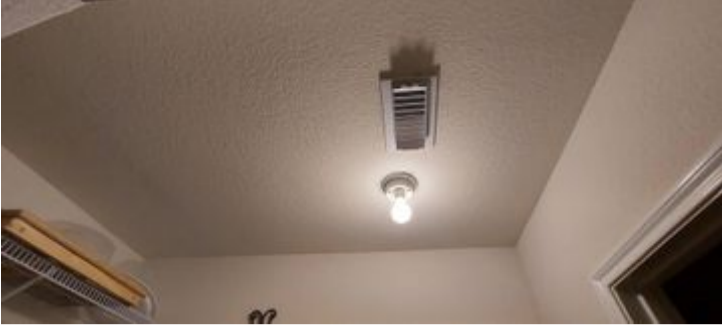
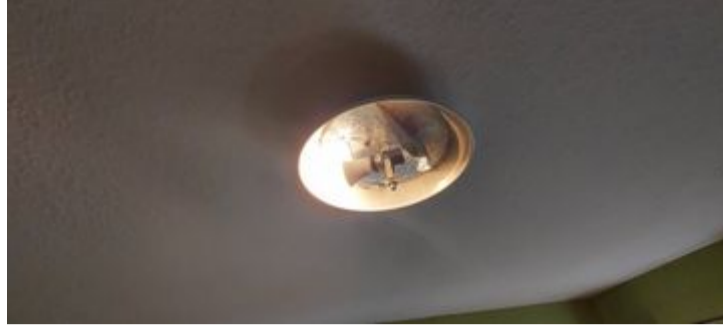
## Light - missing cover

One or more lights are missing their covers.

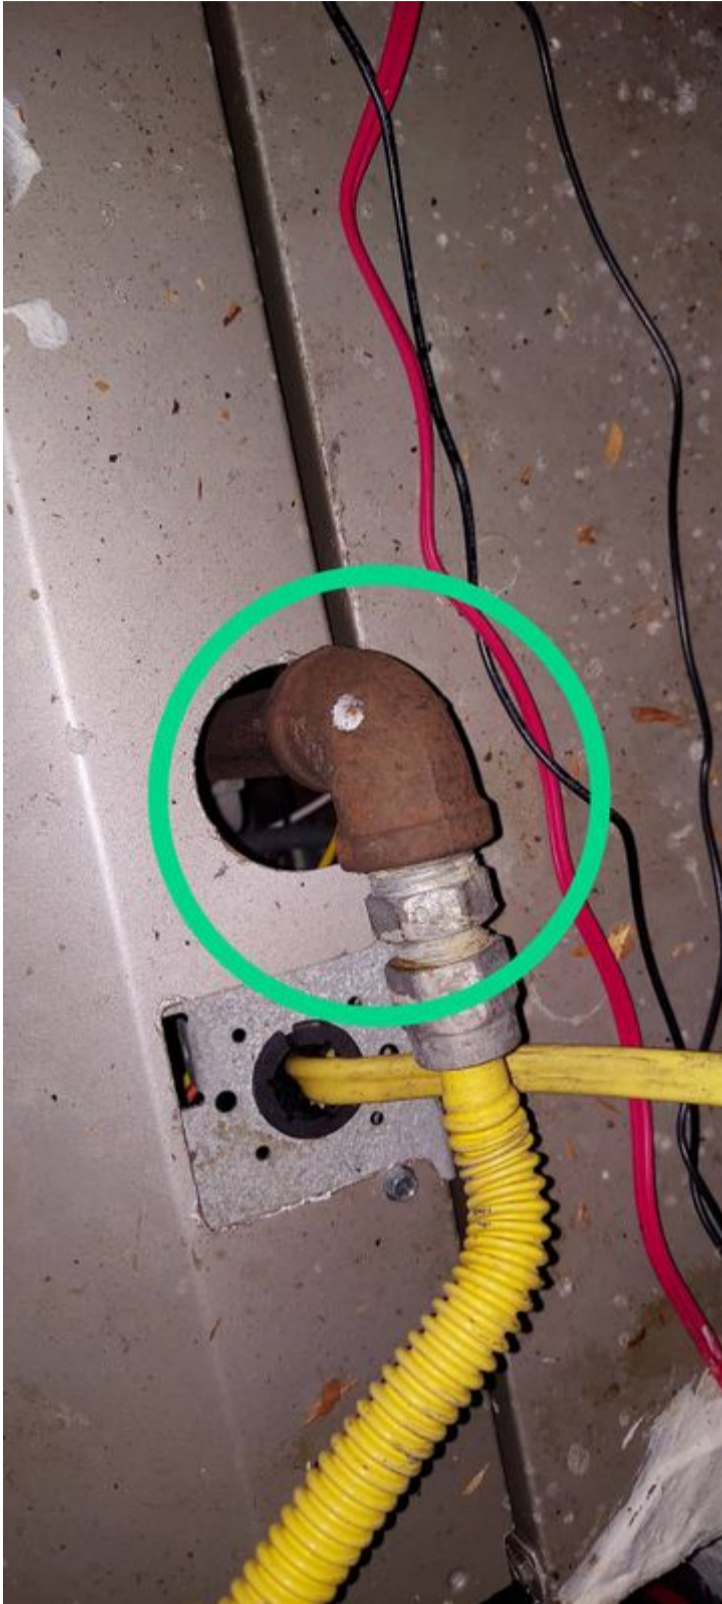
**Gas Line - Missing rust inhibiting paint**

The gas line should have rust-inhibiting paint.

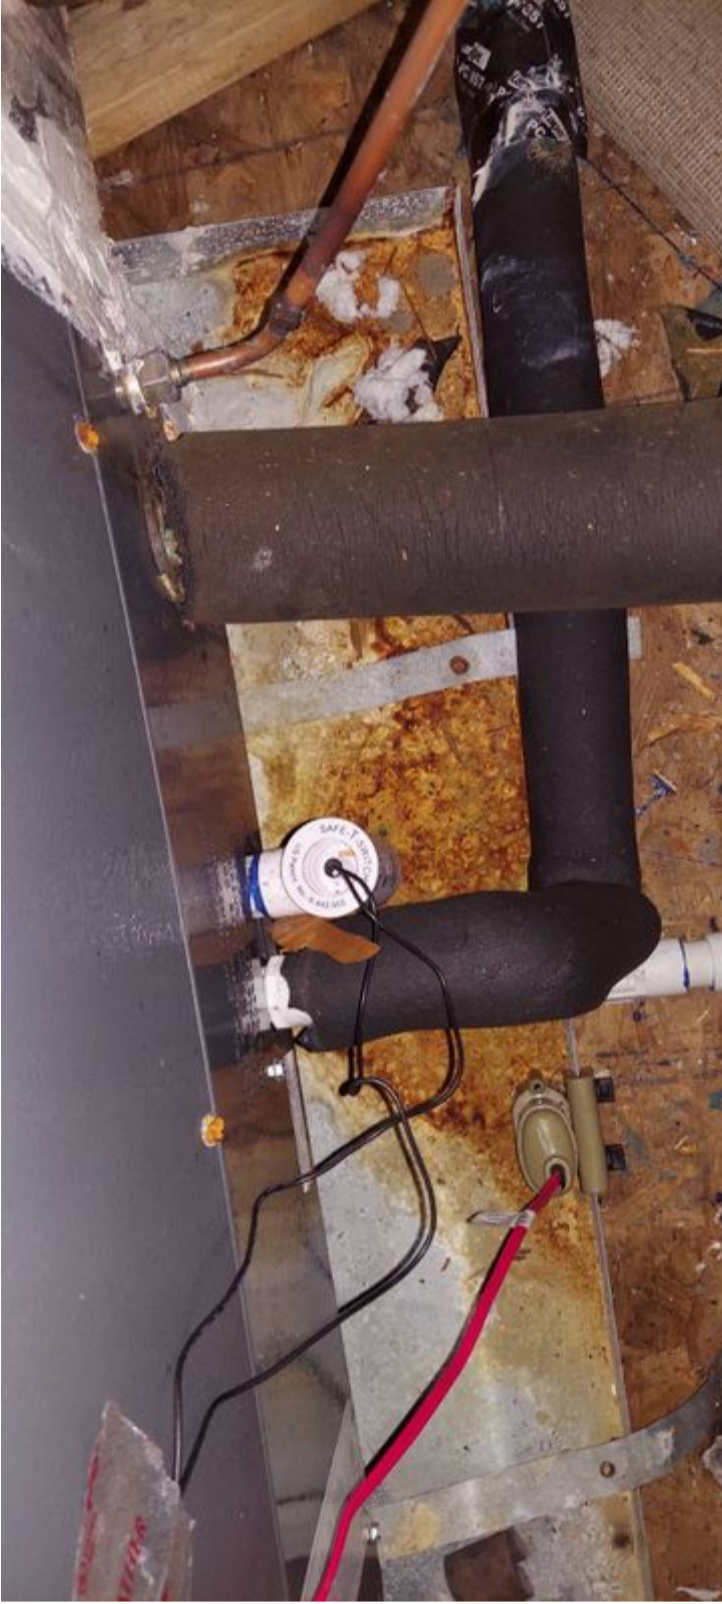
## Rust in drain pan

The drain pan is full of rust.
