**NOTICE CONCERNING HAZARDOUS CONDITIONS, DEFICIENCIES, AND CONTRACTUAL AGREEMENTS**

**ADDITIONAL INFORMATION PROVIDED BY INSPECTOR**

### I. STRUCTURAL SYSTEMS

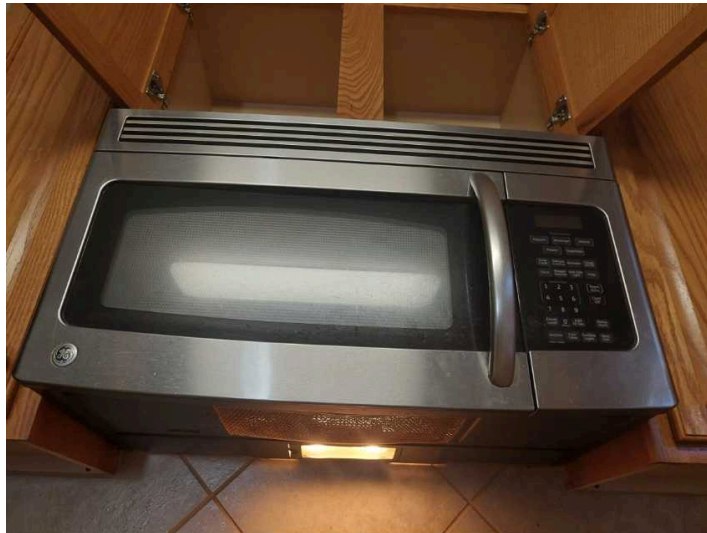
*Range hood*

- The range hood was functional at the time of the inspection

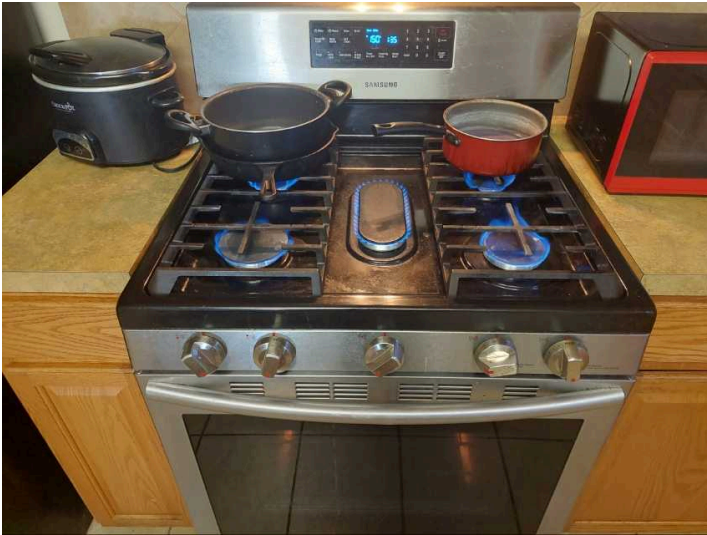
Gas Range

- Oven: Natural gas
- The gas range and oven were functional at the time of the inspection
- **The center burner is missing the grate that should be above it.**

Page 29 Item: D	Ranges, Cooktops, and Ovens	<ul style="list-style-type: none"> <li>• The center burner is missing the grate that should be above it.</li> </ul>
Page 31 Item: H	Dryer Exhaust Systems	<ul style="list-style-type: none"> <li>• The dryer vent cover is damaged, has missing or broken louvers or damper.</li> </ul>

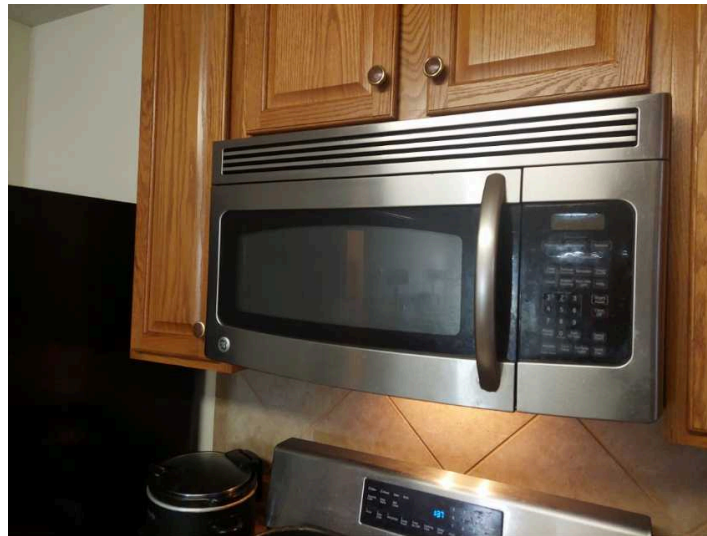
Microwave oven

- The microwave was found to be performing at the time of the inspection. Note: No microwave leak detection and/or output testing was done during this inspection period
