812 W Blum St, Alvin, TX 77511

Inspection prepared for: Pierre Charland

Date of Inspection: 1/18/2023 Time: 12:30 PM

PROPERTY INSPECTION REPORT FORM

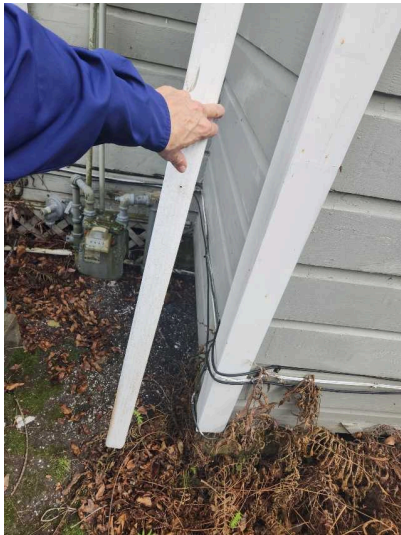
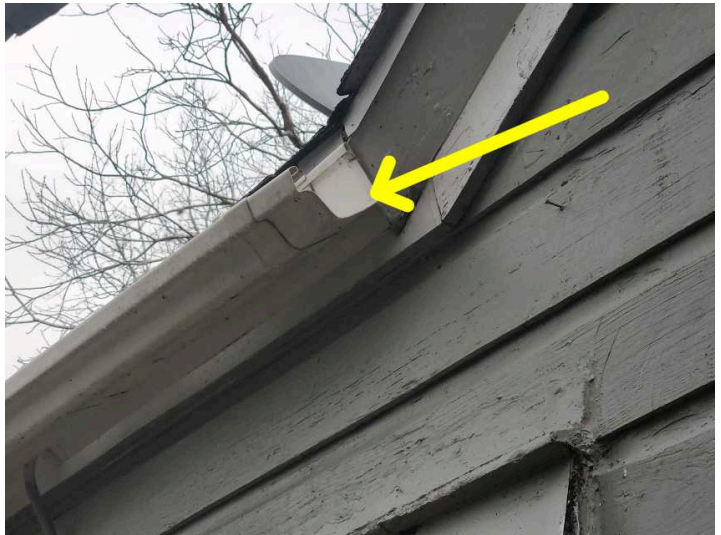
- Gutter downspout splash block is missing or misaligned in several locations. It is recommended to properly install to prevent erosion around foundation.

- Gutters are loosely attached, damaged or missing in several locations, allowing water to be redirected onto residence. It is recommended to be properly repaired or replaced to allow for proper drainage.

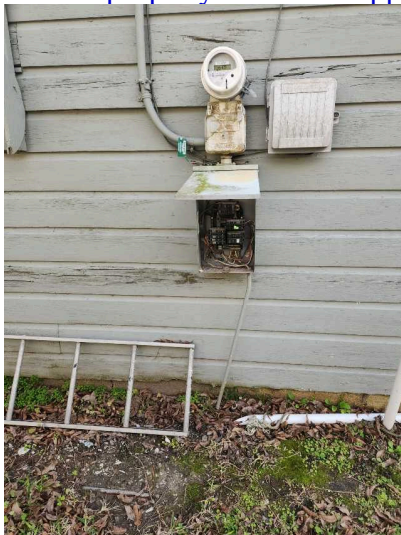
- Service entrance wiring is overhead
- Circuit panel is not properly or completely labeled. It is recommended to be properly labeled designating which breaker is for which circuit.
- White electrical wires connected to circuit breakers are not marked with black or red electrical tape to identify them as HOT. IT is recommended to be properly repaired by a licensed electrician as needed.
- The electrical service panel deadfront is missing inside the panel. It is recommended to properly install the appropriate deadfront as needed.

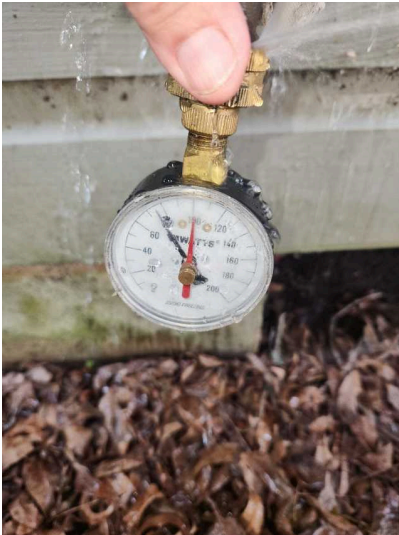
60psi

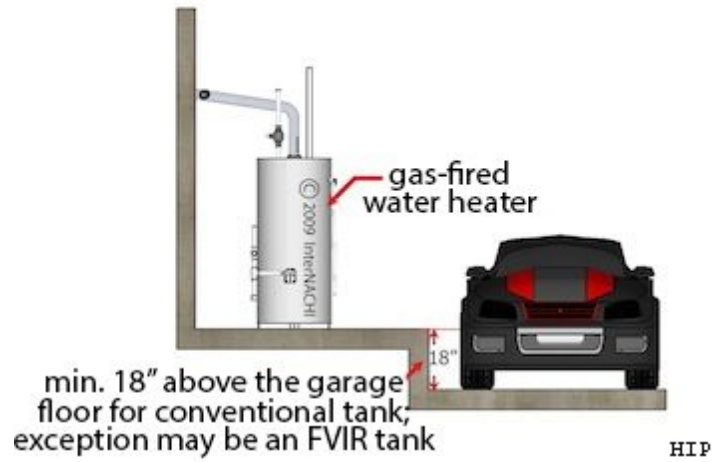
Gas-Fired Water Heater in Garage

TPRV Disconnected

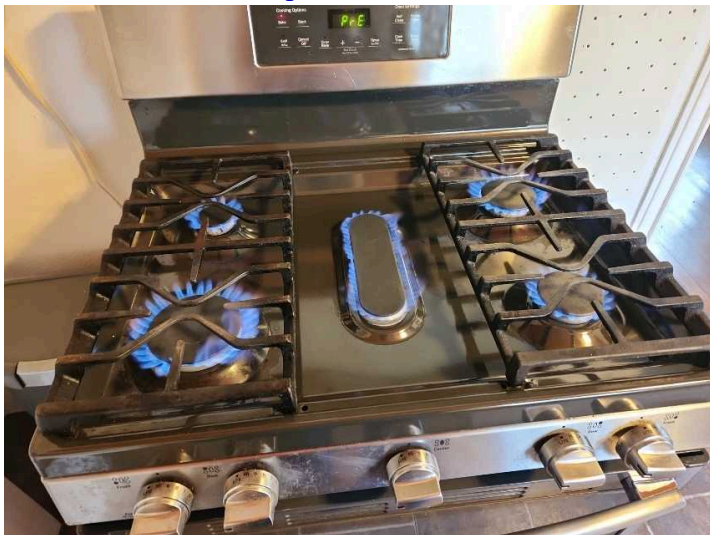
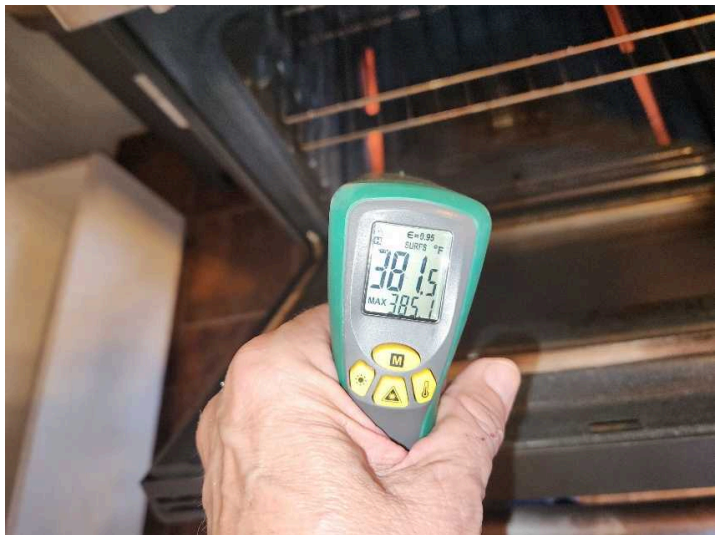
- RANGE — GAS
- Range functions as intended at time of inspection.
- OVEN — GAS.
- Oven(s) functions as intended at time of inspection.
- Anti-tip bracket is missing from range installation. The range was not properly secured to the surrounding cabinet or wall. Children can tip the oven over if the door is used as a stepping stool. All free-standing must include an anti-tip device. It is essential in the safe operation of the range. It provides protection when excess force or weight is applied to an open oven door.
- Is oven light was inoperable at time of inspection. It is recommended to be properly repaired as needed.
