Lone Star Stucco, LLC

Moisture Assessment Report

1843 Sul Ross St

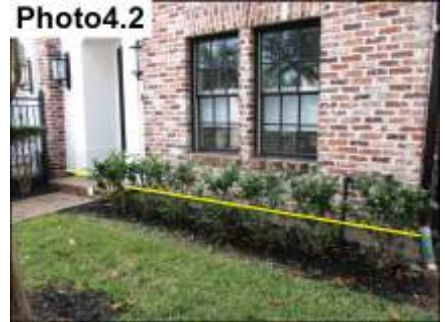
Photo4.2

- Stucco/brick appears to be typically detailed at grade for the time of this construction. The inspector suggests that this is a positive detail and recommends no modification at this time but to always keep soil away from the structure. Please refer to photos #4.2, #4.3, #4.4, #4.5 and #4.6 for more detail.

Proper Grade Termination w/ Weep Screed and Holes/ Positive Detail

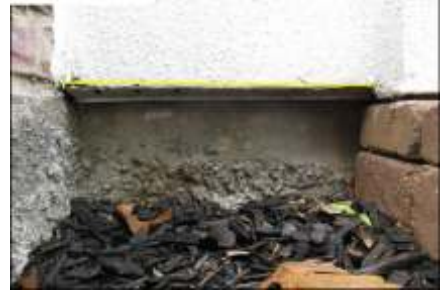
Photo4.3

Proper Grade Termination w/ Weep Screed and Holes/ Positive Detail

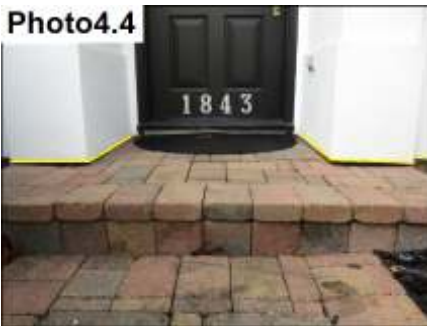
Photo4.4

Proper Grade Termination w/ Weep Screed and Holes/ Positive Detail

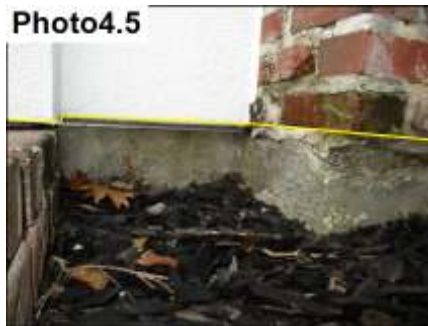
Photo4.5

Proper Grade Termination w/ Weep Screed and Holes/ Positive Detail

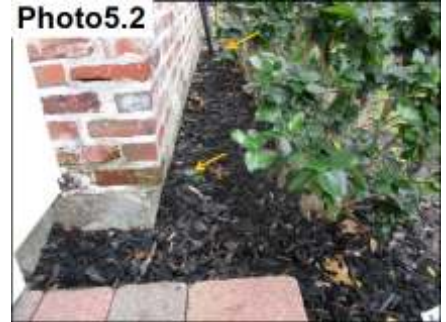
Photo5.2

- Sprinklers have been noted on this home. The inspector suggests to always redirect sprinkler heads away from the system and windows as needed in an effort to prevent moisture intrusion. Please refer to photos #5.2, #5.3 and #5.4 for more detail.

Sprinklers / Redirect as Needed

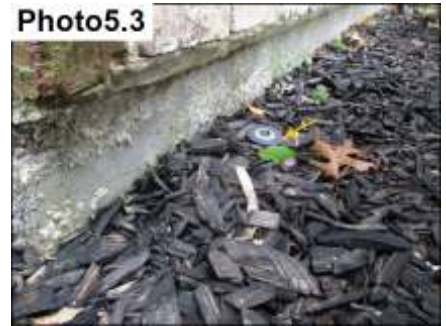
Photo5.3

Sprinklers / Redirect as Needed

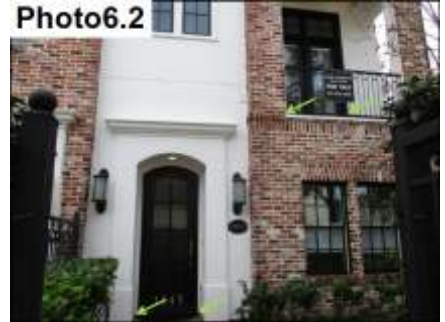
Photo6.2

Door Trim and Miter Sealant / Maintain

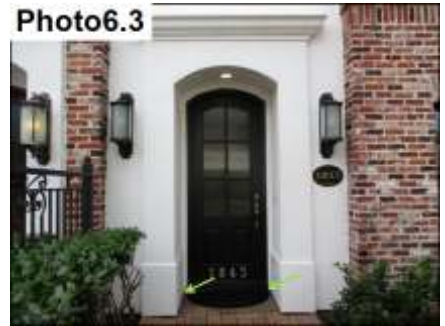
Photo6.3

Door Trim and Miter Sealant / Maintain

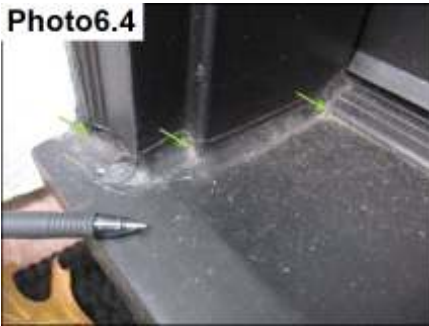
Photo6.4

Door Trim and Miter Sealant / Maintain

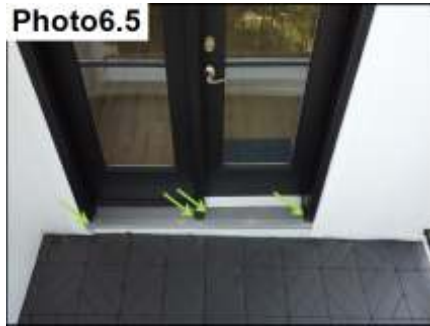
Photo6.5

Door Trim and Miter Sealant / Maintain

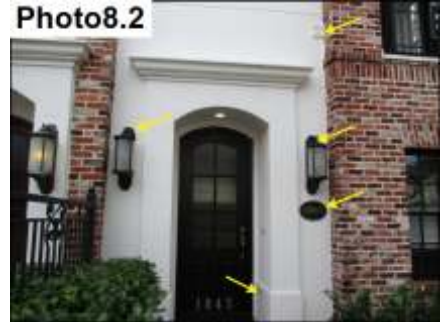
Photo8.2

- Penetration sealants are present at these locations. The inspector states that this is a positive detail and suggests maintaining these sealants in an effort to prevent moisture intrusion. Please refer to photos #8.2, #8.3, #8.4, #8.5 and #8.6 for more detail.

Penetrations / Maintain

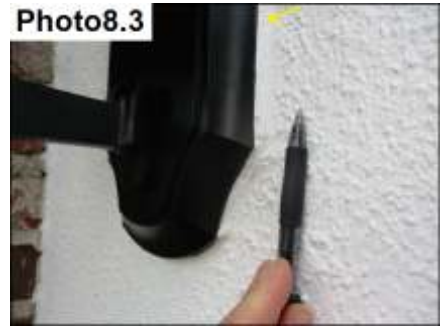
Photo8.3

Penetrations / Maintain

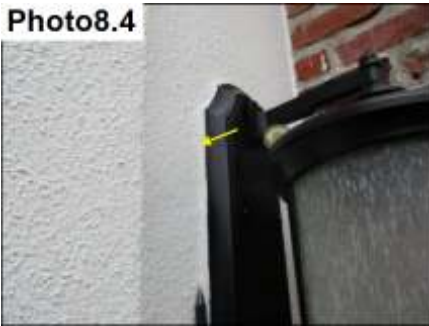
Photo8.4

Penetrations / Maintain

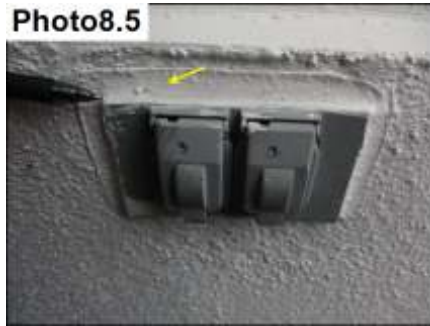
Photo8.5

Penetrations / Maintain

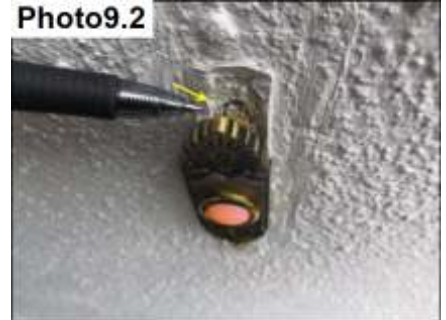
Photo9.2

- The doorbell is detached from the home. The inspector suggests to have a qualified contractor reattach this doorbell and seal this area with a low modulus sealant in an effort to prevent moisture intrusion. These types of sealants are of high quality and compatible with stucco and other termination points. Please refer to photos #9.2 and #9.3 for more detail.

Penetration Sealants / Seal

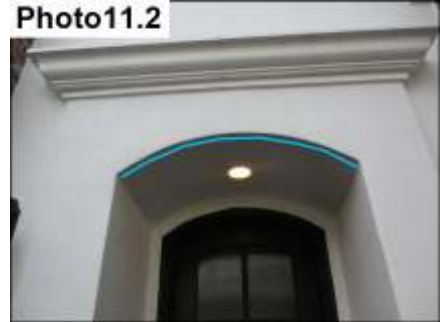
Photo11.2

- Although the bottom of the wall noted does not have a proper relief, this was a proper detail at the time of construction. Upon invasive testing at this location, the substrate was firm with low moisture readings. The inspector recommends no modification at this point in time but recommends to maintain all sealants above this location to prevent potential moisture intrusion. Please refer to photos #11.2 and #11.3 for more detail.

No Relief Present / No Modification

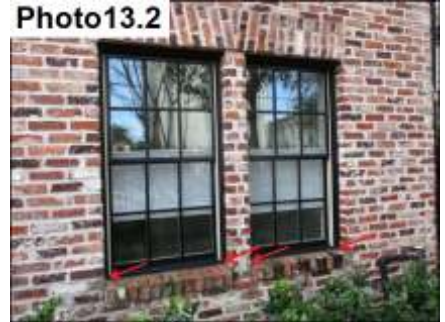
Photo13.2

- The window sealants are separated. The inspector suggests to have a qualified waterproofing contractor further assess and seal this area with a low modulus sealant in an effort to prevent moisture intrusion. These types of sealants are of high quality and compatible with stucco and other termination points. Please refer to photos #13.2, #13.3, #13.4, #13.5, #13.6, #14.1, #14.2, #14.3 and #14.4 for more detail.

Window Sealants / Seal

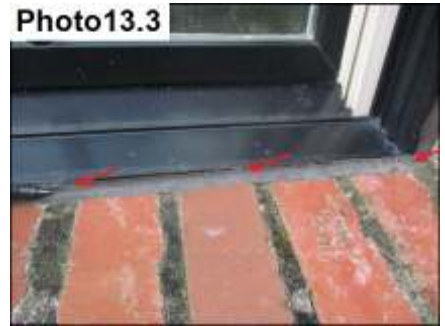
Photo13.3

Window Sealants / Seal

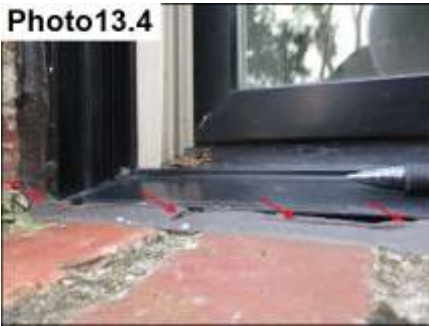
Photo13.4

Window Sealants / Seal

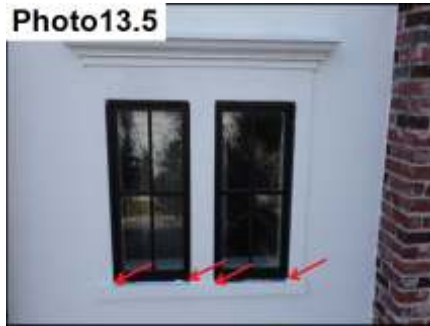
Photo13.5

Window Sealants / Seal

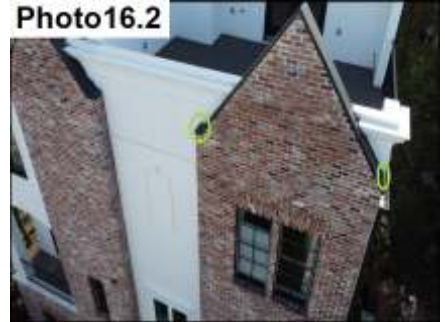
Photo16.2

- The parapet cap flashing sealants are aged and separated at this location. The inspector suggests to have a qualified waterproofing contractor further assess and seal this area with a low modulus sealant in an effort to prevent moisture intrusion. These types of sealants are of high quality and compatible with stucco and other termination points. Please refer to photos #16.2, #16.3, #16.4, #16.5 and #16.6 for more detail.

Kickout Flashing Location / Seal

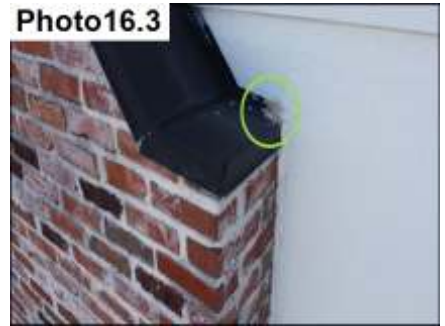
Photo16.3

Kickout Flashing Location / Seal

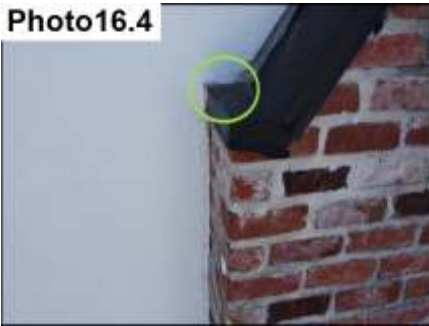
Photo16.4

Kickout Flashing Location / Seal

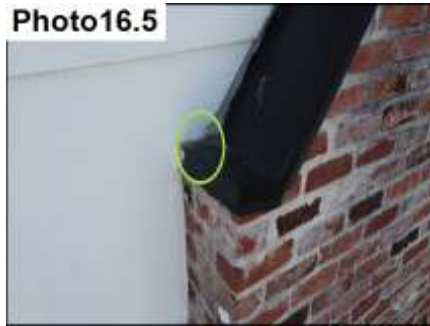
Photo16.5

Kickout Flashing Location / Seal

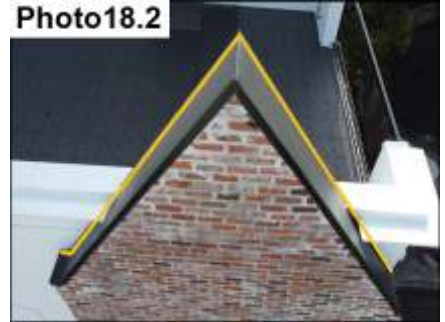
Photo18.2

Metal Cap/Stucco Termination / Seal

Grid Location	Item Description	Moisture Readings	Substrate Condition	Observations
Orange Lines	Metal Cap			The metal cap sealants are aged and separated at these locations with paint overspray. The inspector suggests to have a qualified waterproofing contractor further assess and seal this area with a low modulus sealant in an effort to prevent moisture intrusion. These types of sealants are of high quality and compatible with stucco and other termination points. Please refer to photos #18.2, #18.3, #18.4, #18.5 and #18.6 for more detail.

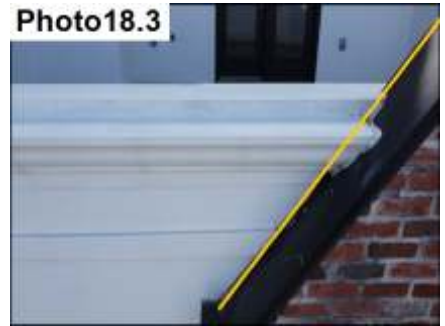
Photo18.3

Metal Cap/Stucco Termination / Seal

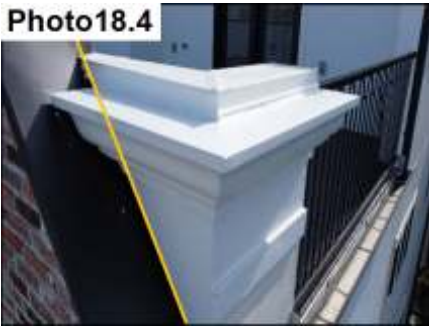
Photo18.4

Metal Cap/Stucco Termination / Seal

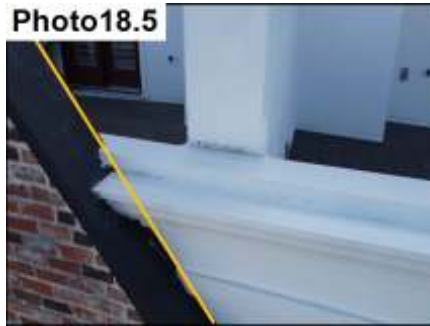
Photo18.5

Metal Cap/Stucco Termination / Seal

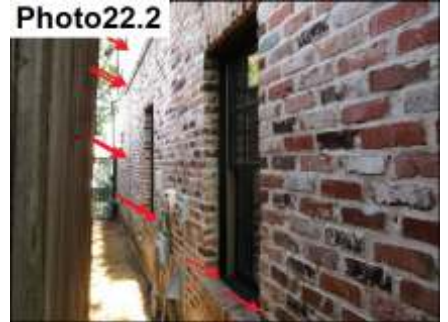
Photo22.2

Window Sealants / Seal

Grid Location	Item Description	Moisture Readings	Substrate Condition	Observations
Red Arrows	Windows			The window sealants are aged and separated. The inspector suggests to have a qualified waterproofing contractor further assess and seal this area with a low modulus sealant in an effort to prevent moisture intrusion. These types of sealants are of high quality and compatible with stucco and other termination points. Please refer to photos #22.2, #22.3, #22.4, #22.5, #22.6, #23.1, #23.2, #23.3 and #23.4 for more detail.

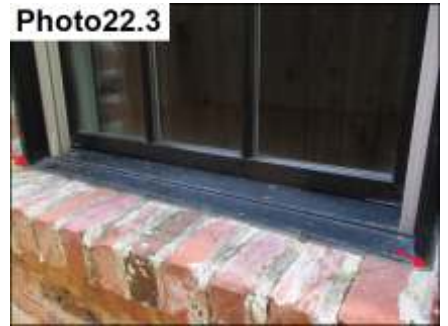
Photo22.3

Window Sealants / Seal

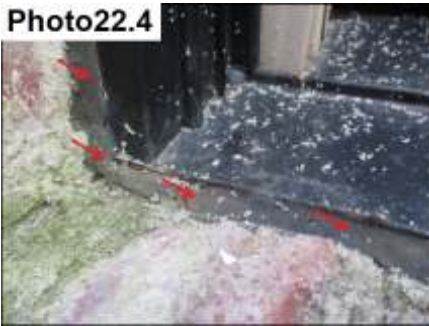
Photo22.4

Window Sealants / Seal

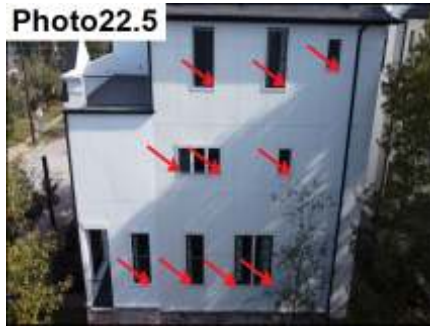
Photo22.5

Window Sealants / Seal

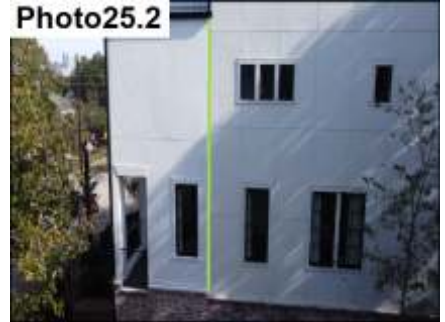
Photo25.2

CFB/Stucco Termination / Seal

Grid Location	Item Description	Moisture Readings	Substrate Condition	Observations
Green Lines	Stucco Termination			The CFB/stucco termination sealants are aged. The inspector suggests to have a qualified waterproofing contractor further assess and seal this area with a low modulus sealant in an effort to prevent moisture intrusion. These types of sealants are of high quality and compatible with stucco and other termination points. Please refer to photos #25.2, #25.3, #25.4, #25.5 and #25.6 for more detail.

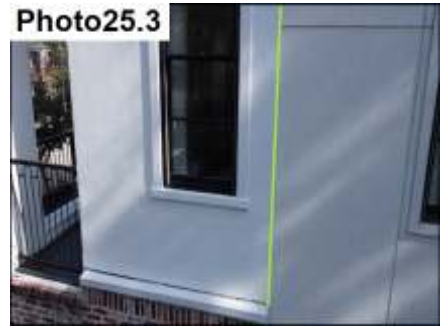
Photo25.3

CFB/Stucco Termination / Seal

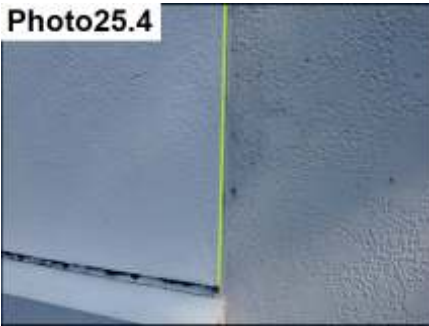
Photo25.4

CFB/Stucco Termination / Seal

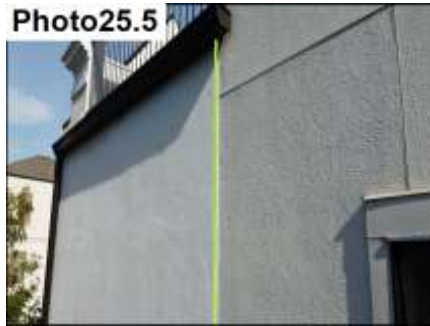
Photo25.5

CFB/Stucco Termination / Seal

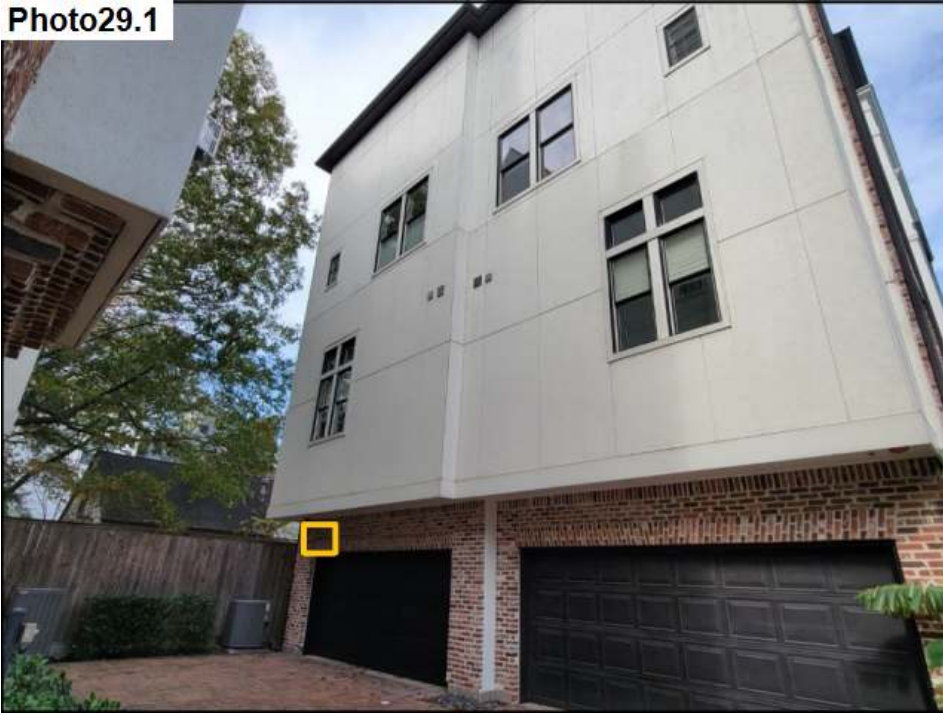
Photo29.1

Grid Location	Item Description	Moisture Readings	Substrate Condition	Observations
Orange Boxes	Cracks			Cracks are noted in the mortar at this location. The inspector suggests to have a qualified waterproofing contractor further assess and properly re point as needed to prevent moisture intrusion. All cracking was not necessarily identified in this report. Please refer to photos #29.2, #29.3, #29.4, #29.5 and #29.6 for more detail.

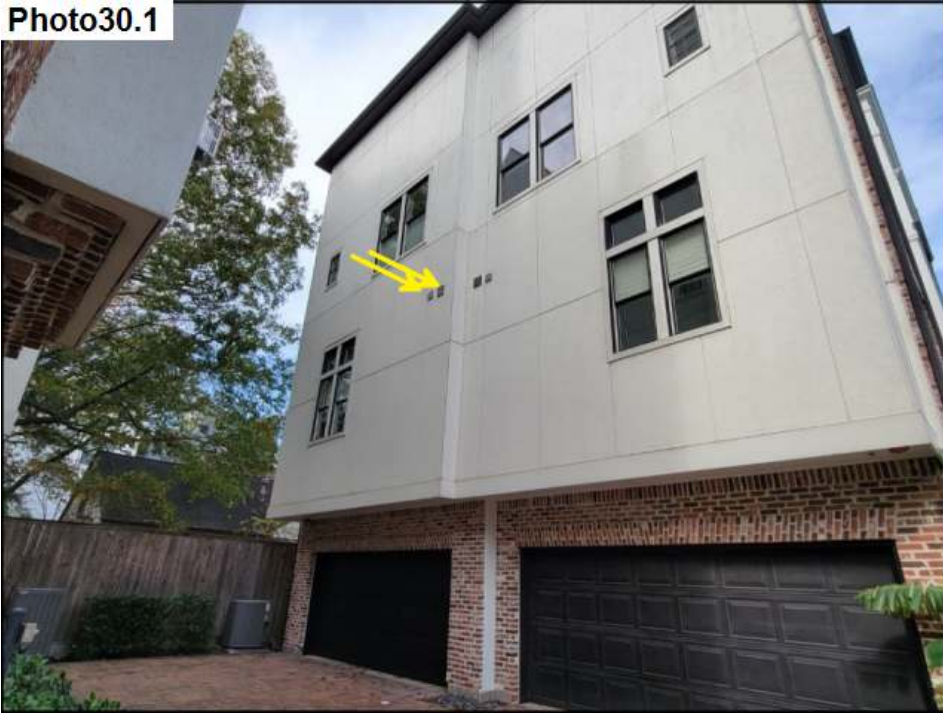
Photo30.1

Grid Location	Item Description	Moisture Readings	Substrate Condition	Observations
Yellow Arrows	Penetrations			The penetration sealants are aged and separated. The inspector suggests to have a qualified waterproofing contractor seal this area with a low modulus sealant in an effort to prevent moisture intrusion. These types of sealants are of high quality and compatible with stucco and other termination points. Please refer to photos #30.2, #30.3 and #30.4 for more detail.

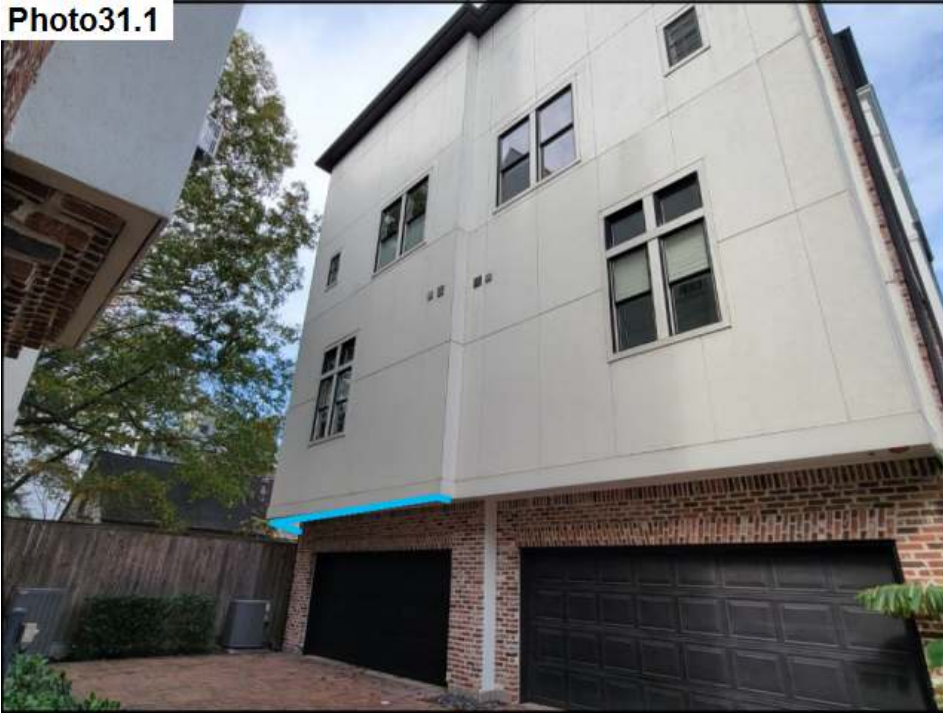
Photo31.1

Grid Location	Item Description	Moisture Readings	Substrate Condition	Observations
Blue Lines	Relief			Although a relief is present at this location, excess sealant was applied to the drainage plane obstructing proper moisture evacuation of the system. The inspector recommends having a qualified waterproofing contractor further assess, clean out excess material and verify the house back wrap has been cut. This will provide the proper functioning of the system at this location. Please refer to photos #31.2, #31.3, #31.4, #31.5 and #31.6 for more detail.

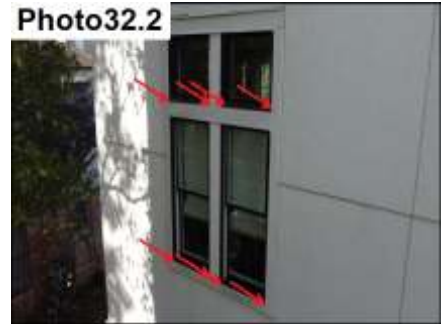
Window Sealants / Seal

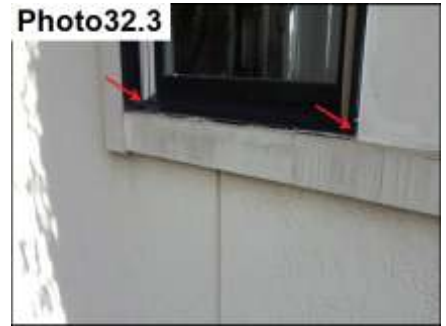
Window Sealants / Seal

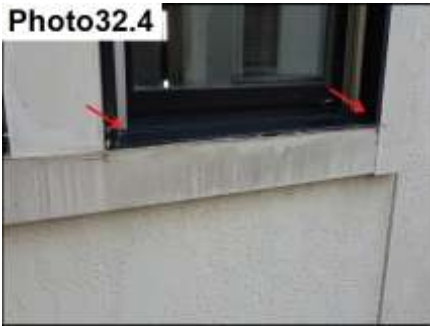
Window Sealants / Seal

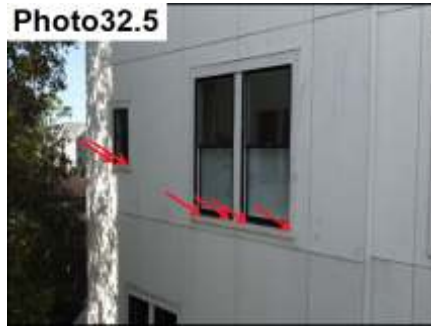
Window Sealants / Seal
