## MECHANICAL INSPECTION

9231 Fordshire Dr  
Houston, TX 77025

# PROPERTY INSPECTION REPORT FORM

Robert & Patricia Pando c/o Katy Pando <i>Name of Client</i>	01/06/2023 12:00 pm <i>Date of Inspection</i>
9231 Fordshire Dr, Houston, TX 77025 <i>Address of Inspected Property</i>	
Gary Atherton <i>Name of Inspector</i>	TREC#24236 <i>TREC License #</i>
<i>Name of Sponsor (if applicable)</i>	<i>TREC License #</i>

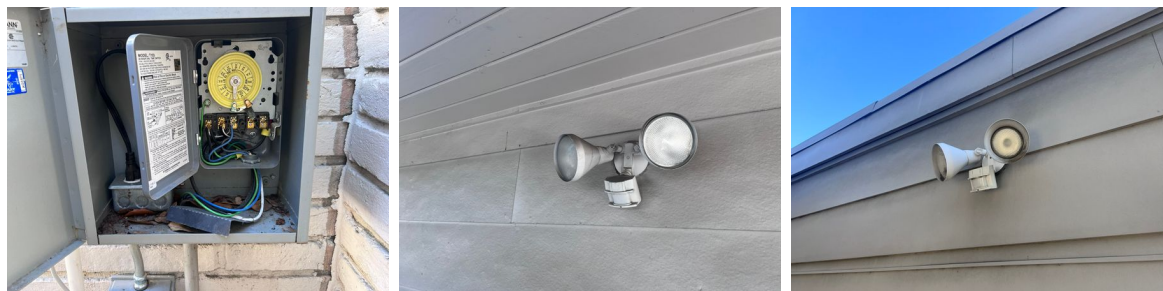
Several of the exterior lights appeared to be on a daylight sensor or timer, and will not come on until it gets dark. Since it was not dark, the lights were not checked at the time of the inspection. Further investigation is recommended.

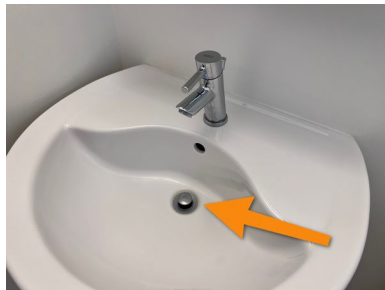
Master Closet Half Bath

### 2: Sink Drain - Leaking

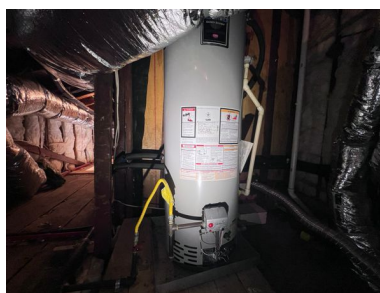
**Water Heater Equipment - limited life:**

Due to the age and/or condition of the equipment, it is our opinion that the equipment has only a limited amount of life remaining. Normal life expectancy for a water heater in the Houston area is approximately 10-12 years.

**2: Water Heater - Tank rusted**

The bottom of the water heater tank is beginning to rust. This indicates that the bottom of the heat exchanger has been rusting. Further investigation is recommended with a service company to determine the extent of the rust and make any necessary repairs.

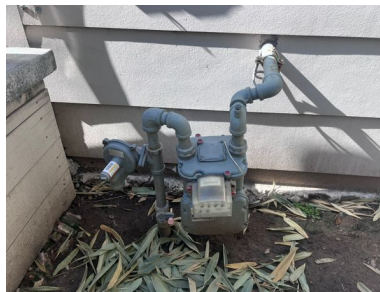
**1: Gas service turned off**

Gas service was not provided to the house at the time of the inspection, therefore the gas fired equipment could not be operationally checked. It is recommended that the gas fired equipment be operationally checked

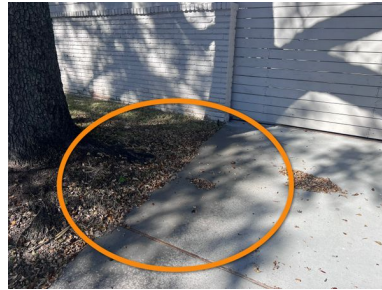
Zone 3

**1: Adjust sprinkler head spray**

Spraying Walk Way, Spraying driveway, Spraying street -  
The sprinkler head spray was in need of adjustment/repair.

Recommendation: Contact a qualified professional.
