PROPERTY INSPECTION REPORT FORM

1005 N Danville St, Willis, TX 77378

02/24/2023 9:00 am

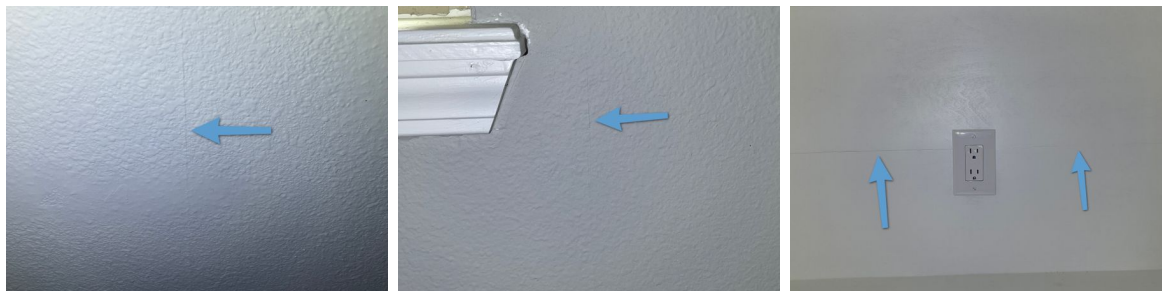
Drywall joint separation cracks were observed. These cracks are mainly cosmetic.

Recommendation: Contact a qualified professional.

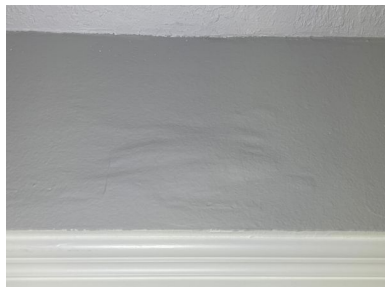
Kitchen

A bubble was observed at areas of the interior wall finish material at the time of the inspection.

Recommendation: Contact a qualified professional.

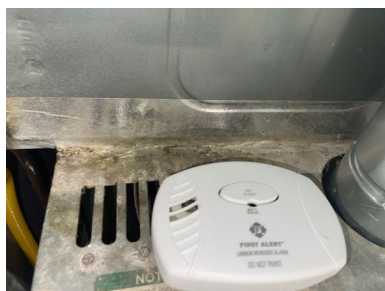
What appeared to be organic growth was observed on the air handler casing and/or condensation drain lines. This is a common occurrence on units that are located in un-conditioned areas due to temperature variations that can cause condensation, which can harbor fungal growth.

Recommendation: Contact a qualified professional.

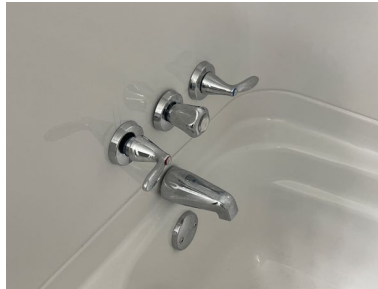
Bathroom #1

4: Bathtubs/showers: Loose Fixture Components

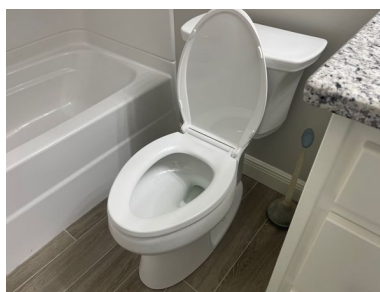
Bathroom #1

7: Toilets: Loose

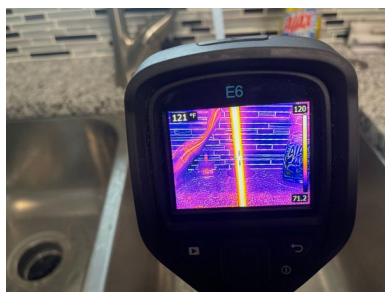
The water heater was observed to be functioning as intended. Adjust the water temperature as

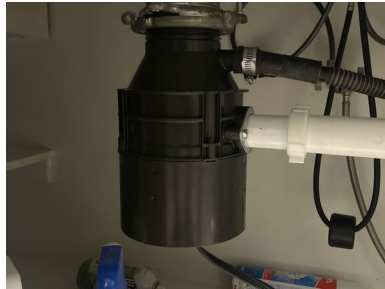
The food waste disposer was operated and appeared to be functioning.

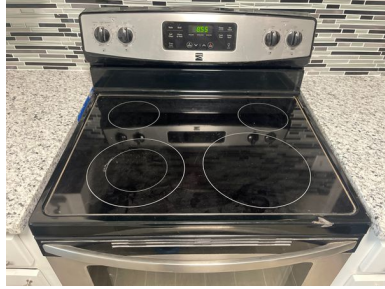
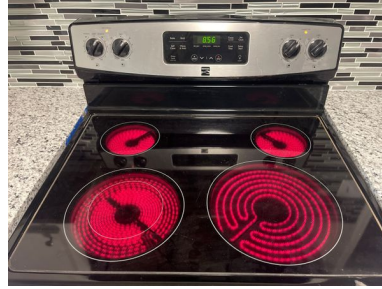
The burners were operated and appeared to be functioning as intended.

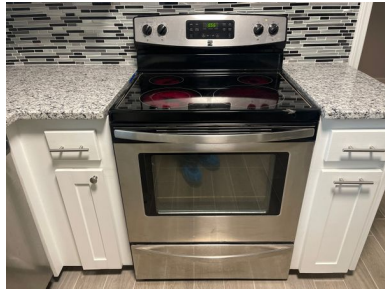
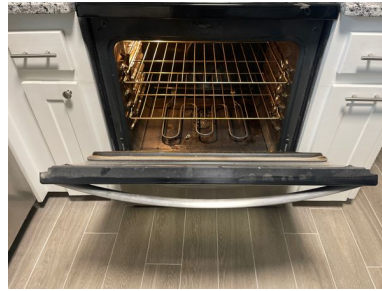
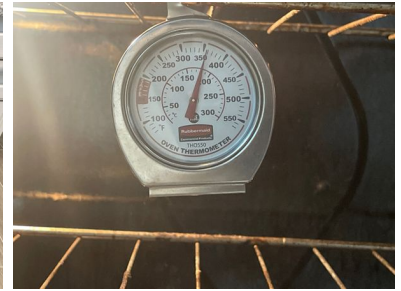
The oven was tested at 350 degrees and read within the acceptable 25 degree range, in my opinion the oven appeared to be functioning as intended.
