## Property Inspection Report

11419 Pampass Pass, Houston, TX 77095

Date of Inspection: 2/27/2023 Time: 8:15 AM - 12:15 PM

Inspector: James Sprouse

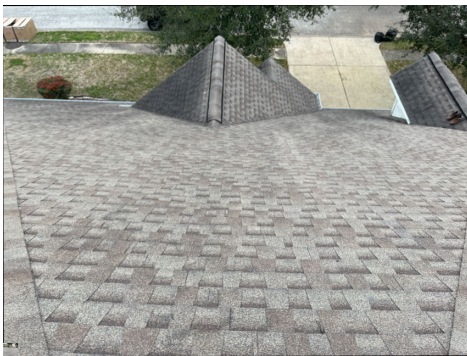
Front

Loose or uplifted flashing was noted on the roof. We recommend having this secured to avoid water intrusion. This was observed on the front.

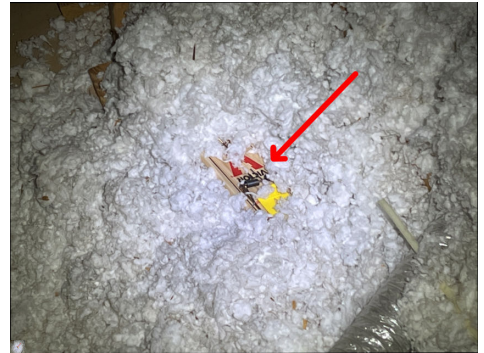
There was evidence of past vermin activity. A pest control specialist should be consulted in this regard.  
 Vermin and other pests are part of the natural habitat, but they often invade homes. Rats and mice have collapsible rib cages and can squeeze through even the tiniest crevices. And it is not uncommon for them to establish colonies within crawlspaces, attics, closets, and even the space inside walls, where they can breed and become a health-hazard. Therefore, it would be prudent to have an exterminator evaluate the residence to ensure that it is rodent-proof, and to periodically monitor those areas that are not readily accessible.

Evidence of pest activity

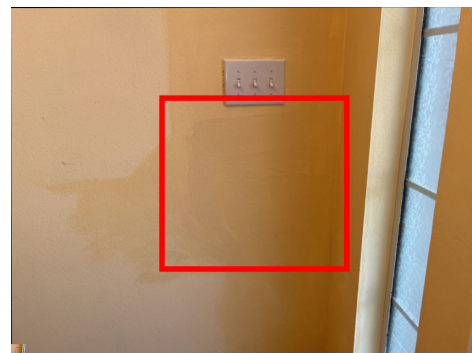
Foyer: Patchwork

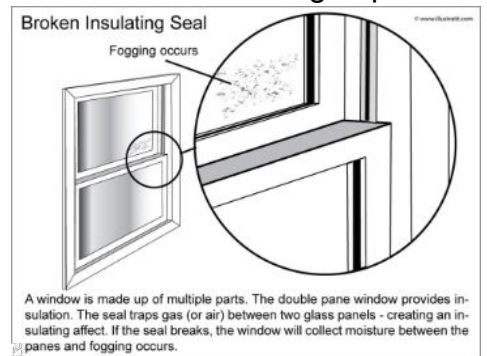
Lost seal

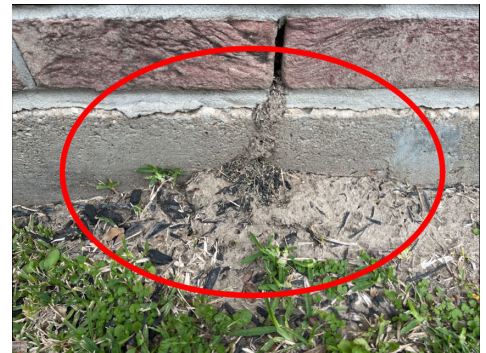
Ant nests were observed, we recommend treatment against any type of insect especially when close to structure. These were noted on the left.

Left: Ant nest

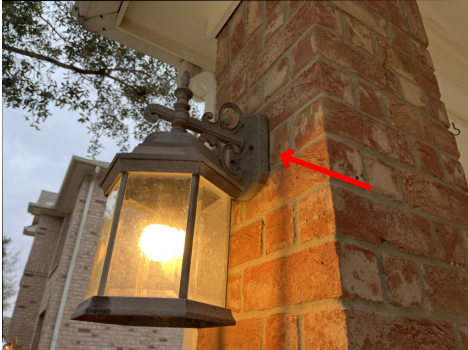
Around House: Caulk missing at fixture to wall connection

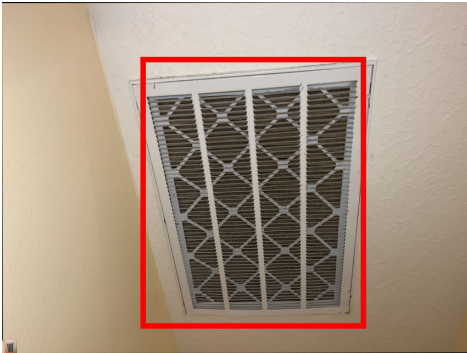
The air filter at the primary return was dirty and should be changed. Conventional filters should be checked every months and replaced as necessary. Homes in areas with high indoor levels of airborne pollen or dust may need to have air filters checked and changed more frequently.

Dirty air filter

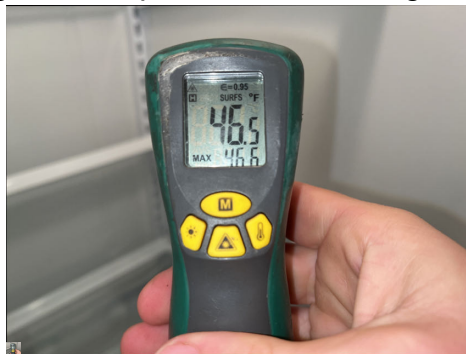
Refrigerator cool temperature

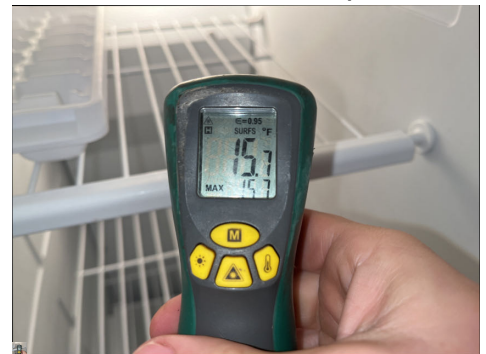
Freezer cool temperature

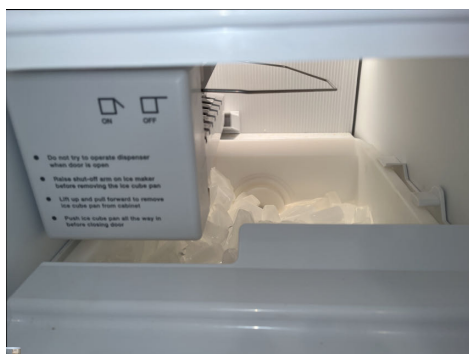
Ice maker on
