## ***PROPERTY INSPECTION REPORT***

**Prepared For:** Erick & Mara Calderon  
(Name of Client)

**Concerning:** 2135 Quenby Street, Houston, TX 77005  
(Address of Inspected Property)

**By:** Jason Fielding, TREC; PI 21810 05/27/2021  
(Name and License Number of Inspector) (Date)

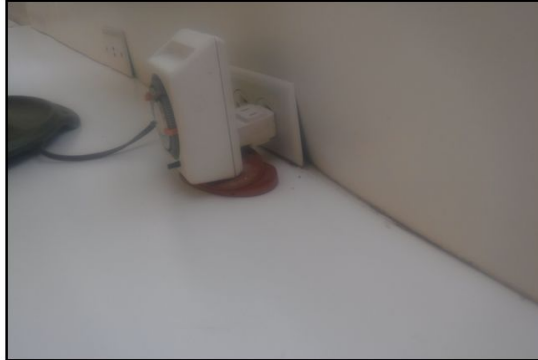
Recommend sealing all holes in interior walls to reduce air and water infiltration; kitchen counter, master bath.

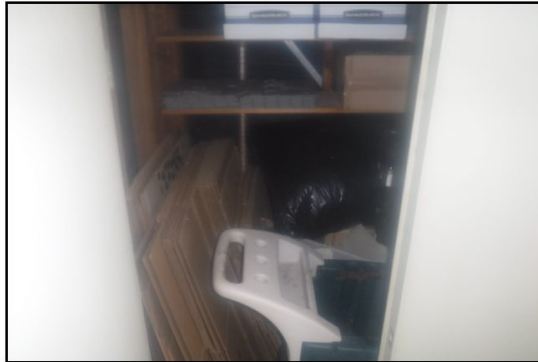
*Buyer's note: Due to a large number of stored items, limited viewing, and full/proper inspection was impaired, particularly in furnished rooms and the garage*

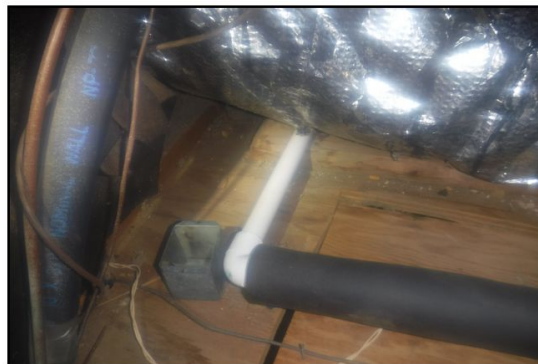
The primary drain line should be insulated along the entire length in the attic to prevent warm attic air condensing on the cool drain line and dripping condensation.

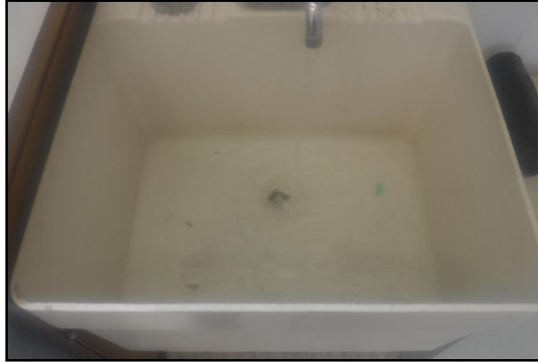
Slow drain; loft room deep sink.

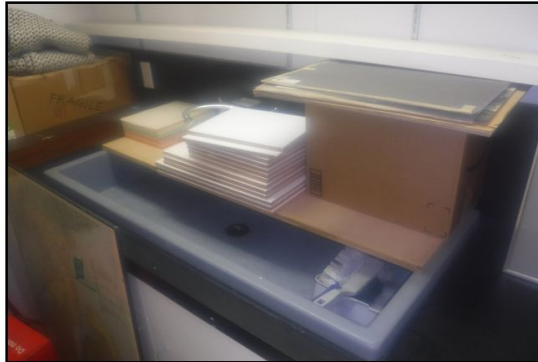
Sink not checked in loft room.

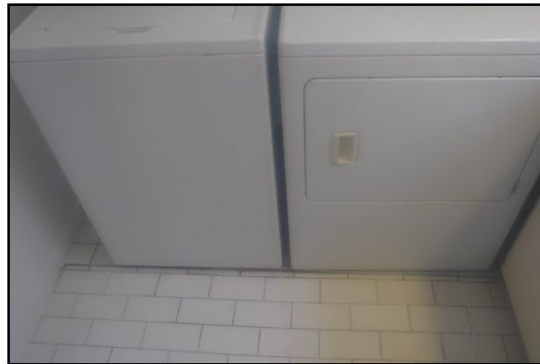
*Unable to verify the floor drain connection below the laundry machine.*

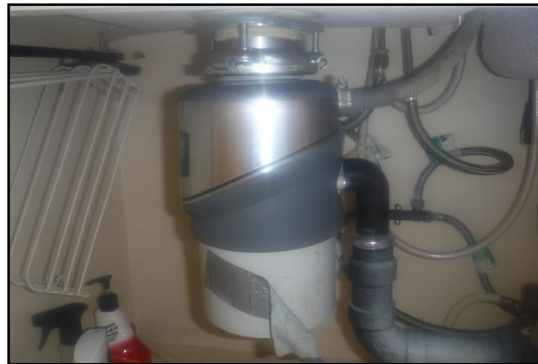
**The food waste disposer is not operational, does not turn when power on to the unit.**
