Smith Group Property Inspections

Property Inspection Report

4613 Knoxville Street, Houston, TX 77051
Inspection prepared for: Michael Jolivet and Dwight Bazile

Date of Inspection: 12/30/2021 Time: 7:00AM
Age of Home: 2006 Size: 4000 sqft

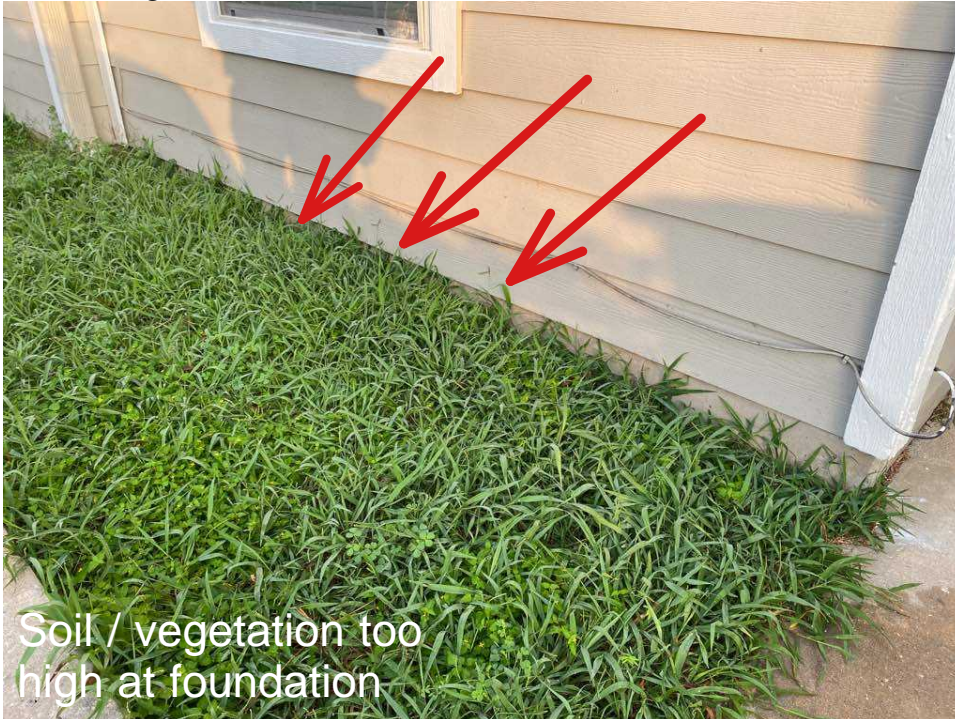
B. Grading and Drainage (continued)

Soil / mulch too high at foundation.

Soil (or mulch) too high at foundation can potentially promote pest intrusion.

It is recommended that at least 4 of foundation be visible.

Correction recommended by qualified contractor.

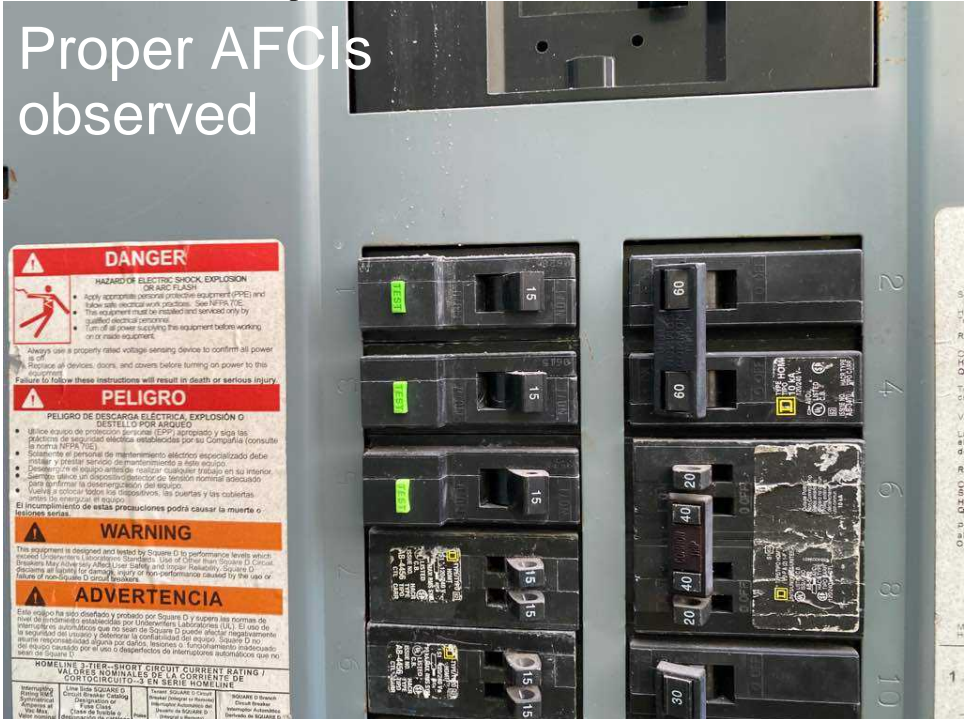
C. AFCI (Arc Fault Circuit Interrupter) (continued)

Comments: Arc Fault Circuit Interrupter: Required at by current building standards, AFCI's appeared to operate as intended at time of inspection.

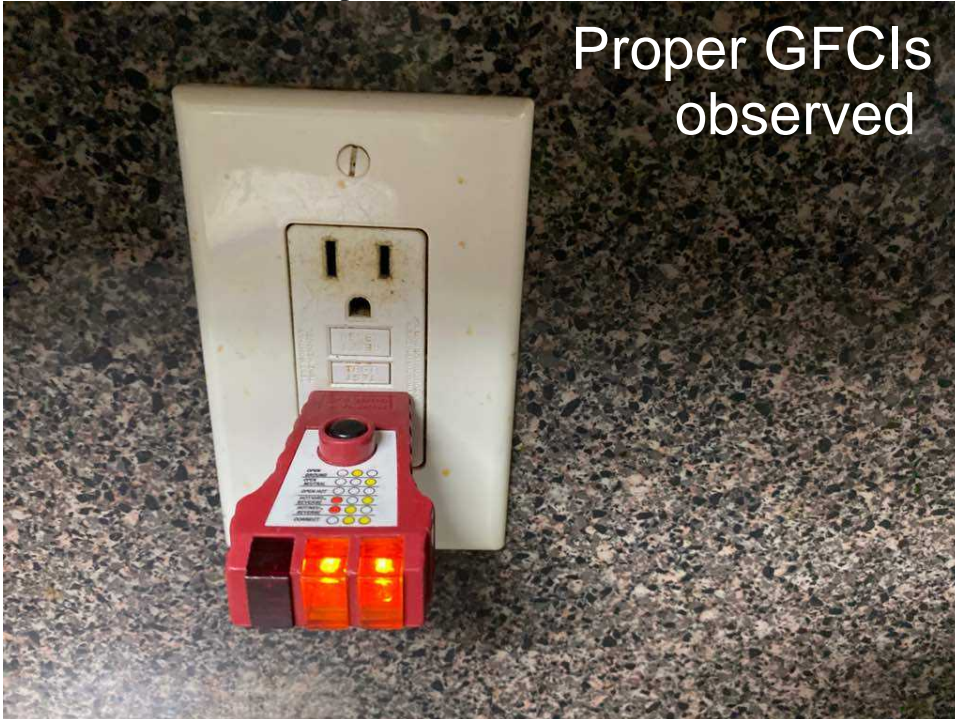
D. GFCI (Ground Fault Circuit Interrupter) (continued)

Comments: GFCIs (Required) Locations: Kitchen, Bathrooms, & Garage, Proper GFCIs observed at time of inspection.

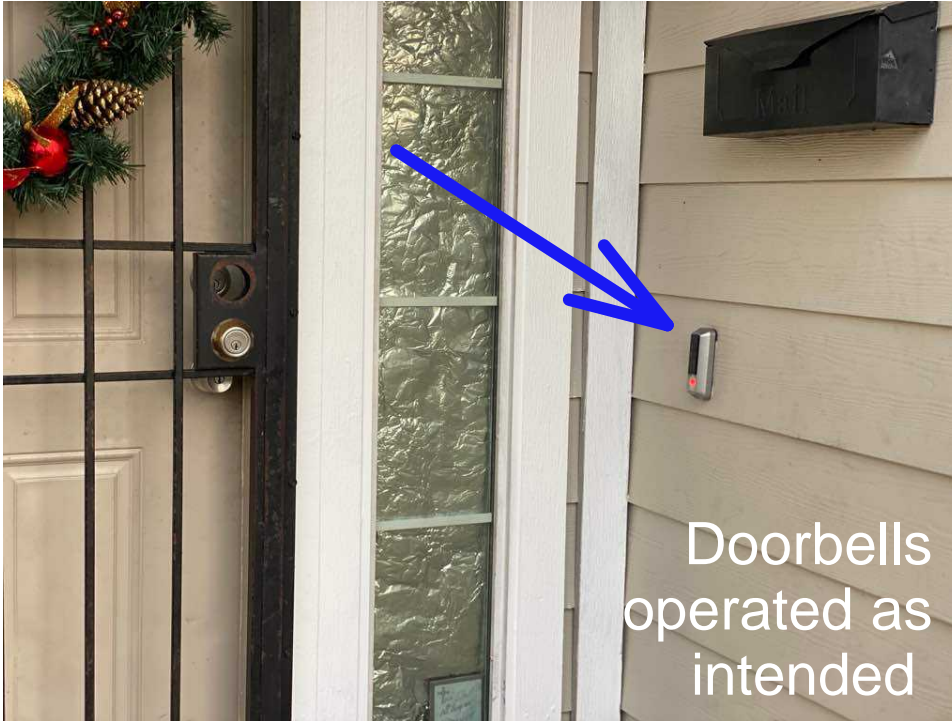
F. Doorbell

Comments: Exterior (front entrance to property),
Doorbell operating as intended at time of inspection.

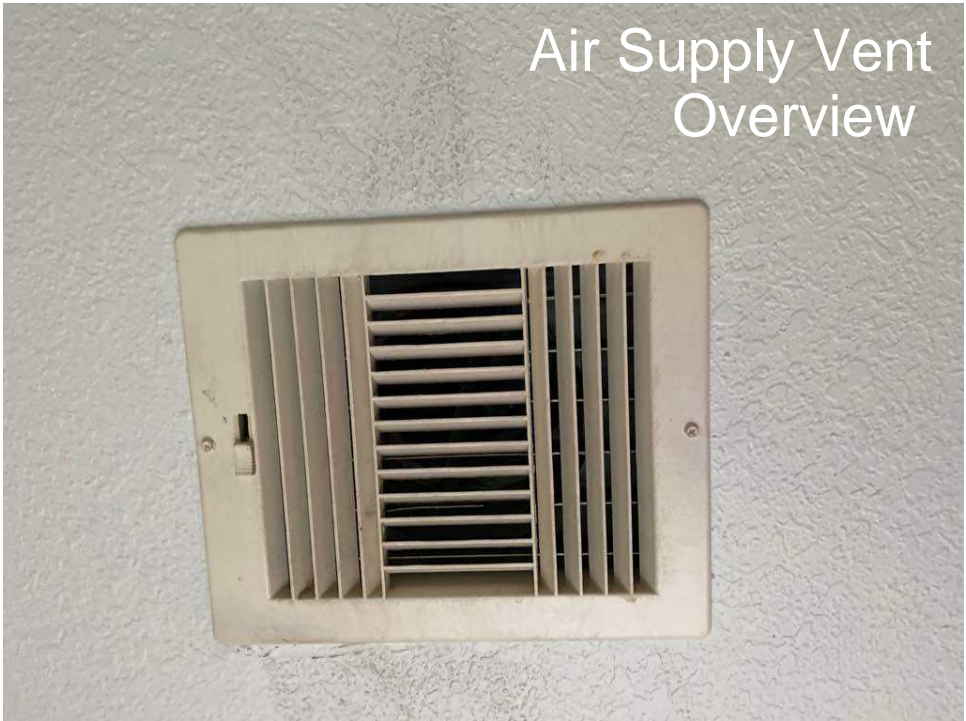
E. Air Vents, Grilles, Registers

Comments: Ceiling Air Supply Vent,
Air supply vents appeared to operate as intended at time of inspection.

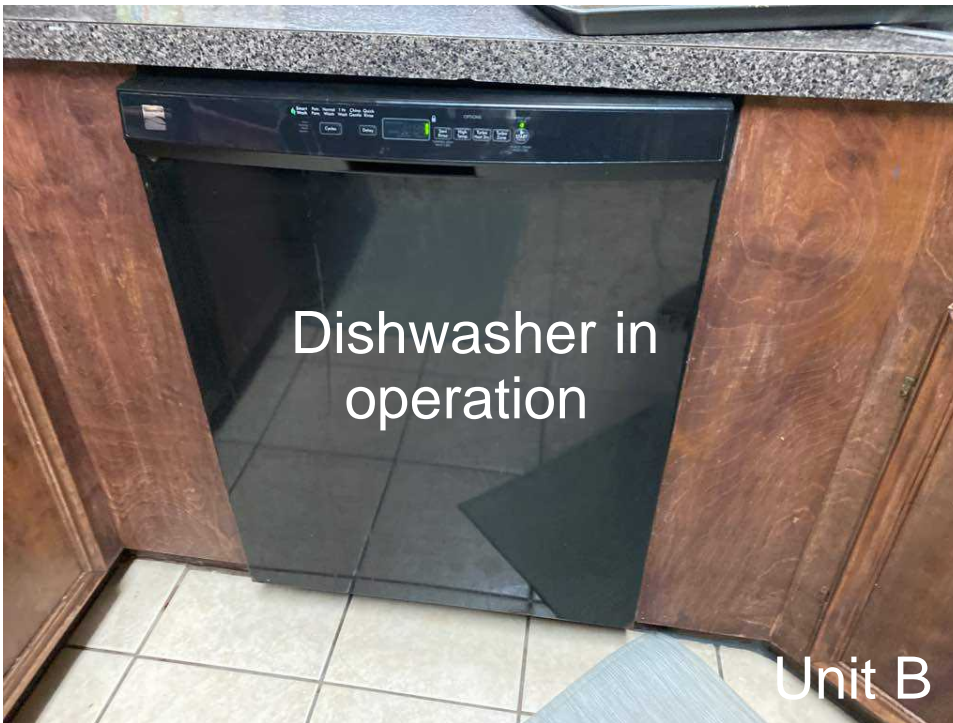
No items requiring repair were visible at the time of the inspection for the operation of the dishwasher.

The unit was run through a cycle at the time of the inspection, and appeared to be operating properly.

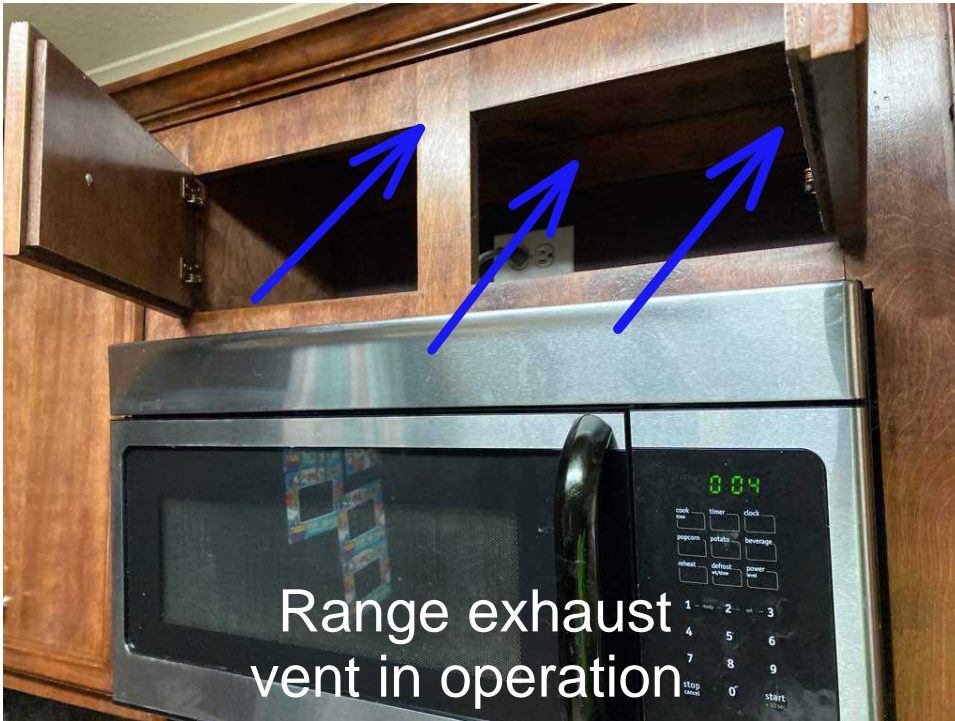
Comments: Frigidaire,
Range exhaust vent operated as intended at time of inspection.

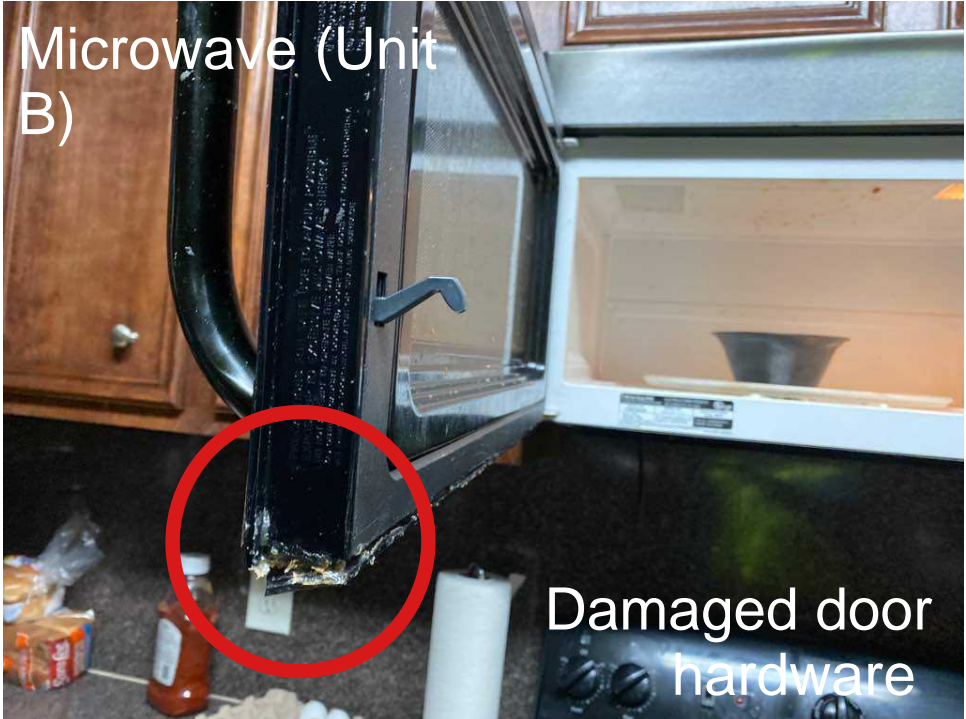
Damaged door hardware observed (Unit B).

Correction recommended by qualified contractor
