SELLER'S DISCLOSURE NOTICE

CONCERNING THE PROPERTY AT 3311 Sunset Field Ln Missouri City TX 77459

Client: Alberto Bazan / 346-816-8149 / Email: 4bazans@comcast.net
Inspection Date: February 20, 2019
Project Address: 3311 Sunset Field Missouri City Texas 77459
Propose Repair: Installation of 34 Exterior Pilings and 20 Interior Pilings

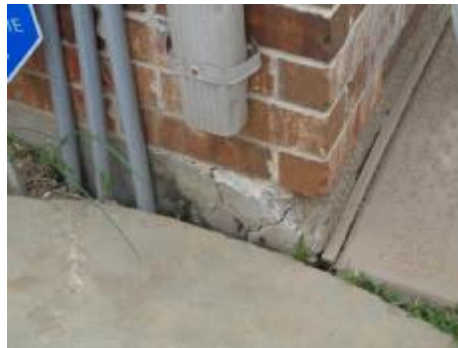
Gutter downspout

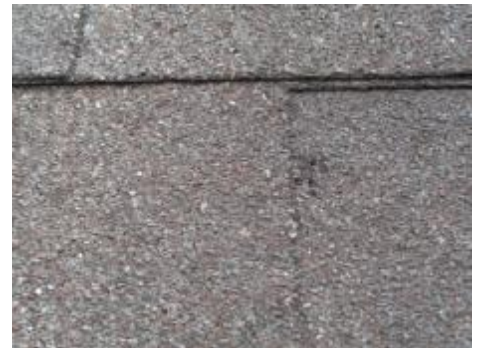
Roof pitting

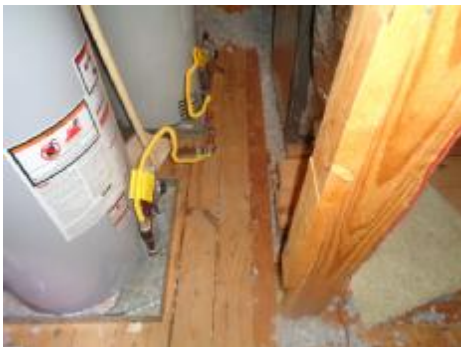
Comments: The service platform in front of the water heaters is not at least 36 inches. Have a contractor widen the area.

Service platform

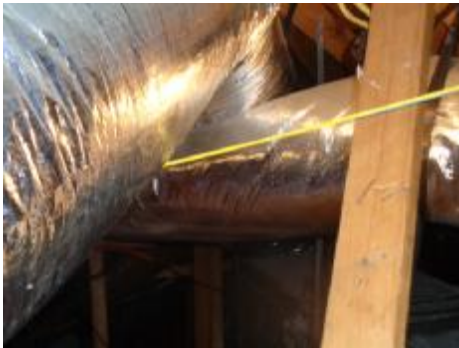
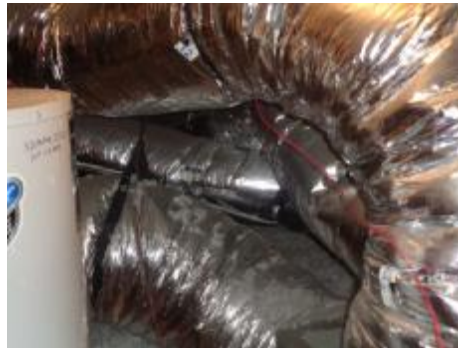
- Ducts *There are ducts that are touching in the attic. Separate the ducts to prevent condensation.*
- Supply Air Flow
- Supply/Return Plenums

Ducts touching

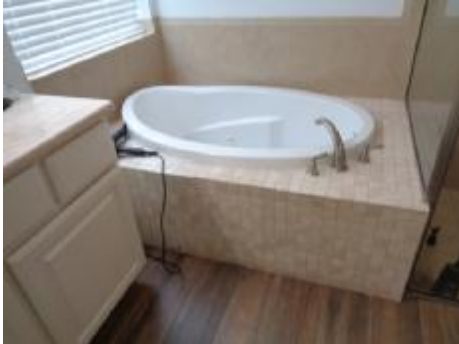
There is no access to the motor/pump. Install an access door in order to have access to the pump/motor.

Hydro tub

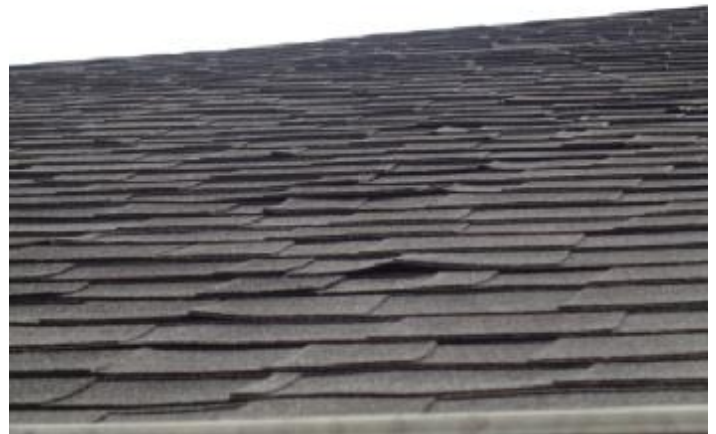
Raised shingle

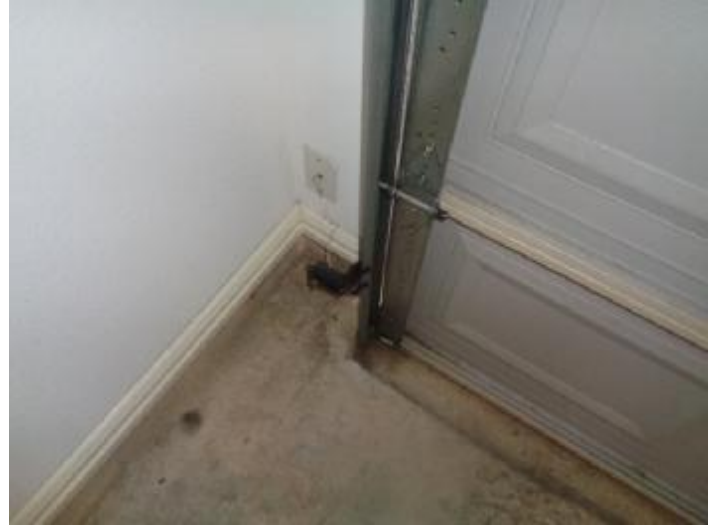
Electronic eye sensors installed to high from garage floor

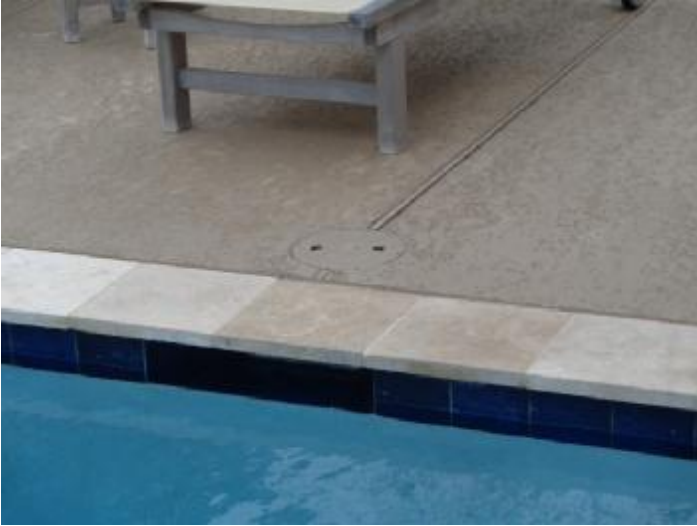
Skimmer

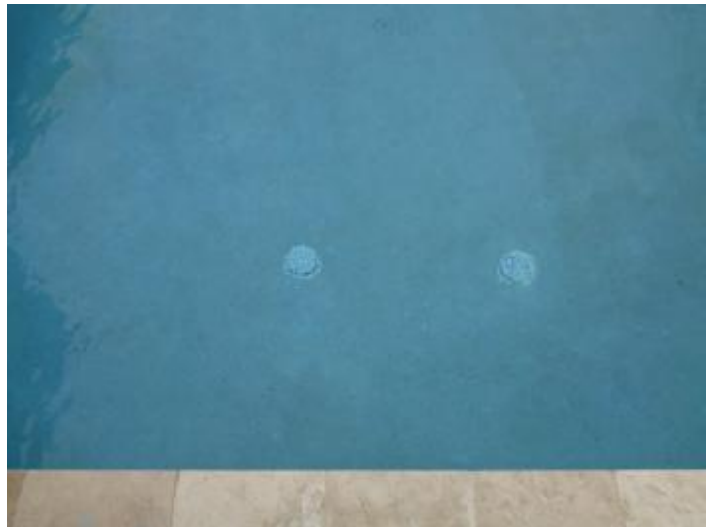
Pool drains

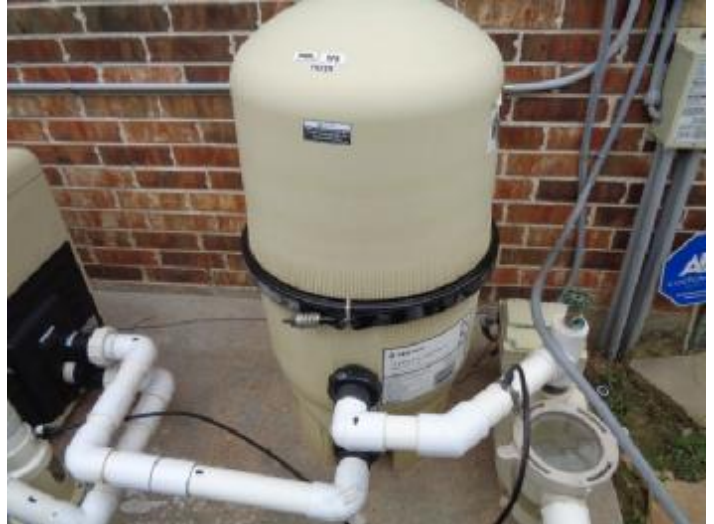
Pool equipment

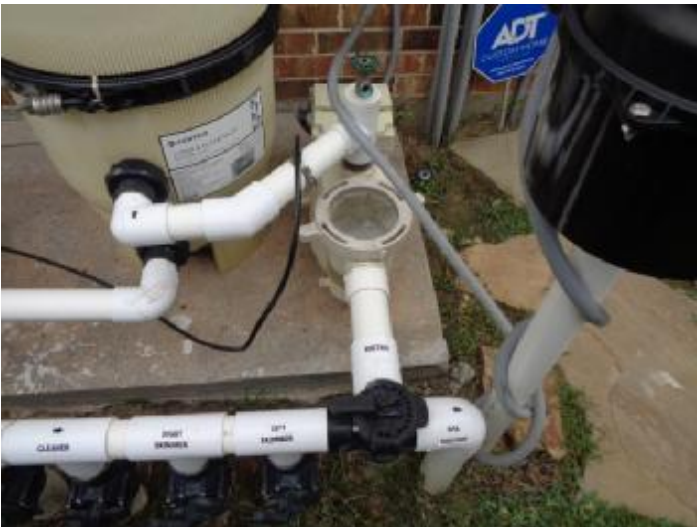
Pool equipment

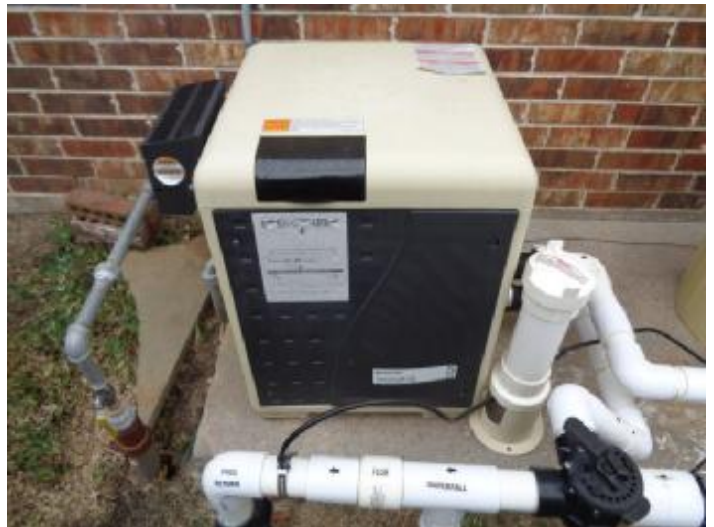
Pool equipment

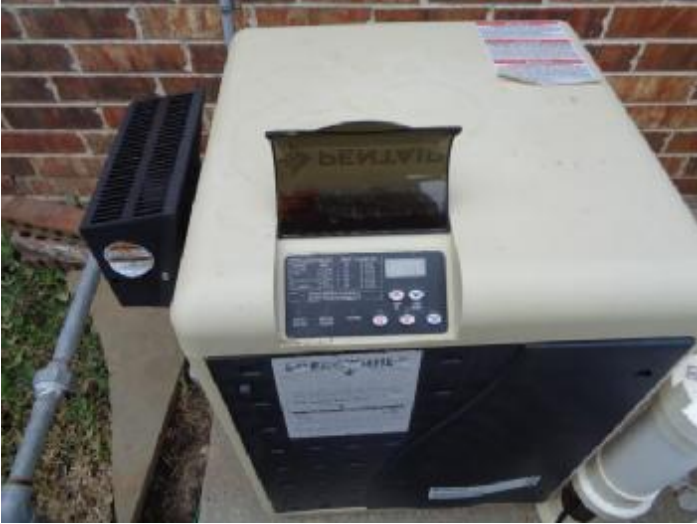
Pool equipment

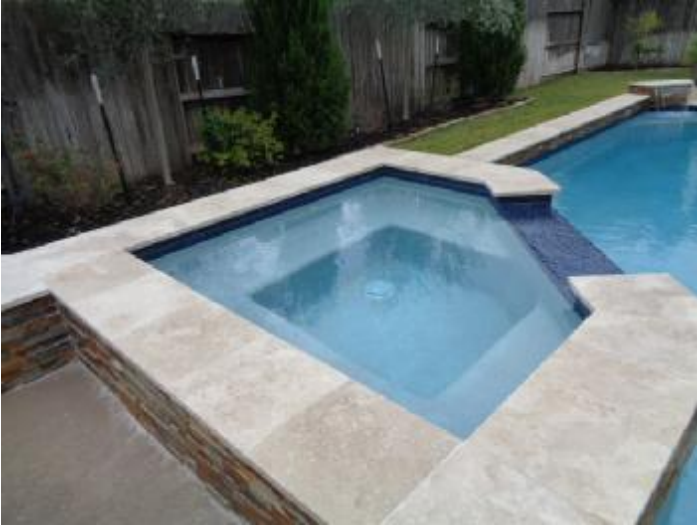
Spa

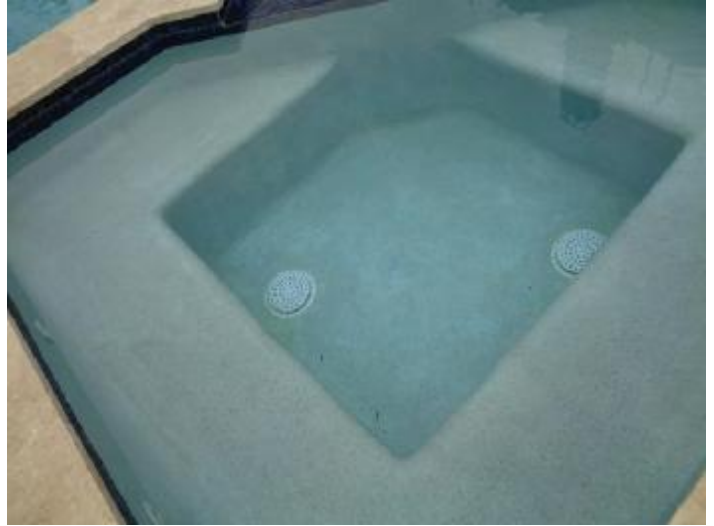
Spa

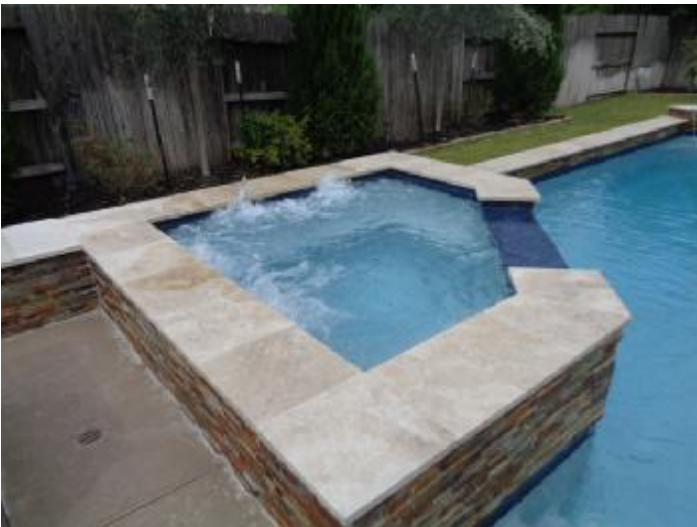
Spa

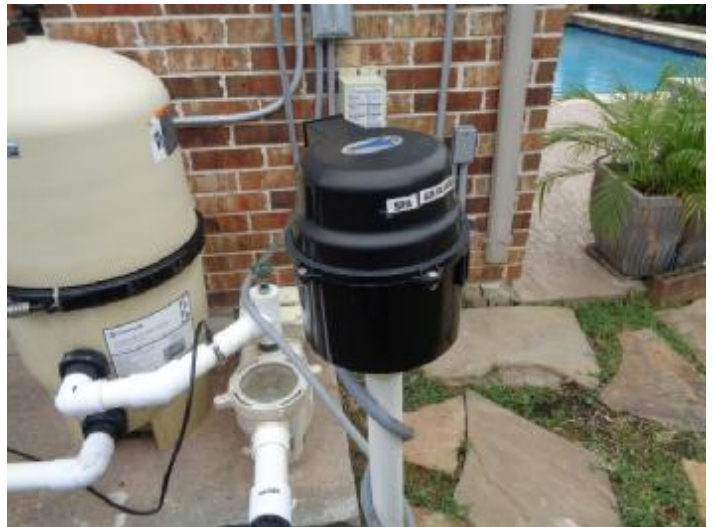
Spa blower

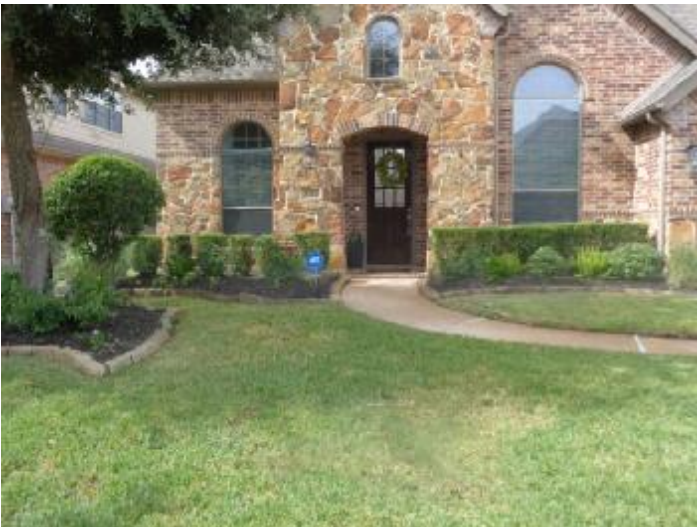
Sprinkler system

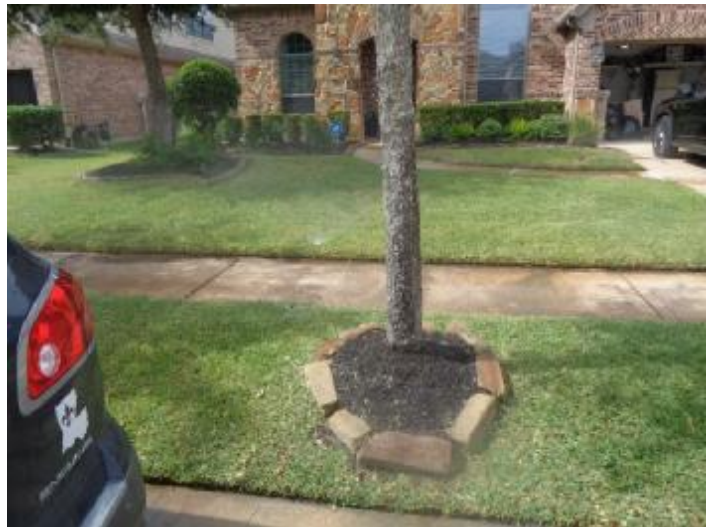
Sprinkler system

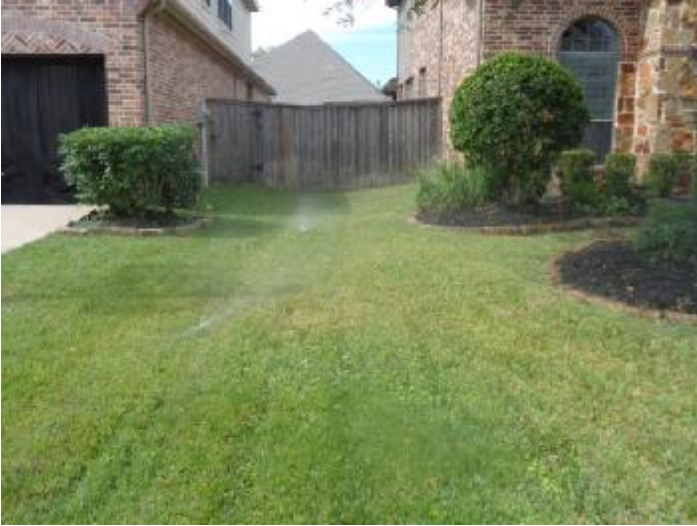
Sprinkler system

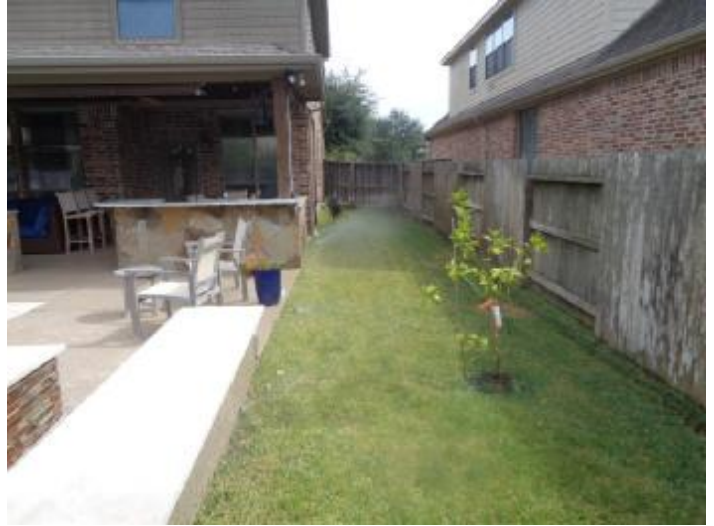
Sprinkler system

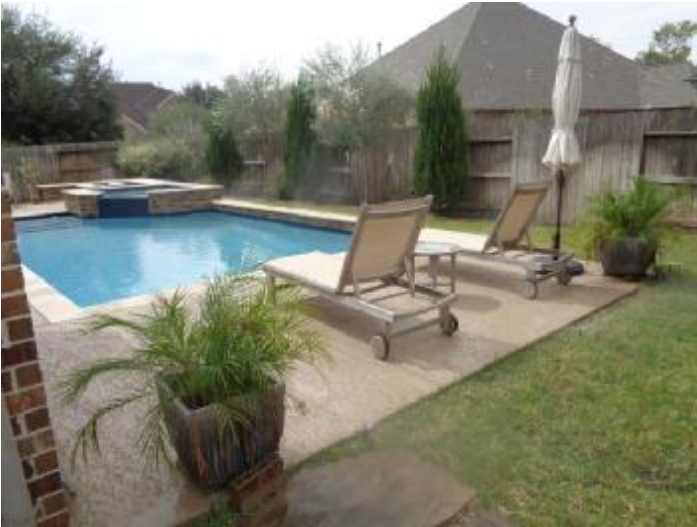
Sprinkler system

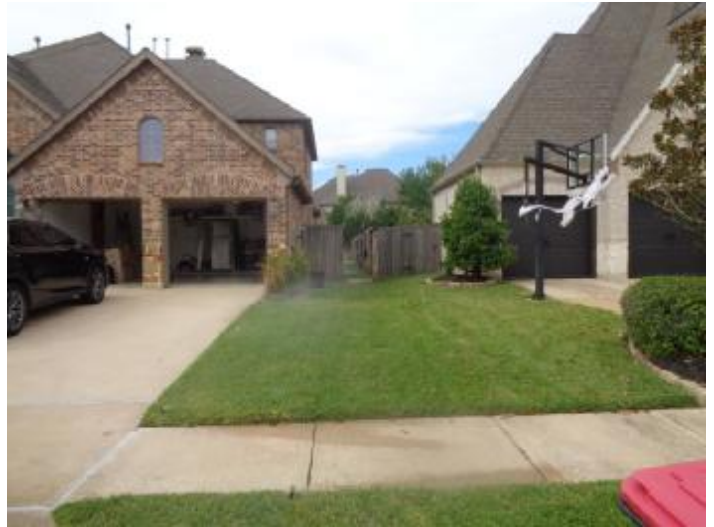
Sprinkler system
