### HOME INSPECTION REPORT

# PROPERTY INSPECTION REPORT

**Concerning:** 275 County Rd 3015, Dayton, TX, 77535  
 (Address or Other Identification of Inspected Property)

**By:** Charles Rowden 22155 Tina Paz 24081 Bertrand Lemelle 24610 5-26-2021  
 (Name and License Number of Inspector) (Date)

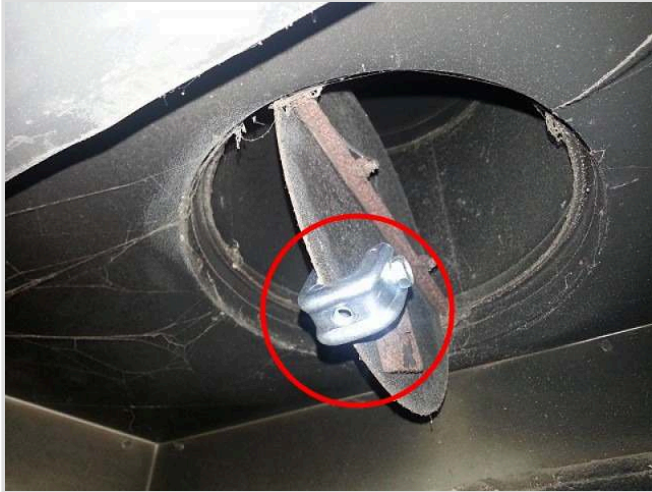
No damper clamp

Damper clamp example

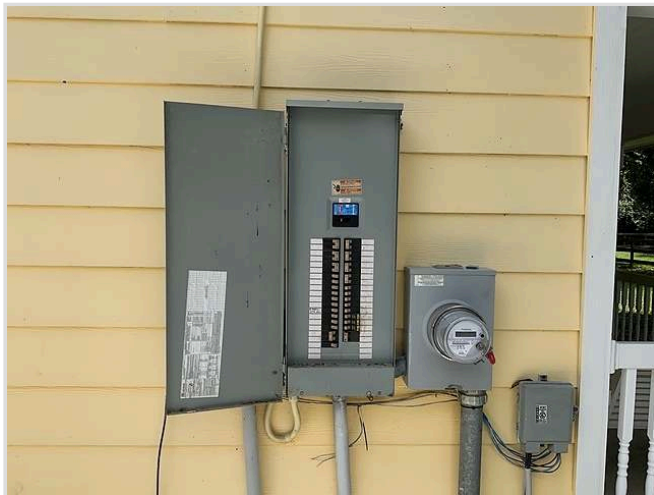
Distribution panel

**Note:** The panel box does not meet current electrical code. When the house was constructed, the distribution panel was compliant and updating to meet code is not required (grandfathered). If there is a desire to bring the panel box and system up to current code, consultation with an electrician is recommended.

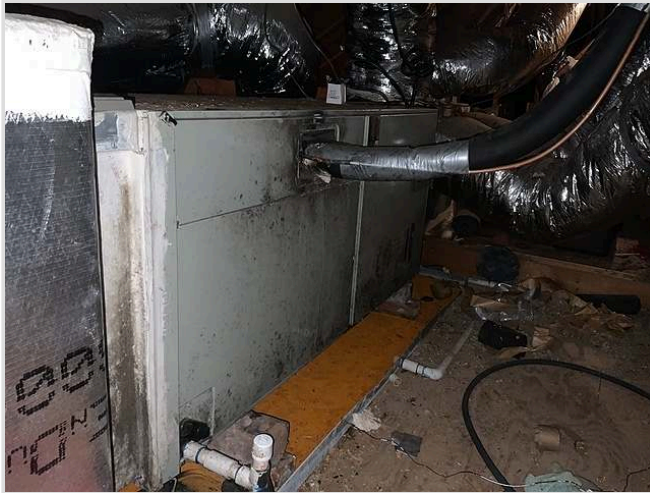
Heating unit

Wires entering the heating unit were not protected from abrasion (no grommet/bushing).

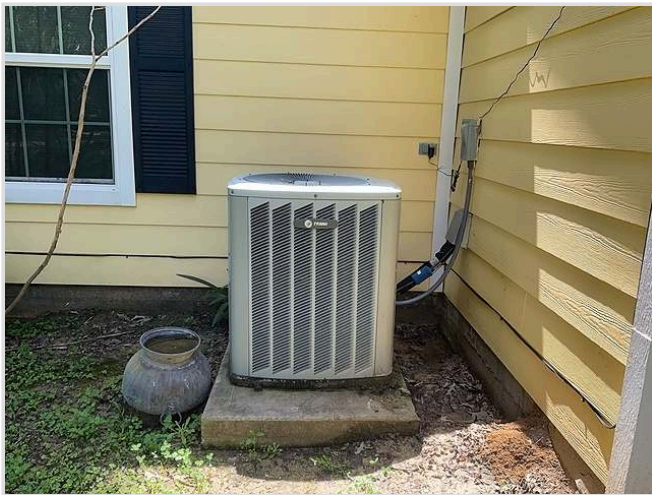
A/C unit

Secondary drain pan had significant rust corrosion. Once the galvanized coating is used up and rust sets in, it will continue to rust even without liquid water present.

A float switch (overflow protection) was not installed on the unit/secondary drain pan at the time of inspection (IMC 307.2.3).

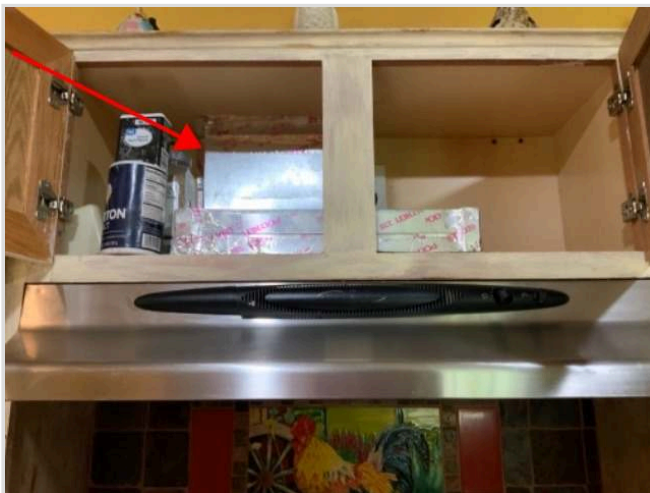
Vented unit

Lights for the range exhaust would not illuminate when placed into the on position.

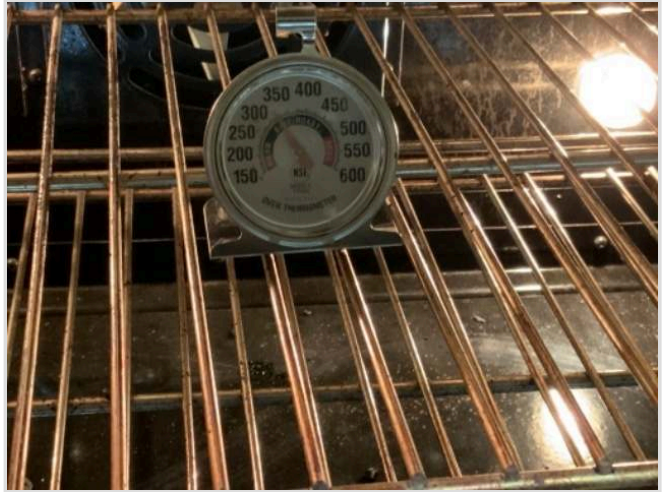
Thermometer showing 325 degrees (within tolerance)
