PROPERTY INSPECTION REPORT

3618 Appalachian Trail , Kingwood , TX 77345
Inspection prepared for: Matt Messer
Real Estate Agent: Open House - Open House

Date of Inspection: 3/17/2023 Time: 3:30 PM
Age of Home: 1990 Size: 1,778
Weather: Clear 53 Degs F
Structure Type: Structure is a wood framed structure
on a concrete slab foundation.

Inspector: Steve McElwee
License 21679
Deer Park, TX 77536

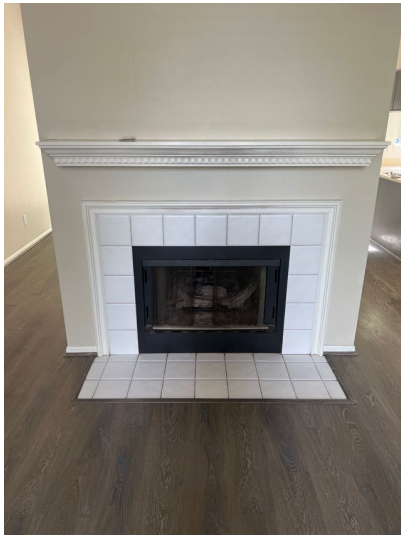
- The gas fireplace damper was missing a damper clamp at time of inspection.

Picture of fireplace.

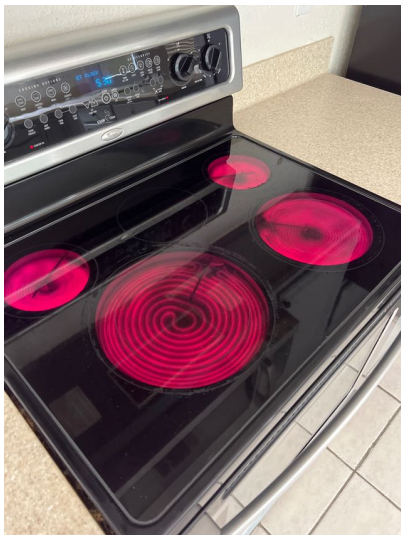
Electric range cooktop in operation
