Inspection Report

Property Address:
786 County Road 308
Cleveland Texas 77327

Lone Star Home Inspections PLLC

PROPERTY INSPECTION REPORT FORM

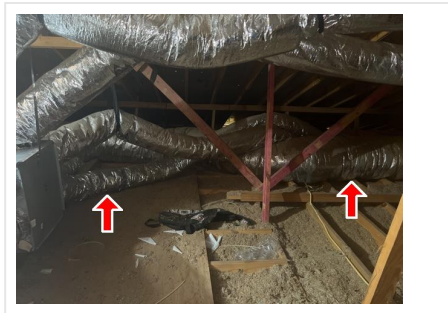
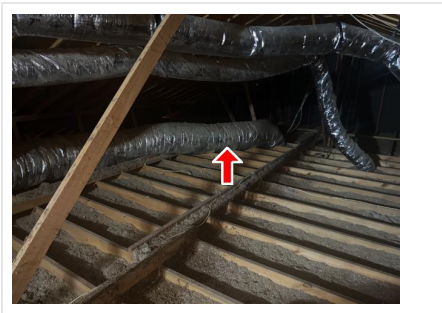
(3) Attic ductwork is not properly strapped above attic insulation at 4' intervals
