PROPERTY INSPECTION REPORT FORM

04/26/2023

15531 Pensgate Street, Houston, TX 77062

Dean Finn

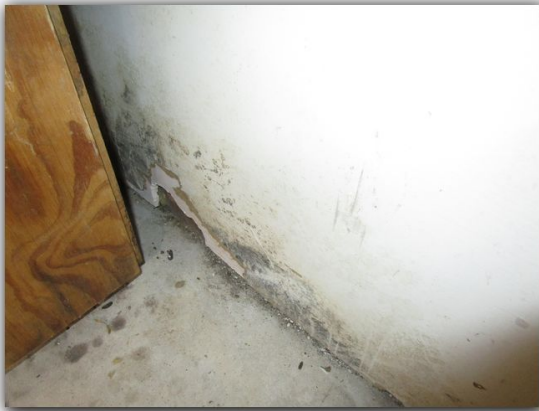
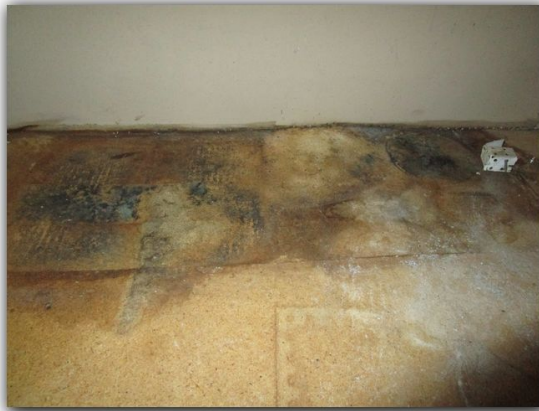
Wood to ground contact is a conducive condition for termites.

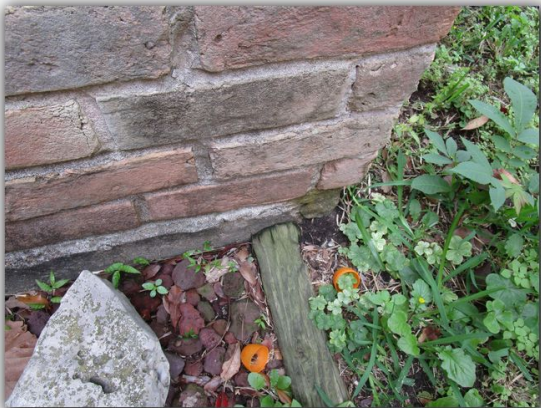
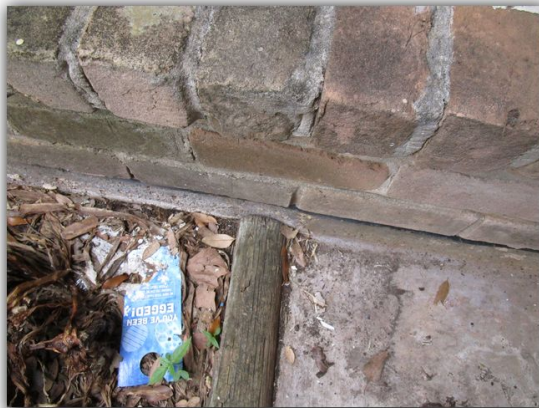
Heavy foliage is a conducive condition for Termites.

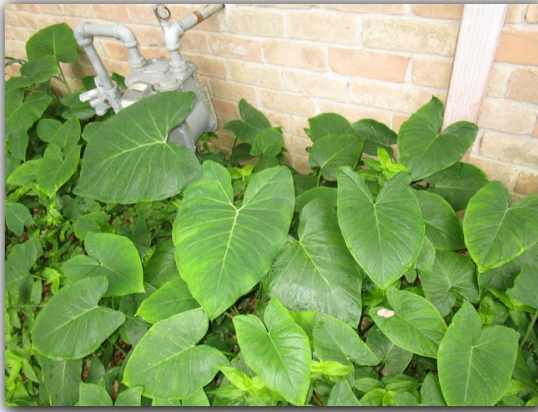
Excessive moisture is a conducive condition for termites.

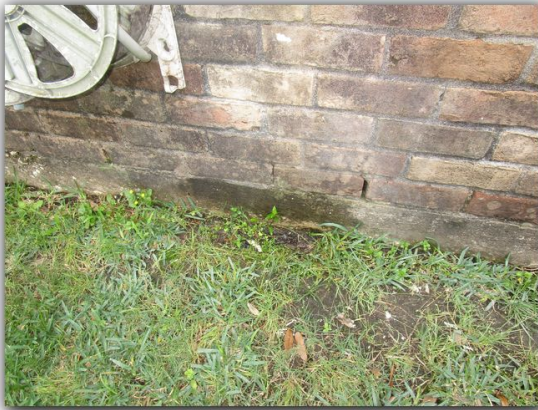
High soil is a conducive condition for Termites.

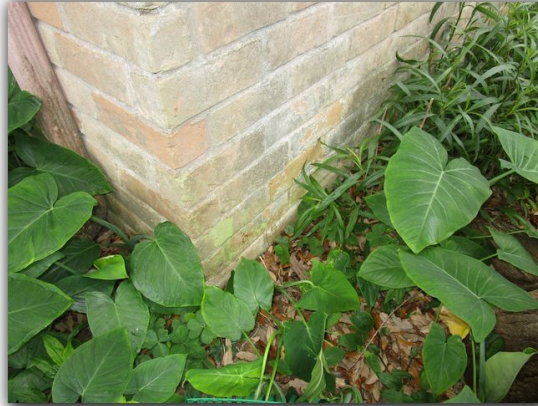
Multiple areas of the foundation were not visible due to high soil and/or heavy foliage.

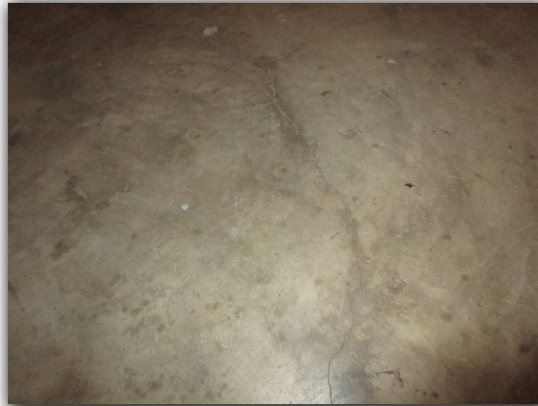
Multiple cracks in garage floor. Did not detect any displacement. Recommend these be monitored.

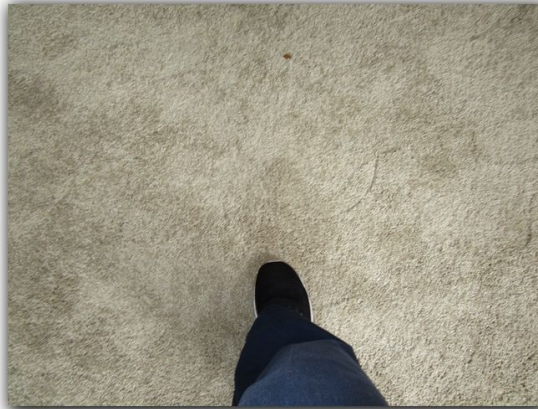
Observed uneven flooring in multiple areas.

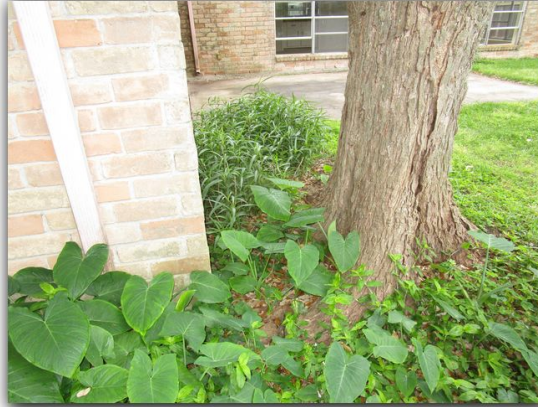
Mature tree within 10 ft of foundation.

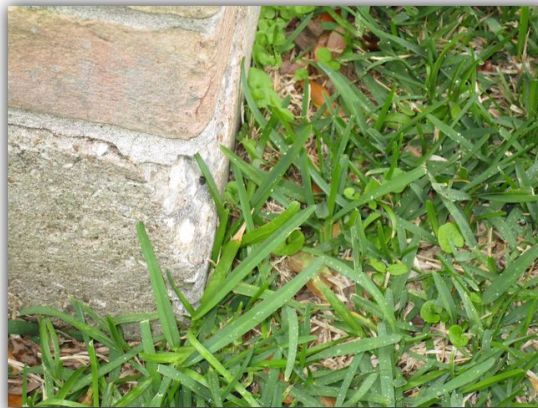
Spalling (i.e., corner pops) at one or more corner(s), Corner spalling is common to slab foundations and does not affect the structural integrity of the foundation.

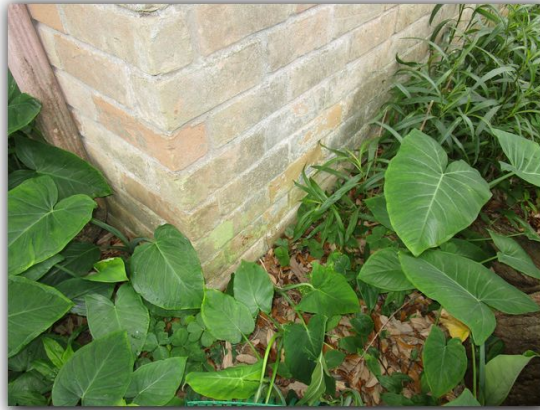
Soil levels were noted to be high in multiple areas. Soil levels against the face of the foundation promotes water penetration of the structure and insect infestation. It is generally accepted that a brick veneer house should have about 4 to 6 inches of clearance.

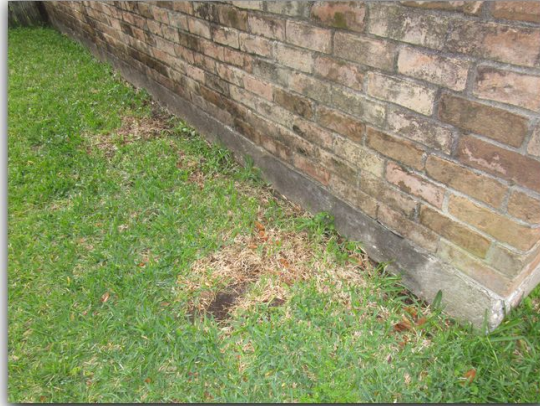
Negative drainage observed in multiple areas.

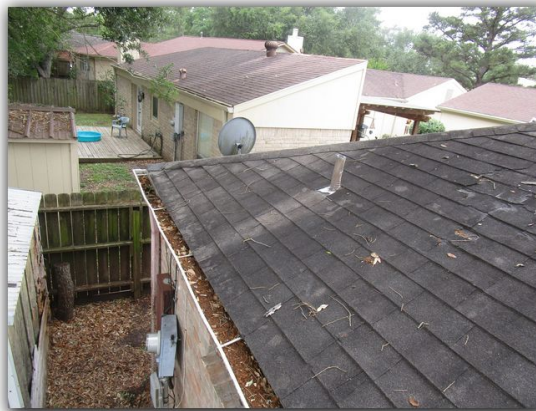
Gutters should be cleaned for proper drainage.

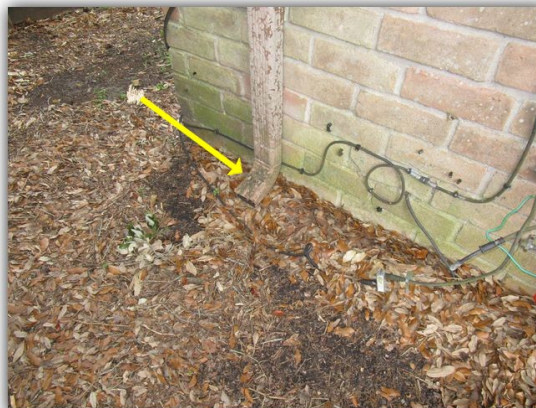
Rain gutters should drain minimum of 6' from the foundation (splash diverters needed).

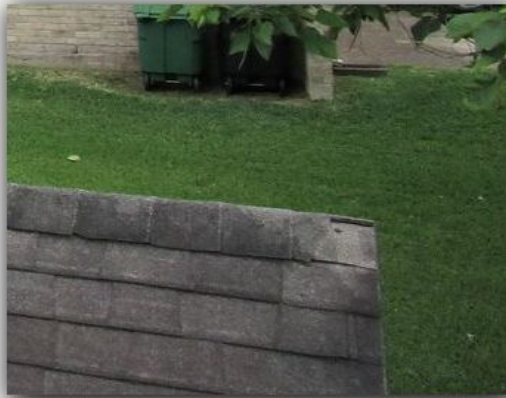
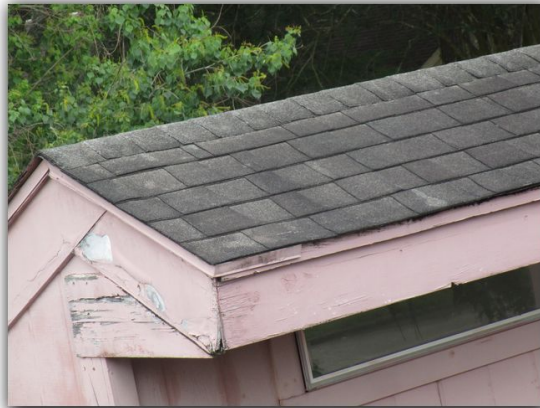
Shingles are damaged and worn in multiple areas. Roof should be considered to be in the end of its useful life.

Recommend a roofing professional to evaluate.

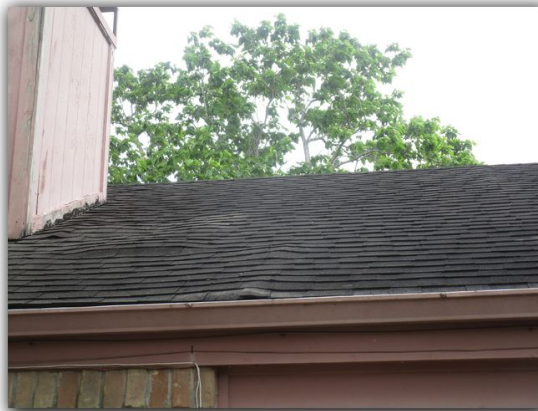
Uneven roof decking was observed in the rear of the house.

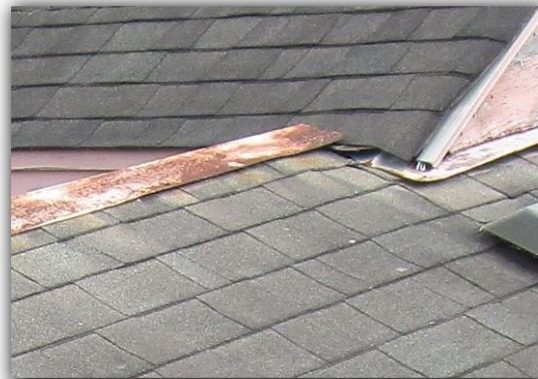
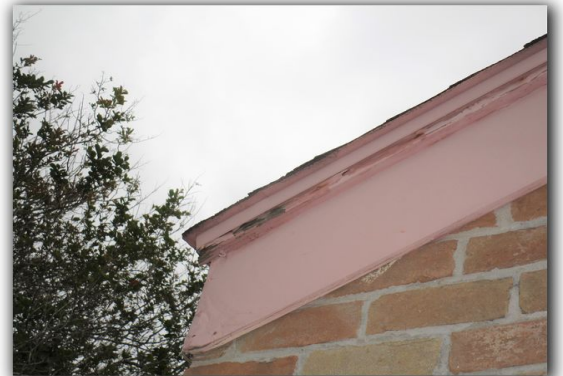
Drip edge and flashing's were loose, rusted and/or showed evidence of prior water penetration underneath the installation.

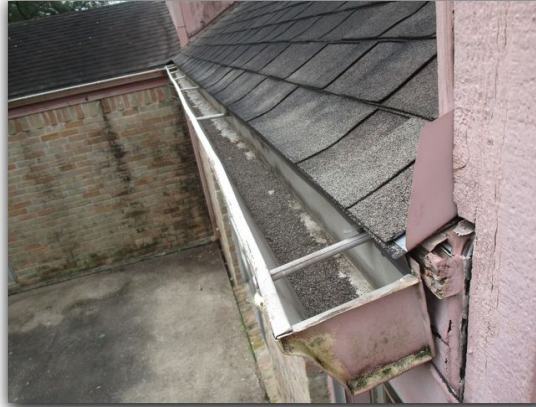
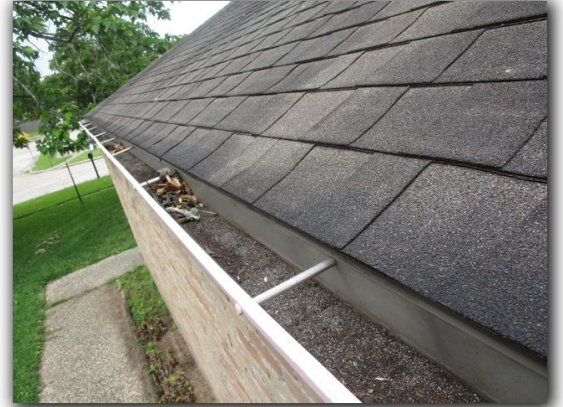
Gutters had granules indicating some de-granulation of shingles.

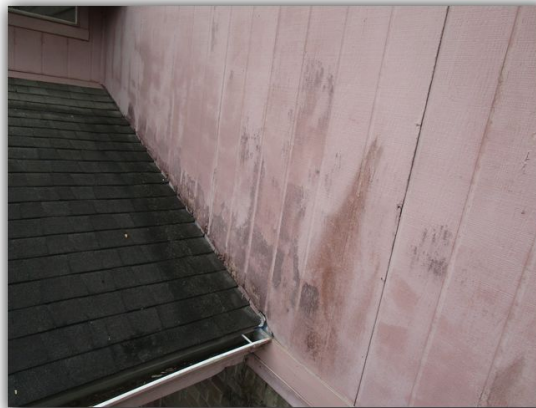
Where the roof terminates at siding there should be kick-out flashing to direct water away from the wall.

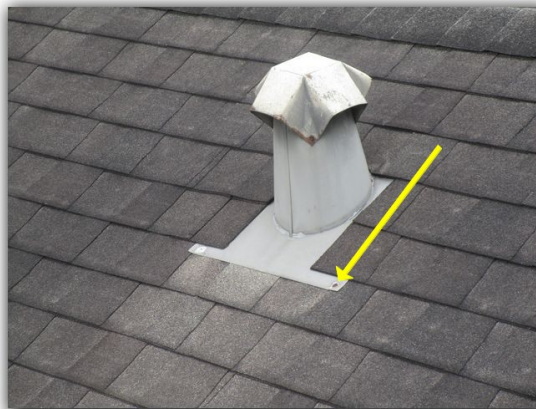
Unsealed nail penetrations were observed at flashing's and/or ridge shingles. Unsealed nail heads can allow water to penetrate past the roof covering over time. As the exposed portion of the nail rusts, more space will become available between the nail and the roofing material for water to penetrate. This condition can usually be remedied by sealing or caulking affected areas.

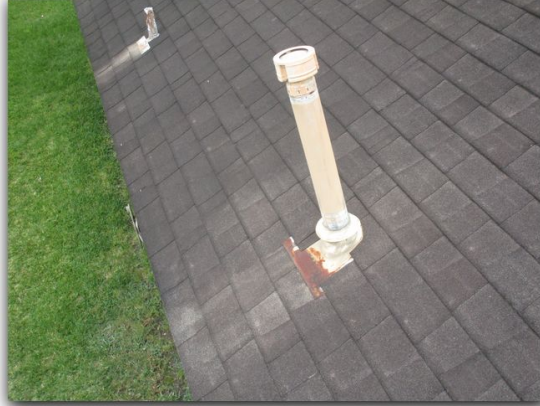
Multiple vent flashing's are rusted. Recommend these be painted with a rust inhibiting paint.

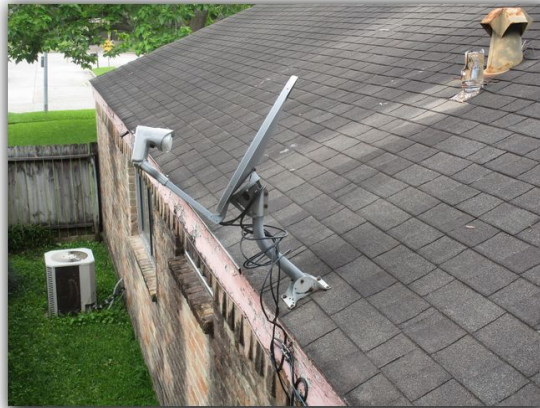
Satellite dishes are not flashed under the shingles as is desirable with all roofing and flashing. If the equipment is no longer in use it should be removed because it is reliant on sealant not leak, which will eventually fail.

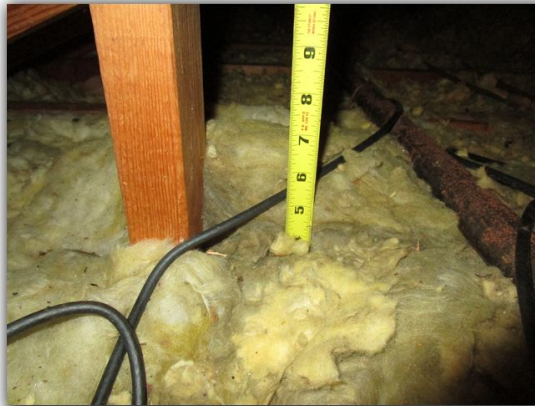
Approximate Average Depth of Insulation: Some areas had less than 4" of insulation. It is recommended to have a minimum of 8" to 10".

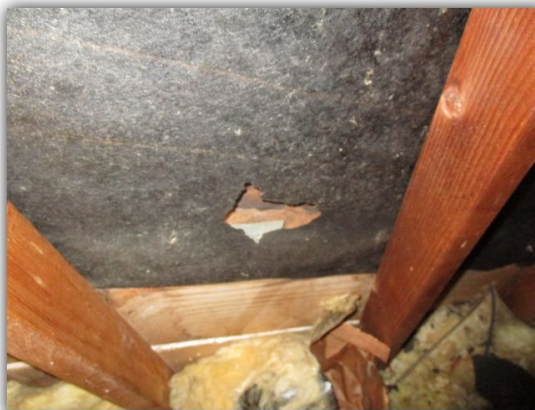
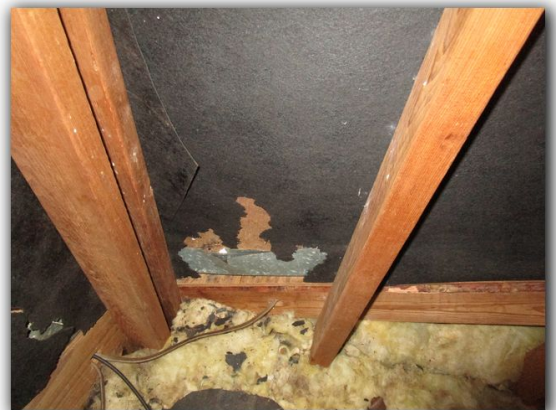
Attic had limited access and multiple sections were not visible.

Light was visible from the outside in multiple locations.

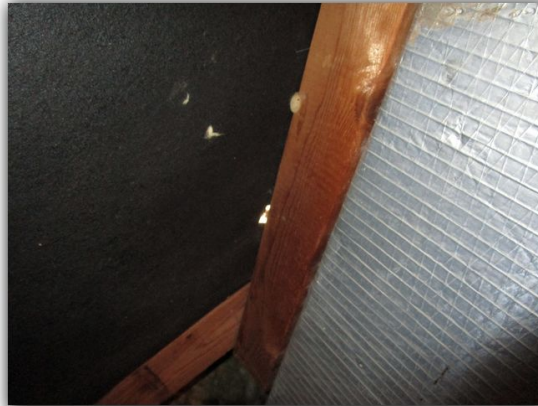
Evidence of prior water penetration in multiple locations.

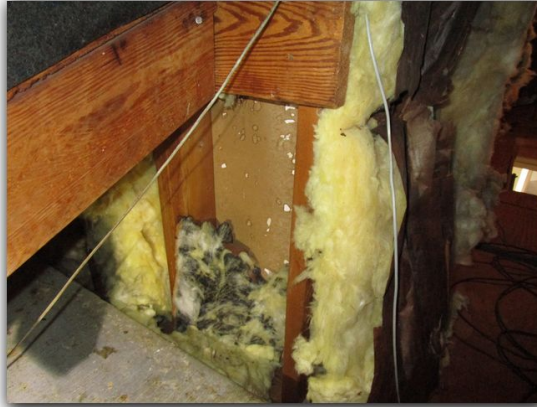
Batt insulation had fallen down from vertical attic walls. Recommend this be replace.

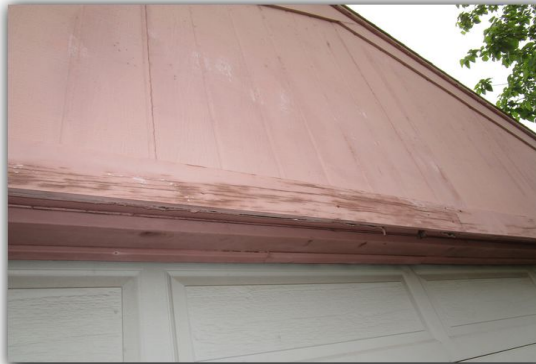
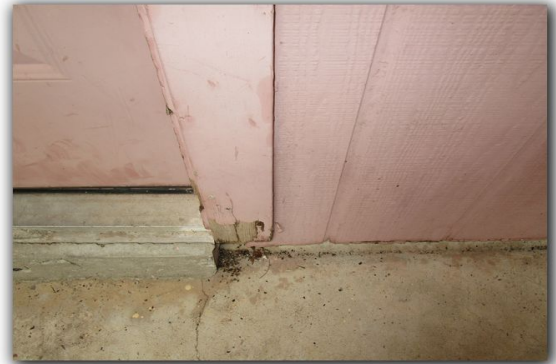
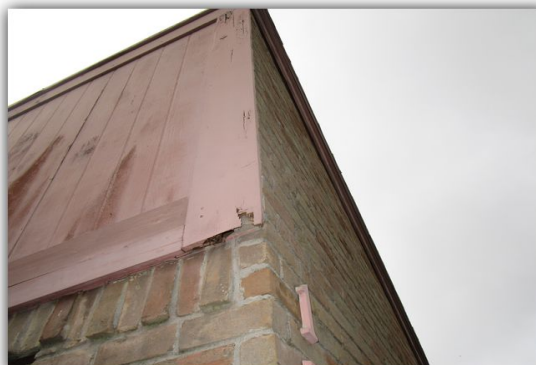
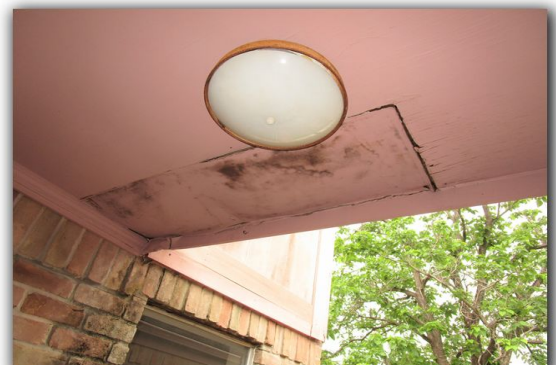
Multiple exterior boards and trim have water damage, deteriorated bare wood, and assorted other damage.

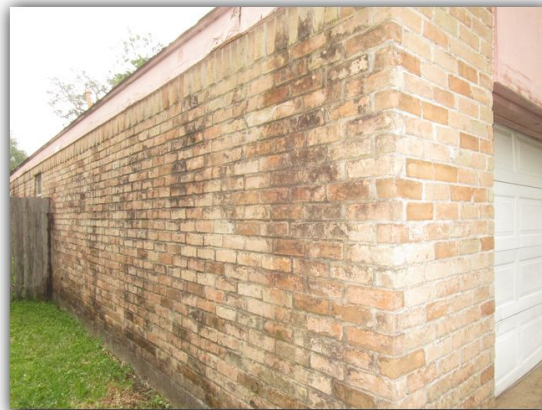
Evidence of excessive moisture in multiple areas. And siding should be cleaned to prevent deterioration.

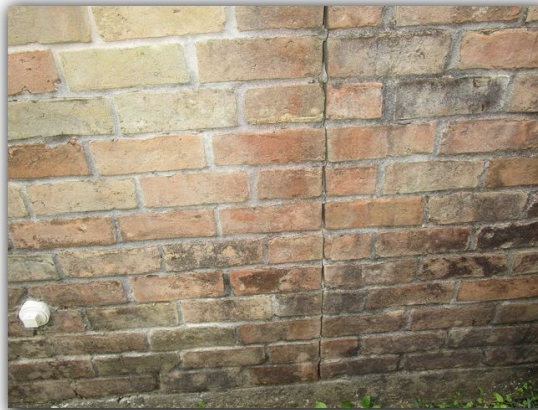
Expansion joint in brick veneer needs to be re-caulked.

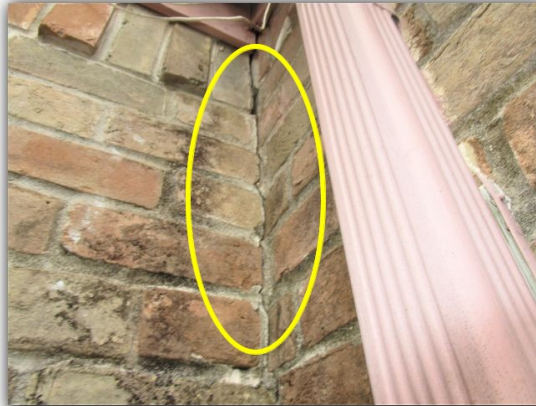
Areas around openings should be sealed to prevent moisture or insect intrusion.

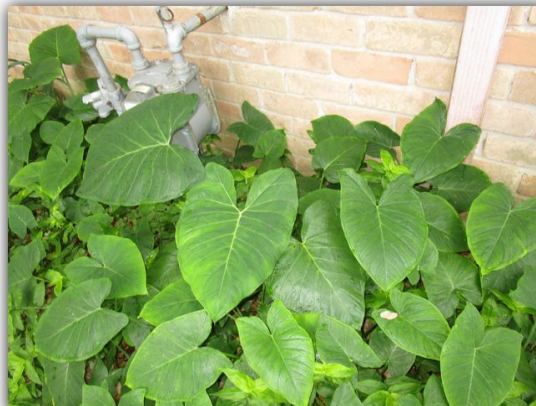
Recommend vegetation be kept away from the exterior walls. These hold moisture to the walls and can cause damage to the finish.

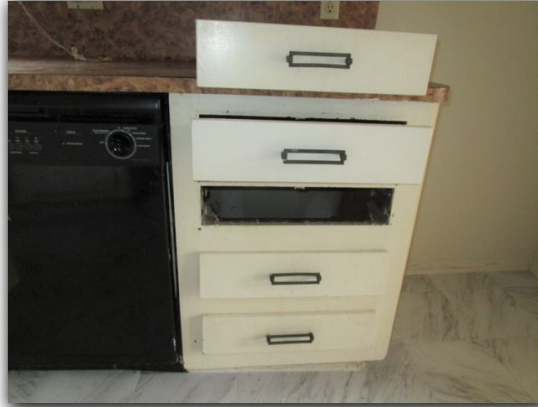
Multiple cabinets were missing parts and/or damaged.

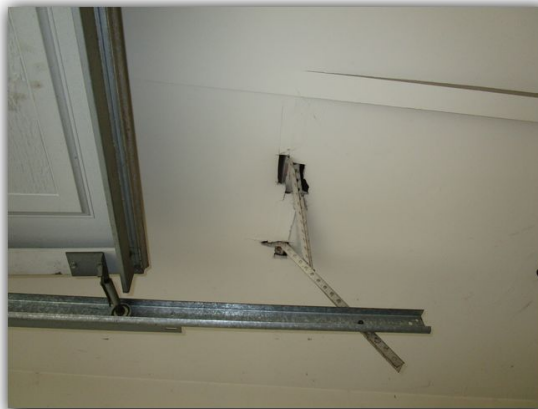
Sheet rock is missing/damaged in ceiling of garage. The garage must be separated from the living area of the structure by a fire break that includes the ceiling of the garage.

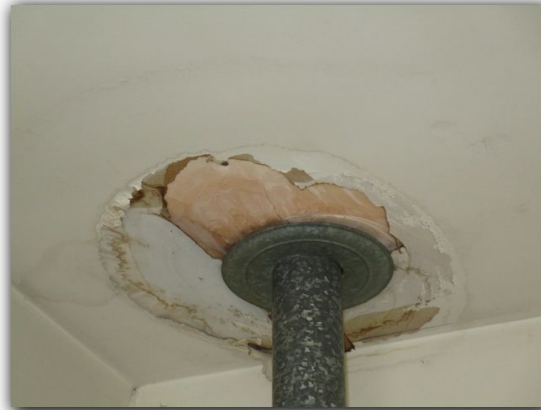
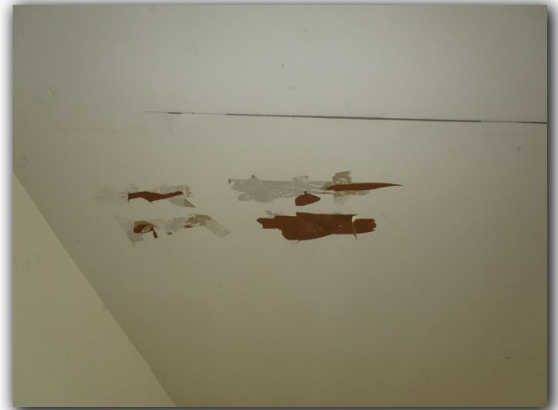
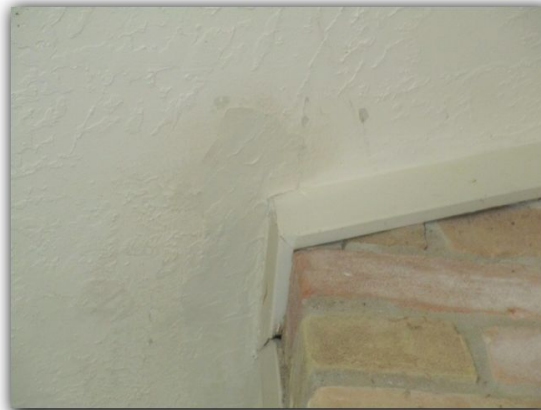
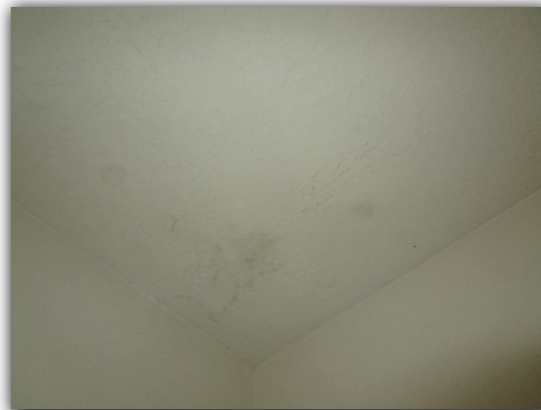
Multiple areas showed evidence of prior water penetration and at least 2, appear active based on moisture readings.

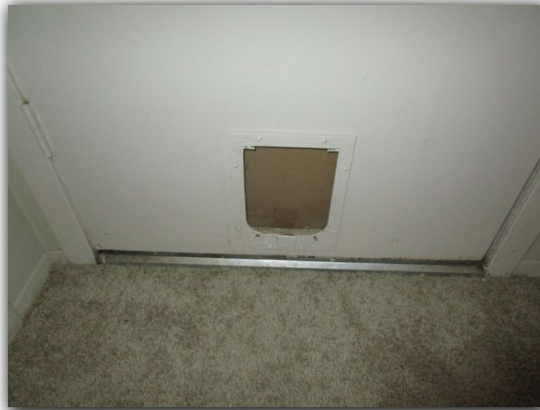
Doors between the house and an attached garage should have self closing hinges.

Doors between house and garage rated 20 minute or 1 3/8" solid core or honeycomb core steel.

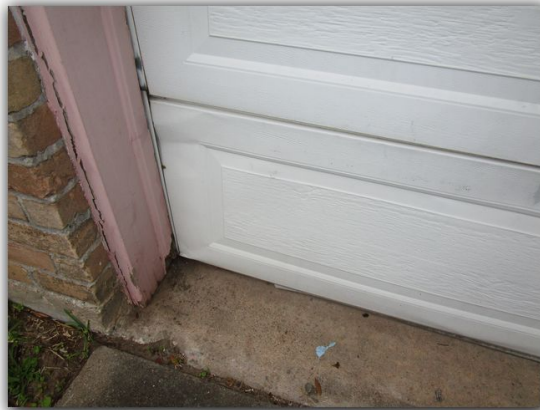
Overhead garage door has multiple dents/damage in panels.

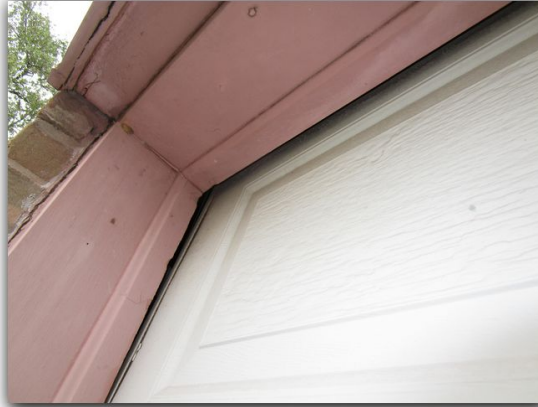
Overhead garage door was not flush to the frame and was missing weather stripping at the bottom.

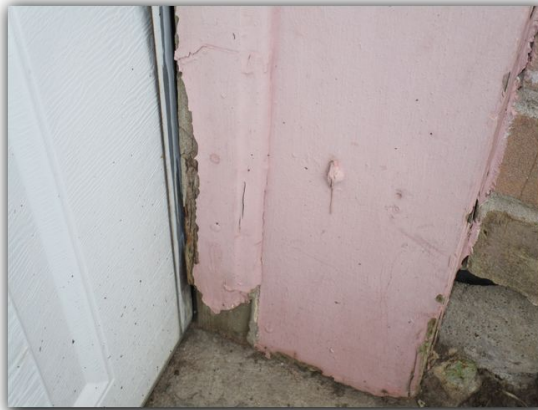
Overhead garage door frame shows evidence of prior water penetration and should be sealed to the bricks.

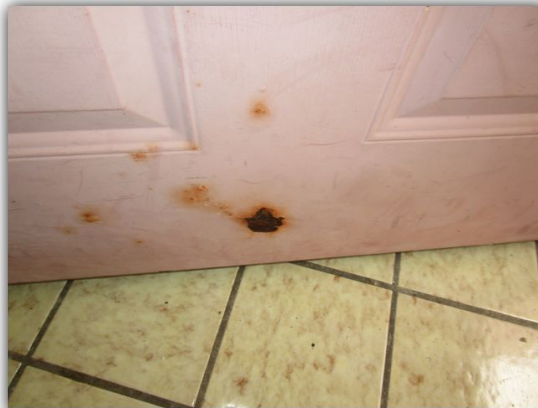
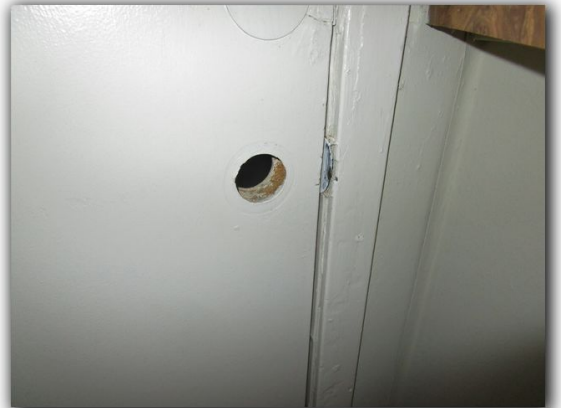
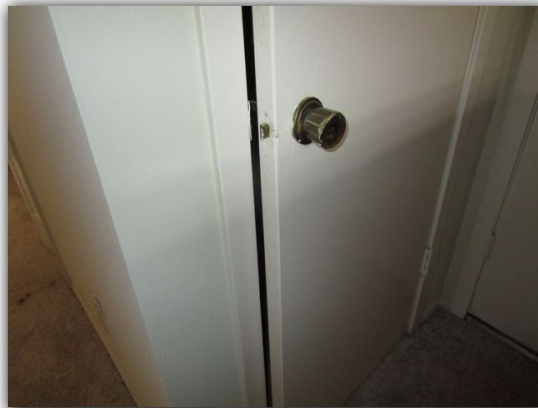
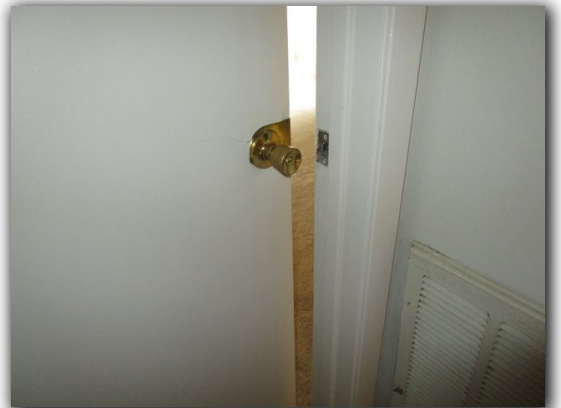
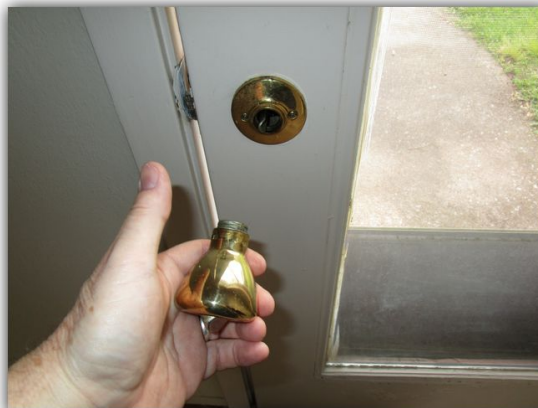
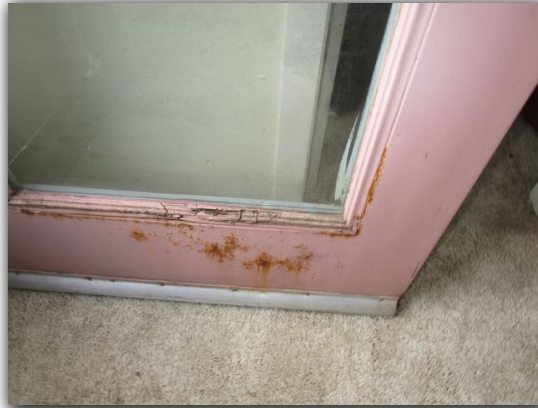
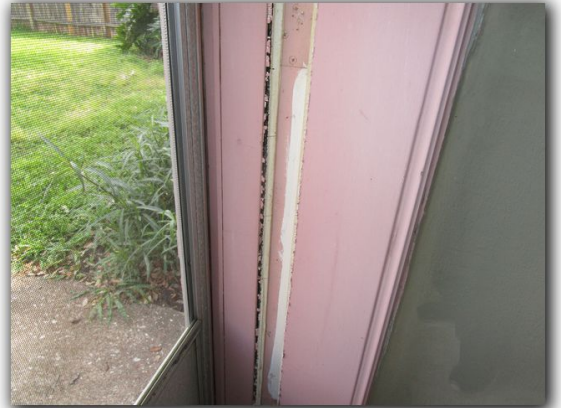
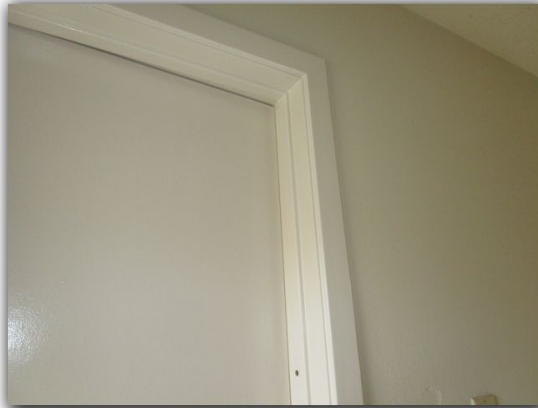
Multiple doors would not latch, were damaged, and/or were missing hardware.

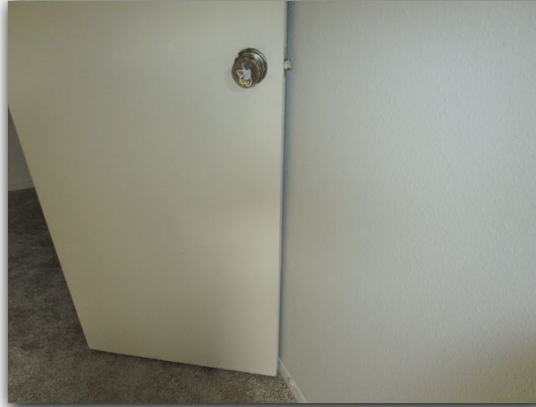
Multiple doors were missing door stops.

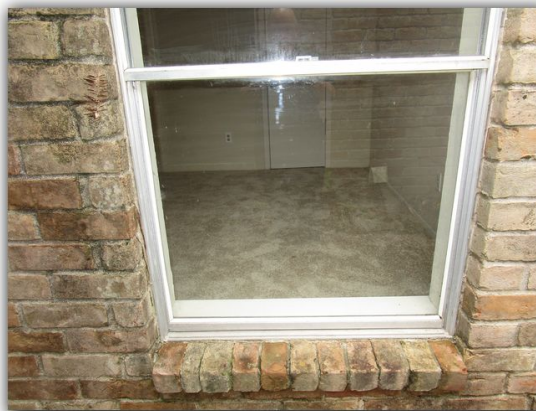
Multiple windows have missing and/or torn screens.

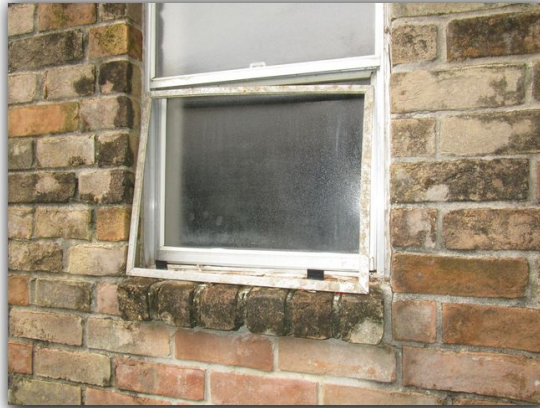
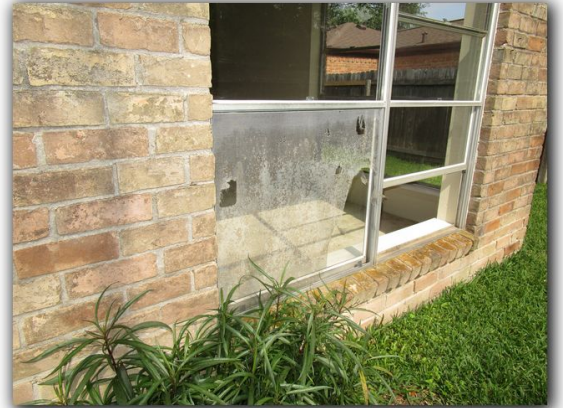
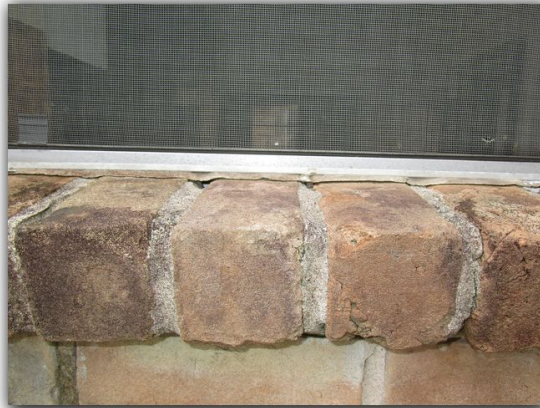
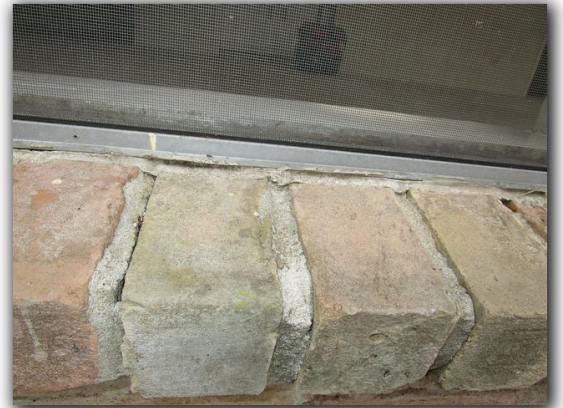
Multiple windows need re-caulking to brick.

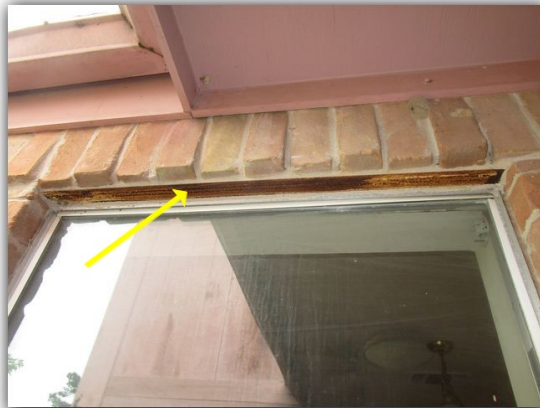
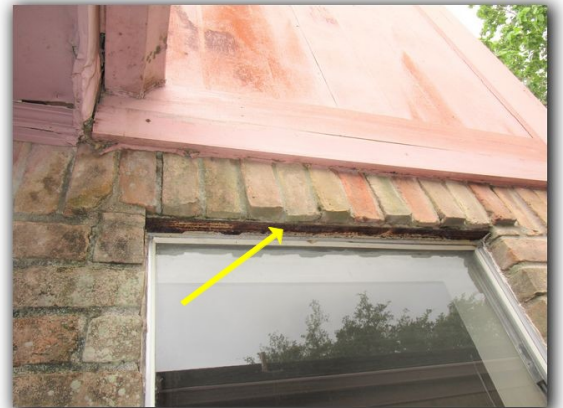
Some windows needed lintels repainted.

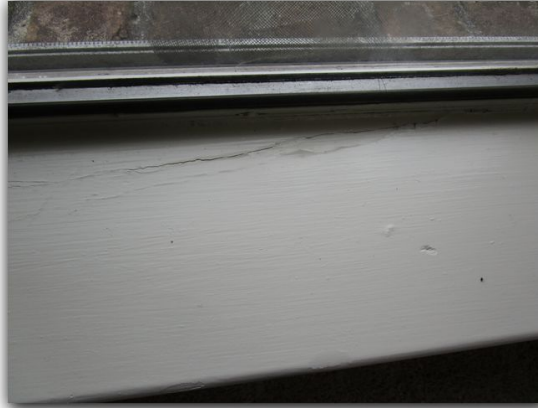
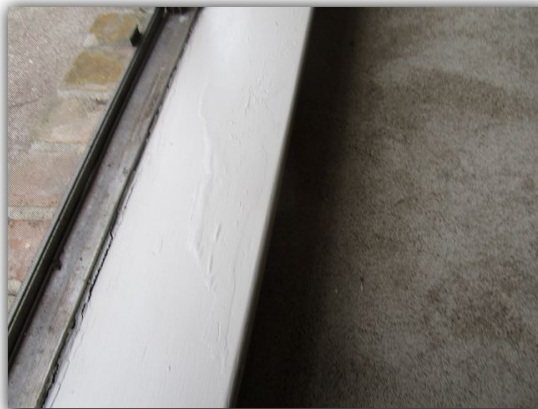
Multiple windows sills show evidence of prior water penetration. Although tested sills were within tolerance. Some had moisture levels at the higher end of the range.

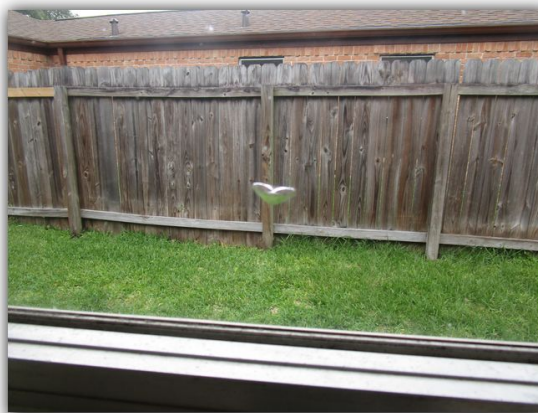
Damage to pane in dining room window.

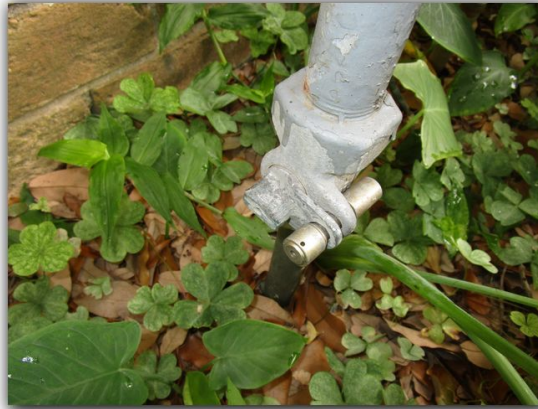
Gas was locked out at the meter by the utility company. Visual inspection of components only.

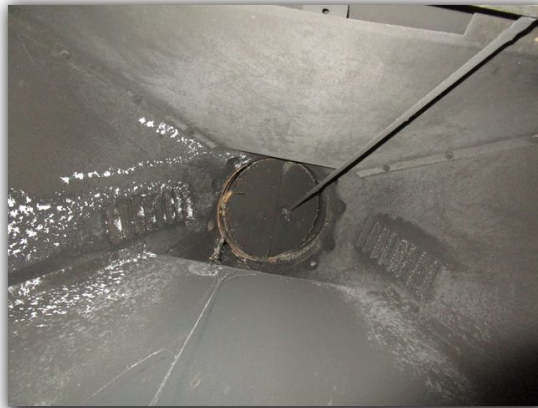
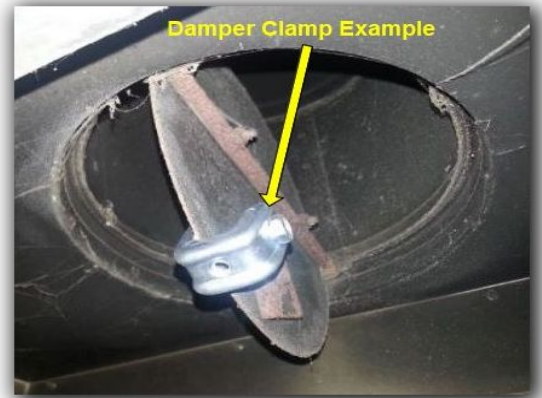
It is a gas fireplace and it did not have a damper block.

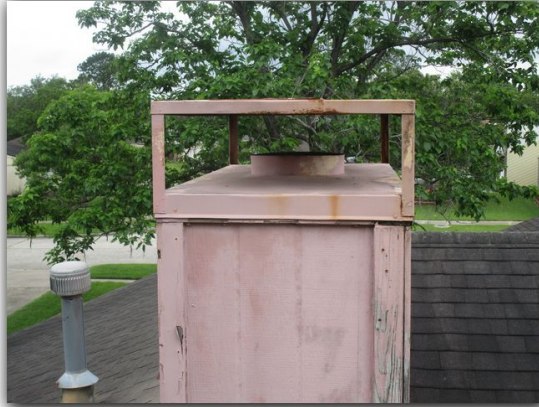
Missing chimney cap, no exclusion devise.

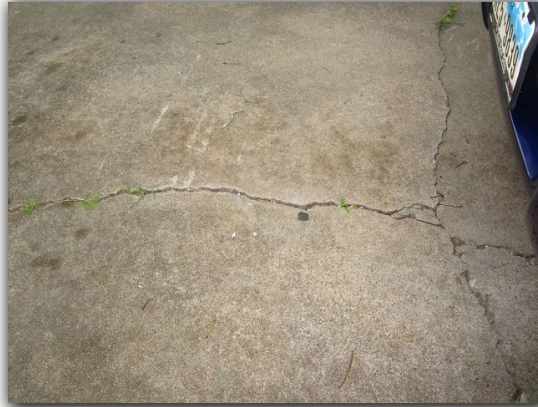
Driveway has multiple cracks.

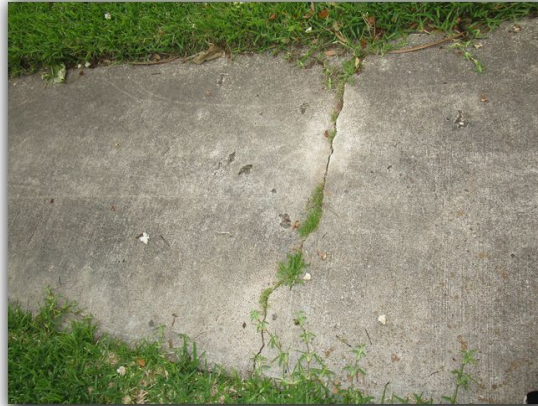
Front sidewalk/walkway had cracking resulting in possible tripping hazards.

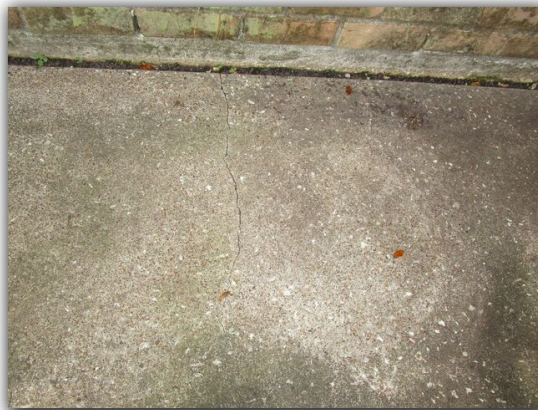
Shrinkage crack in porches. Shrinkage cracks are nonstructural.

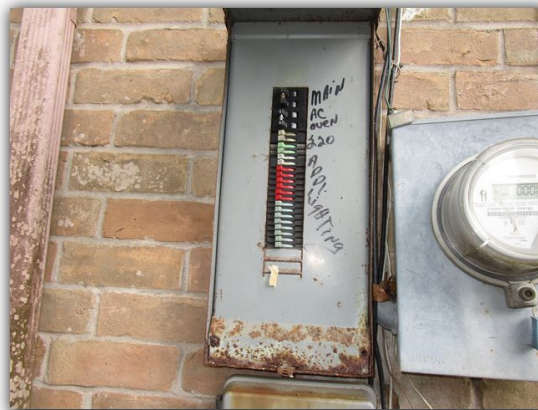
Zinsco breaker panels are known to not trip in the presence of an over-current or short circuit condition. Due to the type of aluminum used, Zinsco breakers also can melt and fuse to the bus bar. Replacement is recommended.

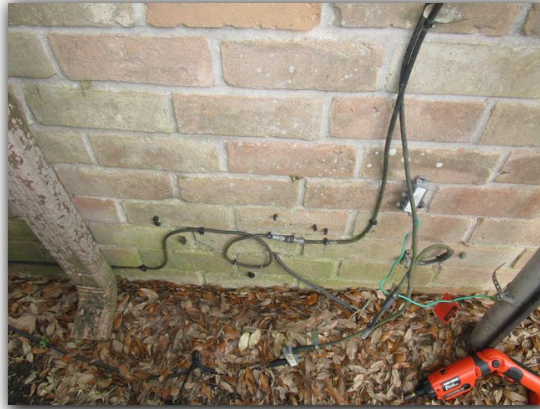
Unable to locate a grounding rod or supplemental grounding source.

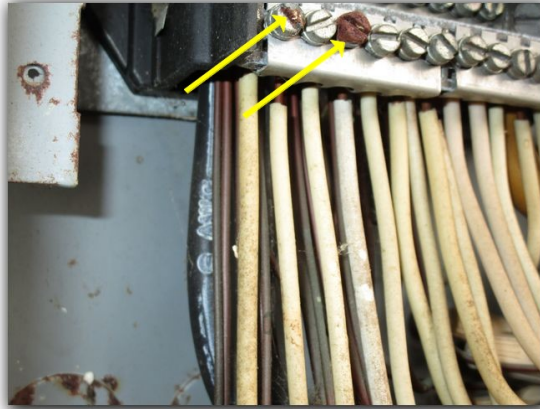
Rust on connections can cause poor contact and should be removed.

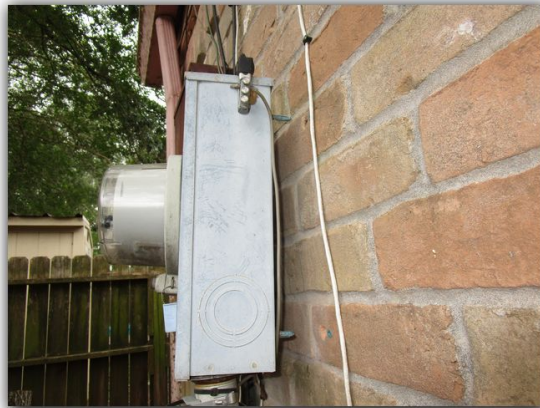
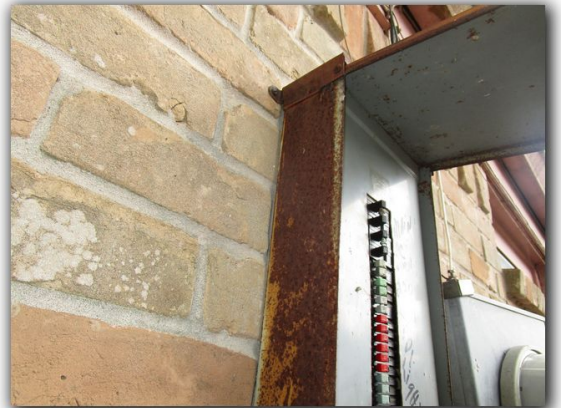
Meter box should be secured and meter box and breaker box should be sealed to the exterior wall on the top and sides to prevent water penetration.

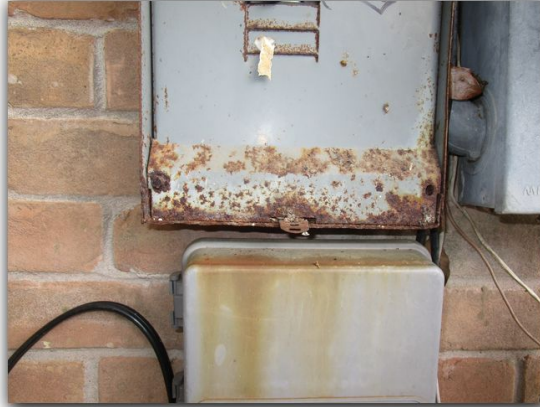
Service box has rust.

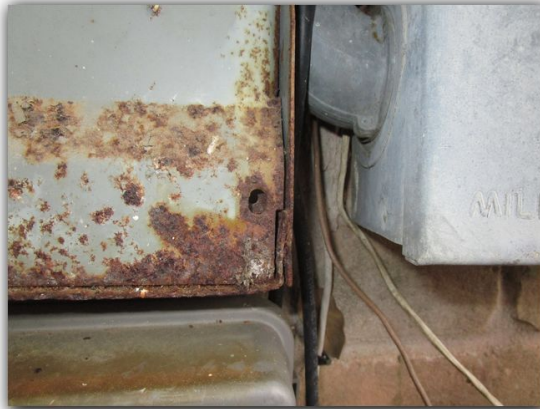
Dead front not secure, missing screws.

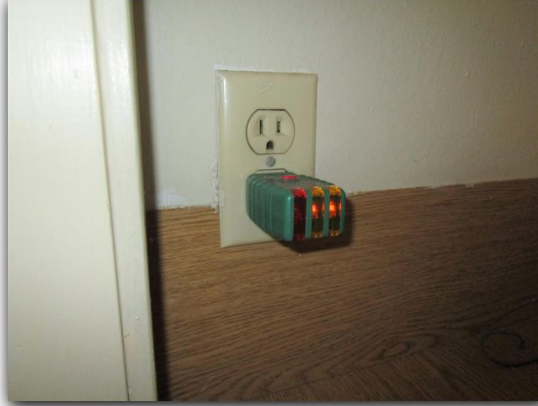
GFCI outlets were missing in multiple locations. These should be in all bathrooms, kitchens, garages and outdoors.

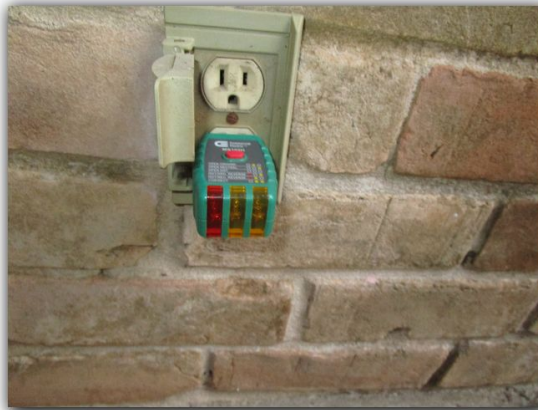
Outlet on front porch had no power.

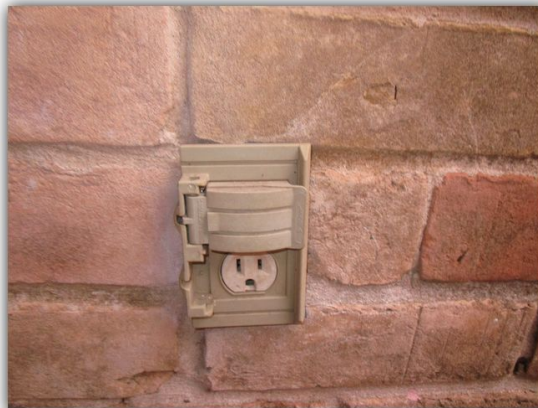
Weather proof covers are required on exterior outlets.

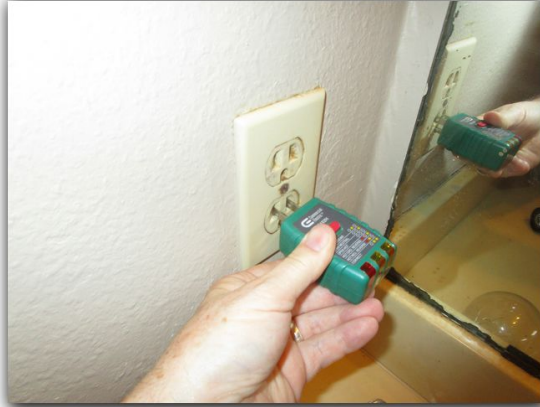
Outlet in hallway bathroom would not accept plugs.

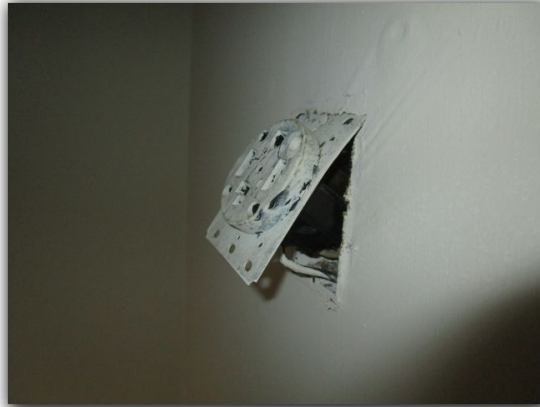
220 Outlet in laundry closet was loose.

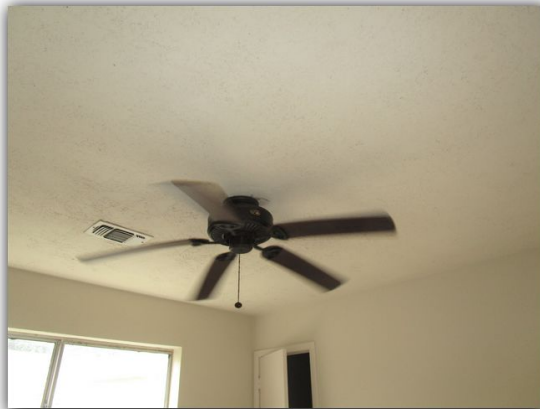
Multiple fixtures/lights were missing and/or nonfunctional.

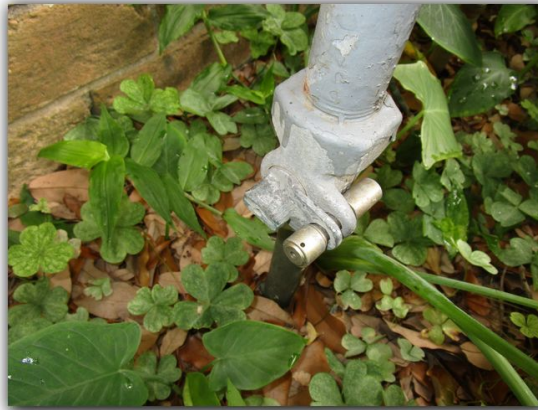
Gas was locked out at the meter by the utility company. Visual inspection of components only.

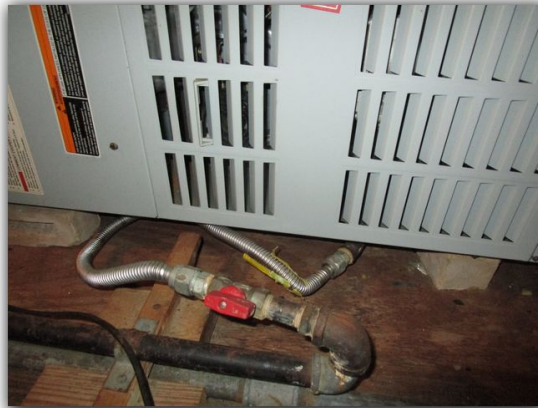
No drip leg/sediment trap before gas entrance into unit.

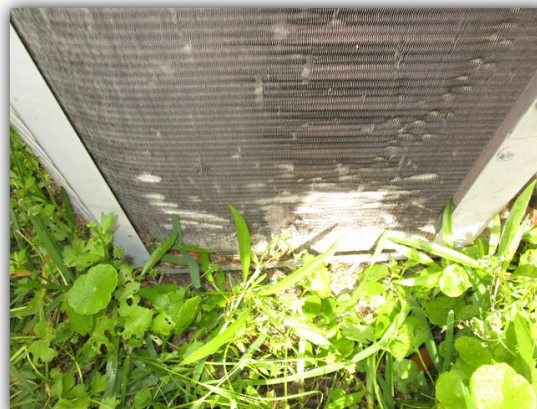
The fins of the outdoor portion of the air conditioning system were observed to be damaged and in need of repair. This condition can reduce the efficiency of the system.

Recommend evaluation and repair by a HVAC professional.

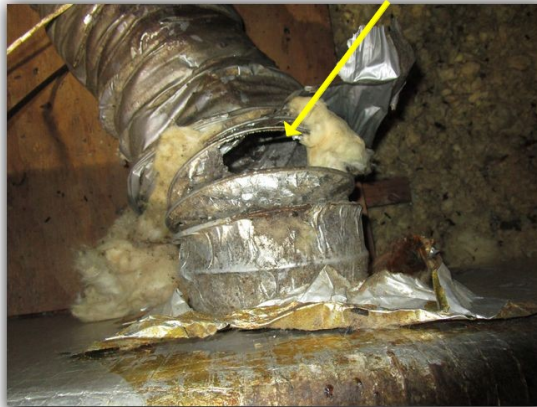
Torn/worn protective cover over duct insulation.

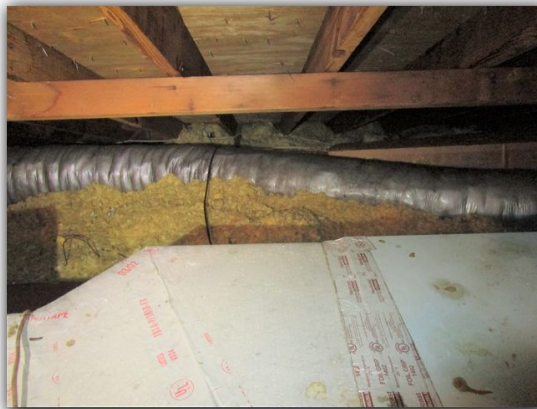
Ducts not supported above attic floor. This is common for a house of this age and is an as built condition.

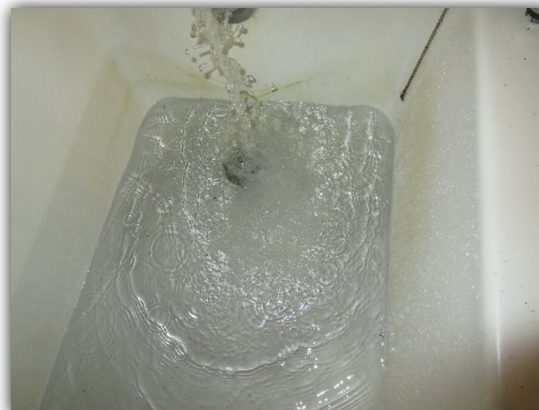
A dark foreign material was observed in the water when the primary bathtub was tested.

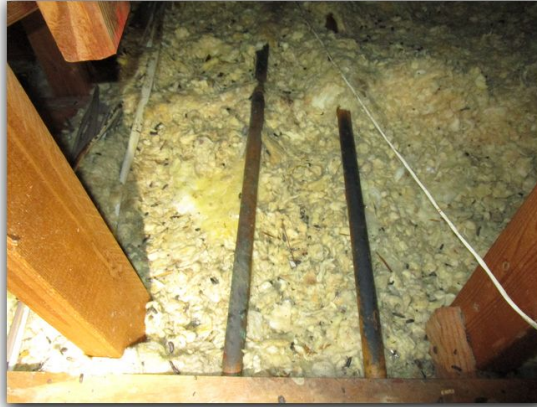
Water pipes in attics should be insulated.

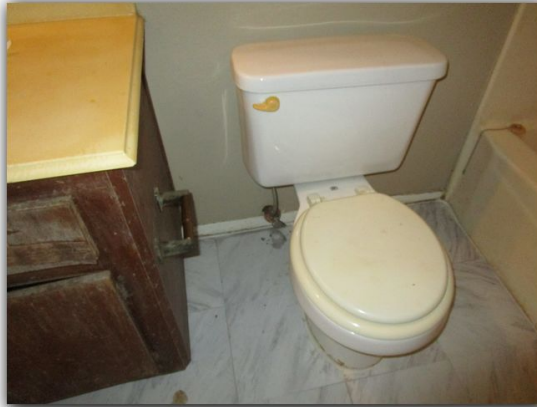
Both toilets were nonfunctional.

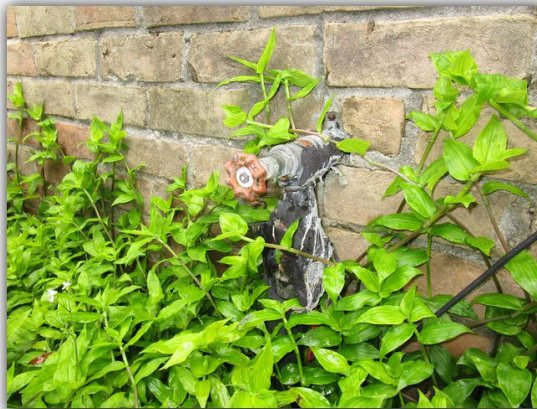
Water was leaking from both exterior faucets and left was missing the control handle.
