PROPERTY INSPECTION REPORT FORM

04/26/2023

15531 Pensgate Street, Houston, TX 77062

Dean Finn

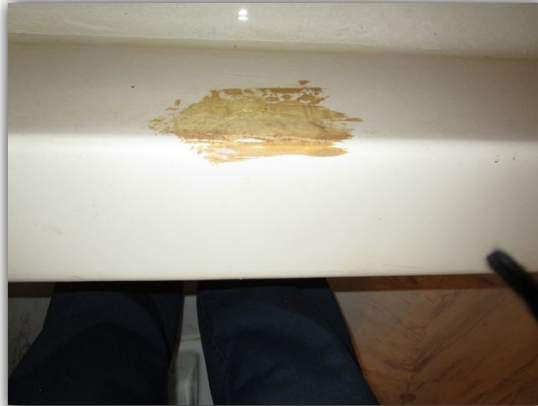
Damage to the finish of multiple fixtures.

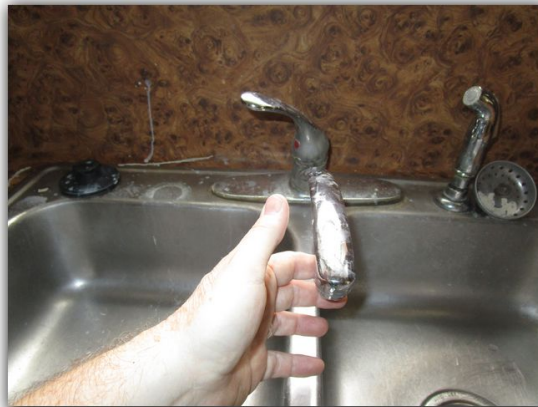
Kitchen sink fixtures were loose.

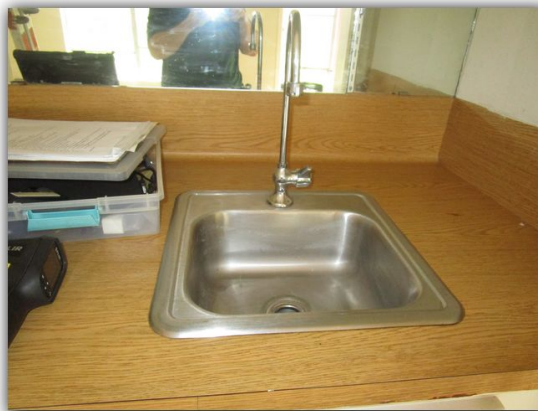
No water at bar sink.

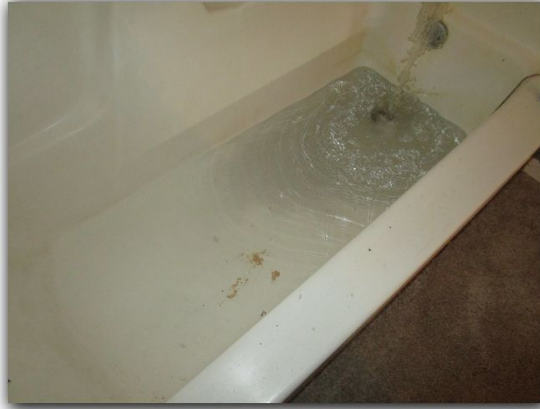
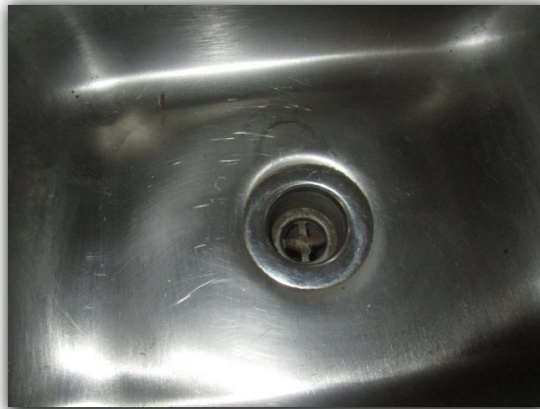
Slow drain at multiple fixtures..

Recommend a plumber to correct.

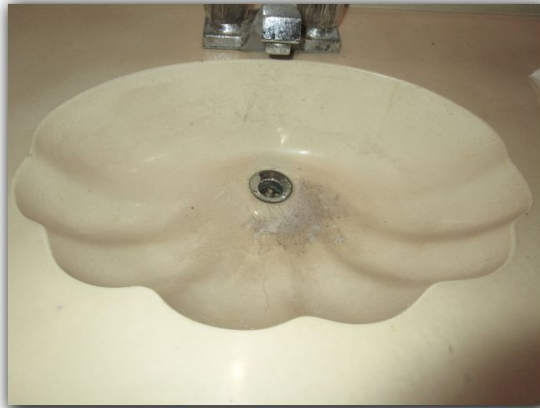
Multiple fixtures were missing drain stops.

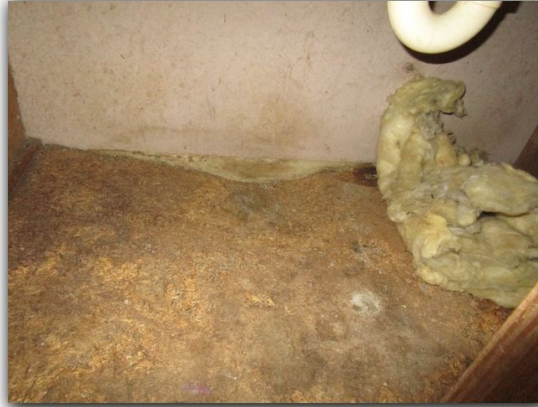
Areas under multiple fixtures showed evidence of prior water penetration.

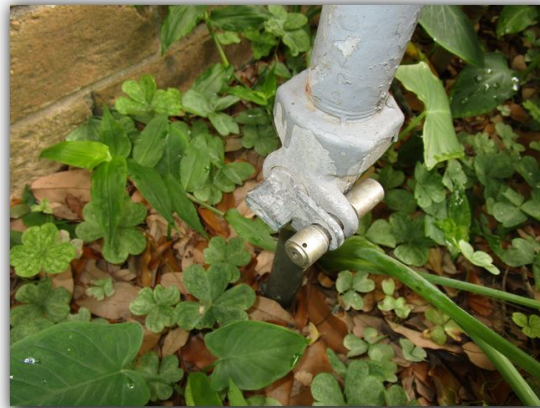
Gas was locked out by gas company. Unable to test gas water heater. Visual inspection of components only.

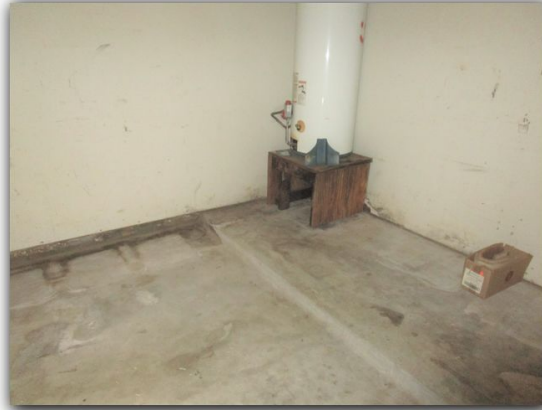
Water heaters installed directly in front of where a vehicle pulls up should be protected by a metal post or bollard.

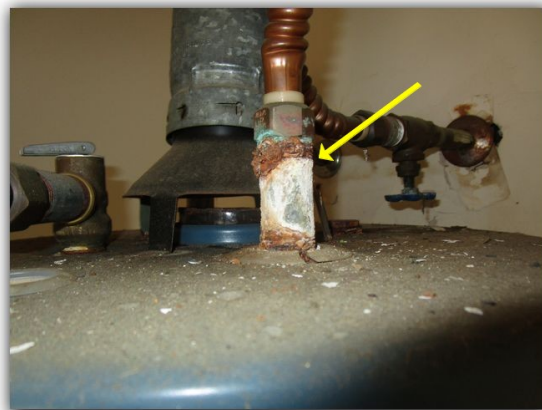
Missing dielectric union connectors on water line. Excessive corrosion was observed.

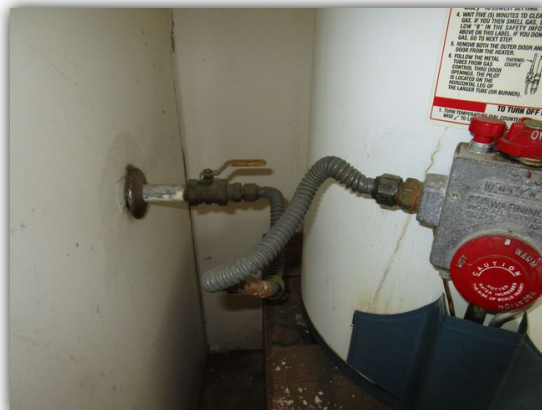
No drip leg/sediment trap before gas entrance to unit.

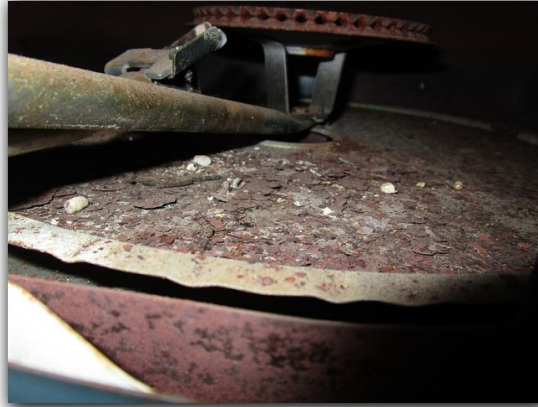
Rust on burners and in the burn chamber.

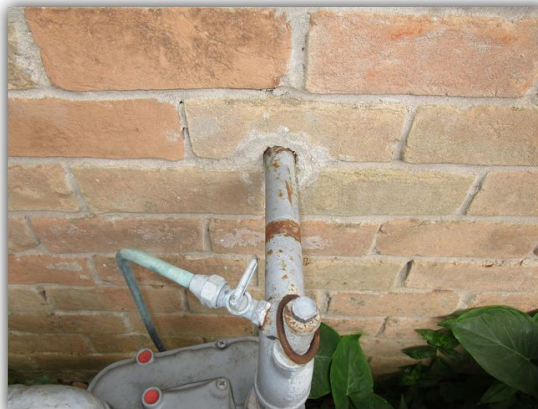
Comments:
Unable to locate a bonding wire on the gas pipe.

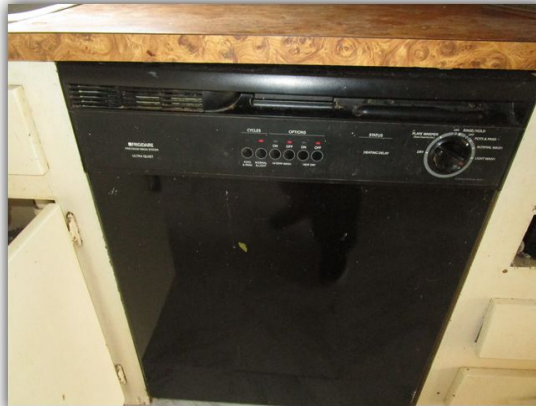
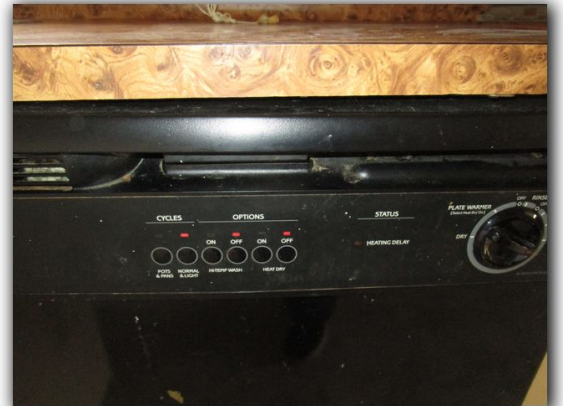
Dishwasher was nonfunctional.

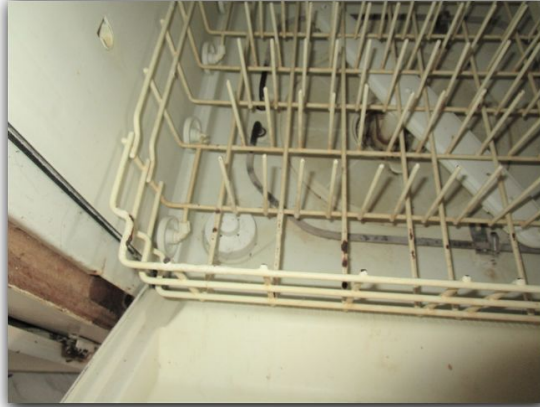
Racks were rusting through the plastic coating.

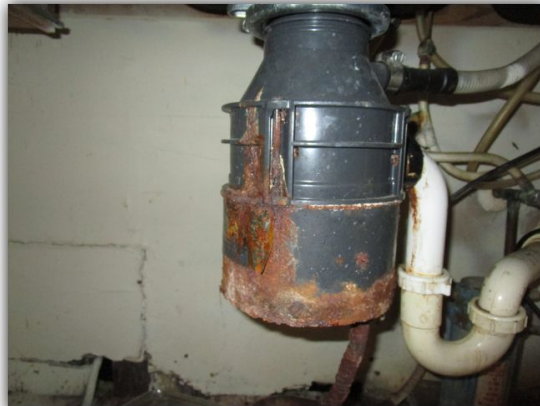
Unit was nonfunctional.

Recommend unit be replaced.

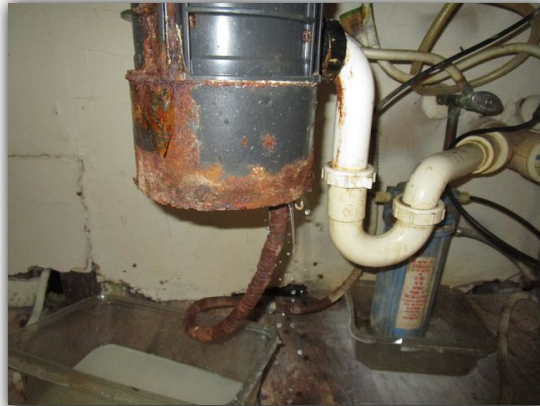
Unit was rusted and leaking from the bottom.

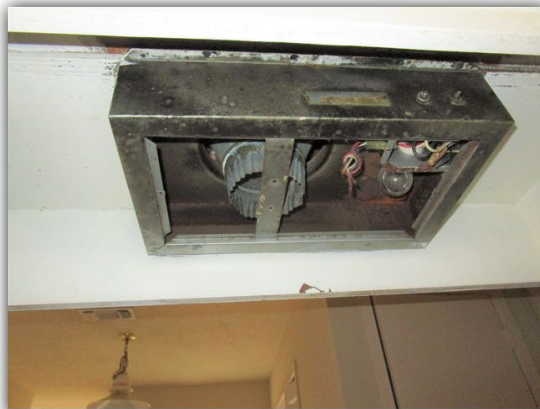
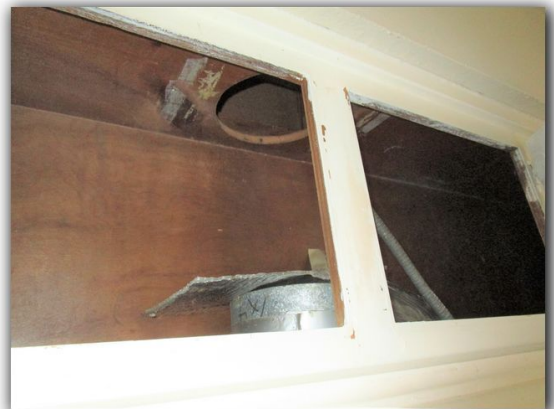
Hood vent and lights were nonfunctional.

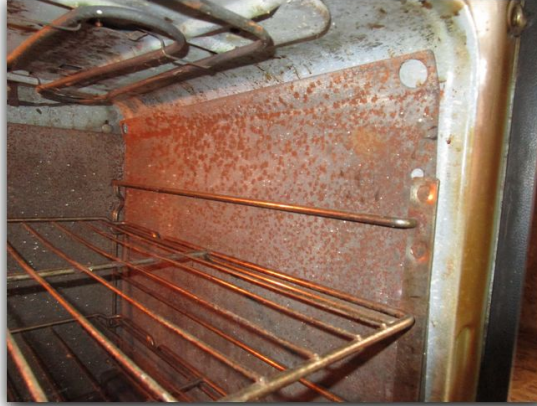
Rust was on the interior finish of both ovens.

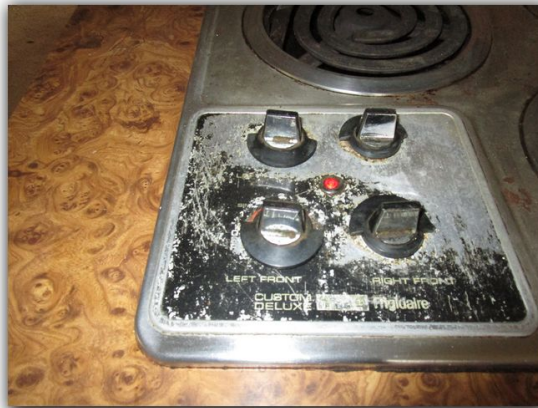
Damaged controls and panel on cooktop.

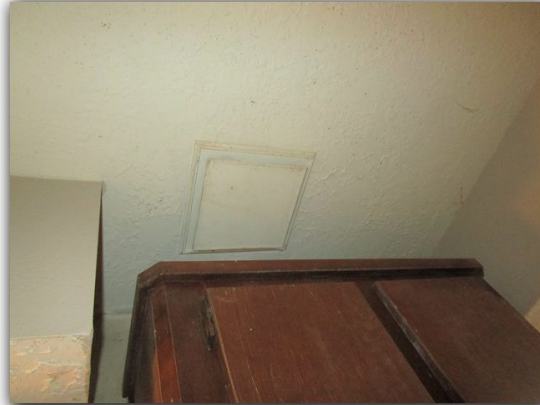
Both units were nonfunctional.

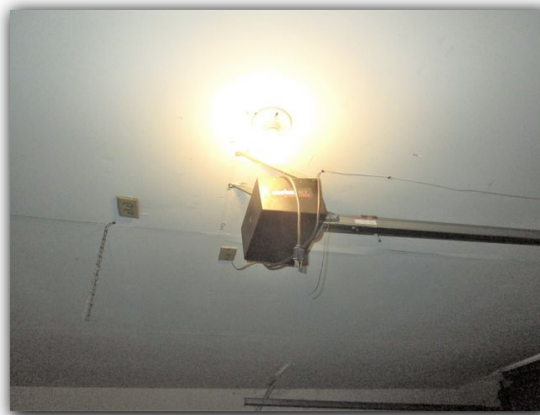
Unit was disabled.

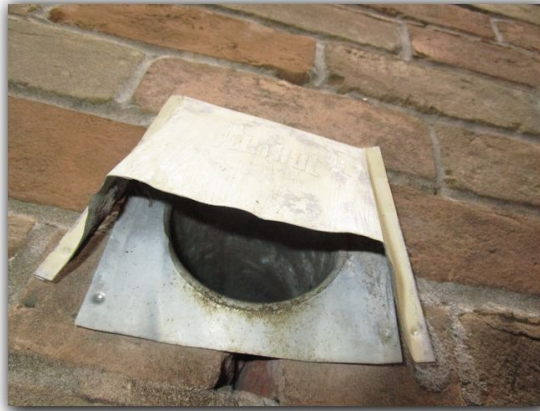
No exclusion device was present at the dryer vent termination.
