Property Inspection Report

Habib Othman 22007
Bullseye Engineering Inspection, LLC

3615 Windy Drift Ln
Inspection Prepared For: Krishnamoorthy Gopal
Agent: -

Date of Inspection: 6/7/2023
Year Built: 2007 Size: 2973
Weather:

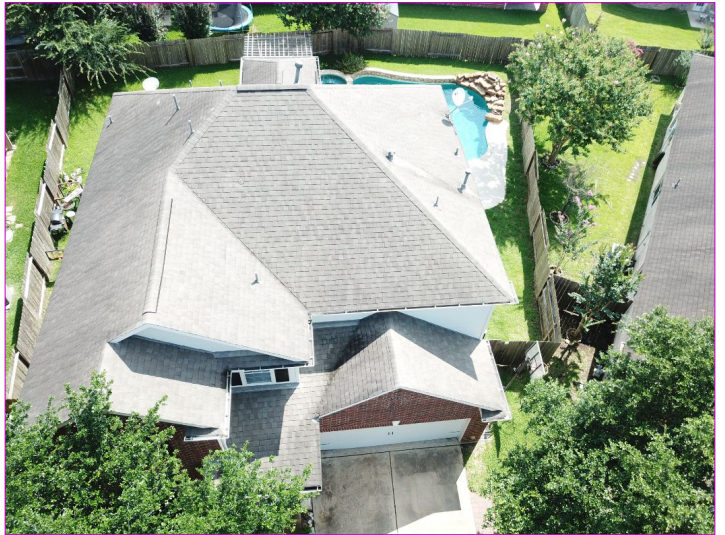
Rooftop view

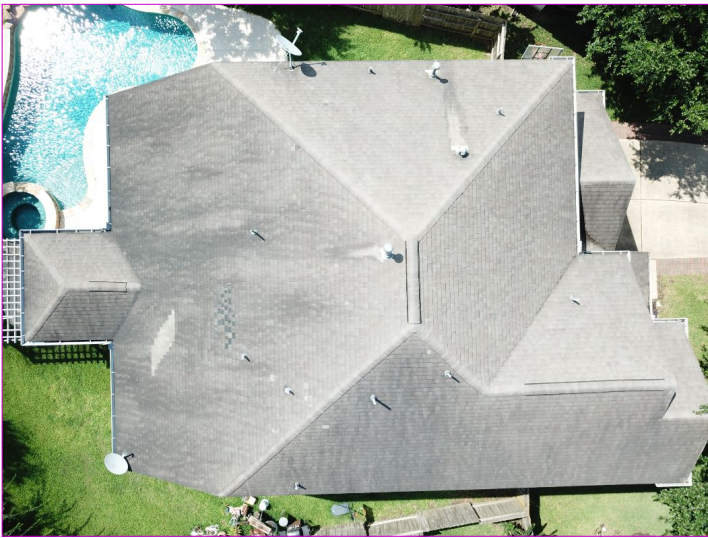
Rooftop view

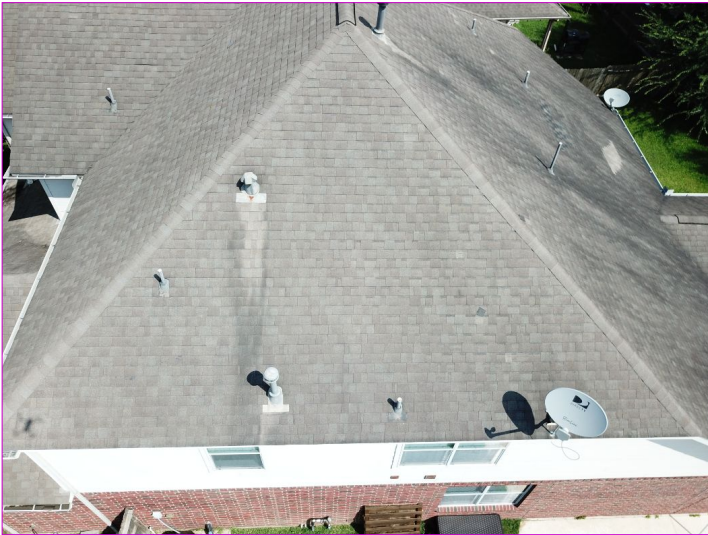
Rooftop view

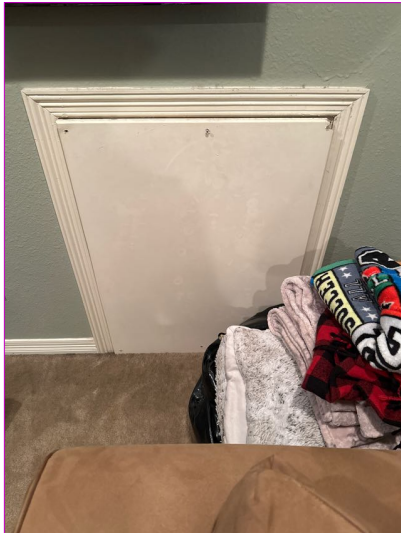
Inaccessible attic

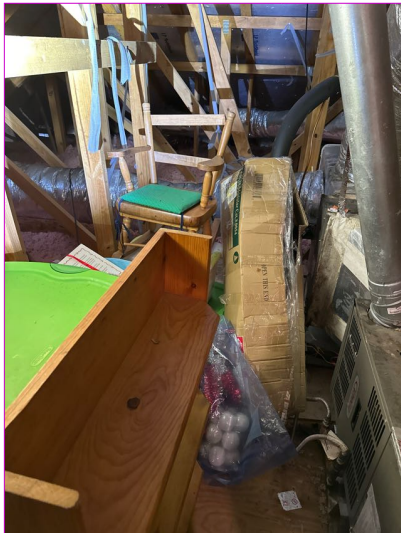
Personal belongings blocking view (attic)

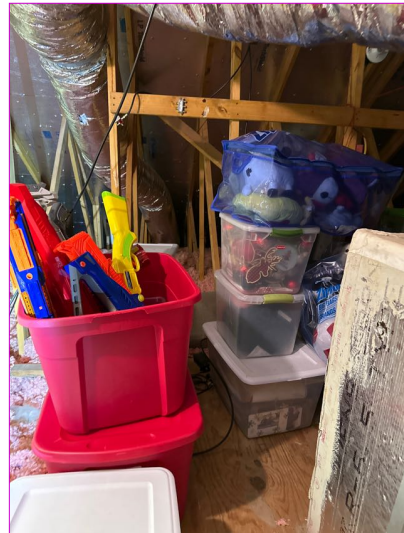
Personal belongings blocking view (attic)

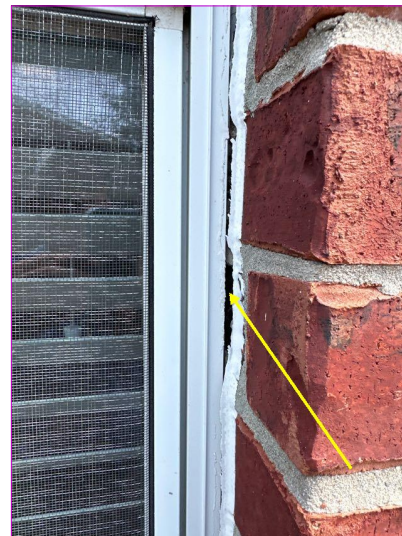
Window frame wall separation (zoomed view)

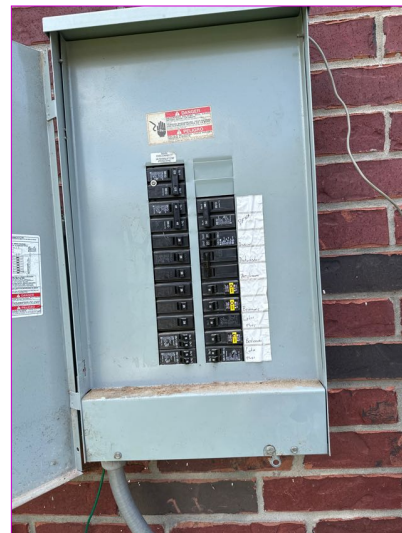
- The Circuit Directory label identifying individual electrical circuits was incomplete. The service panel should contain a clearly-marked label identifying individual circuits so that in an emergency, individual circuits can be quickly shut off. The Inspector recommends that a properly marked Circuit Directory label be installed by a qualified electrical contractor.

Incomplete directory

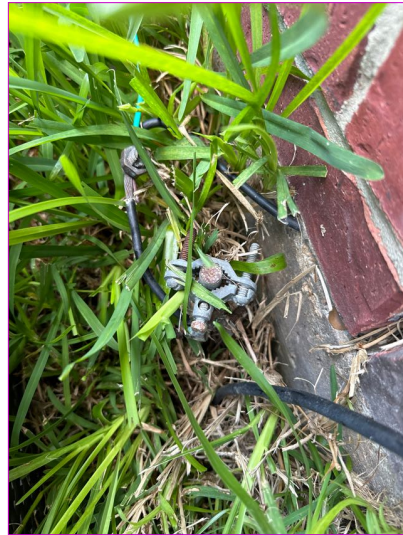
Service grounding

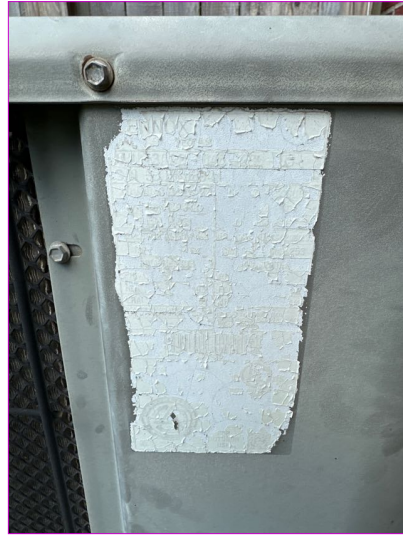
Illegible data plate

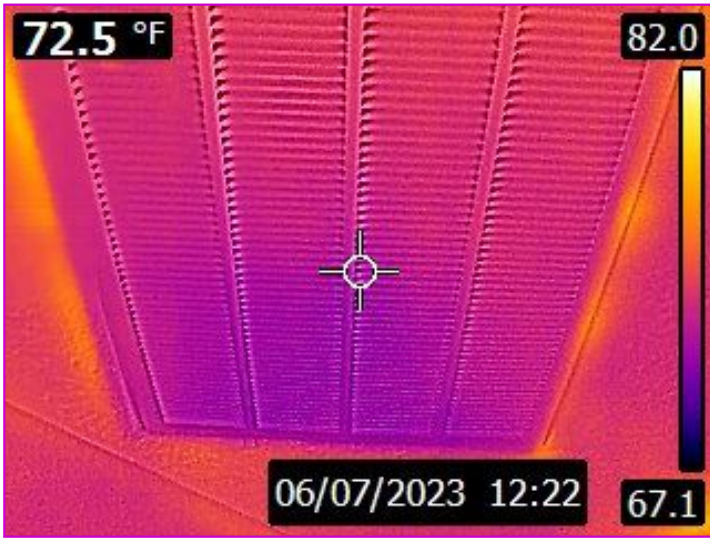
Return register temperature

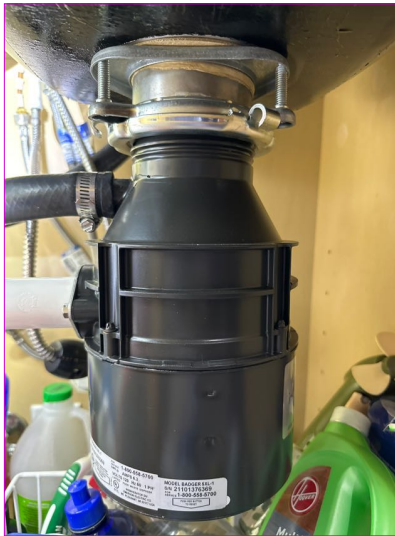
- At the time of the inspection, the Inspector observed no deficiencies in the condition and operation of the garbage disposal.

Disposal OK

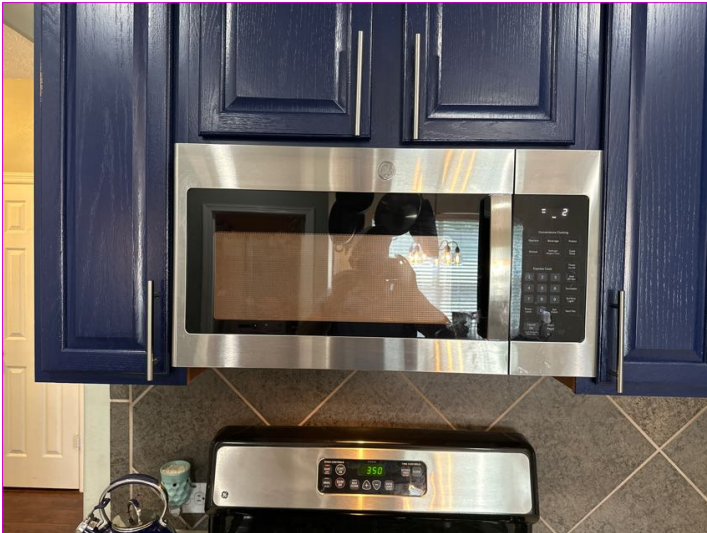
Range hood/Microwave OK

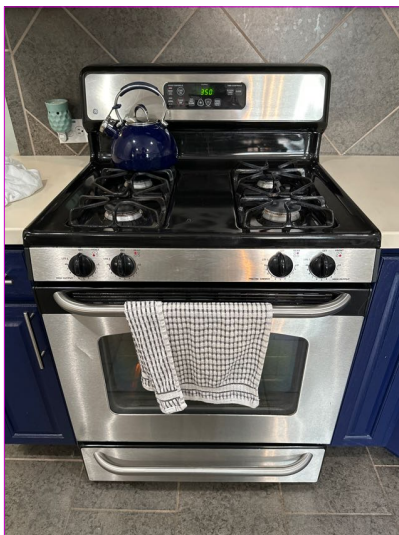
Gas range OK

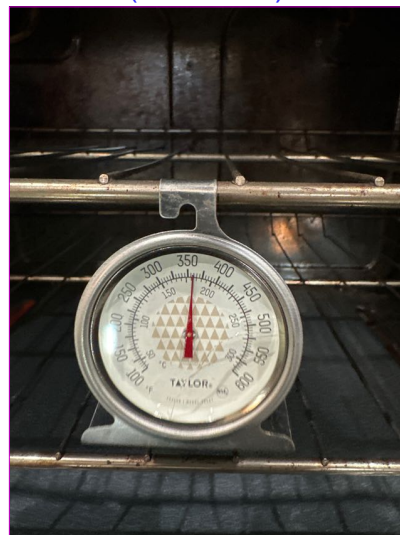
- At the time of the inspection, the Inspector observed no deficiencies in the condition or operation of the gas range. The self-cleaning feature was not tested. Inspection of gas ranges is limited to basic functions, such as testing of the range-top burners, and bake/broil features of the oven.
- Oven # 1 Tested at 350°F , Variances noted 10°F (max 25°F)

Oven temperature testing 360° F

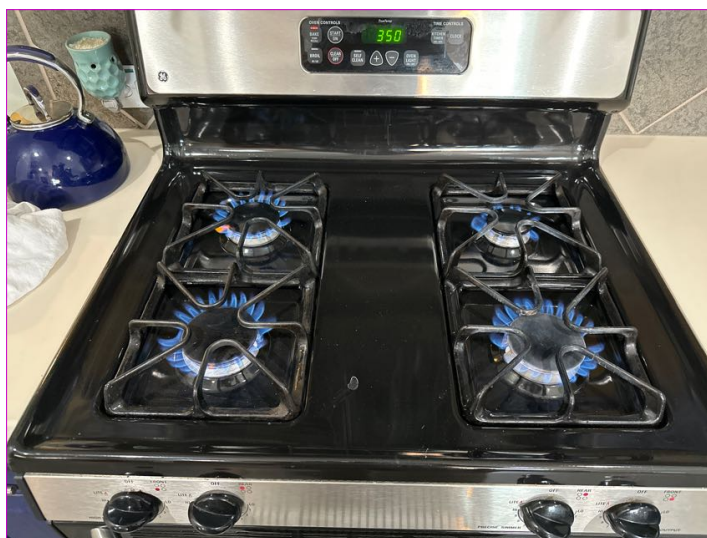
Burners OK

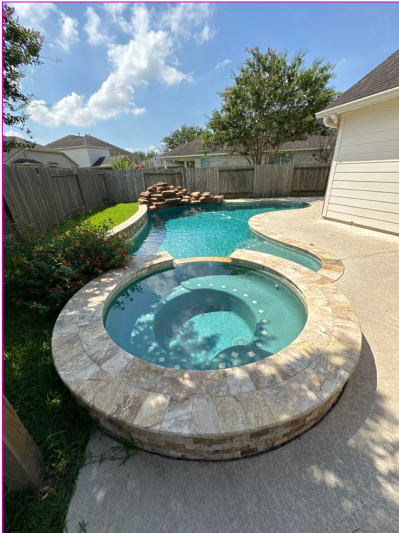
- No protective barrier was installed around the pool. This condition is a potential danger to small children. The inspector recommends that a barrier compliant with modern safety standards be installed by a qualified contractor for safety reasons.
- A door in the wall of a building that served as a part of the safety barrier had no alarm. Such doors should be equipped with an alarm that complies with modern safety standards. The inspector recommends correction by a qualified contractor for safety reasons.

Pool view

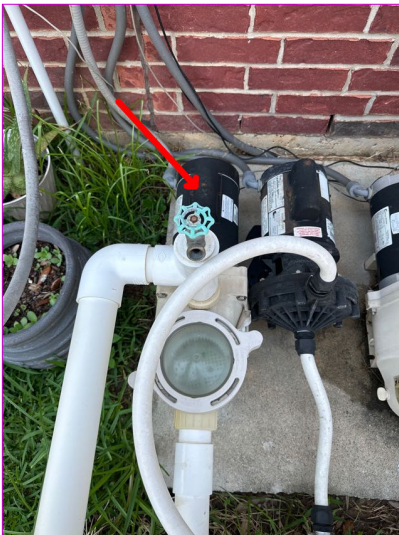
Waterfall pump OK

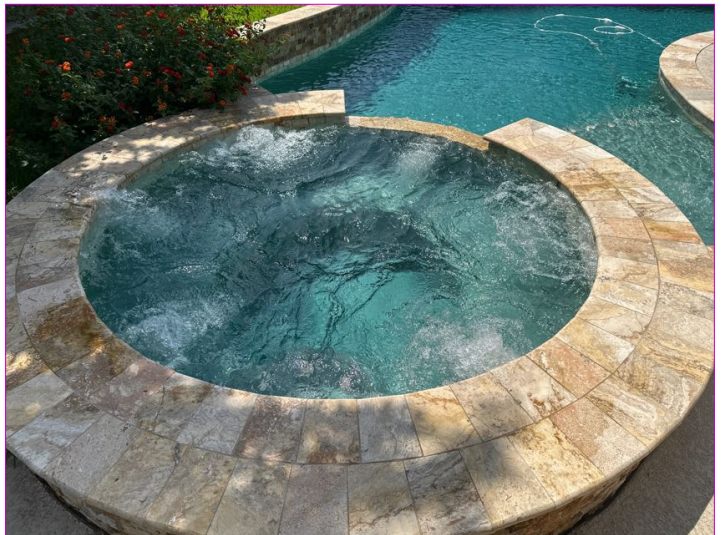
Bubbling SPA

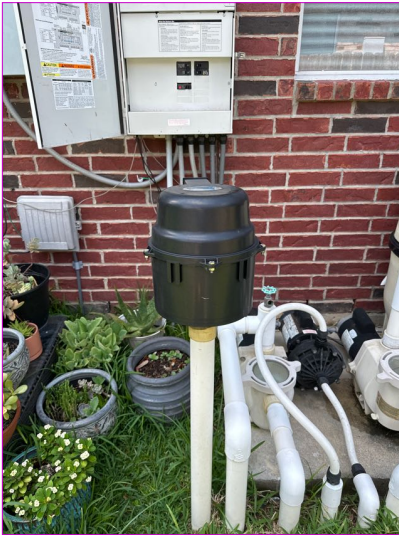
Air bubbler OK

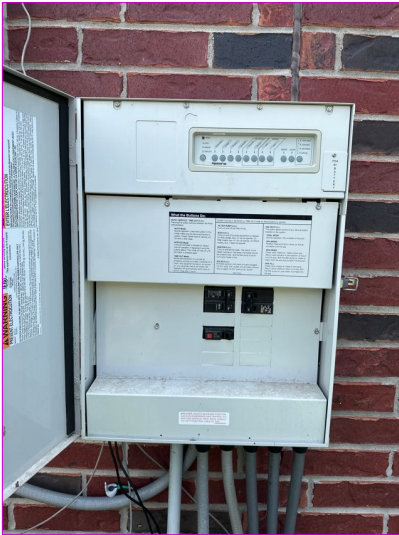
Controller OK

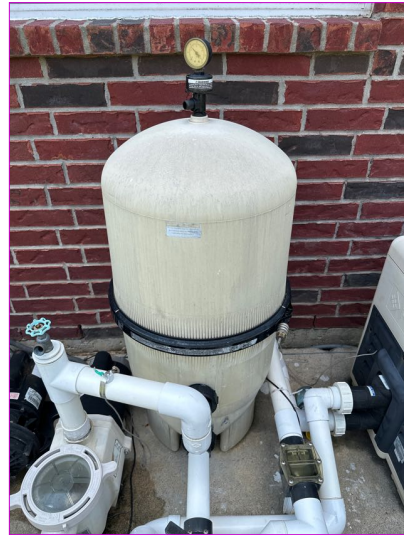
Filter OK

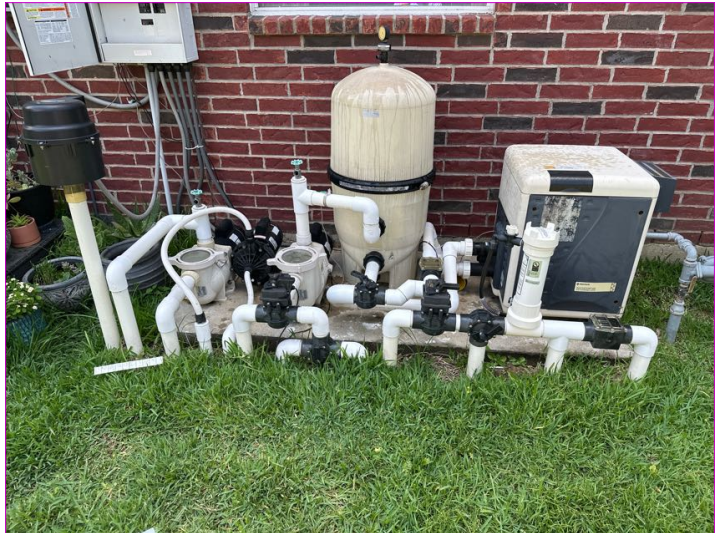
Piping OK

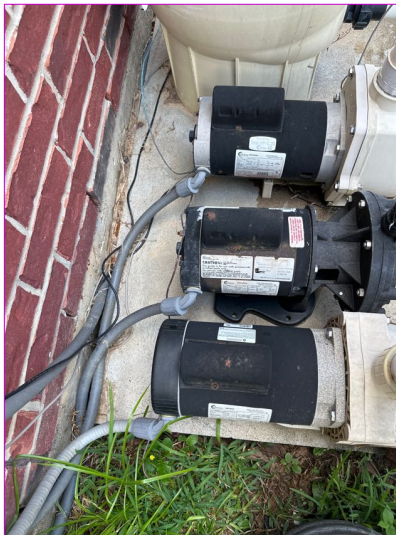
Bonding OK
