HEDDERMAN SERVICES

MECHANICAL INSPECTION

1301 Milford St
Houston, TX 77006

PROPERTY INSPECTION REPORT FORM

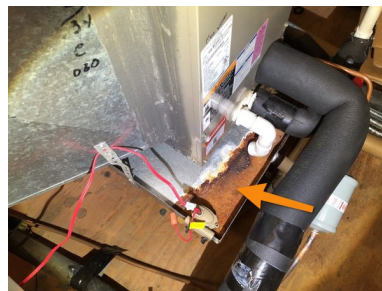
1st Floor South

5: Microbial growth on equipment in attic

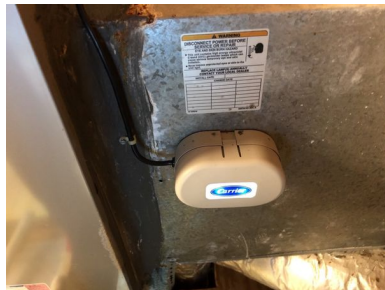
1: Microbial growth on equipment/ductwork

Microbial growth was observed on the outside of the equipment and/or ductwork. This condition is indicative of a moisture/condensation problem, possibly due to air leaks at the equipment and/or a lack of adequate attic ventilation. Further investigation is recommended with a service company to determine the source of the growth and to determine if the growth is present inside the equipment and/or air ducts. It is recommended that you obtain a cost estimate for any needed repairs.

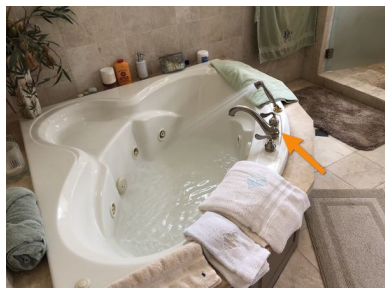
Master Bath

This tub has been replaced during remodel

Recommendation: Contact a qualified professional.

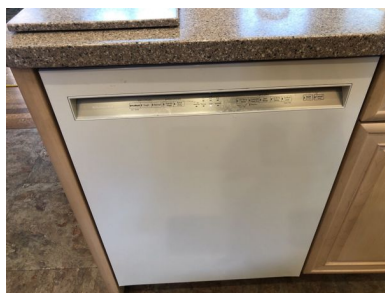
Dishwasher has been replaced in the remodel.

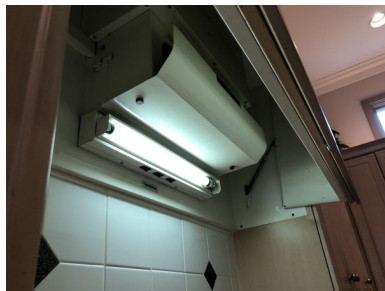
New range hood in the remodel.

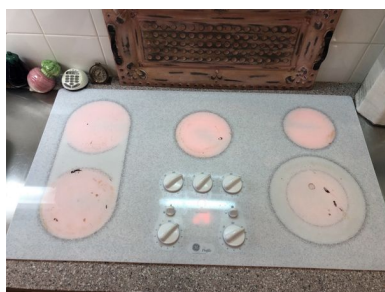
This was replaced with a gas stove top in the remodel.

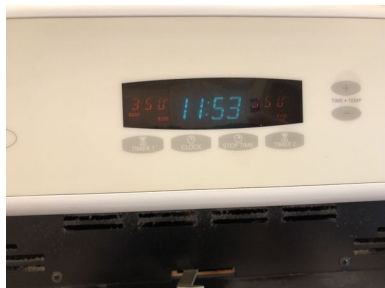
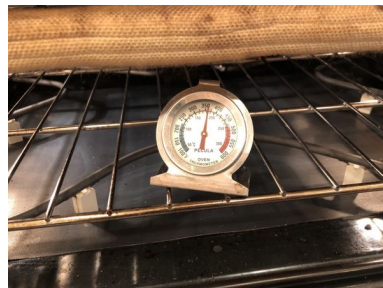
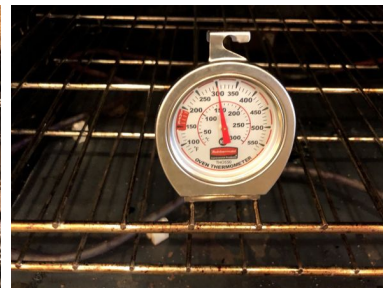
1: Ovens - One improperly calibrated

Both oven thermostats were checked, and one was properly calibrated, and the other was not properly calibrated. The thermostats were set at 350 degrees, and the upper lower oven did not heat to within the allowable ± 25 degrees. The ovens were checked with an oven thermometer, and the upper oven was found to heat to 350 degrees, and the lower oven to 300 degrees.

Obtain Cost Estimate

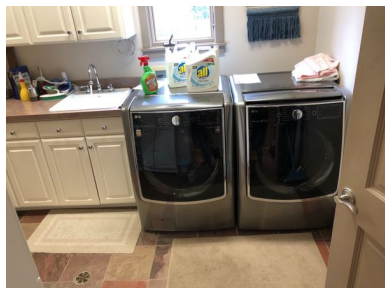
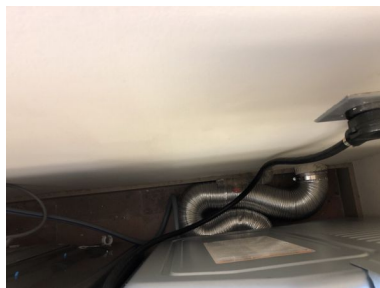
Washer/dryer no longer present.

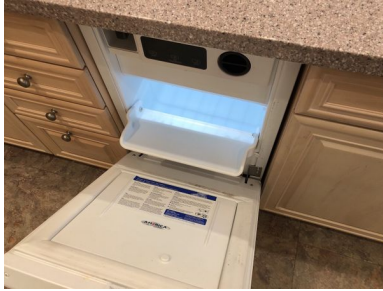
1: Ice Maker - Nonfunctional

The ice maker was nonfunctional at the time of the inspection. Have a service company find the source of the problem and make any necessary repairs.

Obtain Cost Estimate

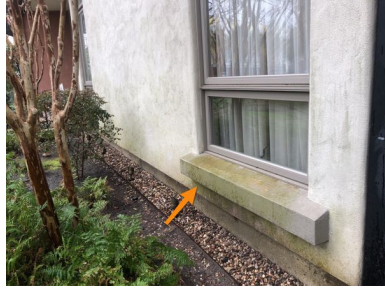
1: Adjust sprinkler head spray

Spraying front of house -

The sprinkler head spray was in need of adjustment/repair.

Recommendation: Contact a qualified professional.
