18615 Sweetjasmine Ln  
Spring, TX 77379  
Matt & Jenny Sneller

## PROPERTY INSPECTION REPORT

**Concerning:** 18615 Sweetjasmine Ln, Spring, TX 77379  
(Address or Other Identification of Inspected Property)

**By:** Mathew Blossom, Lic #21230 11/29/2021  
(Name and License Number of Inspector) (Date)

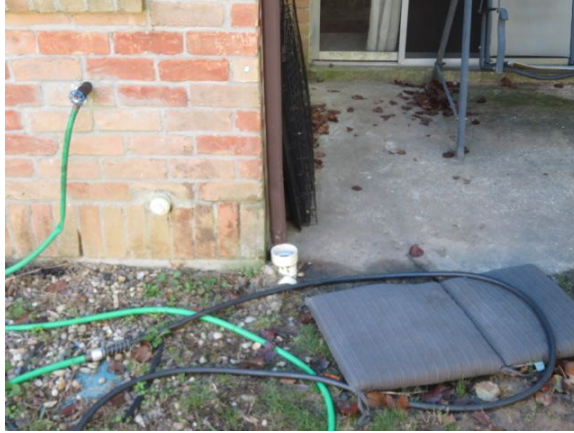
The rain gutter downspout is disconnected to the pipe beneath it on the back side of the house.

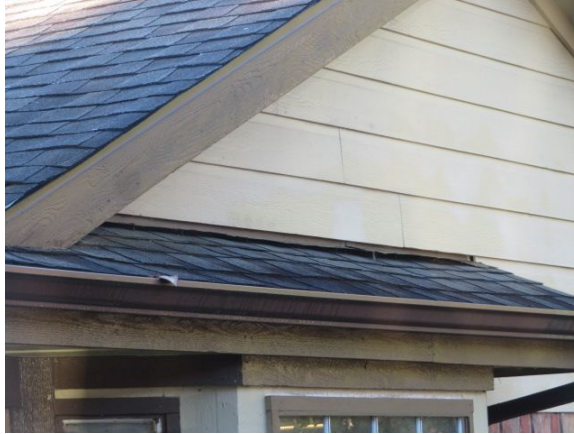
The flashing is lifted on the right side of the house.

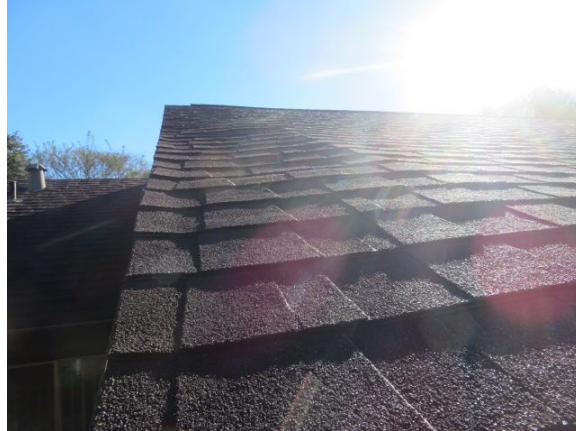
There is a sag in the roof decking on the back right side of the house.

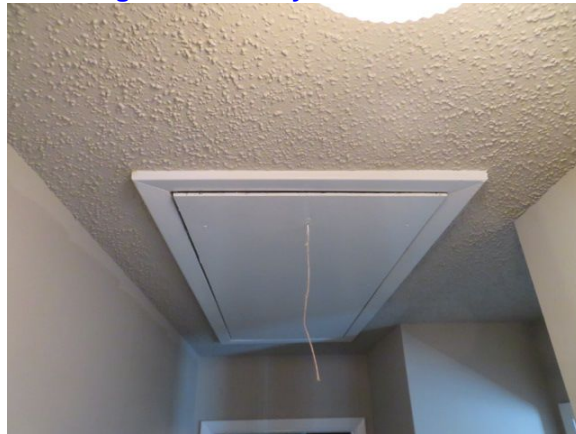
**The attic door is not closing completely. This can allow warm air in the warmer months and cool air in the cooler months to enter into the living space. It can also allow any exhaust gases that may be in the attic to enter into the home.**

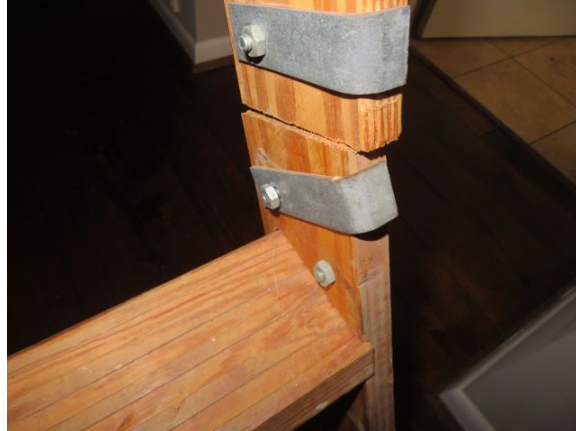
There are loose / missing bolts on the attic access ladder. I recommend tightening all bolts periodically.

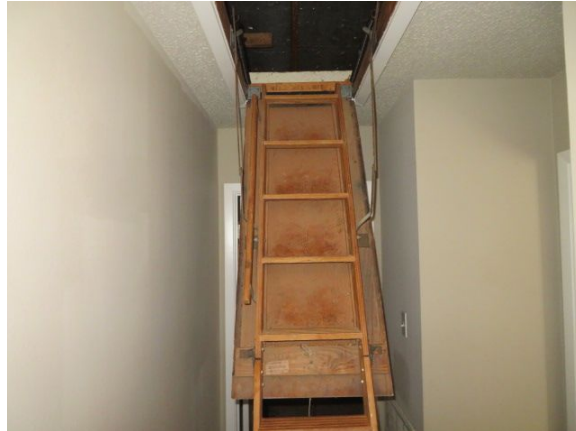
There is no insulation on the attic access door.

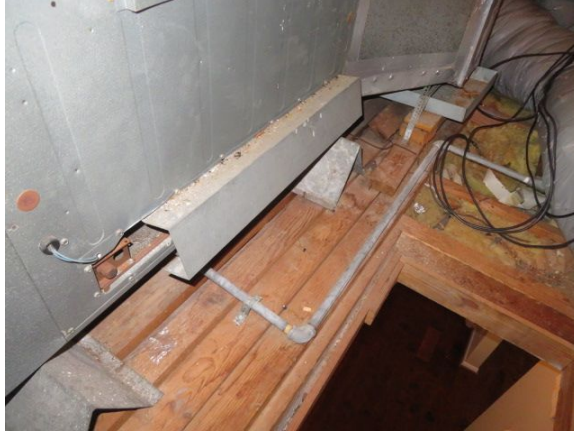
The attic equipment is required to have a minimum 30" platform for service / maintenance. The workspace is inadequate and does not meet this minimum requirement.

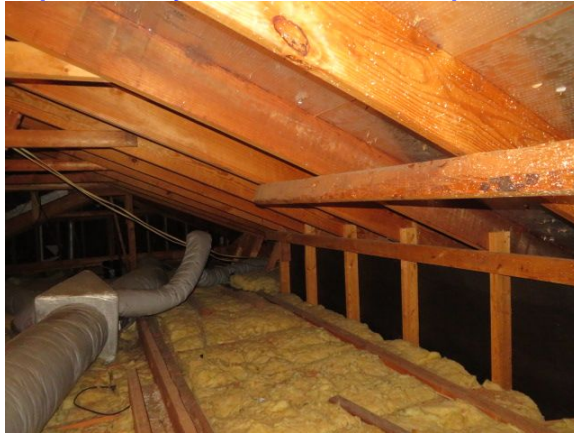
Purlin braces are designed to provide additional support to the roofing structure and are required every four feet. There are purlin braces missing in the attic.

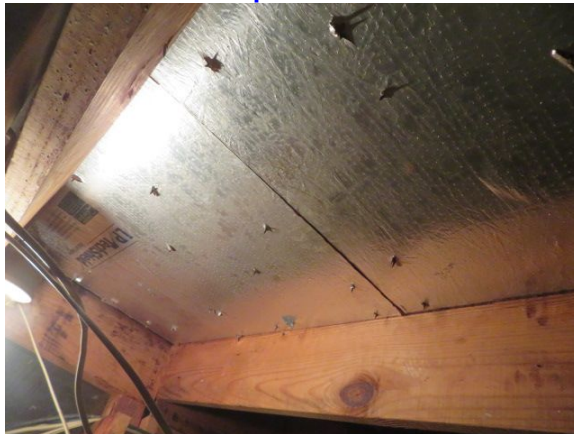
There are no "H" clips between the roof decking.

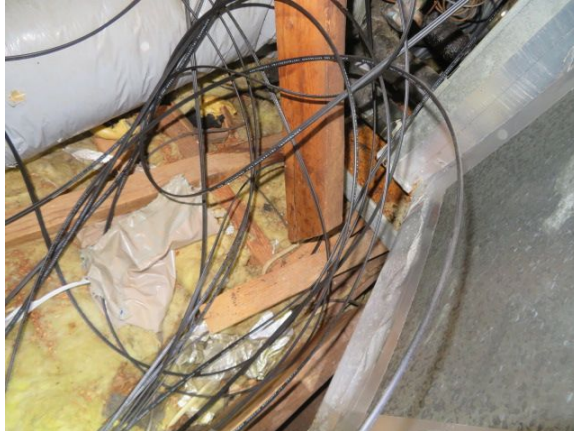
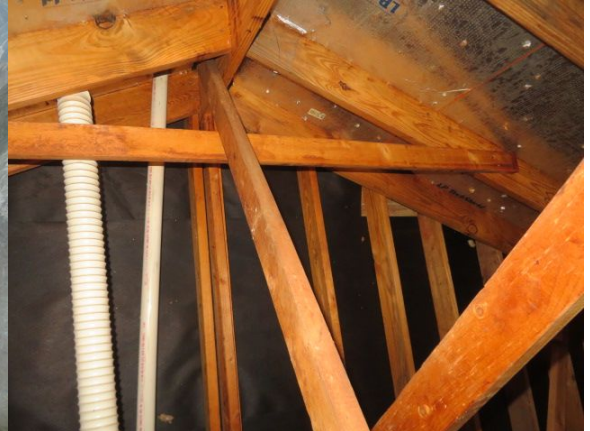
There is a support that is disconnected at the bottom on the left side of the house.

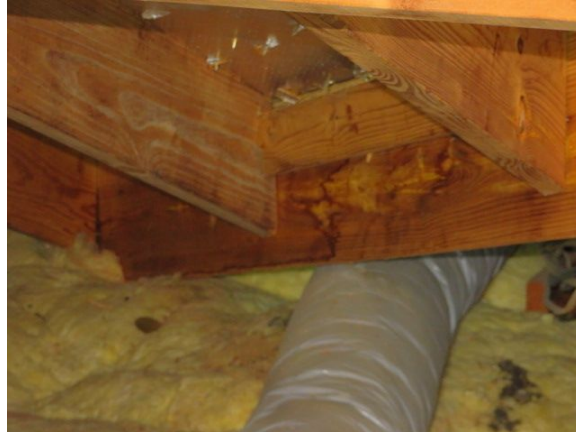
There is evidence of moisture penetration in the attic.

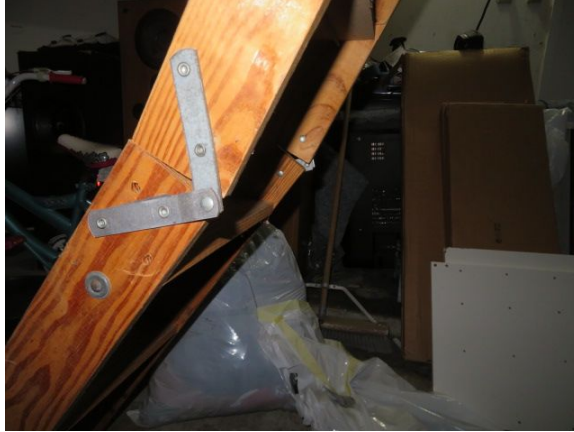
The bottom section of the attic ladder in the garage was cut too short.

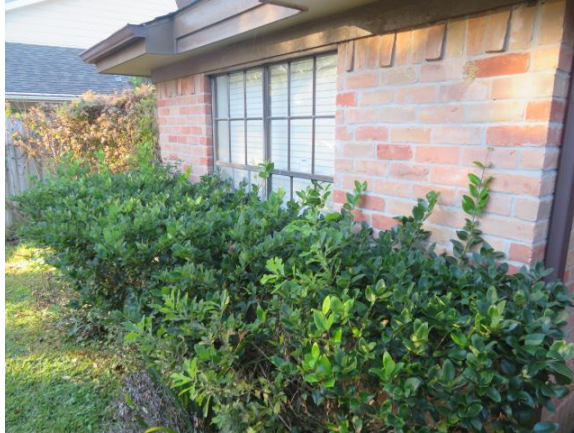
Ideally, plants should be trimmed so as not to come in contact with the cladding of the house. This will help prevent moisture retention against the siding and pests.

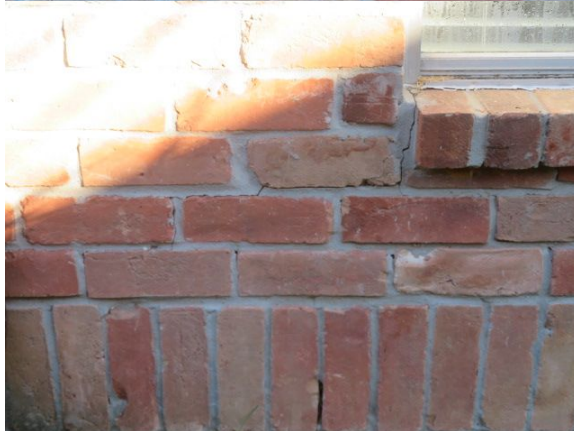
There are mortar joint cracks in areas such as the front entry and the back left corner of the house.

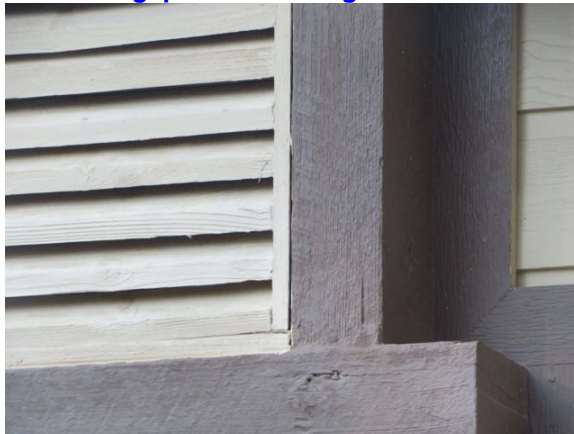
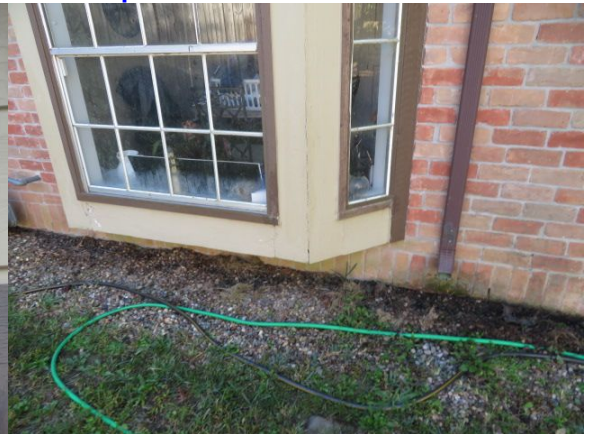
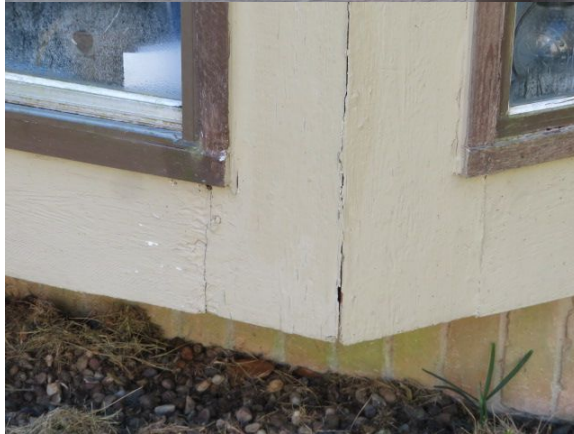
There are gaps in the siding seams on the wall at multiple locations.

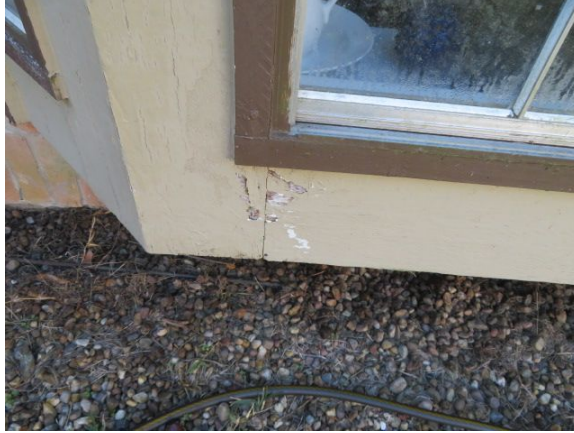
There are some instances where there are cracks or gaps in the paint on the siding. Paint serves as a moisture barrier for the siding and should be sealed to prevent any potential water penetration.

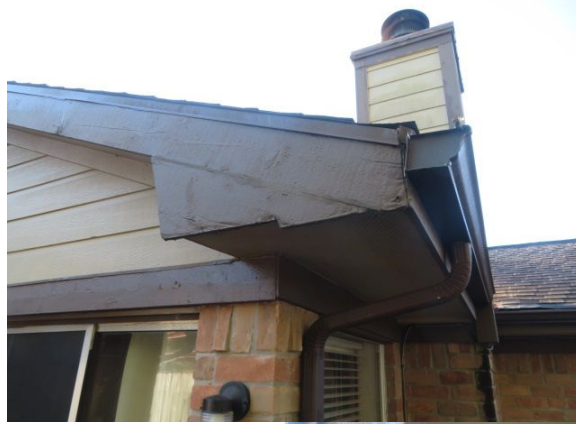
There is wood rot in the fascia in multiple locations.

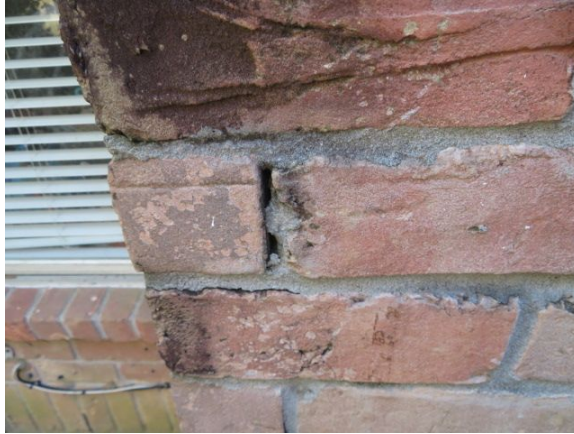
There are gaps in the mortar in areas such as the back side of the house.

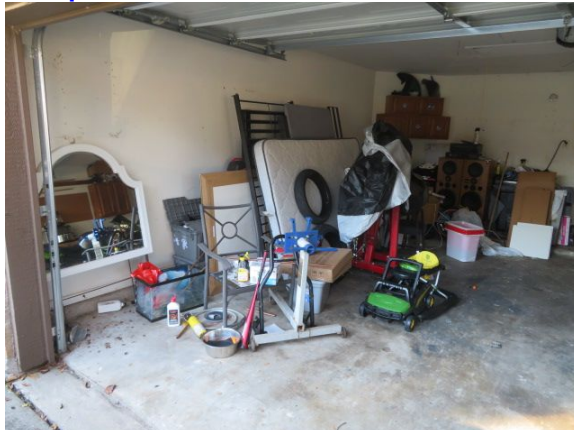
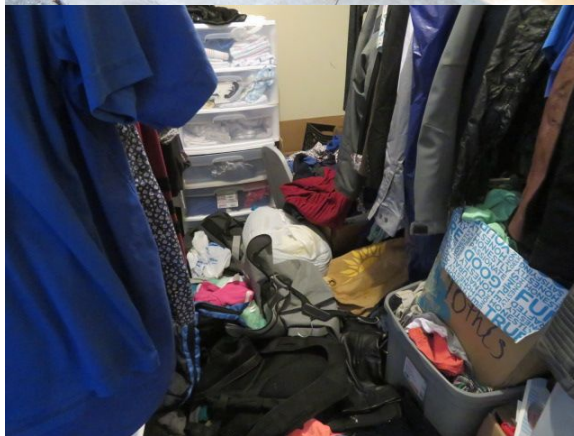
The interior walls (including closets) and garage walls are obstructed by storage and furniture. Not all of the walls are accessible / visible for inspection. NOTE: The photo(s) below are not necessarily all inclusive, and there may be more areas obstructed from view than pictured.

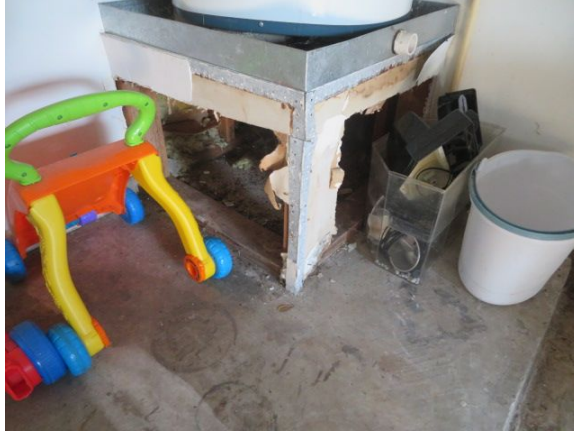
NOTE: There is sheet rock missing on the water heater riser.

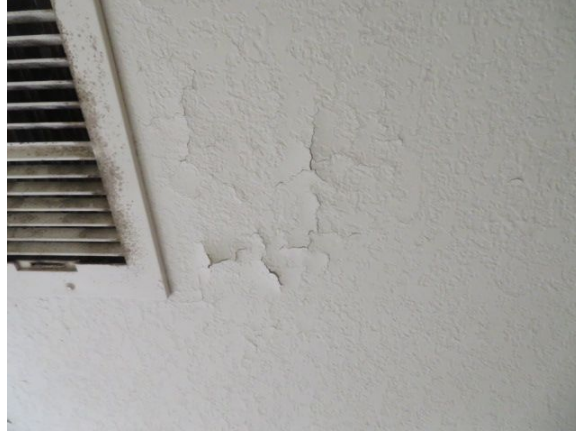
The texture in the hall bathroom ceiling has started to peel. This is likely due to excess moisture in the air whenever a hot shower was running. The exhaust fan should always be on during a shower in a small area.

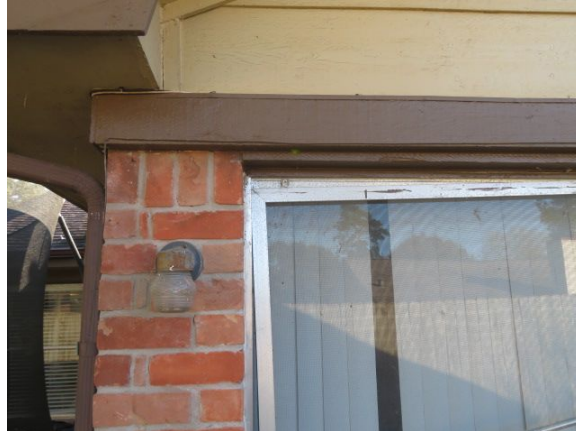
The screen door on the exterior master bedroom door is off its rails.

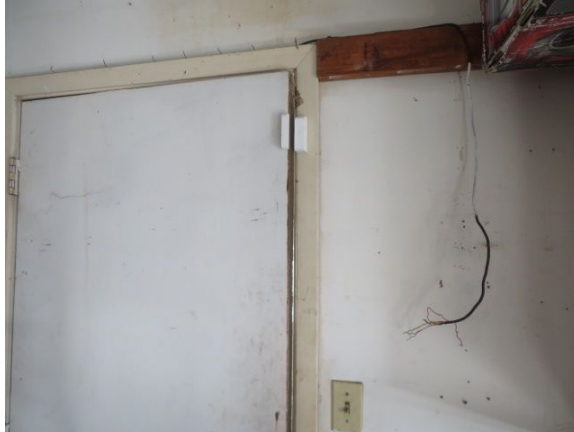
The exterior garage door hits the frame before closing.

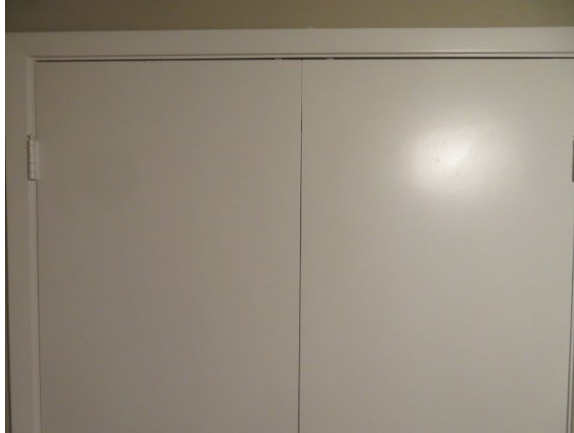
There are doors that appear to be out of square in locations such as the front left bedroom closet.

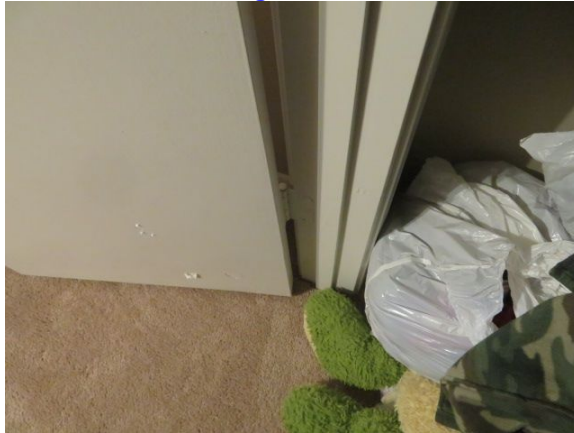
There is a loose hinge on the door to the front left bedroom closet.

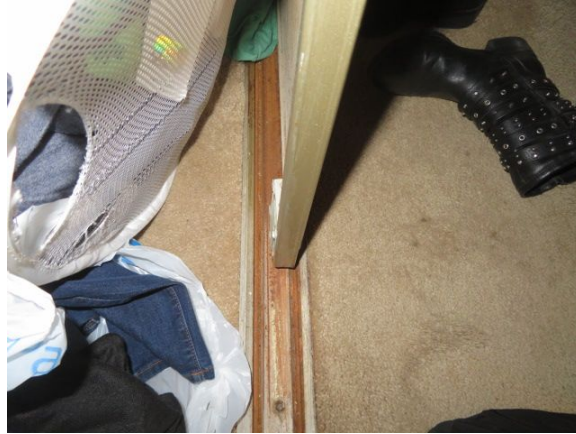
The door to the master closet is off the rails.

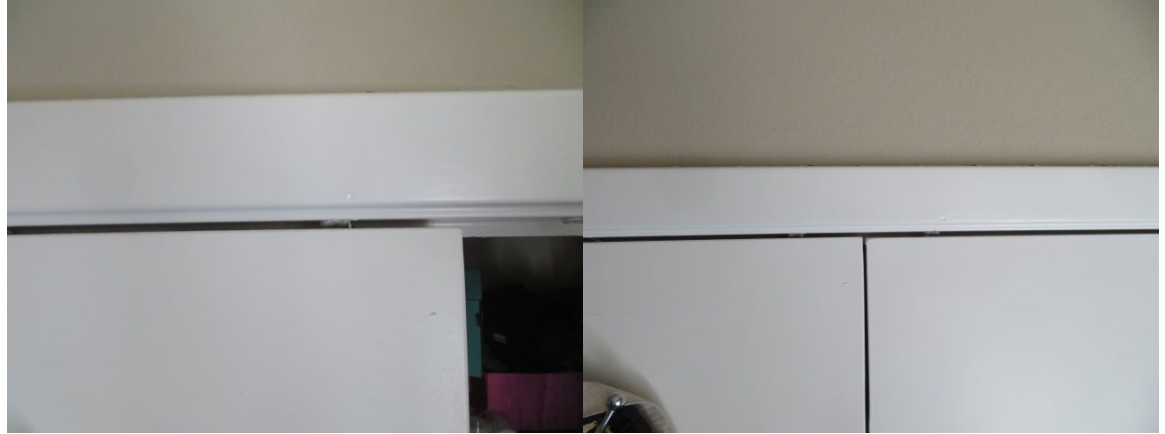
The ball catches in the closet doors in the back left bedroom do not seat in the striker plates.

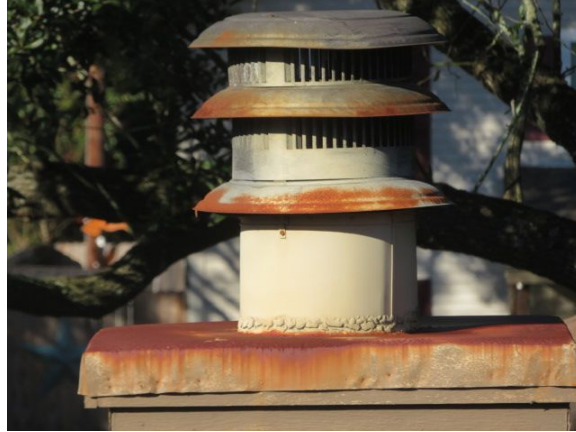
There is rust on the rain cap.

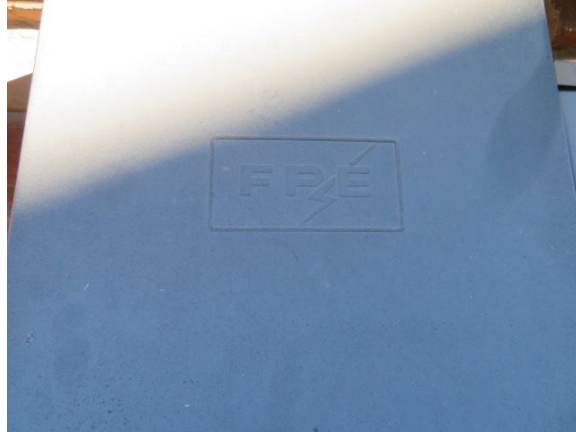
The brand of electrical service panel is Federal Pacific. This brand of panel is known for having breakers that are more difficult to find and more costly to replace. In addition this panel is associated with a higher incidence of safety issues. I did not remove the front cover on this panel. I recommend the service panel be inspected by a licensed electrician. (For additional information about this panel, refer to [ismypanelsafe.com](http://ismypanelsafe.com).)

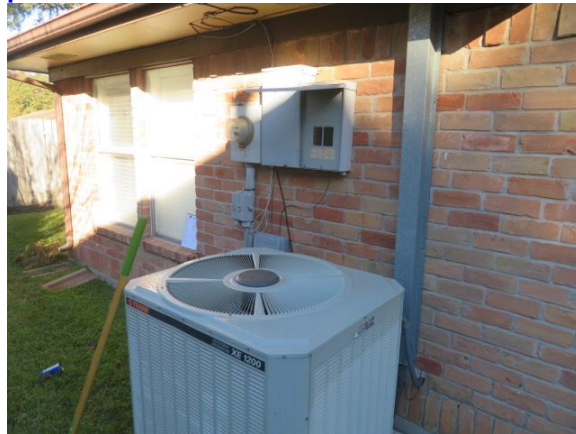
The main service panel is required to have clear access. The area in front of the service panel is obstructed and should be cleared to provide clear access.

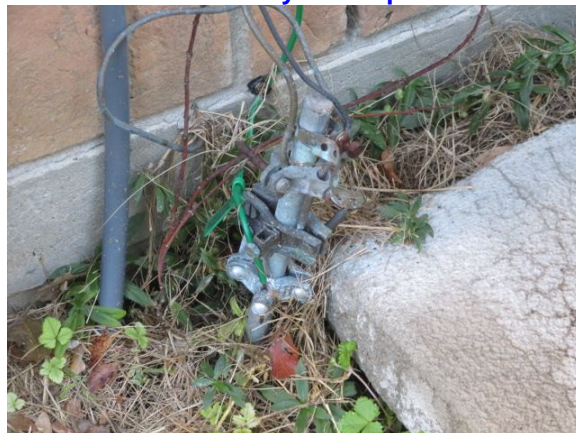
The upper end of the grounding electrodes should be flush with or below ground level. The wrong clamp has been used to secure the ground wire to the ground rod. The clamp should be an acorn style clamp.

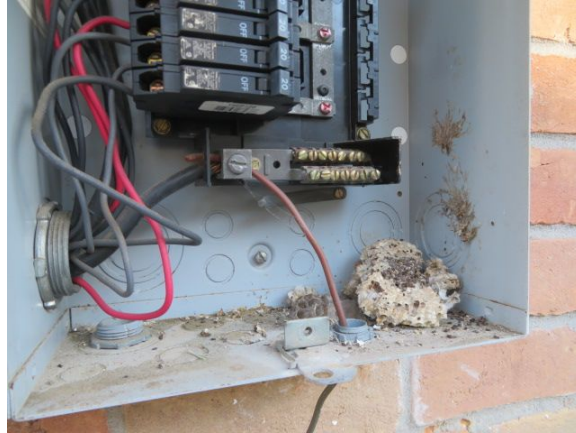
There is a ground and neutral wire attached to the same bus bar. Ground and neutral wires should be connected to separate lugs and separate bus bars to help prevent accidental injury.

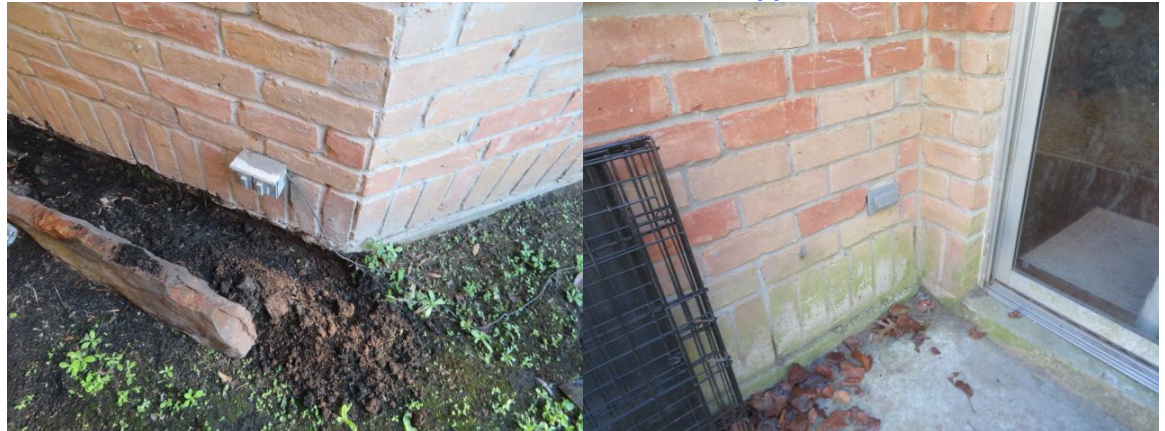
There are exterior outlets that do not have covers that are approved for wet locations.

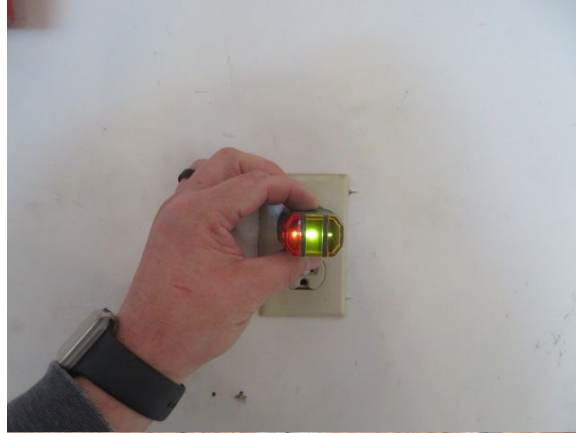
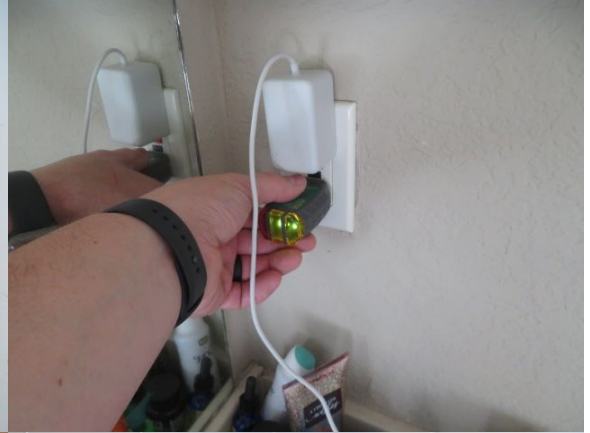
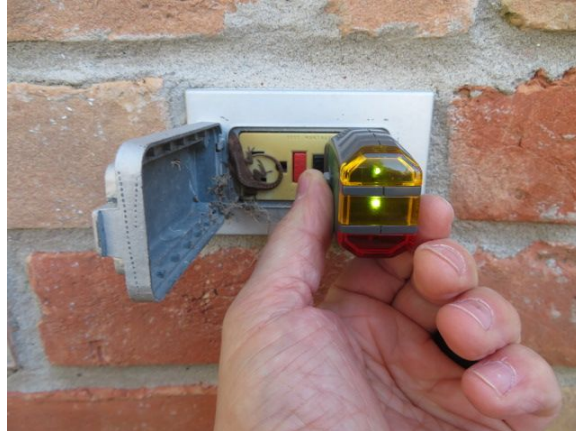
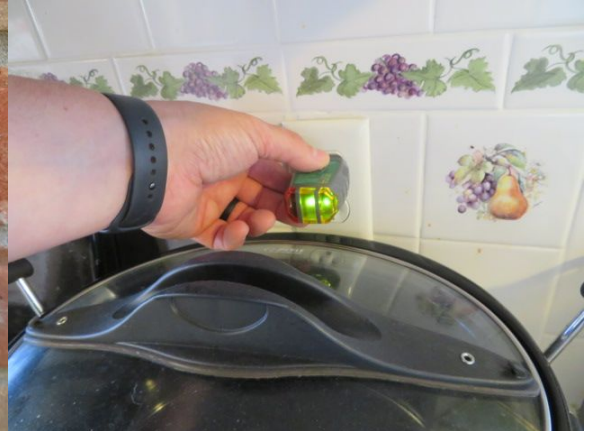
There are outlets that are not GFCI protected, as is currently required, including in the garage, exterior, some outlets in the kitchen and the master bathroom.

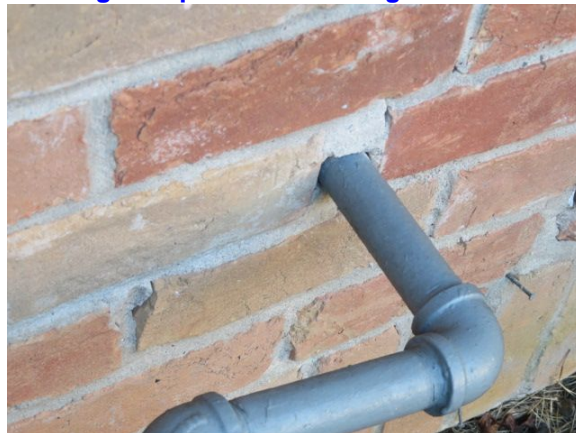
The gas meter is not visibly bonded to the remainder of the electrical system. The unit may be bonded at a point later in the line / system. However, the clamp and bond wire are required to be in a location that is visible and accessible for inspection. I did not locate a bonding clamp or wire on the gas meter at the time of the inspection.

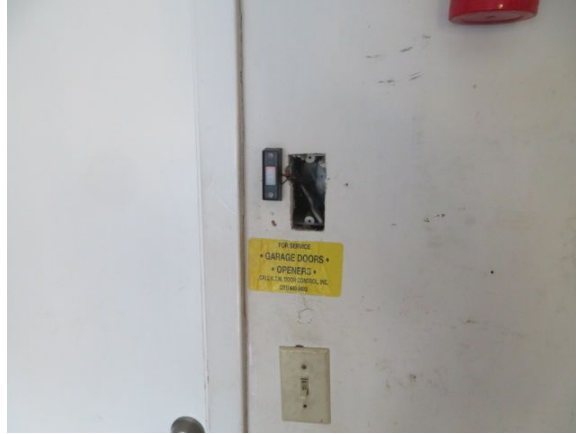
There are open junction boxes in the garage.

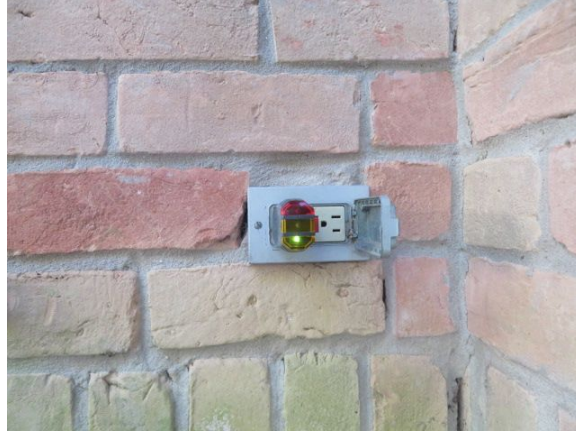
There is an open neutral outlet on the back porch.

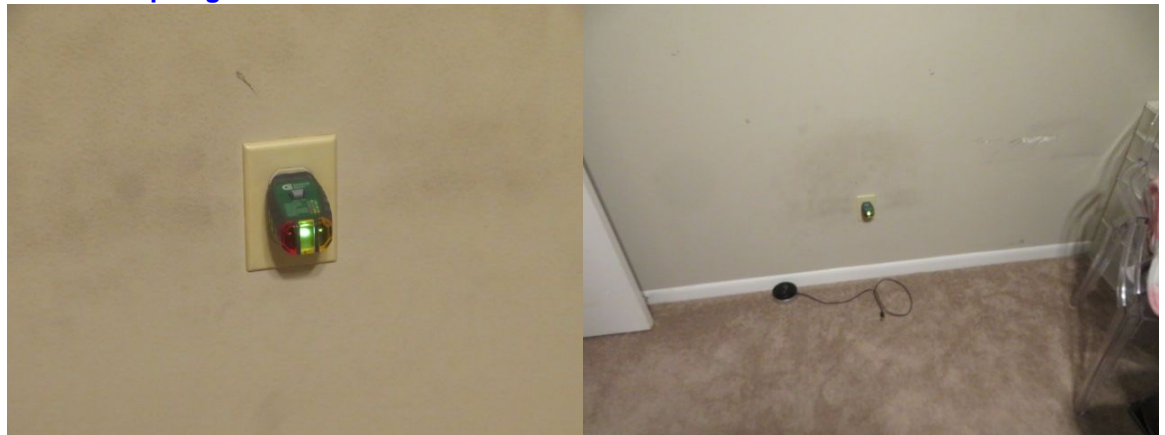
There are open ground outlets in areas such as the front left bedroom.

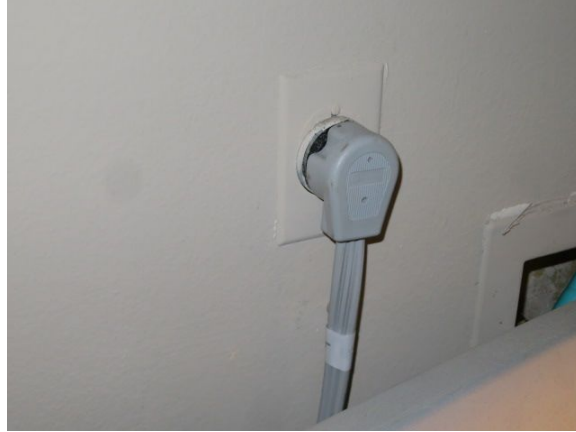
**NOTE: The dryer outlet is a three prong outlet. New dryers use a four prong outlet.**

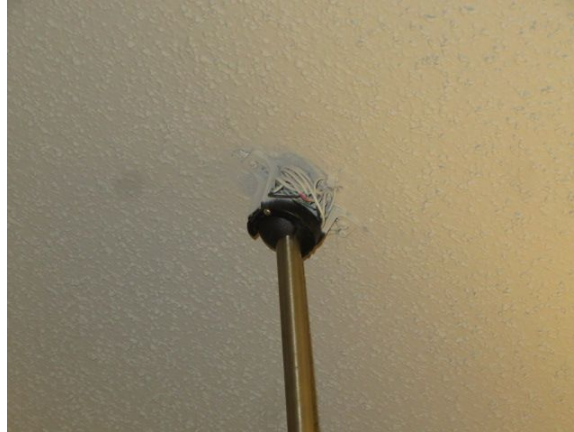
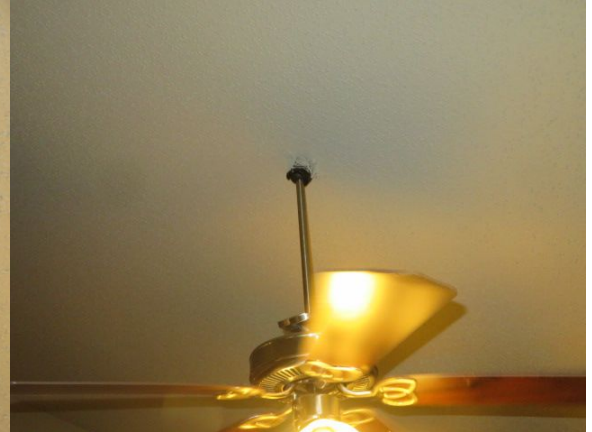
The escutcheon on the fan in the living room has fallen out of place.

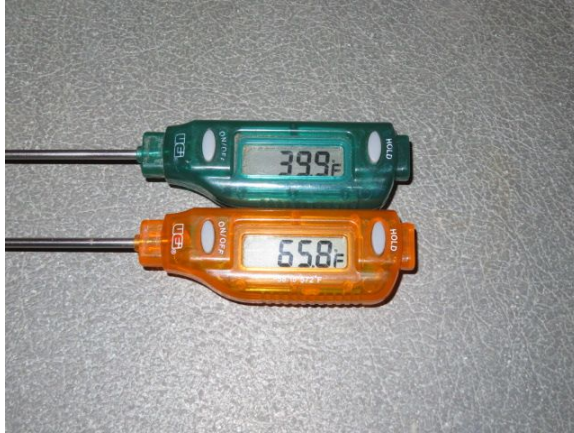
**The temperature differential between the supply and return registers should be no more than 22 degrees. The unit is producing a temperature differential that exceeds this maximum requirement. This could be symptomatic of other issues inside the system. I recommend asking the sellers if the unit has had recent service, including adding freon.**

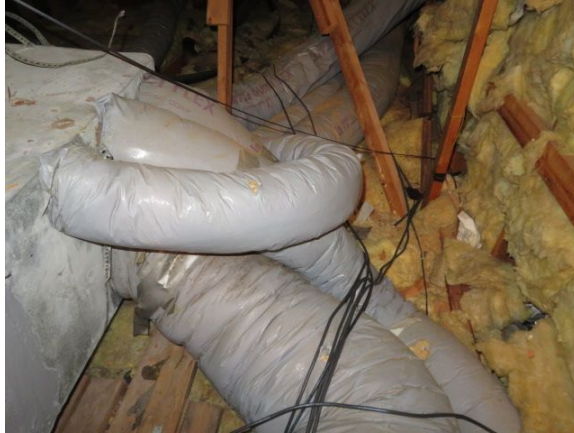
**There are A/C ducts in the attic in direct contact with one another. The ducts are not separated by a non cellulose material. The contact can cause condensation which can then drip into the attic space.**

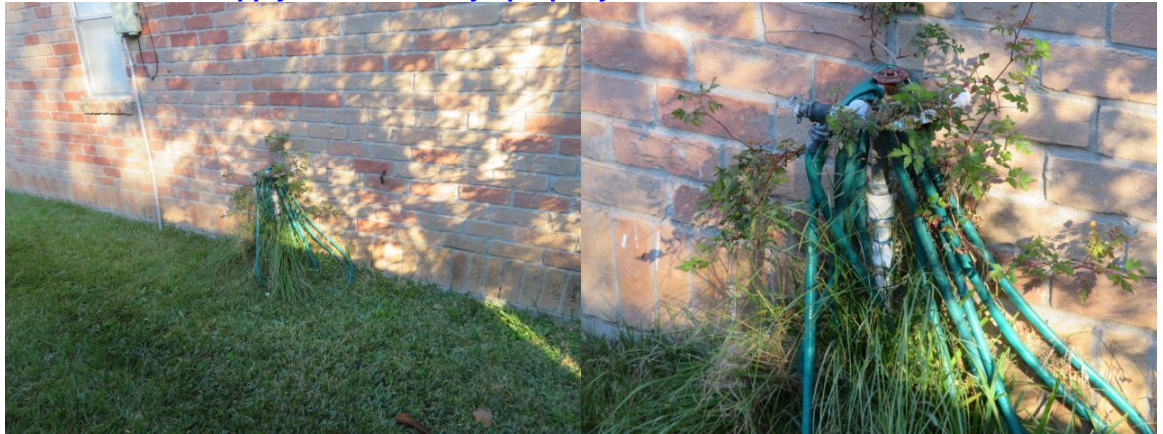
*Location of main water supply valve:* **Left exterior wall near the front corner**  
**The main water supply line is not fully / properly insulated.**

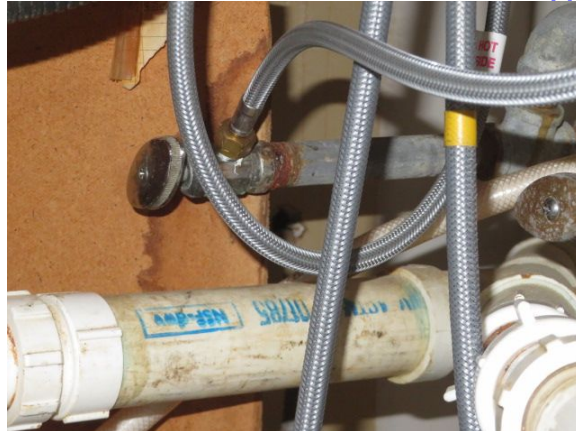
**There is some corrosion on some of the supply connections under the sink.**

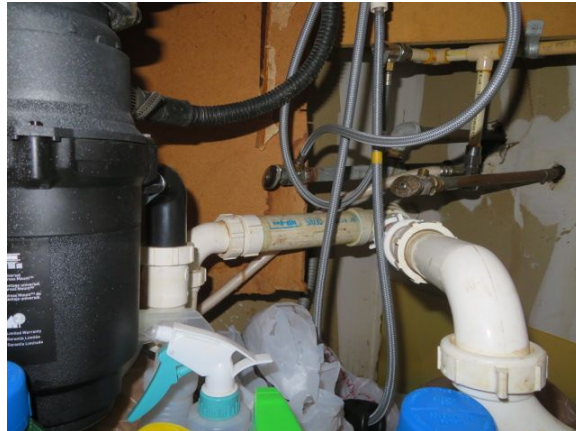
**There are moisture stains in the wall of the cabinet under the sink. I did not find an active leak at the time of the inspection. I recommend a licensed plumber evaluate the plumbing under the sink to determine if correction is necessary.**

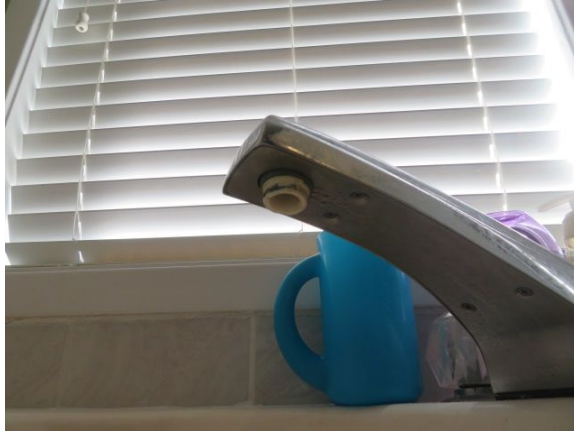
**The aerator is missing in the tub faucet.**

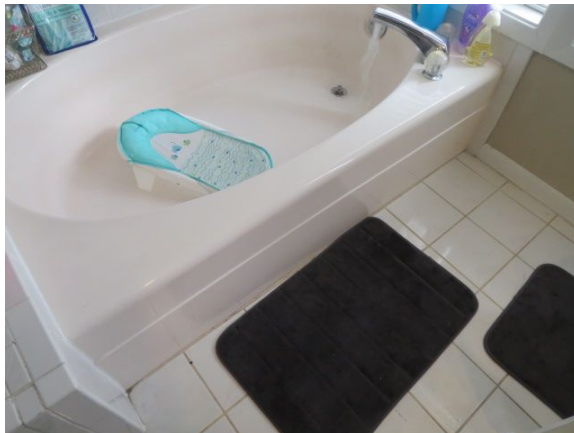
**Tub plumbing connections are required to be readily accessible. There is no immediate access opening installed. The water supply and drain connections could not be inspected in this area.**

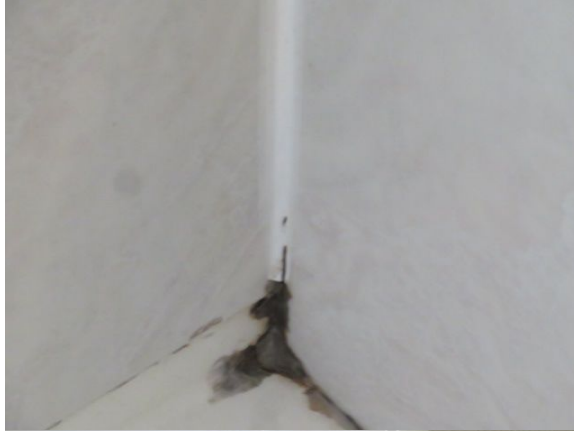
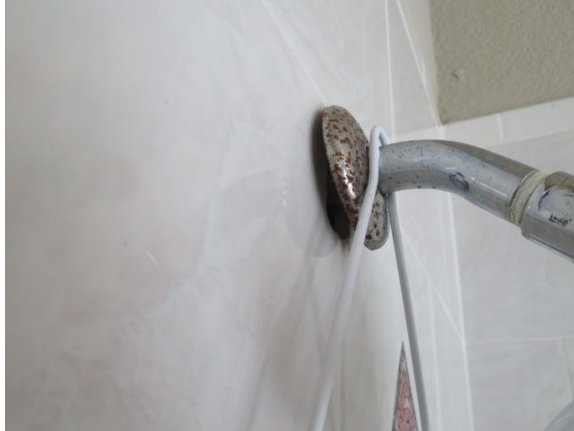
All bathtub wall penetrations and corners should be silicone sealed to help prevent water penetration into the wall cavity. The silicone is missing / deteriorated at the control knob and shower head as well as at the shower wall corners and edges in the master bathroom.

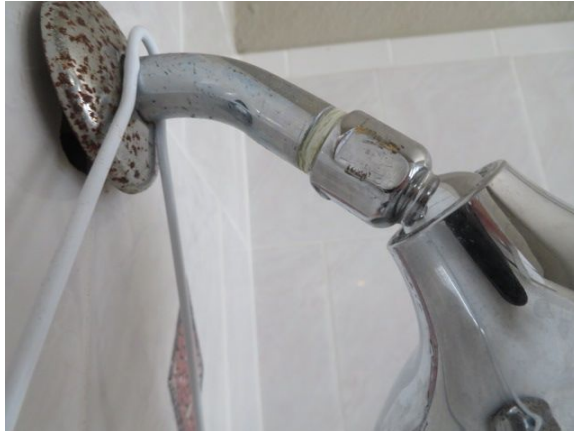
There is a leak at the shower head connection.

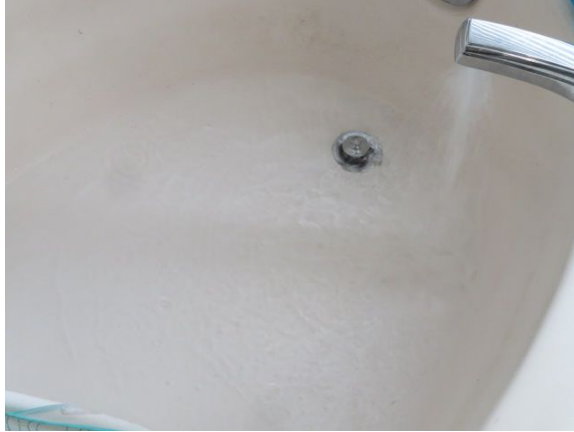
The tub drains slowly.

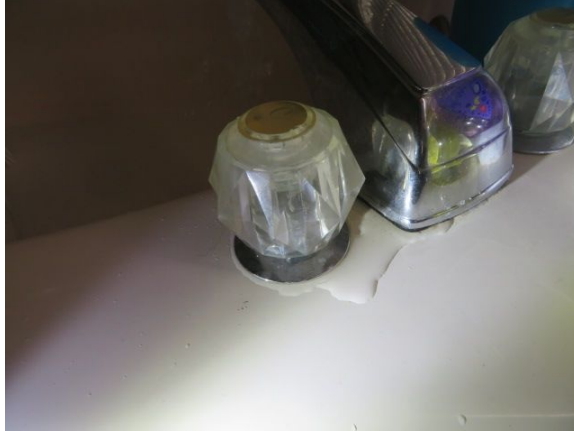
There is a leak at the control handles on the tub.

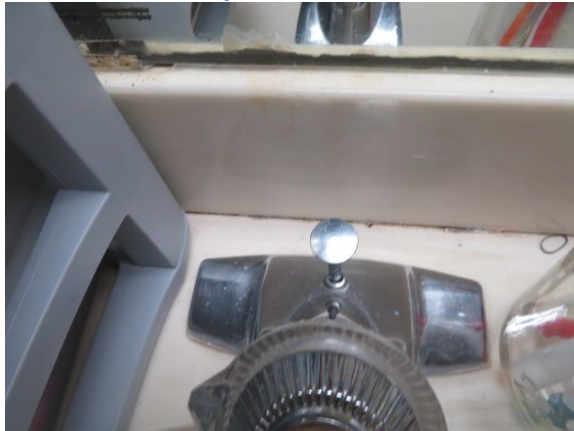
The silicone seal at the sink backsplash is deteriorated. This may allow moisture to leak into the cabinet space below.

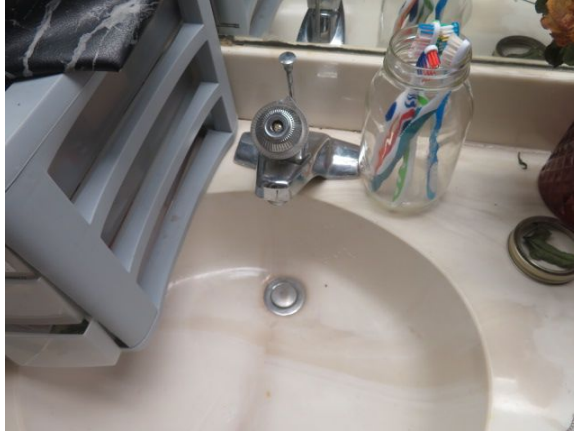
The sink plunger is not working properly. This sink will not hold water.

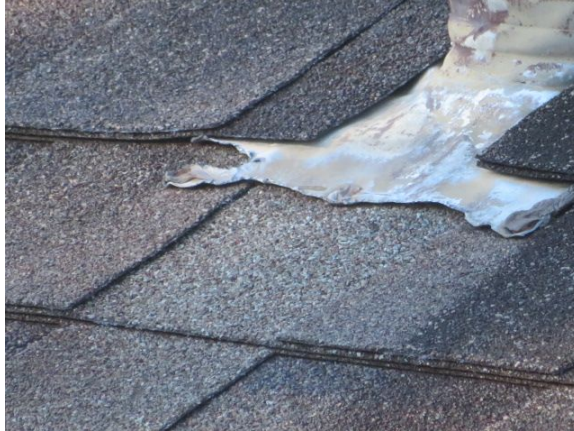
**Some of the lead vent pipe roof flashings have deteriorated. These should be replaced/repared to prevent any possible water penetration into the structure.**

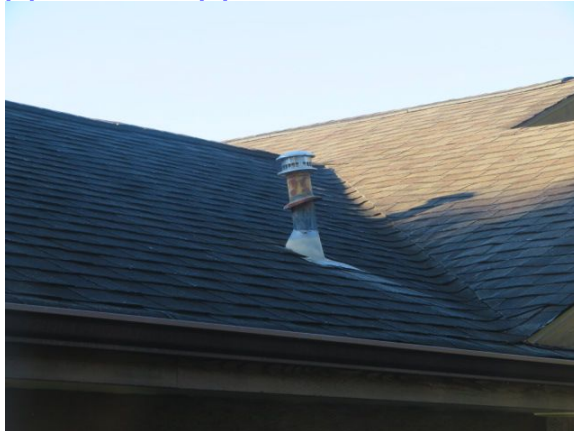
**Vent penetrations through the roof for the water heater or the furnace are required to be at least 2 feet higher than the roof line that is within 10 feet of the termination of the vent pipe. The vent pipes do not meet this minimum requirement.**

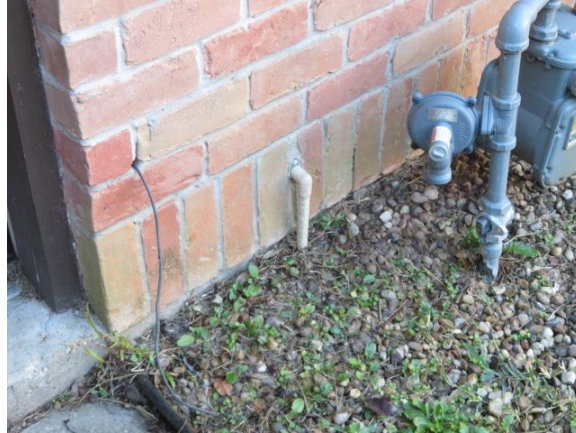
The TPR Drain line discharges right against the ground. This may hinder the flow of water in the event the TPR valve is opened.

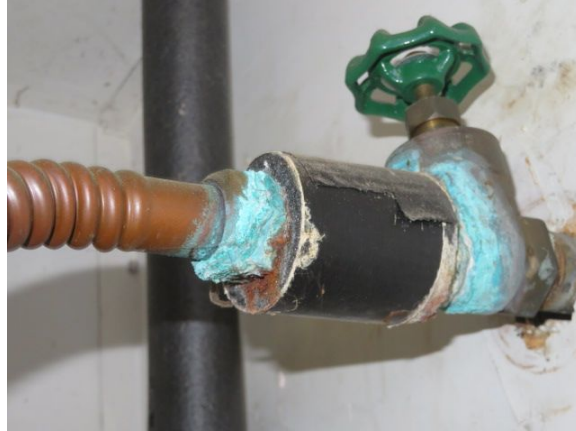
There is corrosion on the water supply connections at the water heater. I recommend having the connections reviewed by a licensed plumber to make sure they are not in danger of breaking.

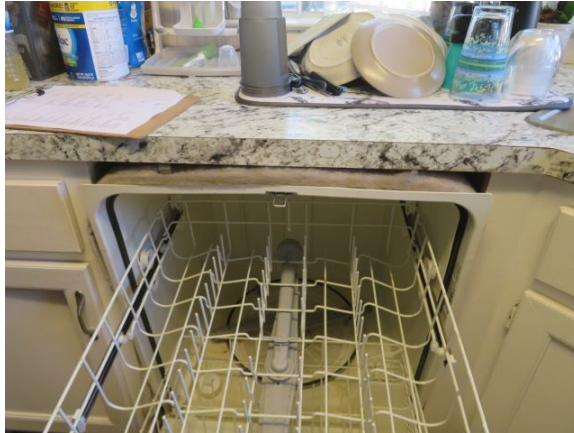
**The dishwasher is not properly secured inside the cabinet.**

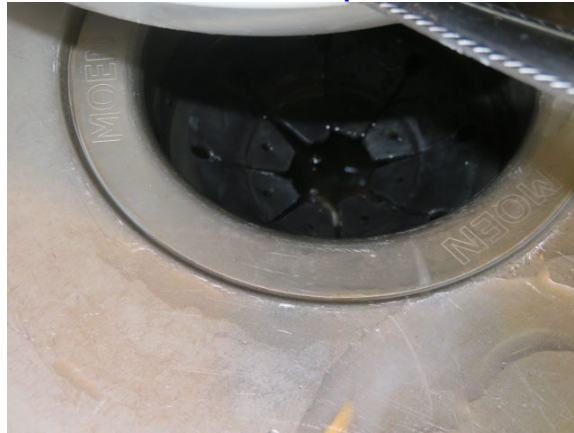
**There is rust inside the disposal unit.**

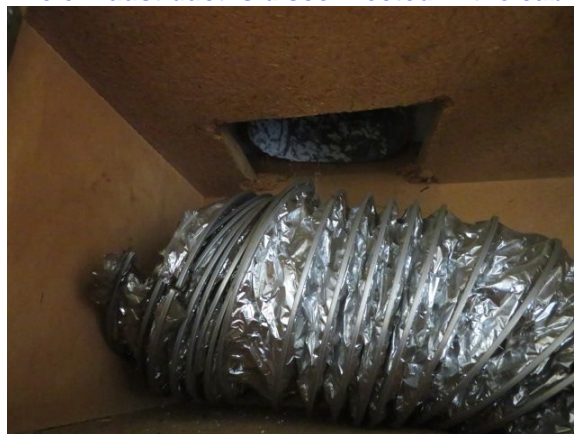
**The exhaust duct is disconnected in the cabinet.**

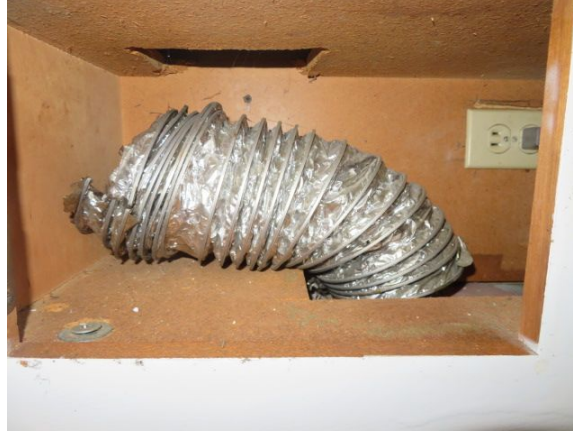
There is flexible vent pipe material to the hood vent. Only smooth wall vent pipe material should be used to help prevent debris or other greasy materials from obstructing the inside of the vent pipe.

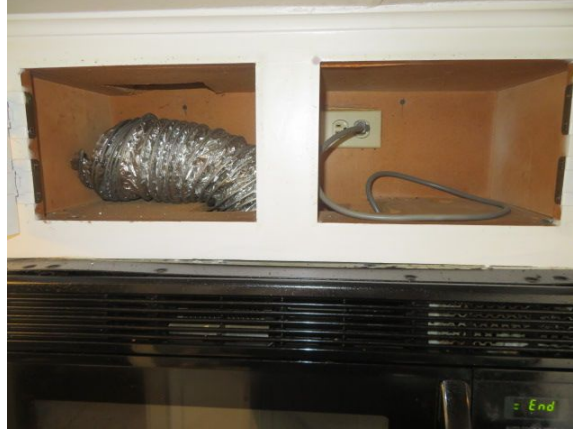
NOTE: The unit is self circulating and does not vent to the exterior.

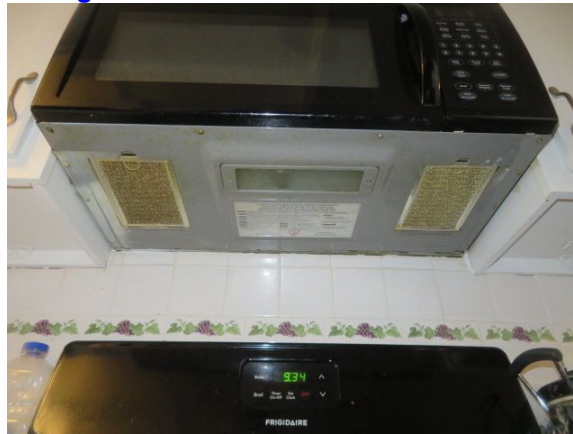
The light on the vent hood did not turn on.

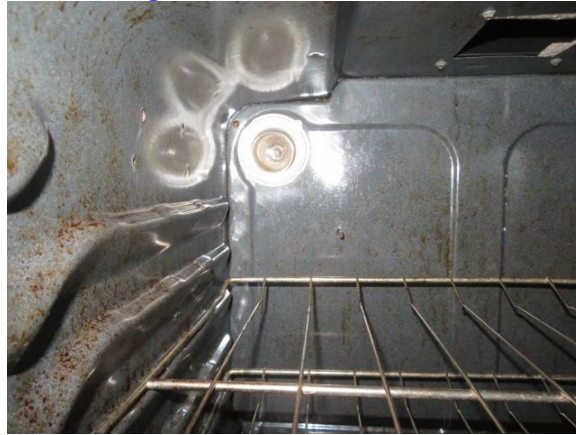
**The oven light does not work.**

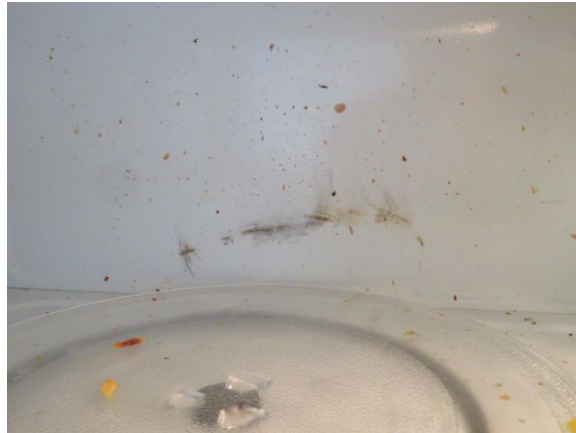
**There are scorch marks on the inside of the unit.**
