**BPG Inspection, LLC**

Client(s): Wiede  
Inspection Date: 1/13/2022  
Inspector: JB Atterberry , 24834

**Concerning:** 1523 Pine Gap Drive, Houston, TX 77090

**By:** JB Atterberry 24834 / BPG Inspection, LLC 1/13/2022

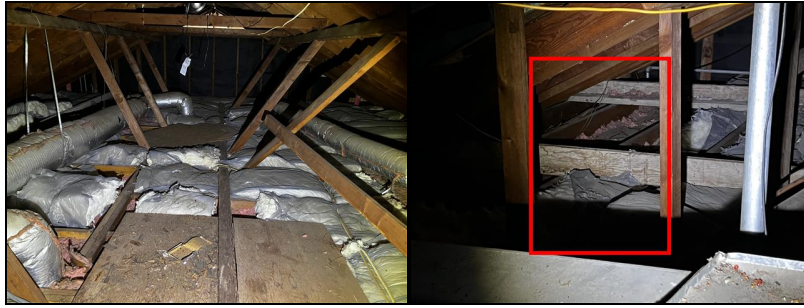
Observed the attic pull down ladder/hatch is not insulated completely, nor does it have weather stripping installed at edge of door that meets ceiling framing. Recommend fully insulating the attic stairway to keep the house more energy efficient. On average the insulation R-value for the entire attic area will drop approx. 27% when the attic stairs/hatch is not fully and properly insulated. The reason for this is that, although the attic stairs/hatch account for only 1% of the total attic area, the rate that heat flows through them by conduction (per square foot) is 38 times higher than in the insulated part of the attic.

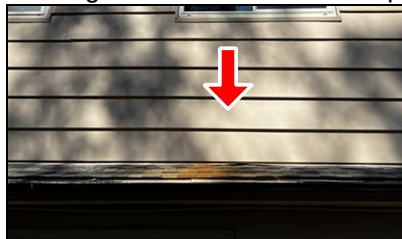
Noted shingle staining on the rear of the home. This appears to be caused by prior leaking of the HVAC secondary drain line onto the roof. No leaking was noted at time of inspection.

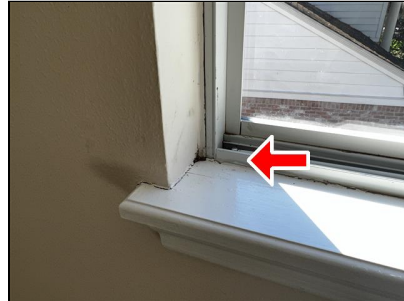
Noted multiple window sills at 2nd level rear with peeling paint present. Over time the suns UV rays take a toll on this area of the home and dry out paint in area causing the paint to peel/lift. The concern is that when paint peels it leaves bare wood condition that if hit by rain water from an open window could result in further damage including wood rot. Recommend having window sills affected cleaned, sanded and repainted.

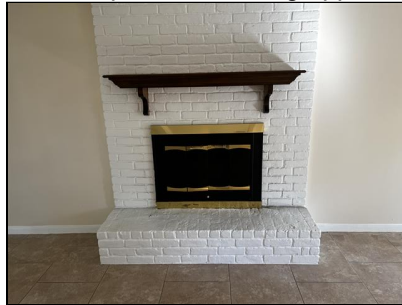
Fireplace does not have a damper blocking device installed as called for by today's standards in fireplaces with gas log systems. <http://damperclamp.com/installation.php>

The damper for fireplace at the same location is rusted tight or "seized" (non-operational). Repairs should be made so unit works properly. Recommend a qualified contractor inspect and repair as needed.

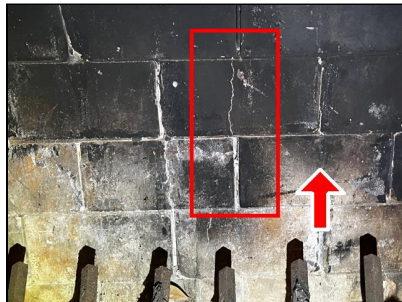
Hearth bricks are cracked, may be unsafe for use. Evaluation by qualified chimney sweep or contractor recommended.

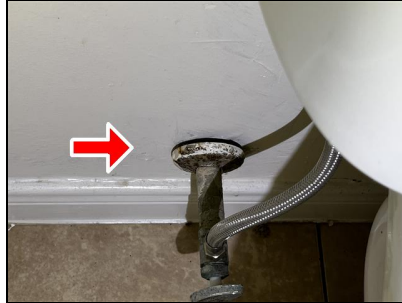
I recommend sealing the pipe penetrations in the under sink cabinets, and behind toilets.

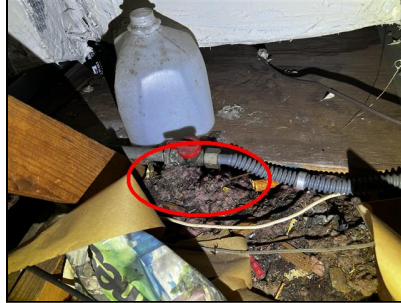
Gas supply to unit is missing a sediment trap, or drip leg as called for by current standards.

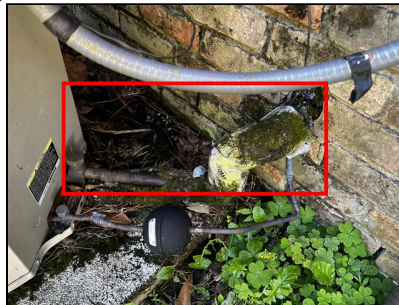
Repair/replace insulation on refrigerant lines between house and condenser.

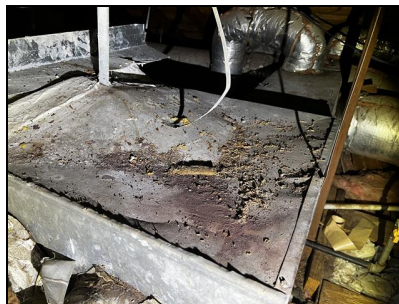
Noted damage to the HVAC plenum in the attic. Recommend further evaluation, for efficiency, by a licensed HVAC tech.

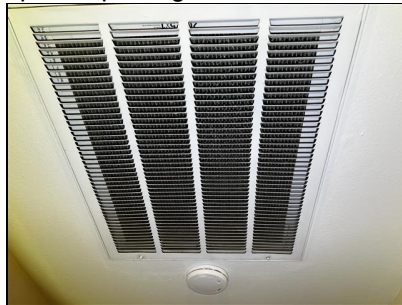
The filter(s) are soiled, dirty and require replacing.

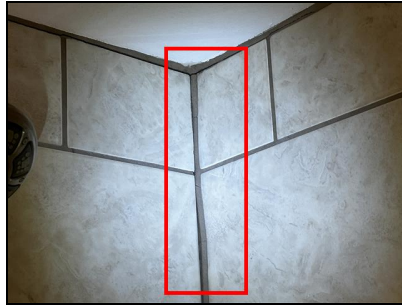
The water at upstairs tub nozzle would not terminate when showerhead was activate over the tub. Each is to dispense water independently of each other at 100%. Recommend properly repair/replace the shower diverter at the tub.

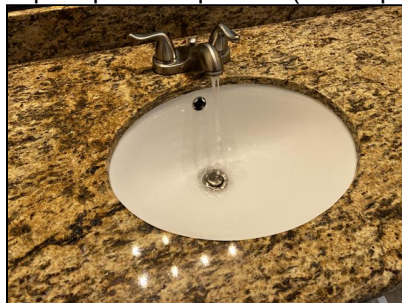
Have all missing/not functional drain stops repaired/replaced. (Most upstairs bath sinks)

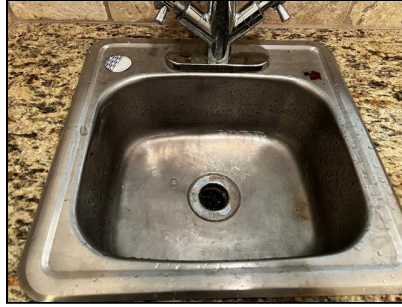
❌ The drain was slow, and may be clogged in the upstairs bath tub, and wet bar sink. I recommend repair by a plumber.

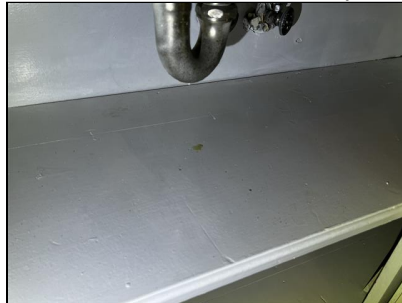
Noted the P-trap is leaking under the wet bar sink. Recommend repair/replacement by a licensed plumber.

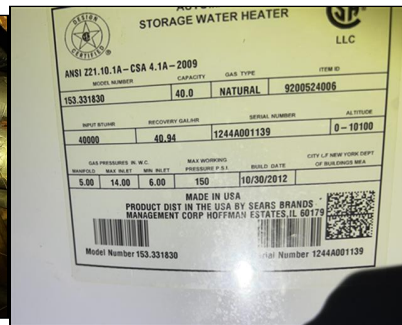
Gas supply to unit is missing a sediment trap, or drip leg as called for by current standards.

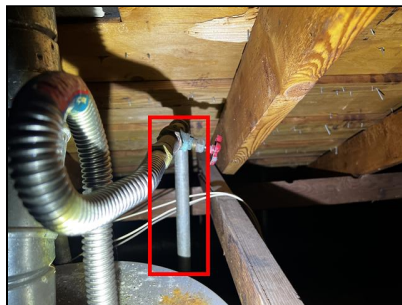
Water supply lines are not properly insulated.

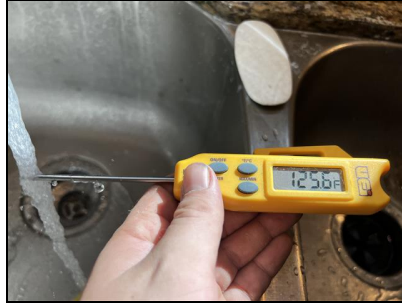
Temperature readings at sinks were measured at a higher than suggested setting. The U.S. Consumer Product Safety Commission (CPSC) urges all users to lower their water heaters to 120 degrees Fahrenheit. In addition to preventing accidents, this decrease in temperature will conserve energy and save money. Most adults will suffer third-degree burns if exposed to 150 degree water for two seconds. Burns will also occur with a six-second exposure to 140 degree water or with a thirty second exposure to 130 degree water. Even if the temperature is 120 degrees, a five minute exposure could result in third-degree burns. Consumers should consider lowering the thermostat to the lowest settings that will satisfy hot water needs for all clothing and dish washing machines.

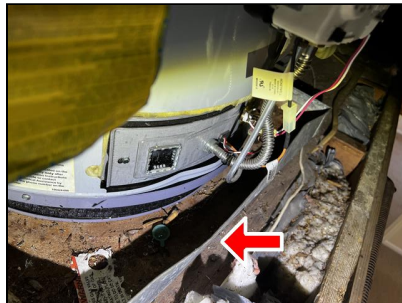
Water heater pan is filled with debris that could obstruct or clog drain line. Recommend having drain pan cleared of all debris

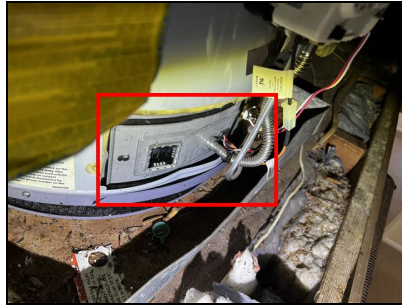
Observed the flame guard is missing at water heater. Recommend having flame guard plate installed at front face of water heater.

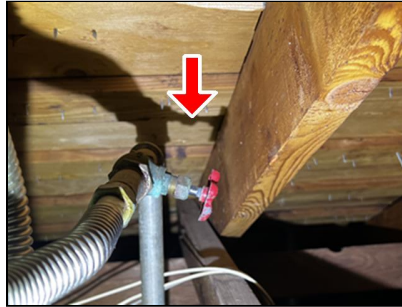
Current standards require quarter turn ball cock valves for the water heater shutoff, and not gate valves.

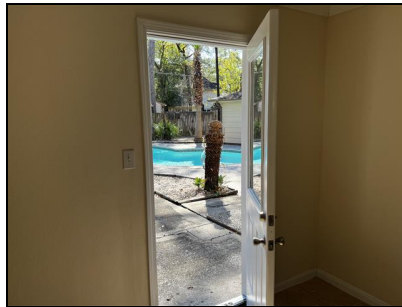
☒ Rear door and windows that face the pool area do not have an audible alarm system installed as called for by today's child safety standards.

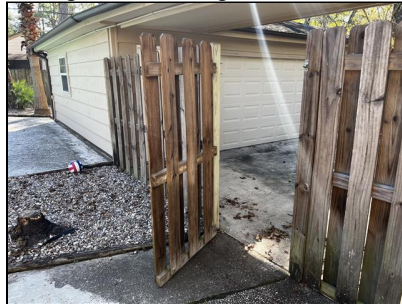
☒ The rear fence gate(s) is not self closing and latching as called for by today's child safety standards.
