Property Inspection Report

Texas Premium Inspections

1213 55th St

Date of Inspection: 6/17/2023

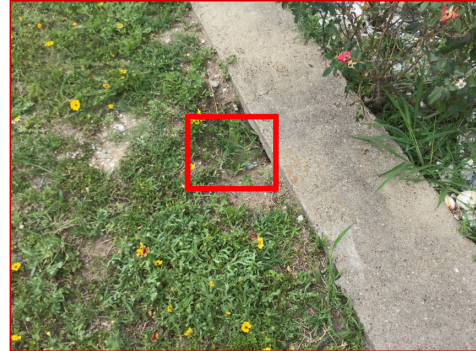
- The home had no roof drainage system to channel roof drainage away from the foundation. The Inspector recommends installation of a roof drainage system to help protect the home structure and occupants.
- The building site was relatively level and flat.
- Plants and bushes need to be trimmed back away from the structure by at least 6" inches. Trees also should be trimmed back at least 12" inches, especially above the roof.
- The inspector observed holes in yard that could potentially hurt or cause injury to a person or animal.

Holes

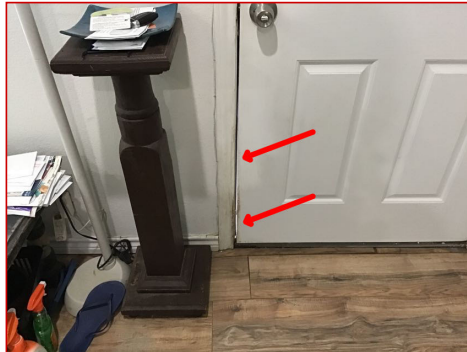
Visible light

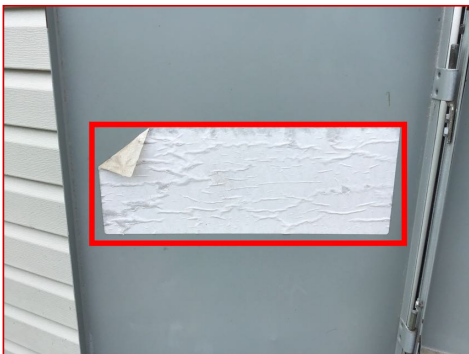
Illegible info sticker
