PREMIUM INSPECTIONS

2707 Mapleglade Dr, Humble, TX 77339

Date of Inspection: 3/23/2020 Time: 9:00 AM

Property Inspection Report

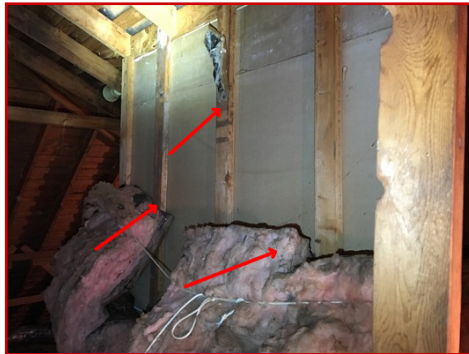
Fallen insulation

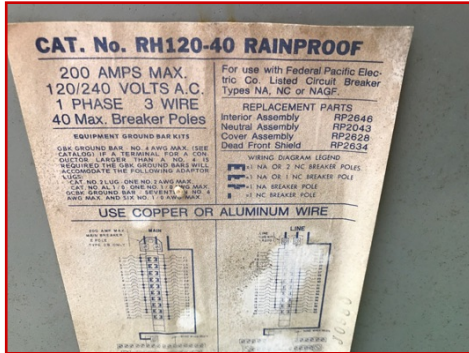
Federal Pacific Stab Lok panel, 200 amp max rating

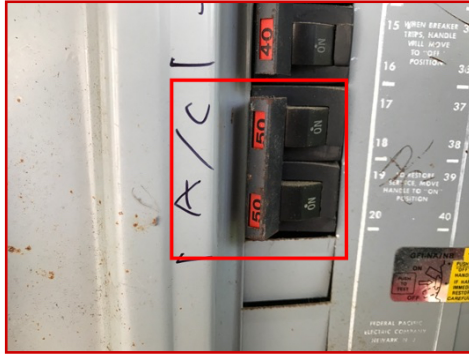
AC on 50 amp breaker, mfg label states max allowed of 40 amps

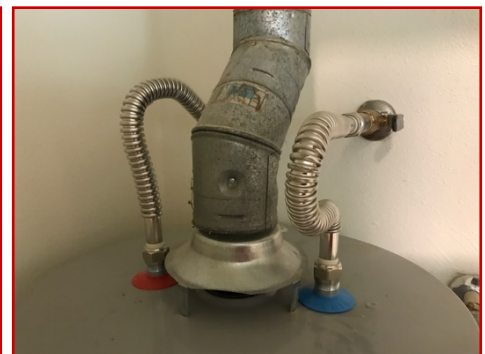
Water connections appear ok

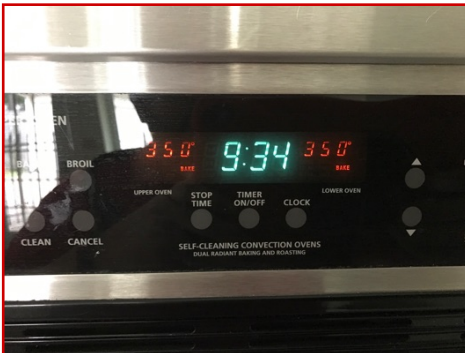
Oven set to 350° F

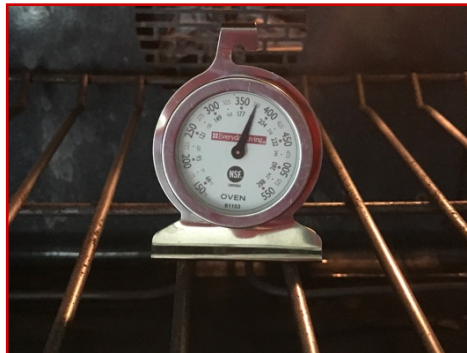
- The thermostat for the oven was found to be inaccurate and should be calibrated. The temperature was found to be greater than a 10° degrees difference of 350° degrees as measured by a detached thermometer.

After 30 min upper oven was approximately 375° F

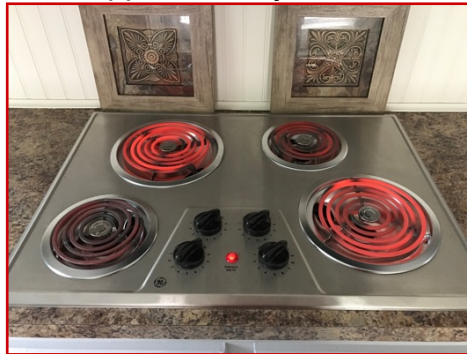
All burners appear to function

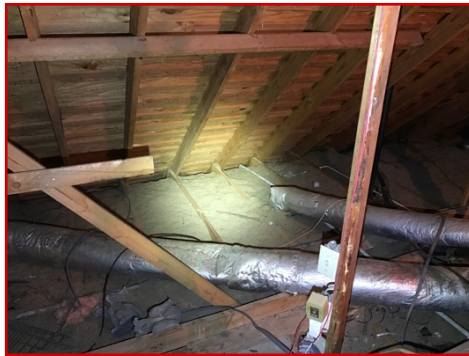
- Destination or termination of vent pipe could not be determined.

No visible termination for bath fan in hallway bathroom
