PROPERTY INSPECTION REPORT

1903 Sekola Ln
Spring TX 77386

Meredith Taylor & Iram Humberto Guerrero
JUNE 8, 2021

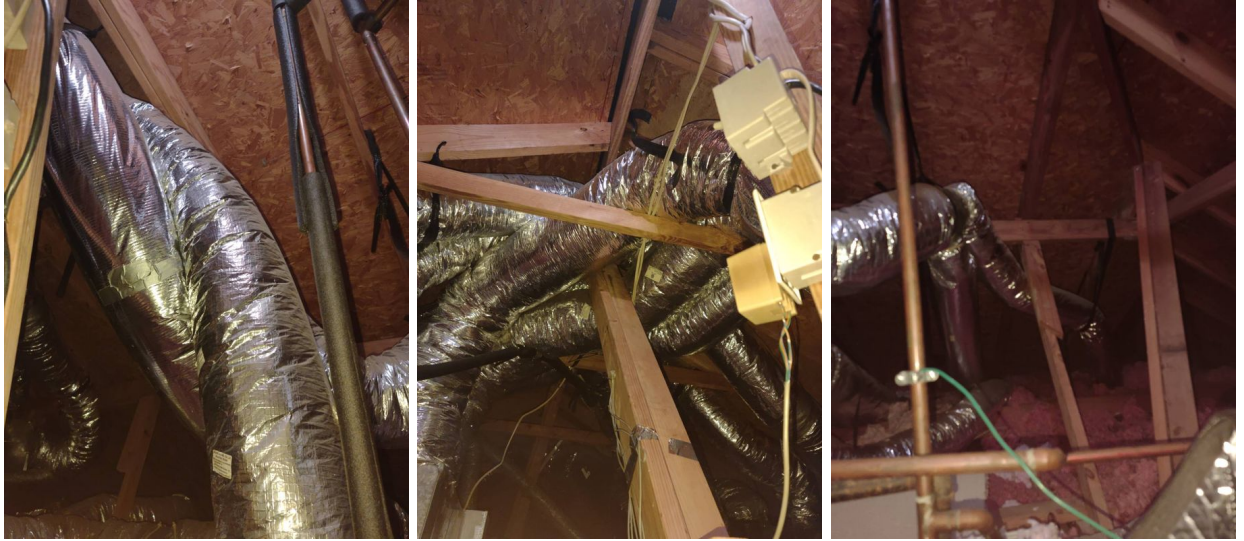
General Ductwork Photos:

Filter Type: Disposable

Filter Location: Downstairs Ceiling

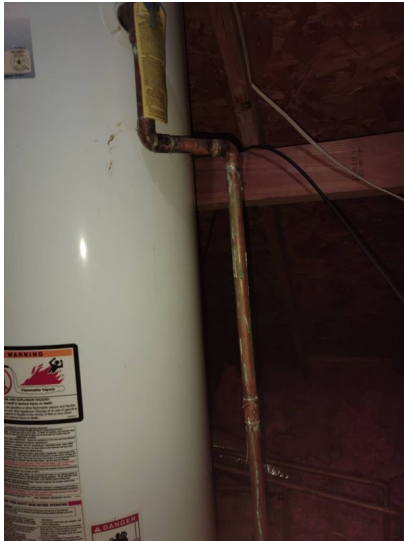
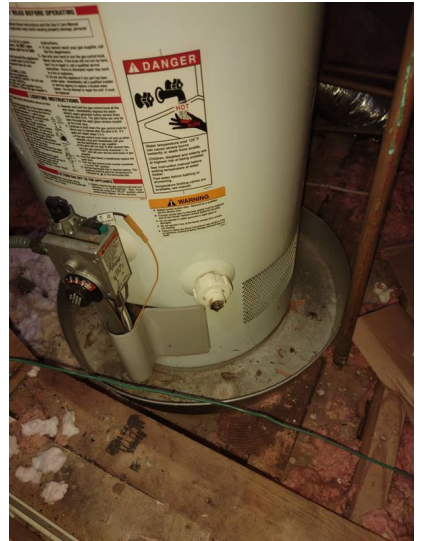
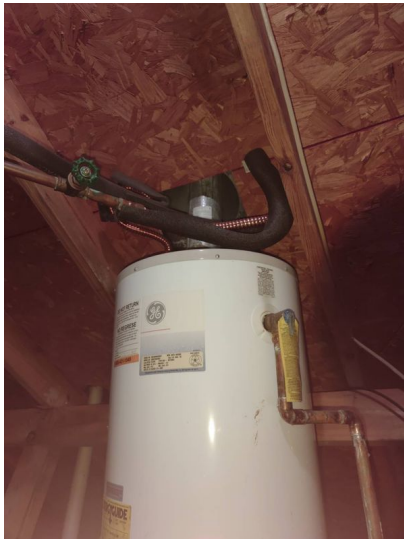
General Mechanical Photos:

Energy Source: Gas
WH Size: 40
WH Location: Attic
TP Material: Copper
WH Pan: Yes

FYI: Recommend draining and flushing unit once per year to reduce deposits/noise, and extend life of unit.

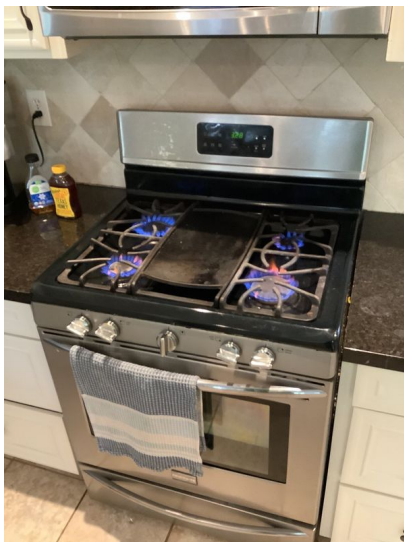
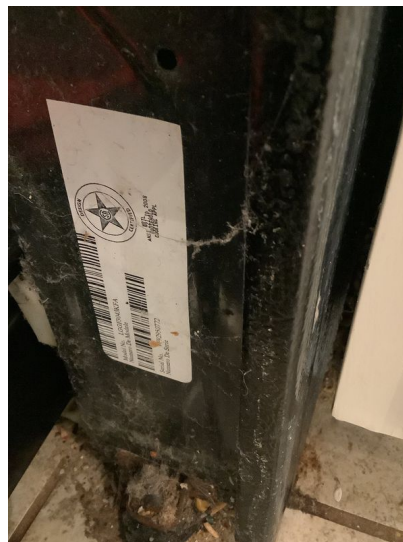
Appliance Information:

Oven Type: Gas

Range Type: Gas

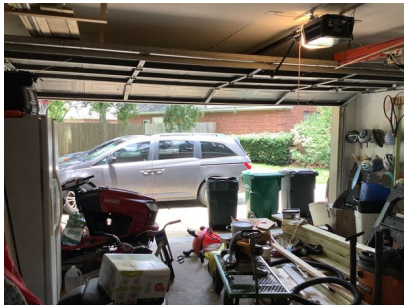
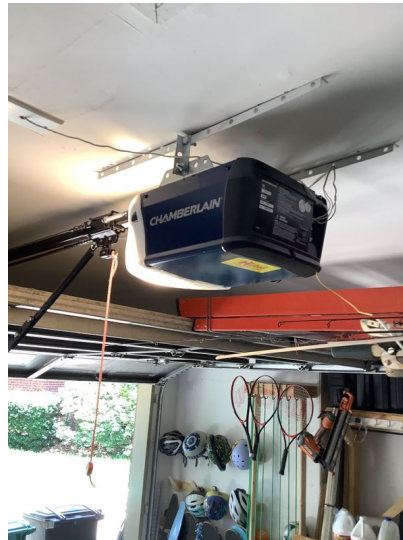
General Operator Photos:

Door Operated: Yes - Automatic door controls

Sensors 6 Inches Or Less From Garage Floor: Yes

Not Tested. The "Door Reversed When Obstructed Test" was not performed in order to avoid damage to door and operator.

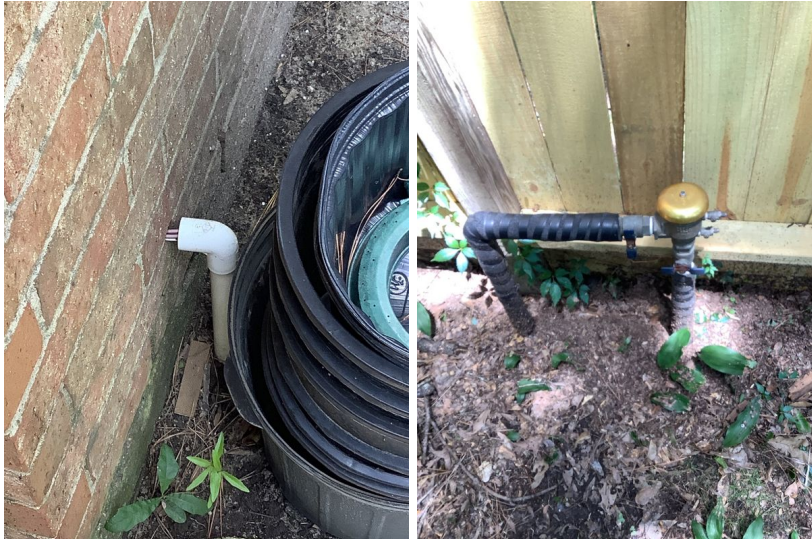
General Operating Photos:

Sprinkler Panel Location: Garage

Full Yard Coverage: Yes
