PROPERTY INSPECTION REPORT

Concerning: 2915 Loganberry Park Lane, Houston, TX
(Address or Other Identification of Inspected Property)

By: Danny Drake, Lic ##5322 11/27/2019
(Name and License Number of Inspector) (Date)

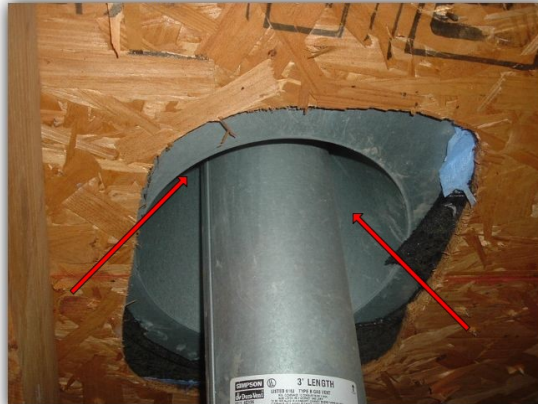
There is evidence of water penetration in the attic at the type B vent to the HVAC unit.

3: High moisture was detected in the ceiling above the entry area of the master bathroom. High moisture was detected in the ceiling above the entry area of the master bathroom linen closet. There is evidence of water penetration in the attic at the type B vent to the HVAC unit. There is evidence of water penetration in the attic at the roof vent. Reset the flashing at the right side of the front entry. Needs kickout flashing at the front of the house and the right side of the garage. *Consult a bonded roofer for further evaluation.*

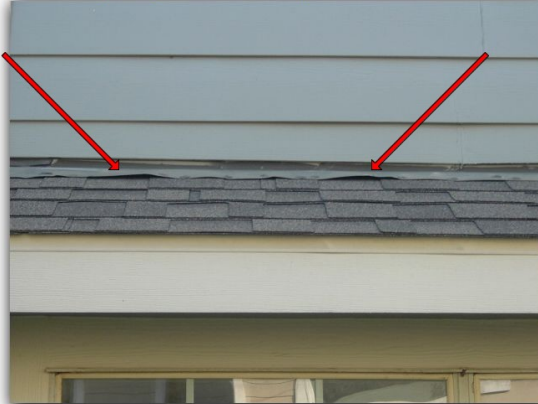
Reset the flashing at the right side of the front entry.

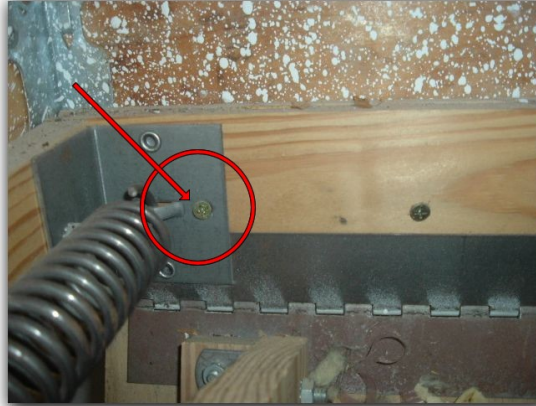
4: The attic ladder requires 16 D nails at the frame. The attic ladder hatch needs weather stripping. Note there are animal traps visible in the attic.

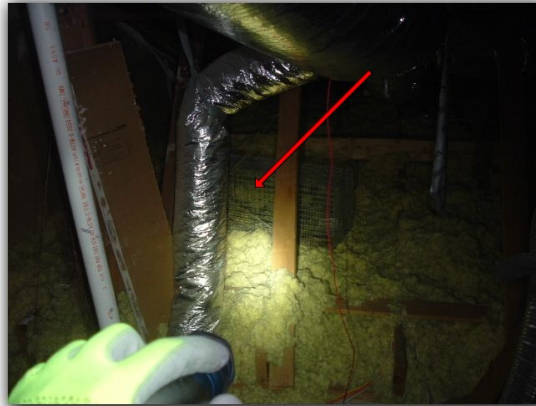
Note there are animal traps visible in the attic

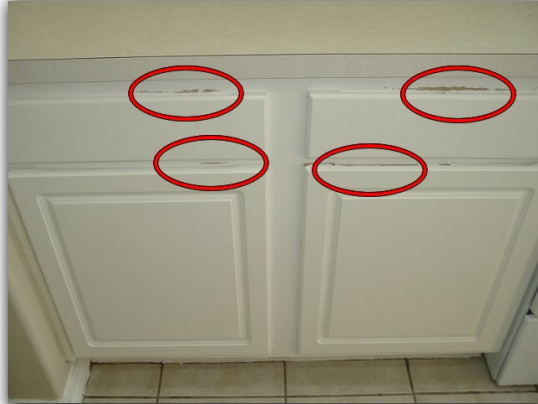
The kitchen cabinets/drawers have visible delamination.

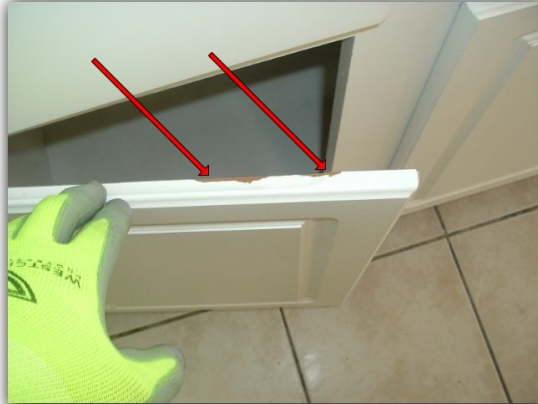
The kitchen cabinets/drawers have visible delamination.

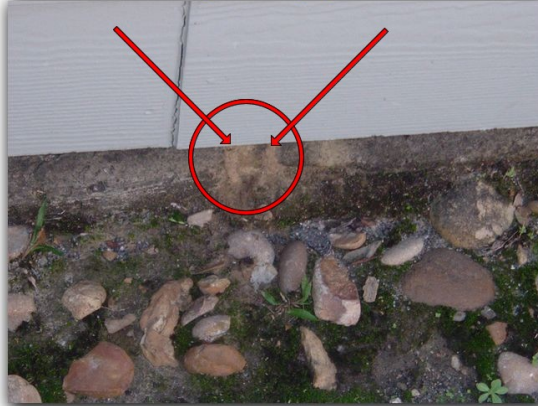
There are visible dirt tubes at the right side of the garage.

5: **Interior Walls:** The kitchen cabinets/drawers have visible delamination. The master shower needs repair to the sealant. **Exterior Walls:** There are visible dirt tubes at the right side of the garage. Consult a licensed exterminator for further evaluation. Not inspected for structural damage behind the dry wall. The rear exterior siding has damage.

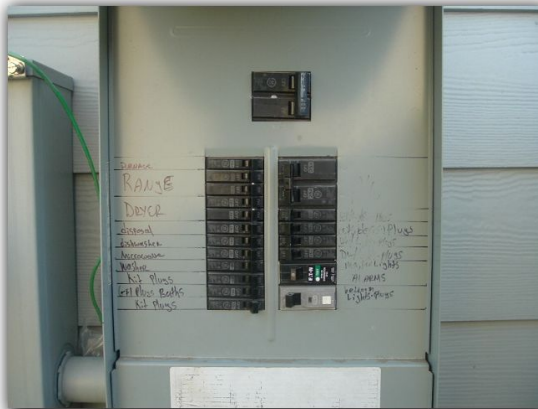
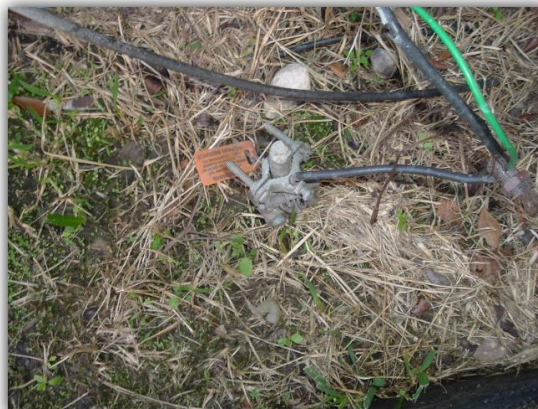
Underground Service:**Main Disconnect Panel:** The panel box is GE brand 100 amp. rated with a 100 main breaker.

10: The aluminum service wires require anti corrosive compound. There are double lugged neutral wires in the panel box. *Each wire needs to be on a separate screw.* The

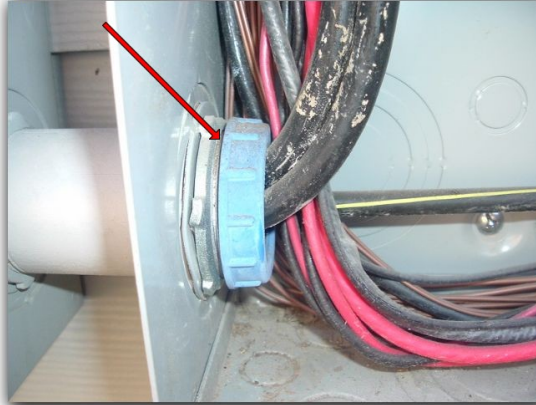
The panel box needs to be bonded.

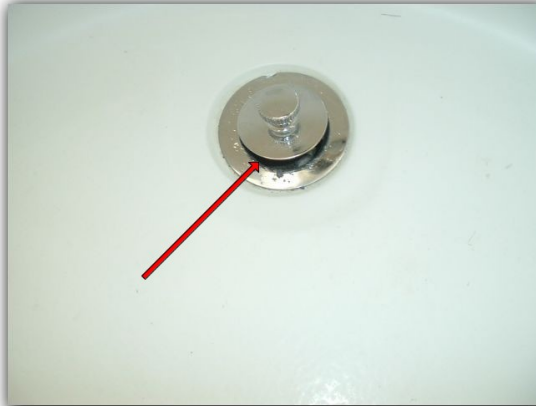
Remove the hair obstruction from the guest tub drain.
