Property Inspection Report #6/27/20239122 Golden Sunshine Drive
8616 Daffodil St. Houston, TX 77063

PROPERTY INSPECTION REPORT FORM

9122 Golden Sunshine Drive, Houston, TX 77064

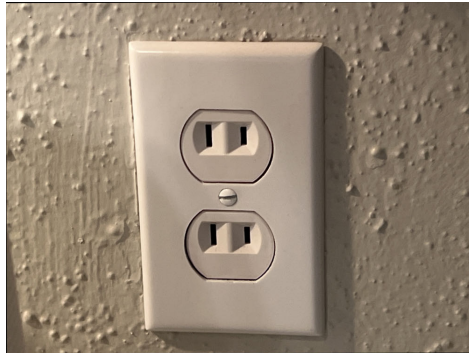
Antiquated romex

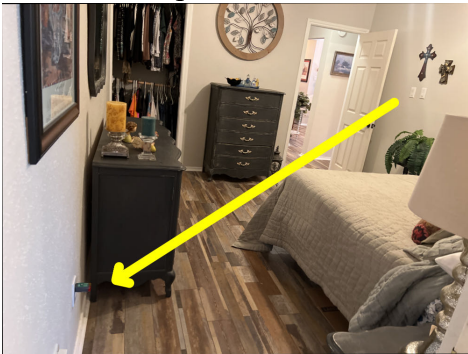
Outlet is switch controlled

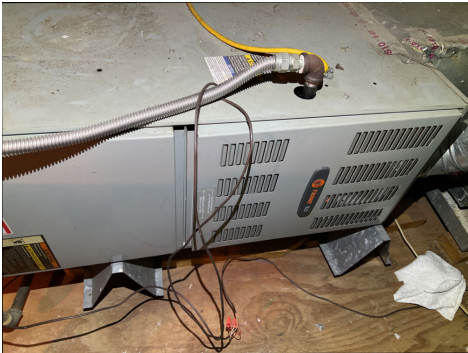
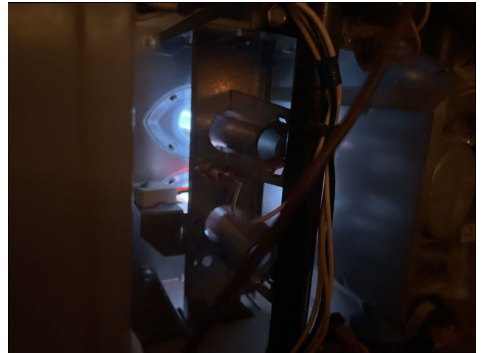
Furnace:
2007 Trane

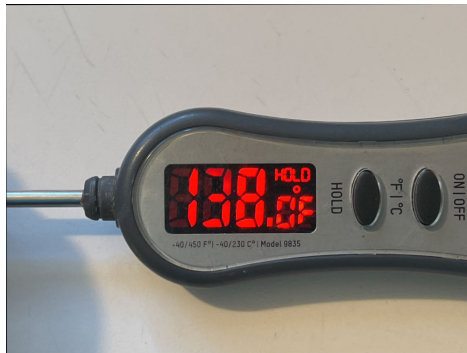
Water temperature
