Property Inspection Report

3618 Goodhope St, Houston, TX 77021
Inspection prepared for: Alexis Vargas

Date of Inspection: 07/22/2023 Time: 2:30PM
Age of Home: 2006 Size: 3072 sqft

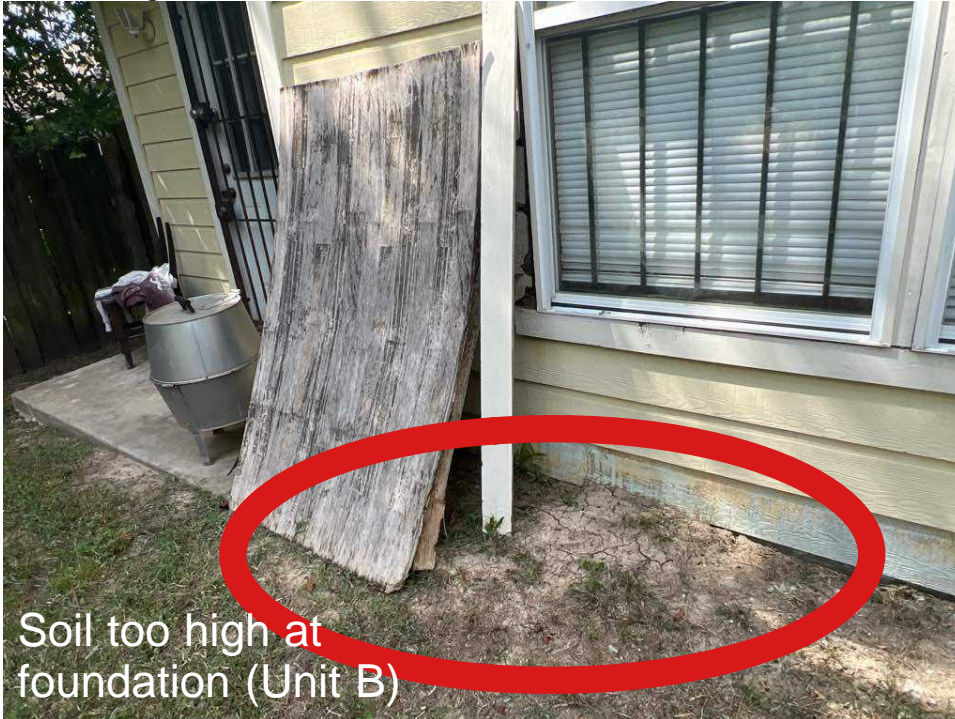
Soil too high at foundation (Unit B)

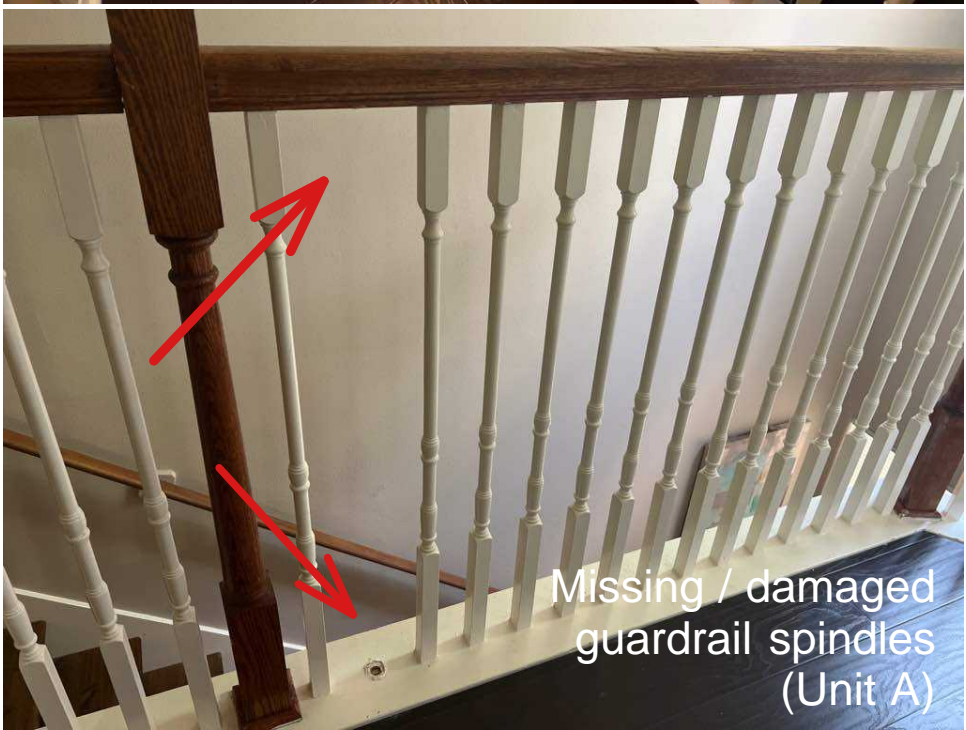
Comments: Wood stairs with wood handrails,
Observed stairway spindle spacing too wide.

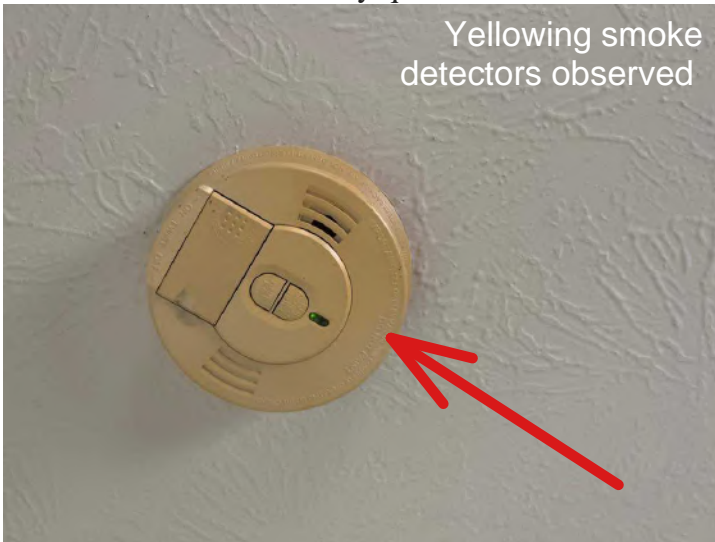
Comments: Kiddie,
Yellowing smoke detectors observed.

Yellowing smoke detectors indicate detectors are beyond the recommended lifespan.

Correction recommended by qualified contractor.

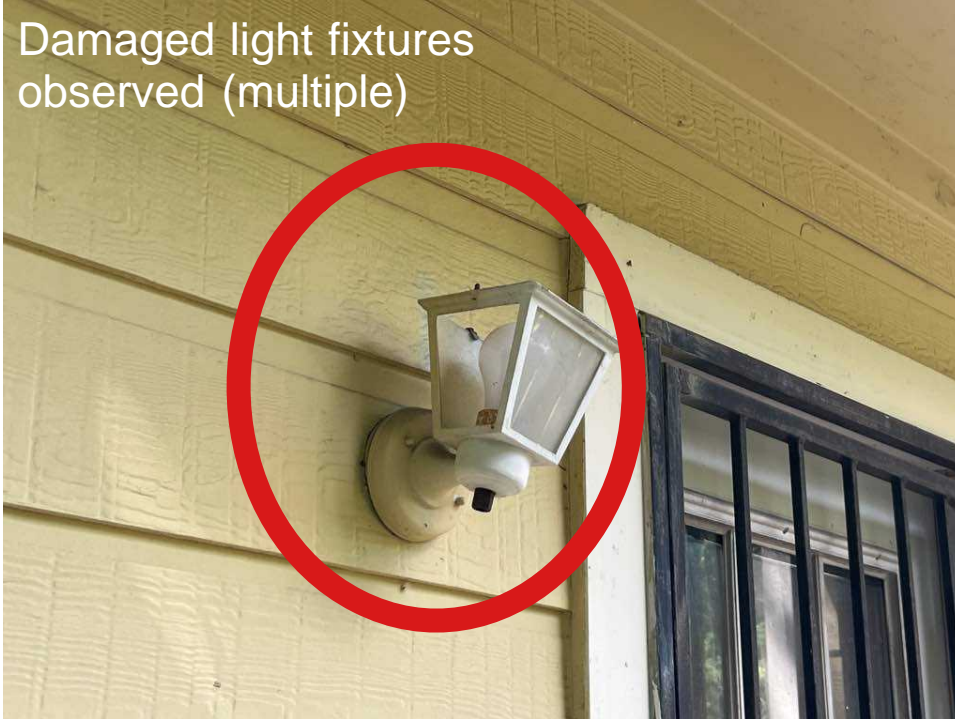
Damaged light fixtures
observed (multiple)

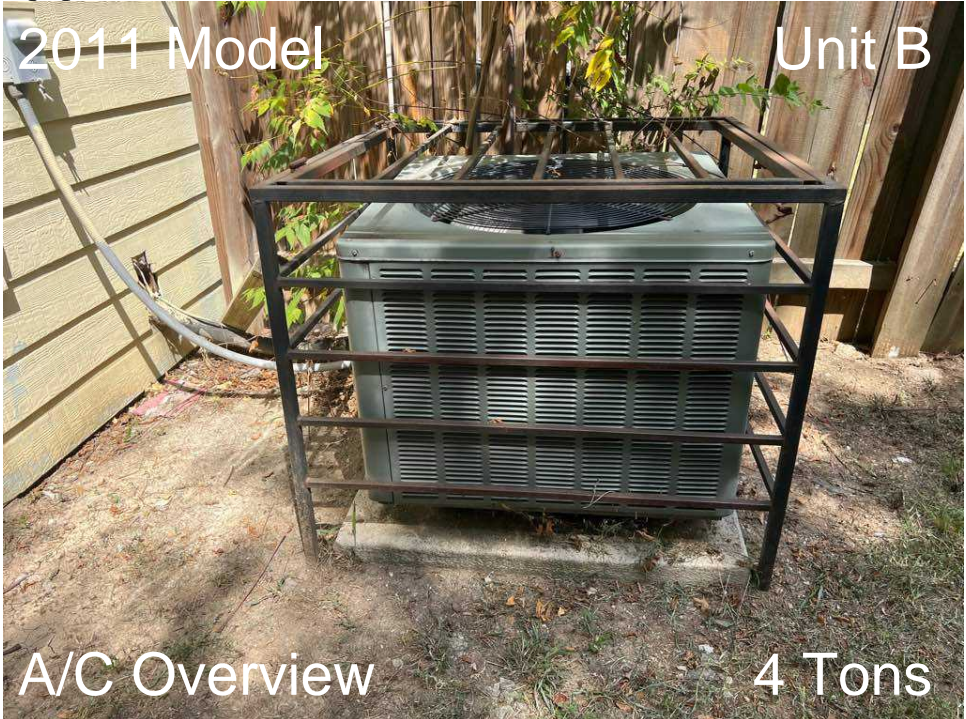
Year of Manufacture 2009, 2011
Tonnage of AC System 3 Tons, 4 Tons

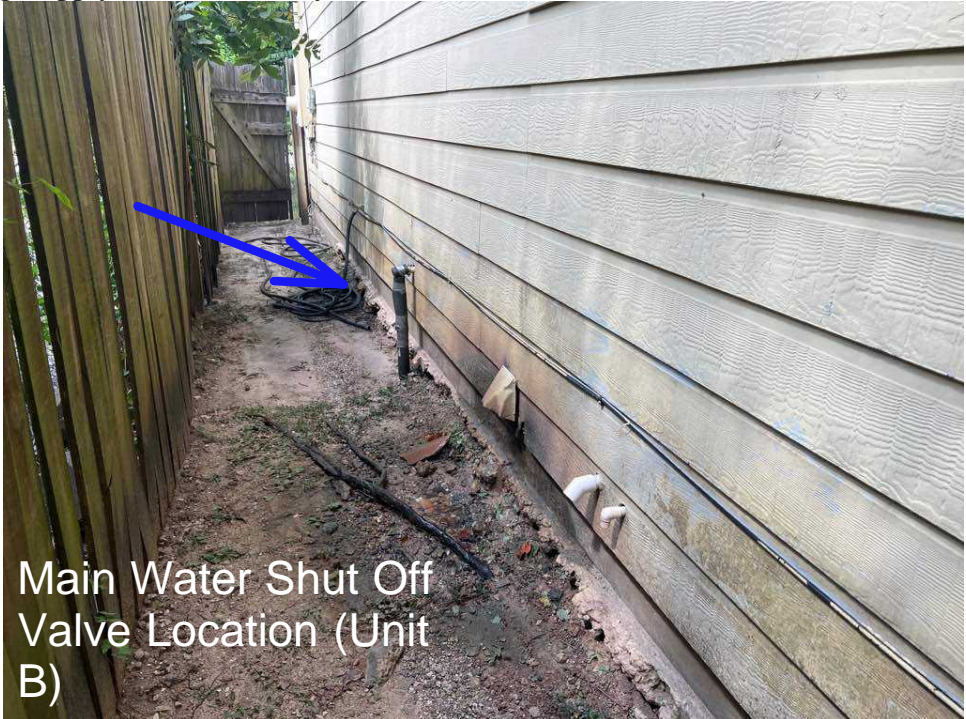
Main Water Shut Off Valve Location (Unit B)

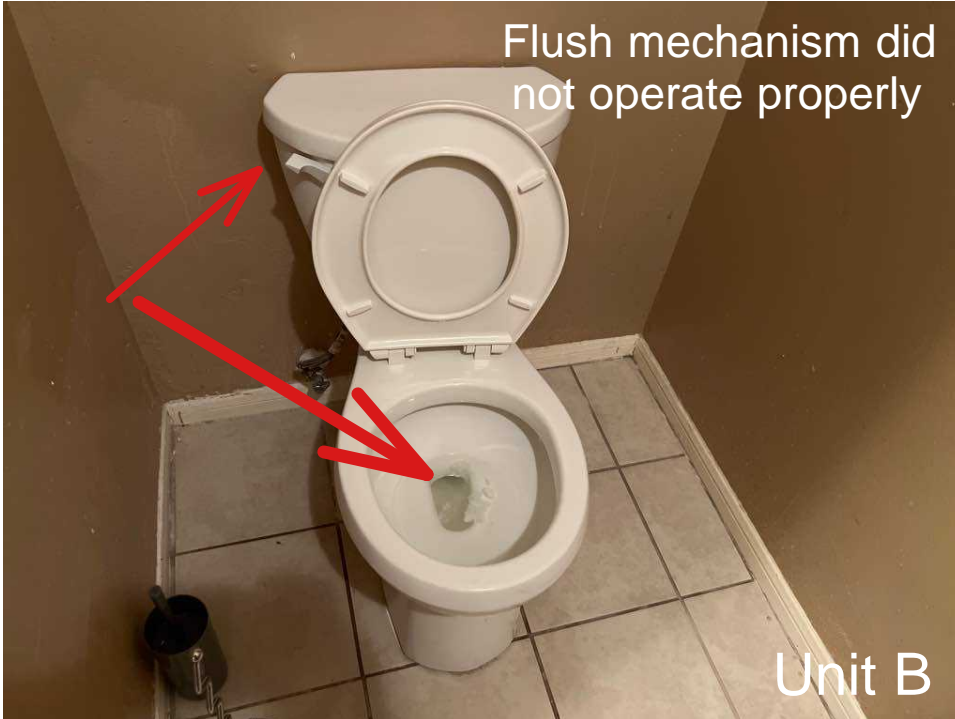
Comments: Flushing (Two-Piece) Toilet,
Observed toilet loose at floor mounting.

Correction recommended by qualified contractor.

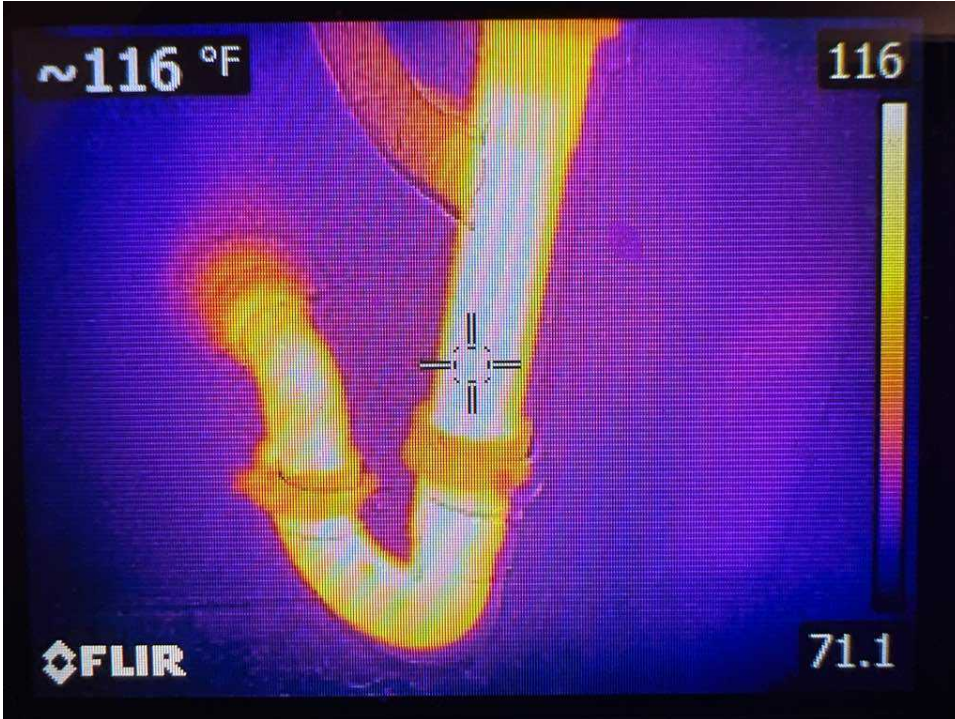
Comments: Built In Sink,
Possible organic growth observed under sink (Unit B)

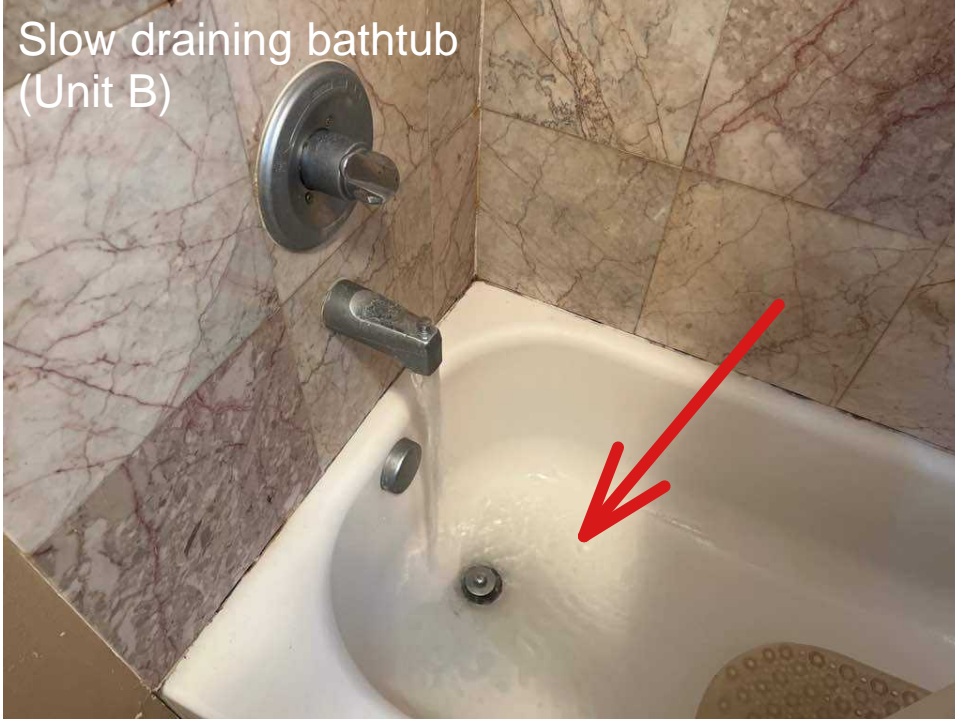
Comments: Built In bathtub / shower,
Slow draining tub observed (Unit B)

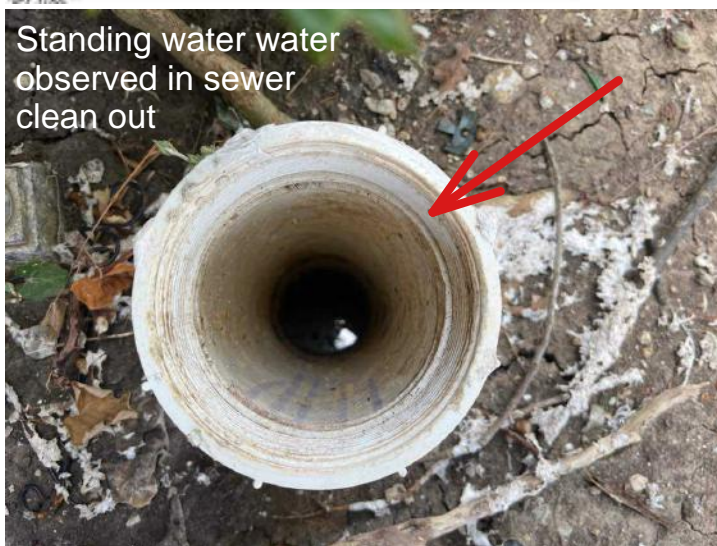
Standing water water observed in sewer clean out location.

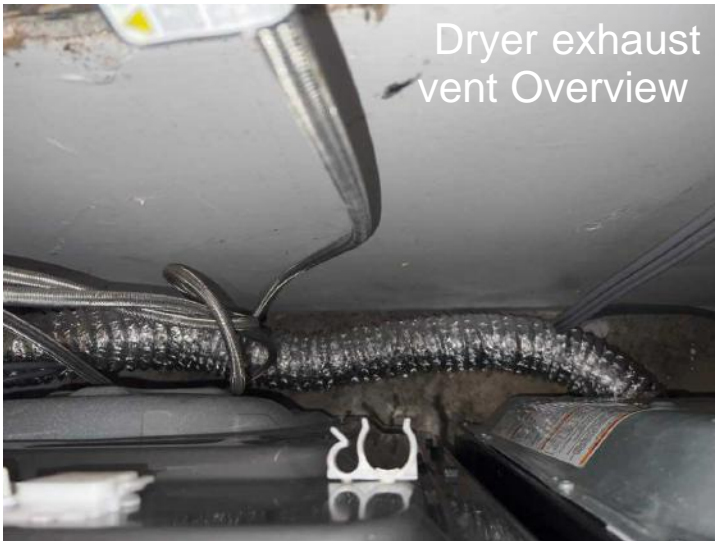
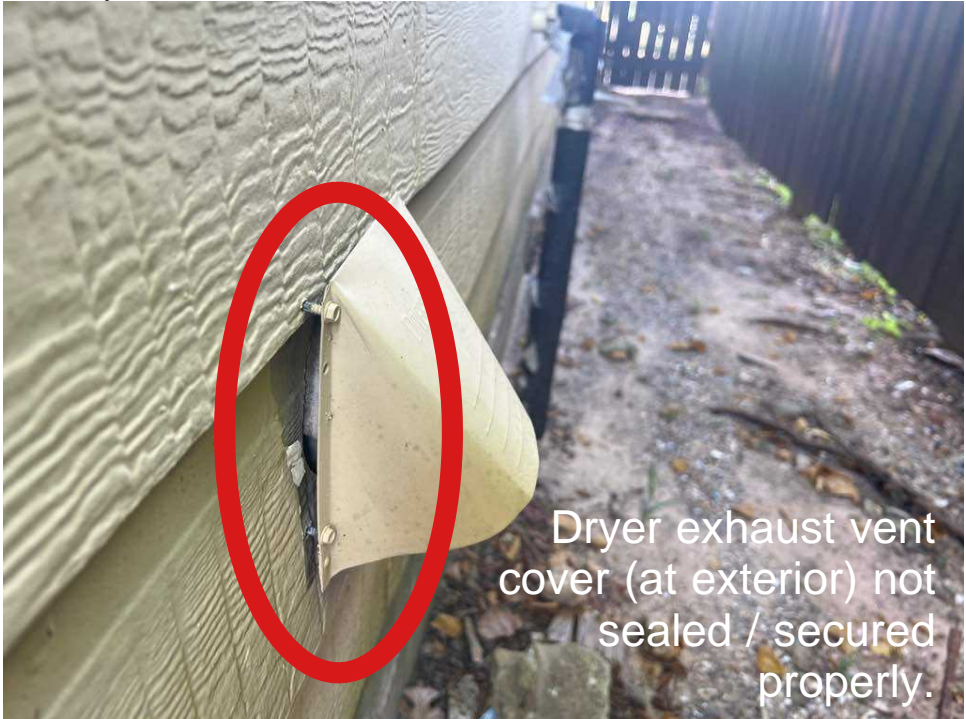
Comments: Metal flex,
Dryer exhaust vent cover (at exterior) not sealed / secured properly.

Dryer exhaust vent cover (at exterior) not sealed / secured properly.

Correction recommended by qualified contractor to minimize potential of pest / moisture intrusion.
