HOUSTON INSPECTIONS

March 12, 2021

PROPERTY INSPECTION REPORT

Concerning: 4713 Lido Ln, Houston, TX 77092
(Address or Other Identification of Inspected Property)

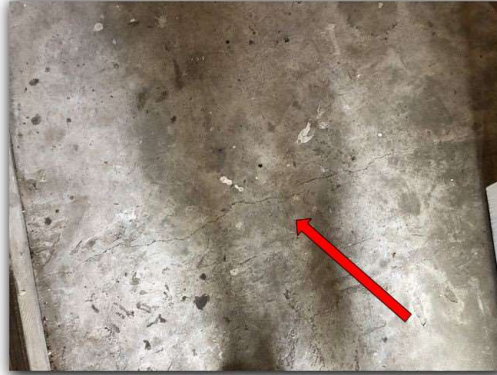
Shrinkage cracks were observed at various visible locations on the foundation / concrete floors. Cracking is a normal property of concrete as it dries and shrinks during the curing process. Additional shrinkage cracks may be present under the floor coverings in the structure.

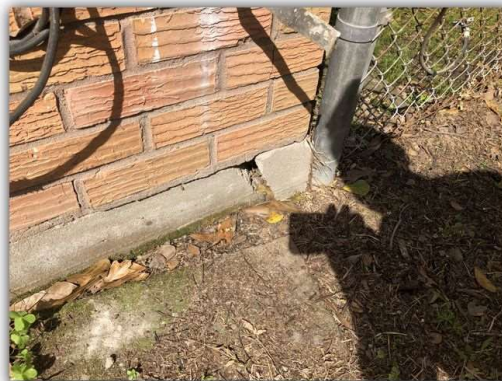
A small portion of the rear corner of the foundation has separated.

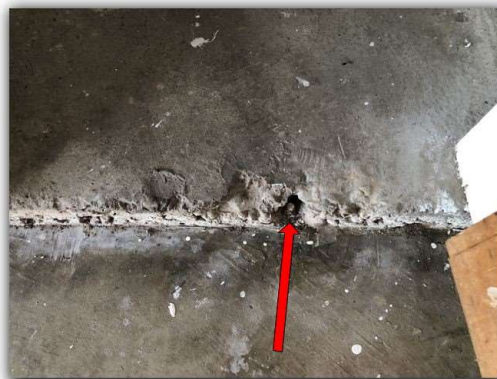
Exposed steel reinforcing bars (rebar) was noted in the garage. Recommend repairs to prevent ongoing corrosion and deterioration of the steel.

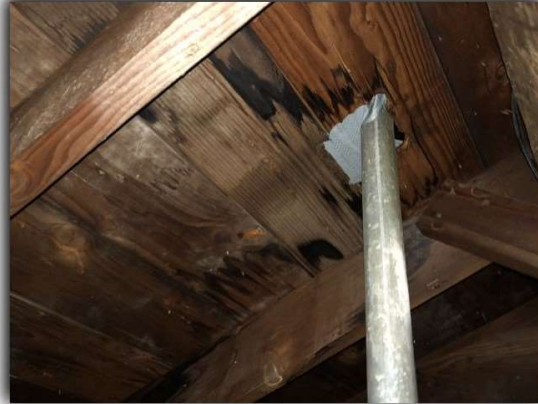
Evidence of previous roof leaks were noted during the inspection as evident by staining on the roof decking, repairs at roof penetrations, or other signs. The current owner(s) should be consulted to verify that the leaks have been repaired properly and that no water penetrations exist.

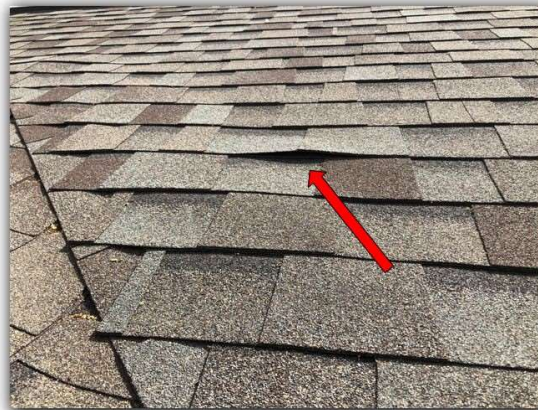
Raised shingles were found at the sections of the roof covering.

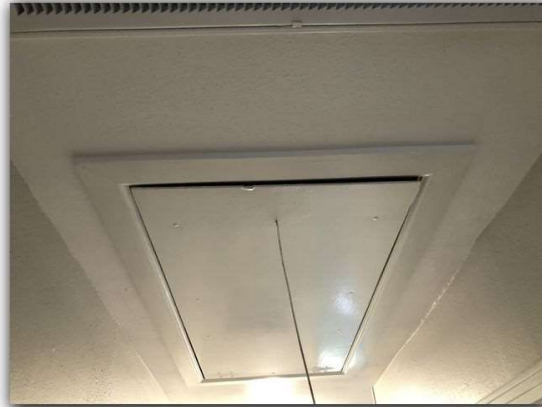
The attic door does not close completely. The door should be adjusted.

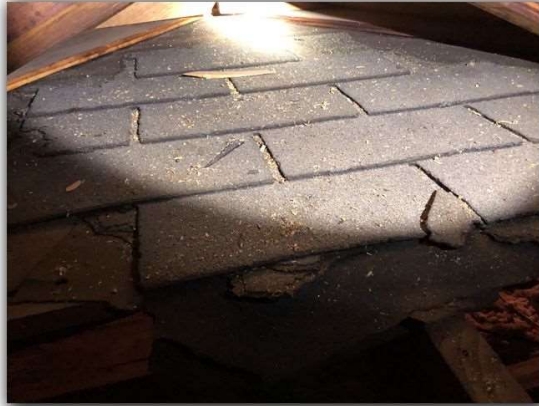
An addition to the home is evident in the attic due to the old roof structure still being present in the attic area.

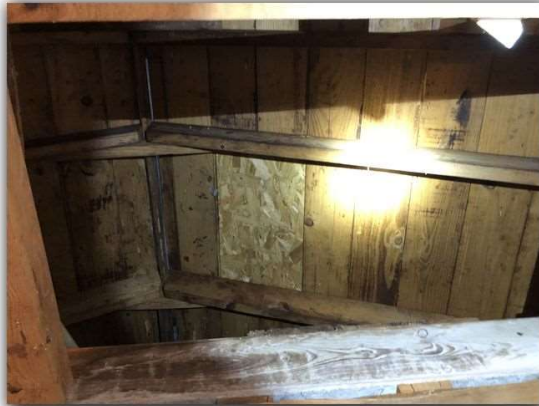
Evidence of previous structural repairs were found in the attic as evident by new lumber at several locations.

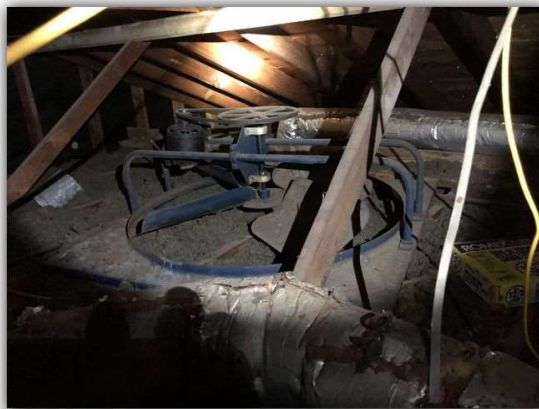
Old / out of service mechanical equipment (water heater, heater, a/c, etc) was found in the attic that was not removed when the equipment was replaced in the past.

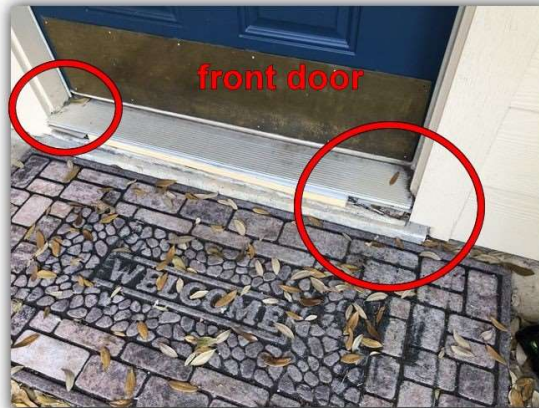
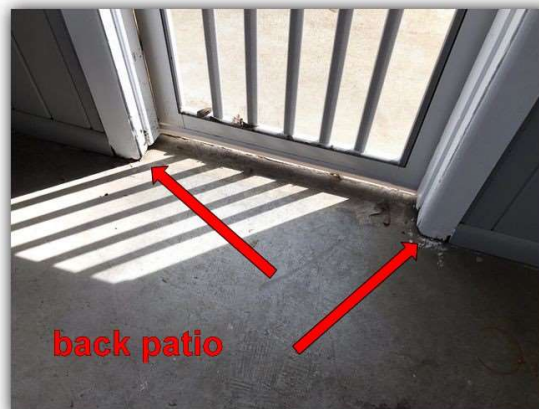
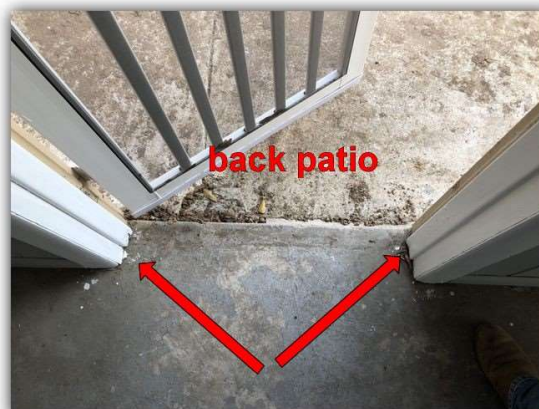
Damaged and / or missing items were found on the exterior of the property. Recommend repairs / replacement of the affected areas. In addition, areas where decay is present should be removed, exposing underlying materials for inspection prior to repair by a qualified tradesman.

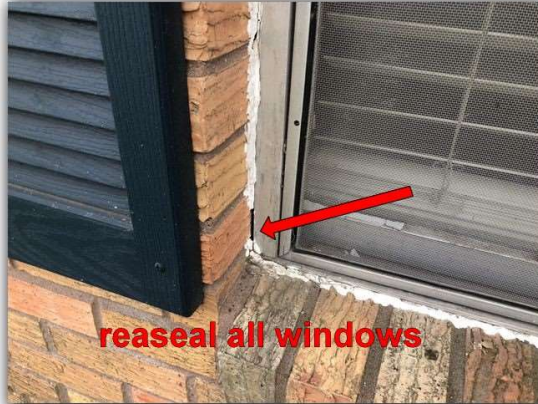
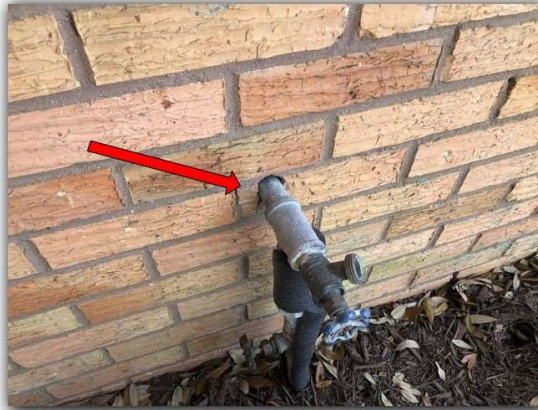
All exterior wall penetrations (electrical panels, electrical disconnects, light fixtures, etc.) and openings (expansion joints, windows, door thresholds, etc.) should be sealed with an approved material to prevent water penetrations into the wall cavities. Properly sealed exterior veneers help provide a barrier against the weather, insects, and enable environmental control of the interior spaces.

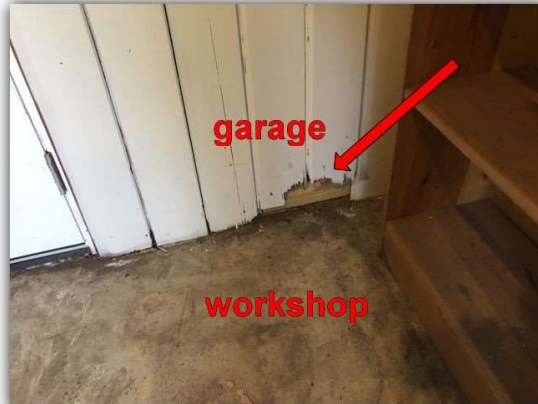
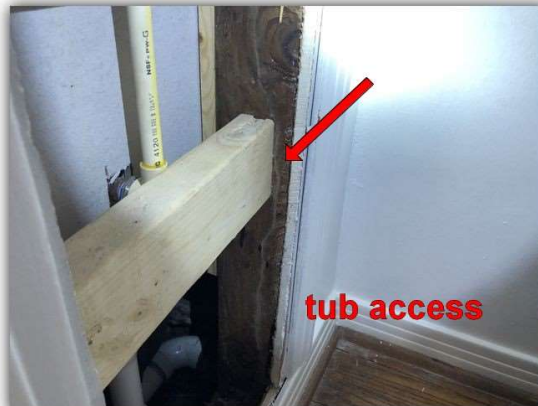
Damage wood and other veneers were found in the garage, bathroom tub access, and attic. The damage appears to have been caused by wood-destroying insects. All visible and underlying damage should be removed and repaired. In addition, the wood-destroying insects, if active, should be treated by a licensed pest control company.

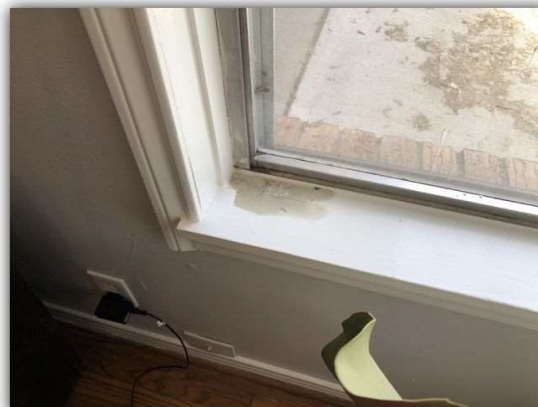
Staining and discoloration was found at the windowsills in several rooms.

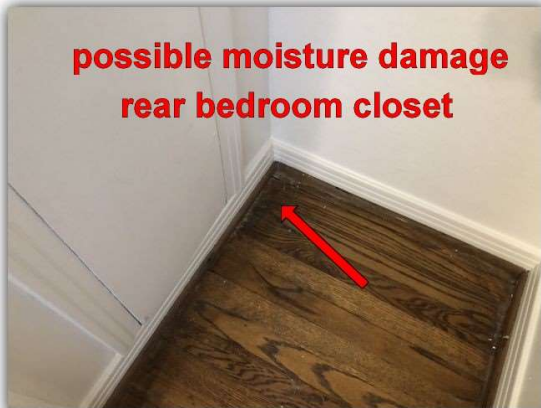
The wood floors are showing signs of wear and tear (ding's, scratches, etc.).

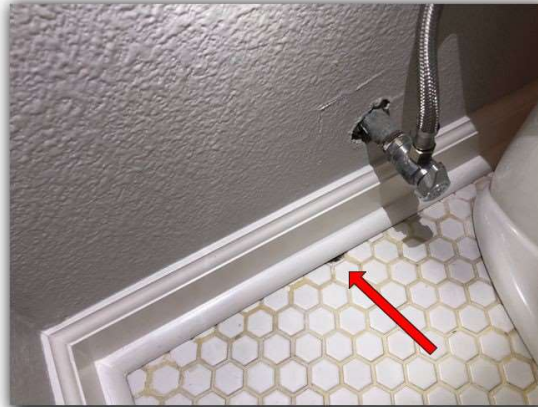
Damaged and missing grout was found at the floor tiles in the kitchen and bathroom.

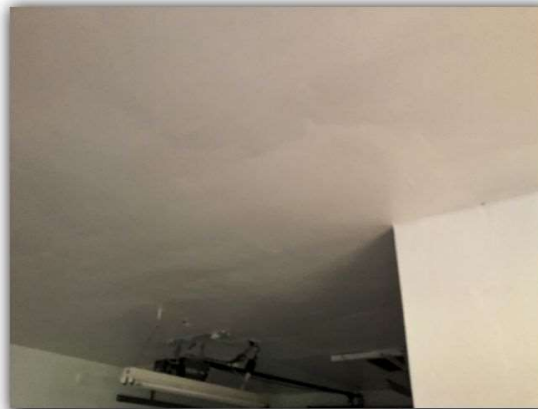
Evidence of patching was found at several sections of the ceilings in the home.

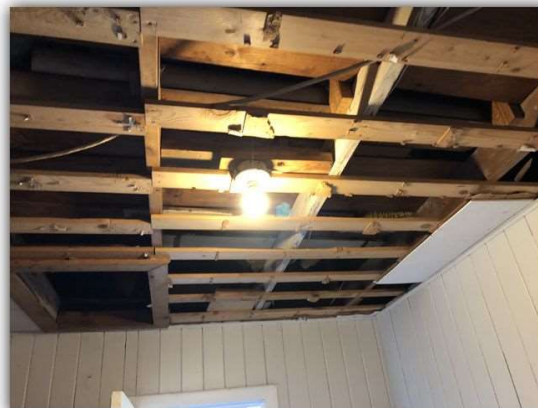
The ceiling has been removed in the garage workshop area.

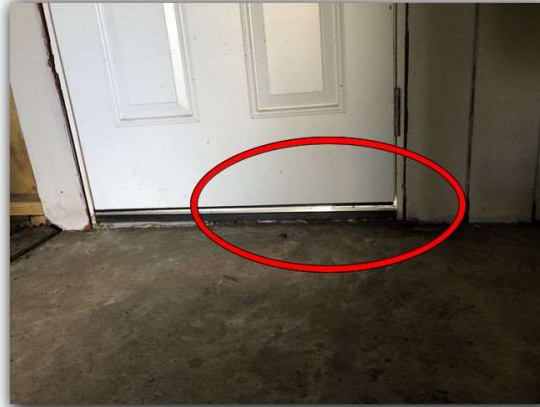
Voids were found at the weather stripping at the garage workshop exterior door. .

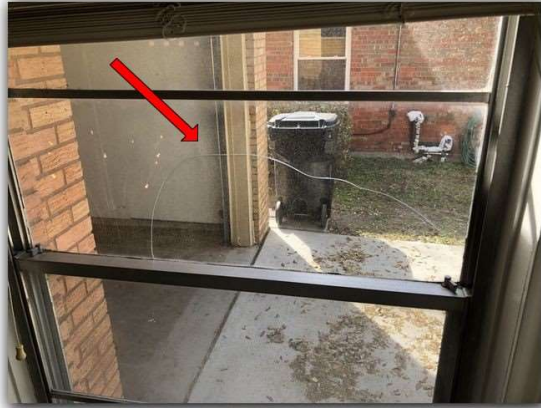
Cracked glass was found in the formal living room.

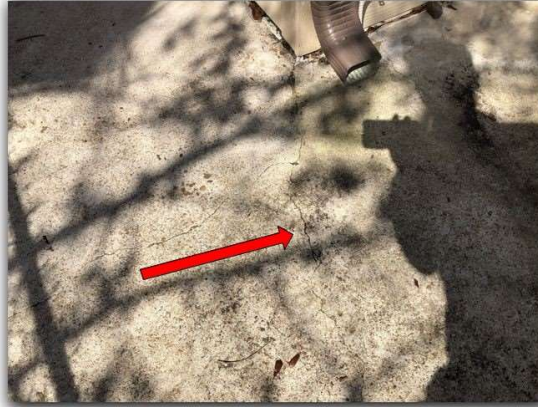
Cracked, uneven, and damaged patio flatwork was found around the property.

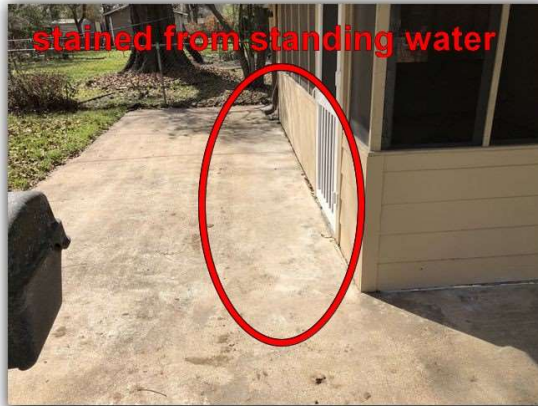
The patio appears to slope toward the structure. Evidence of standing water was found at this area. Flatwork should slope away from the dwelling.

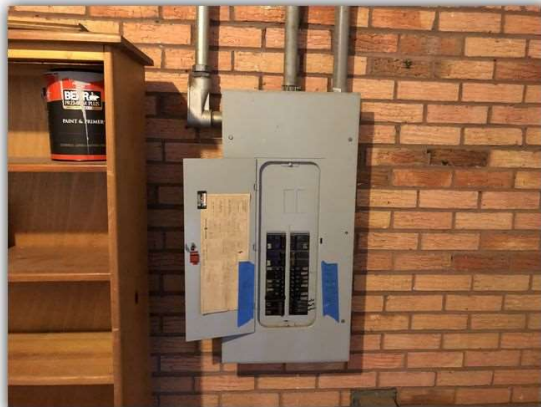
- Grounding clamp improper style for rod Installations
- Wires not secured to the panel openings and / or run through common holes
- Bonding not present / visible at gas lines

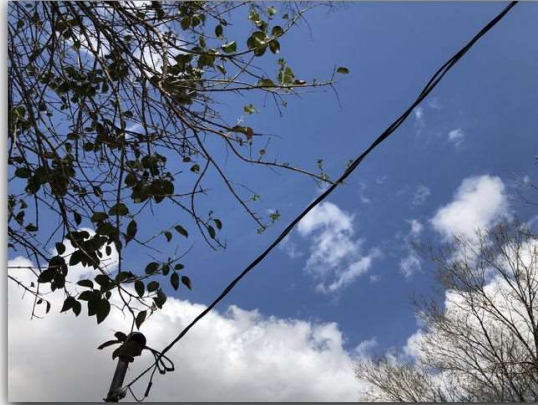
The tree limbs in contact with the overhead electrical conductors should be removed.

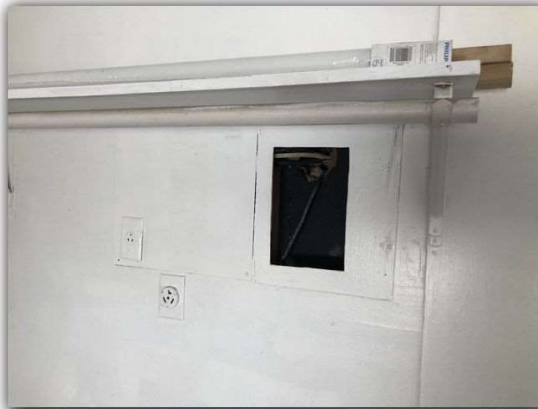
Access was made in the wall behind the sub panel. This is a safety hazard and the access should be sealed to prevent shock hazard.

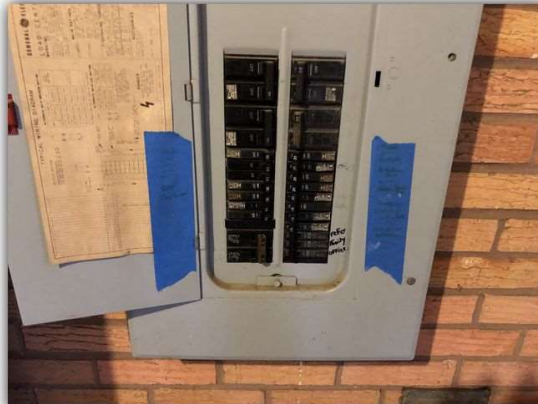
The electrical panel should be relabeled as the original markings are beginning to fade.

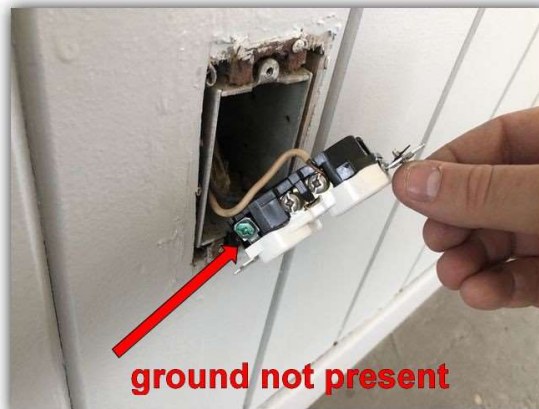
1. throughout the home

Only approved & compatible receptacles & switches should be used. A licensed electrician should be consulted to further investigate the electrical system and perform all necessary repairs.

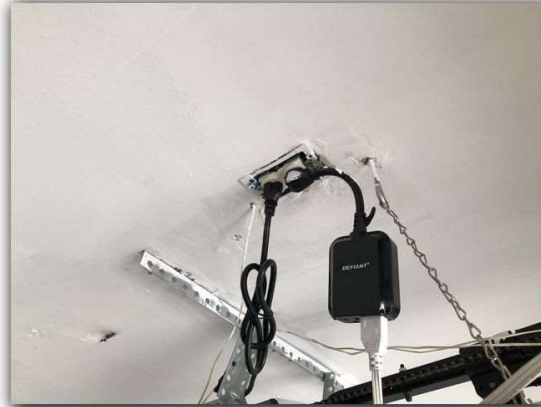
Missing / loose receptacle and switch plates were found at various locations at the property being inspected. All cover plates should be installed.

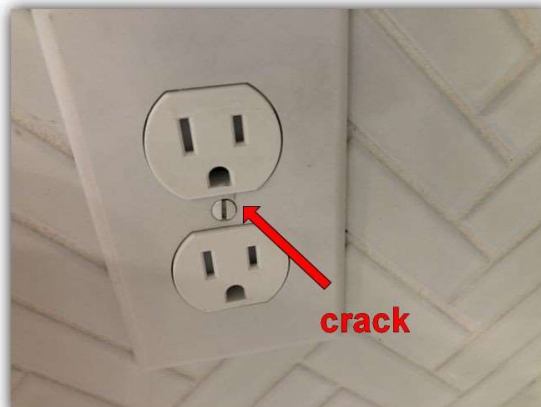
Damaged cover plates were found in the kitchen and attic. Recommend replacement of the plates.

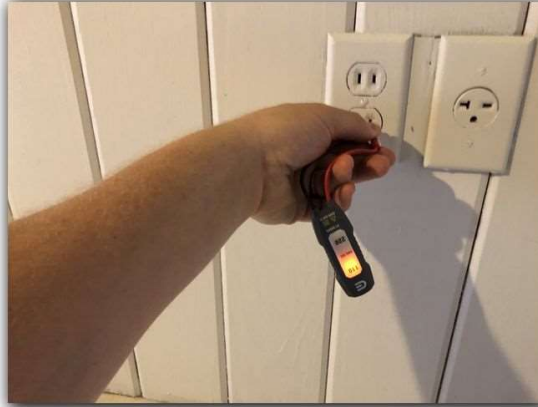
Two prong un-grounded receptacles were found at various locations in the property.

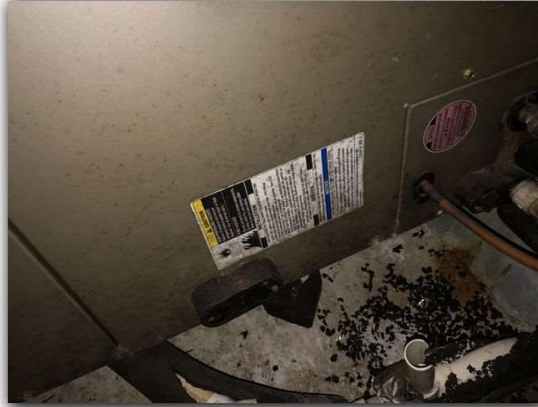
What appears to be microbial growth was noted on the exterior of the HVAC components located in the attic. Recommend further evaluation to determine if repairs are needed.

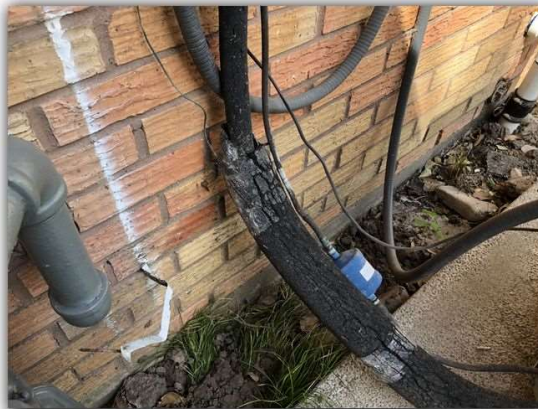
Damaged and missing insulation on the visible portions of the refrigerant lines should be repaired/replaced.

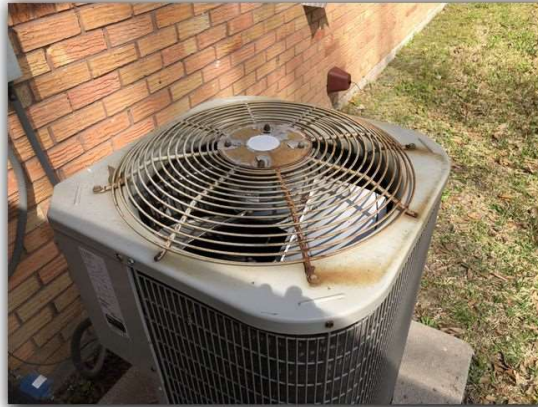
Rust and corrosion was noted at the exterior of unit(s) # 1.

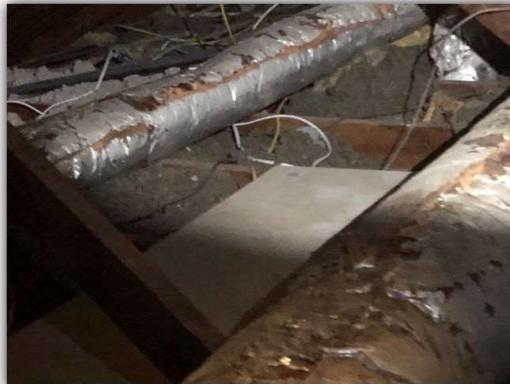
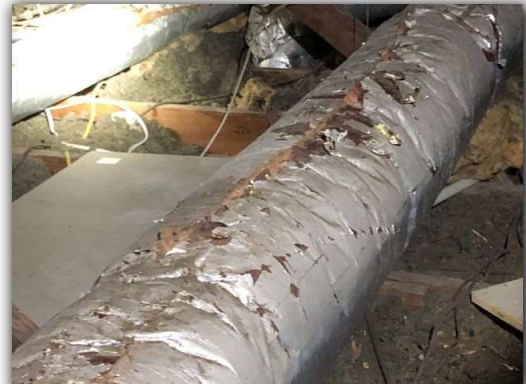
Damaged ductwork was noted in the attic.

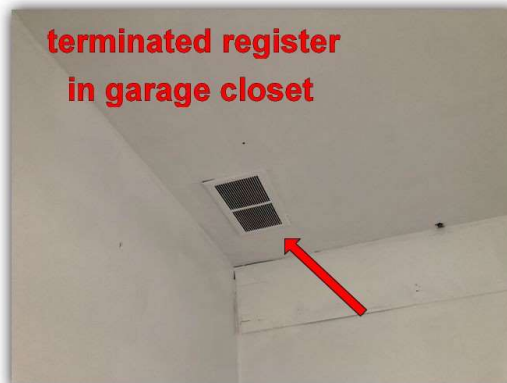
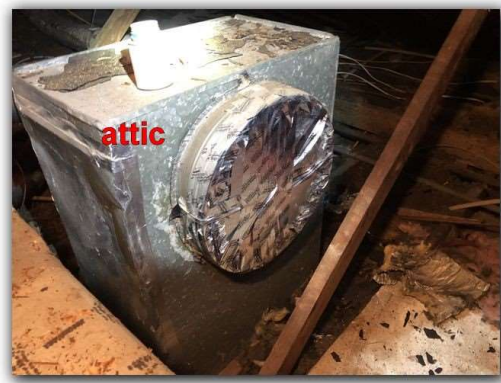
Terminated ductwork was noted in the home.

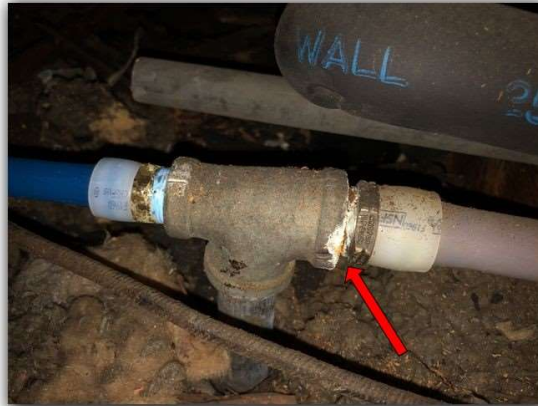
Corrosion was found at the supply piping at the following location: attic. No active leaks were found during the inspection, but these can develop at any time. A licensed plumber should correct this problem.

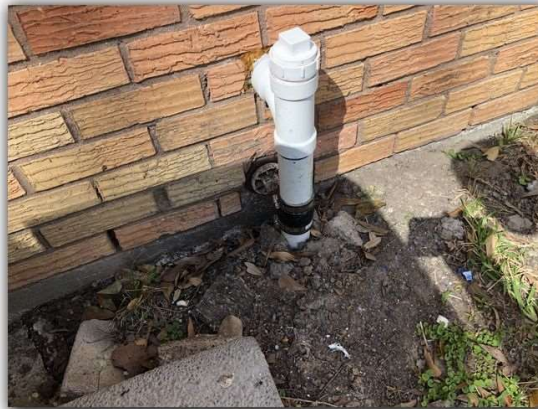
- PVC piping exposed on exterior not painted to protect from UV rays

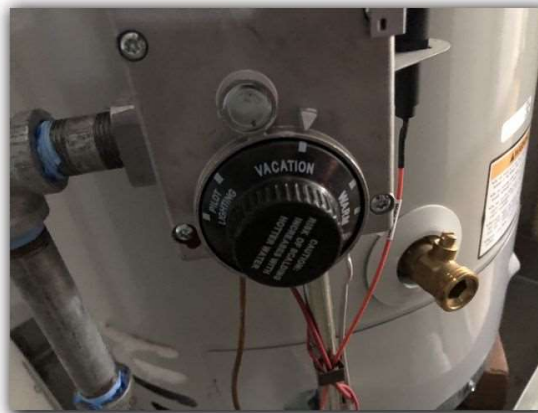
The hot water heater was functional at the time of inspection. The unit should be drained and flushed periodically to eliminate chemical deposit buildup. Adjust temperature to a maximum of 120 degrees to prevent scalding. The water heater was set to "vacation" mode at the temperature control.

Improper clearance of flue pipe from combustibles

Discoloration was noted at the water heater flue pipe possibly due to the improper clearance at the pipe. Recommend improvements.

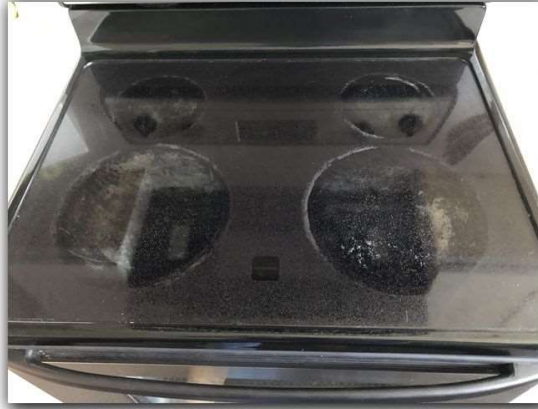
Items Damaged, Non-Functional, or Operating Improperly
Damage was found at sections of the surface on the oven/stovetop.

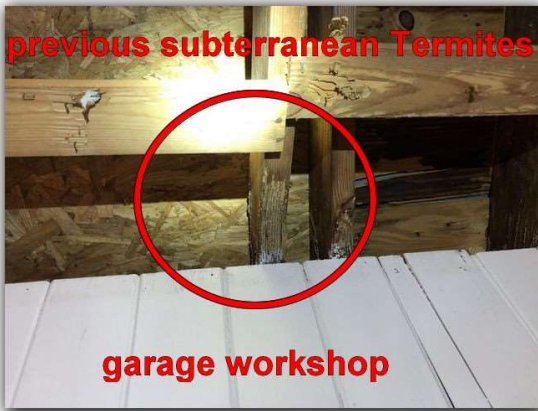
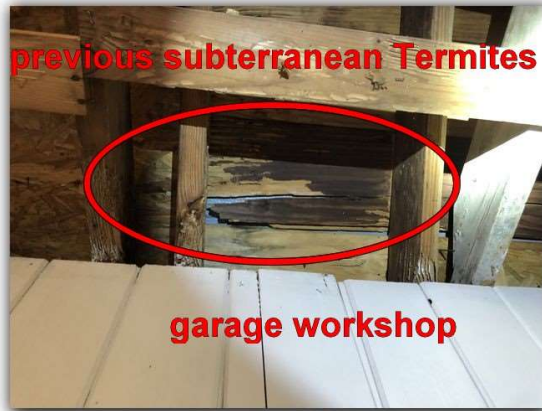
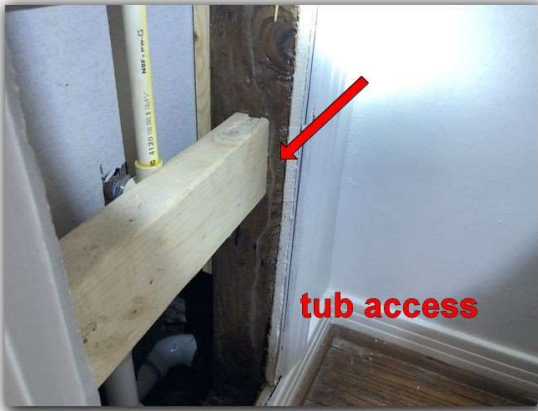
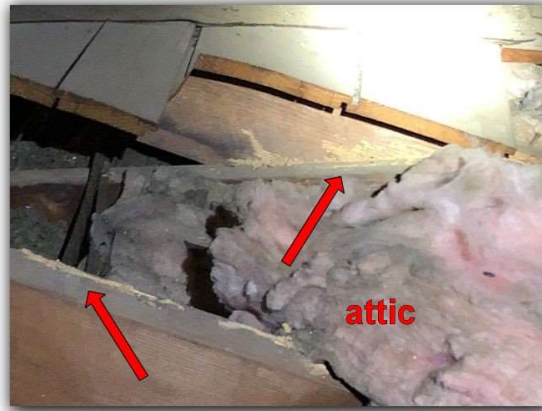
Wood Destroying Insect Activity or Evidence: Yes (Sample Pictures Below)
