**A-BETTER INSPECTION INC.**

Residence is a one-story wood frame structure.  
For the purpose of this report, residence faces west.  
Residence was vacant at the time of the inspection.

5342 Marisol Cove  
Katy, TX 77493

# PROPERTY INSPECTION REPORT FORM

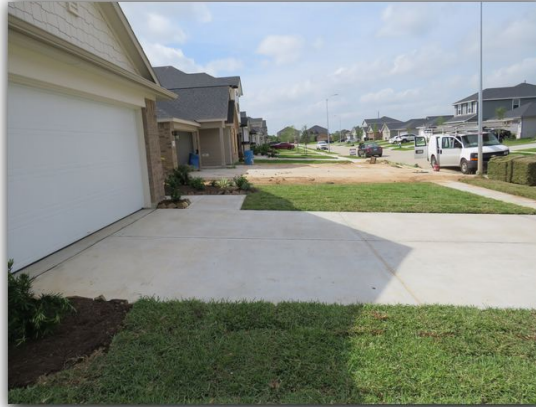
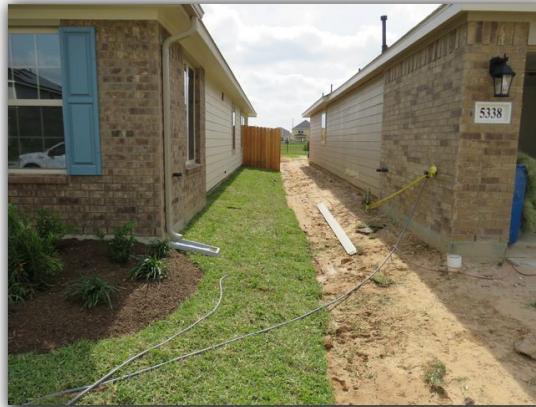
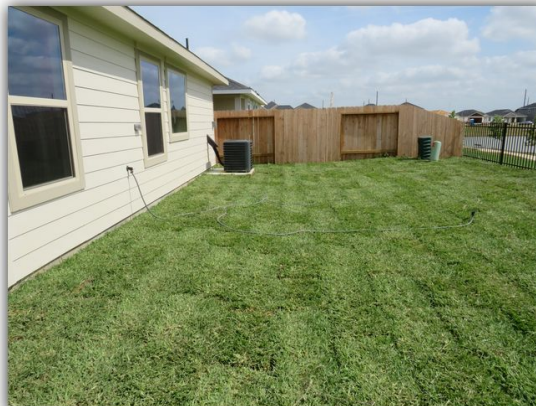
The grading on the property appears satisfactory at this time. The slope and drainage was considered typical and normal. It is recommended that 3-5" of foundation exposure be kept around the perimeter of the foundation and that a consistent moisture content be maintained. Improper grading and moisture control can lead to possible foundation problems.

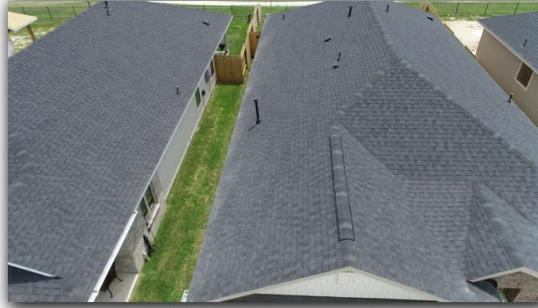
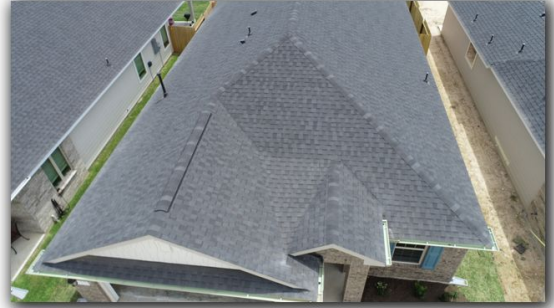
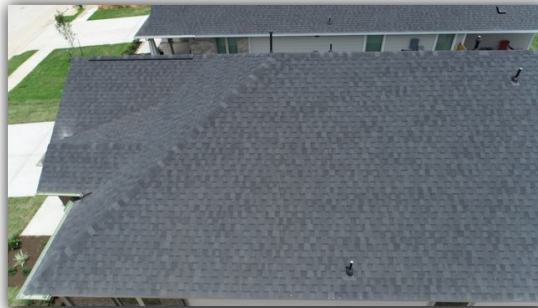
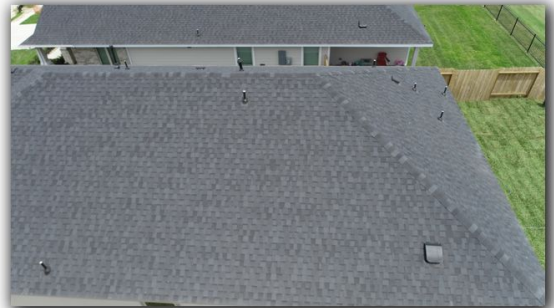
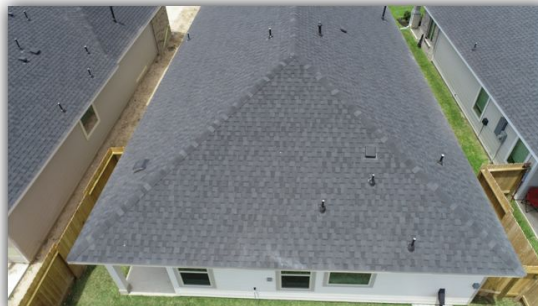
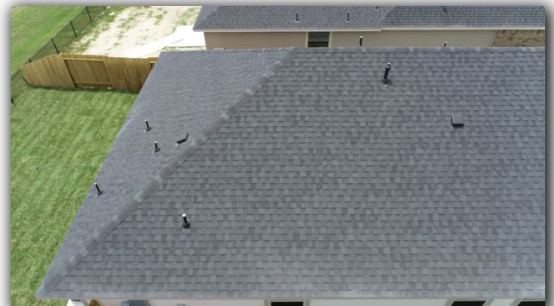
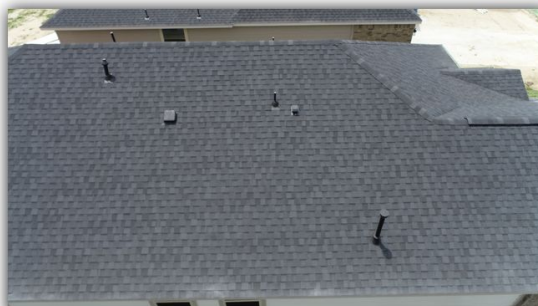
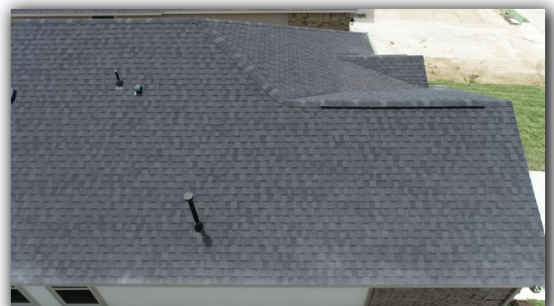
The residence was observed as having a hip and gable framed roof with a composition shingle cover. The roof was observed and inspected from ground level using visual aids. The overall visible shingle cover, associated flashing, and roof venting jacks appeared in satisfactory

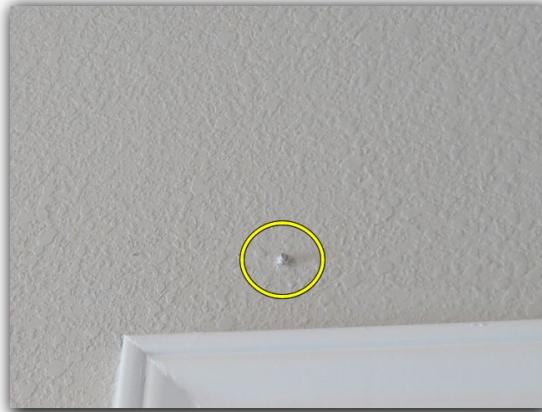
There appears to be a protruding nail at the drywall in the northwest bedroom above the bedroom entry.

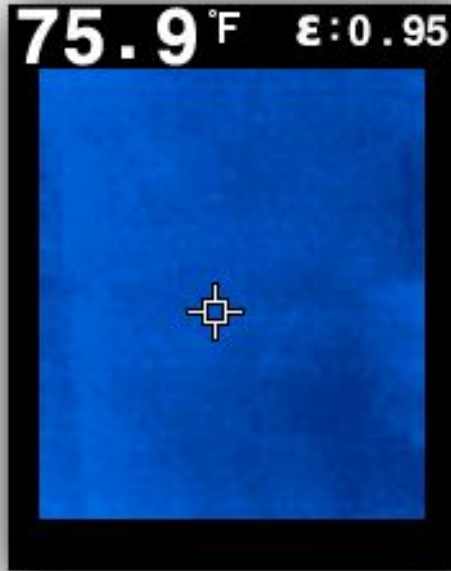
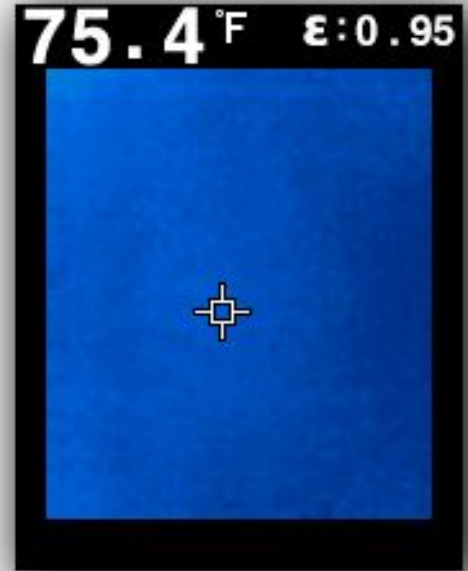
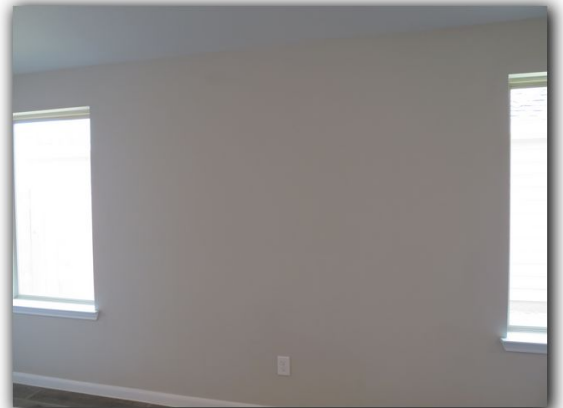
Thermal imaging of the perimeter walls of the living area did not reveal any anomalies at this time. The following thermal images are followed by the digital pictures of the area below the image.

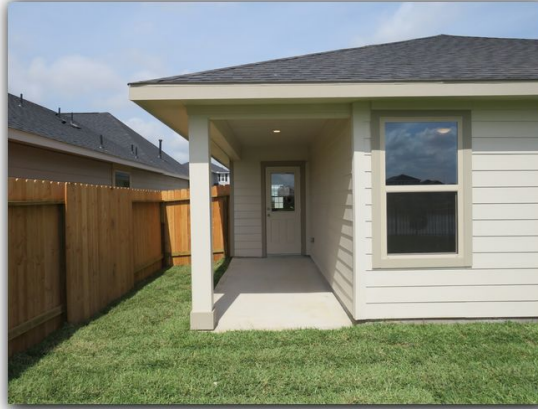
The patio area looked unremarkable at this time.

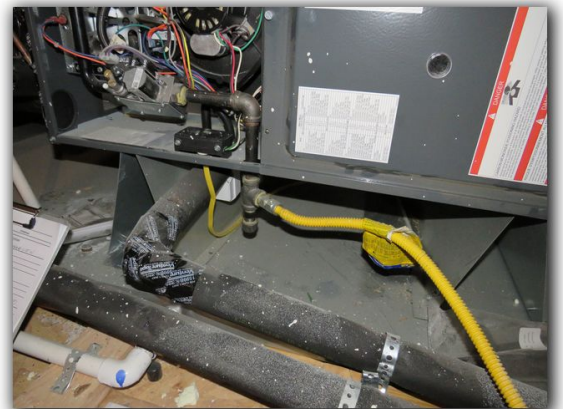
2021 GOODMAN gas fired forced air 40,000 BTU furnace MOD. #GMVC960403BN.

Furnace was operated using the standard manual controls. Furnace operations appeared satisfactory at this time. Burner compartments were relatively free of rust or scale deposits and the flame color was consistent. Furnace installation was also considered satisfactory at this time.

Air handler was equipped with a media filter. Recommend replacing the filter every 6-8 months. Additional filters may be used on air returns if desired. Recommend using the economy filters so as not to impede air flow.

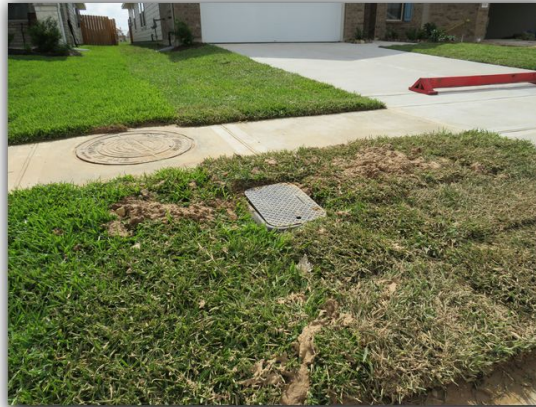
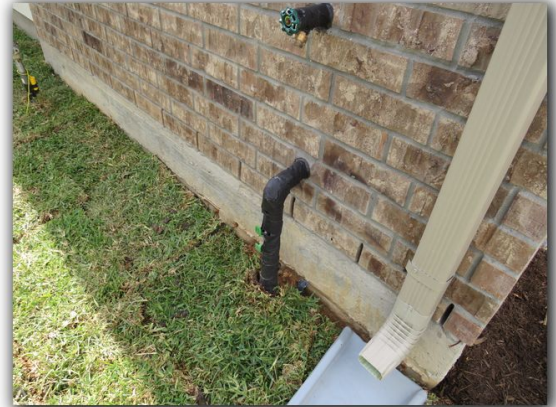
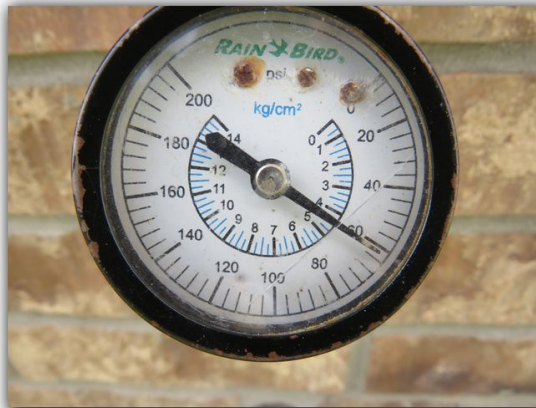
The plumbing in the residence appears to be constructed of PEX piping. No plumbing leakage from the visible or accessible piping was observed at this time. While no piping leakage was observed, it should be noted that the majority of the piping is concealed by interior walls and insulation in the attic and is not visible. Functional flow was observed at all plumbing fixtures at the time of the inspection.

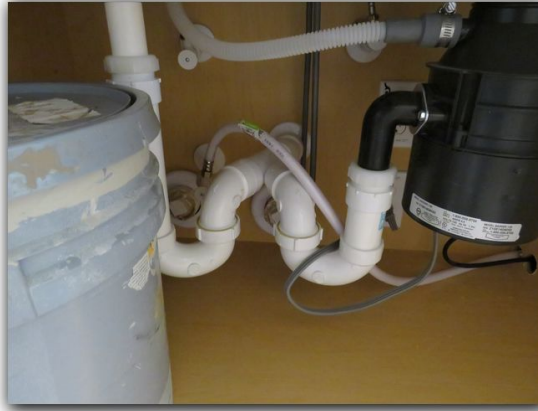
The plumbing fixtures in the residence were operated simultaneously for an extended period of time in an effort to determine the condition of the drainage system. No drainage problems were observed during the operation of the fixtures at this time. It should be noted that no underground leak testing of the drainage pipes were performed at this time.

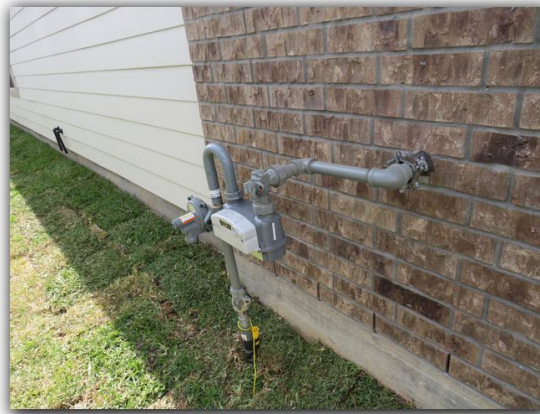
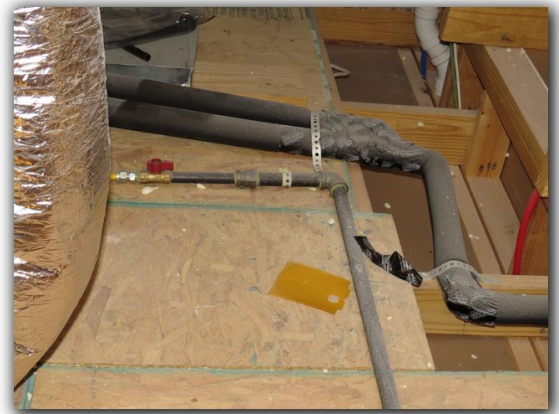
The gas supply system appears to be in satisfactory condition at this time. Please be aware, the majority of the piping is concealed and not visible for inspection.

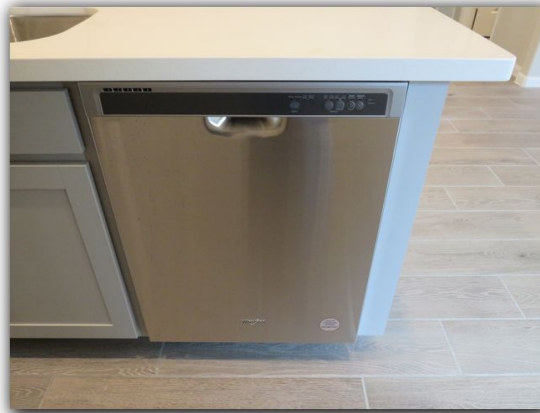
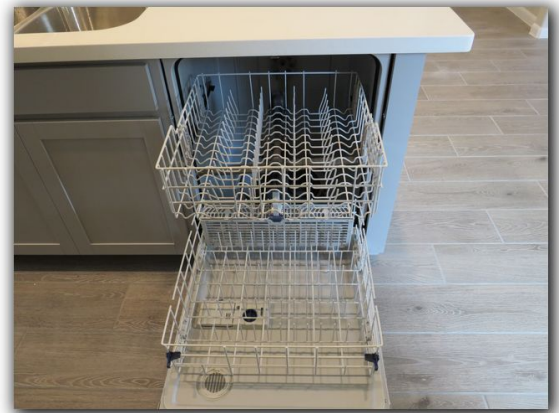
The WHIRLPOOL dishwashing unit was found to be operational. No leakage or cycling problems were observed at this time.

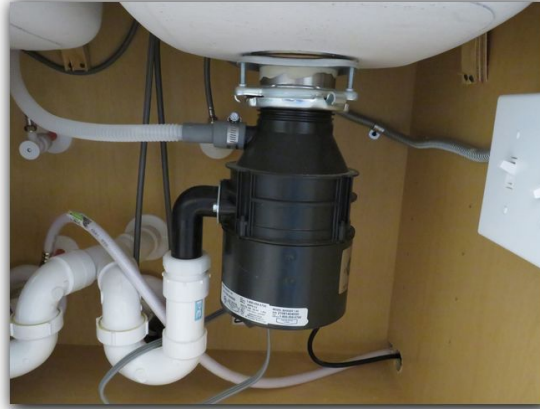
Disposal was operational at the time of the inspection.

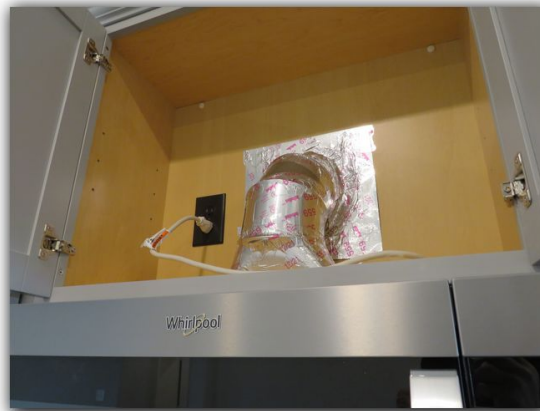
Range hood was operational, vented and incorporated in the microwave.

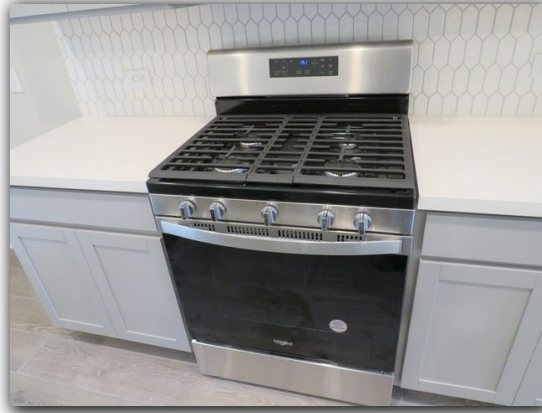
The WHIRLPOOL gas range and oven were observed to be operational. Oven temperature was consistent with oven settings.

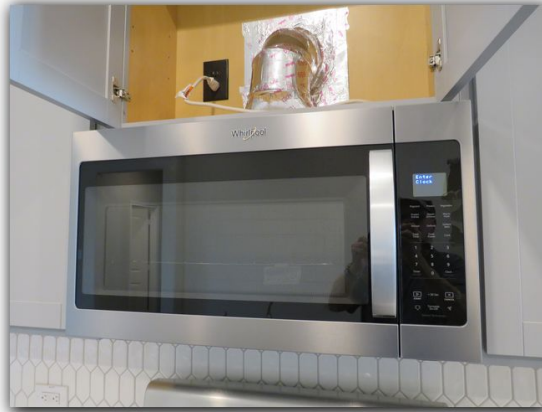
The WHIRLPOOL microwave oven was observed to be operating properly. No microwave leakage was detected at the time of the inspection.

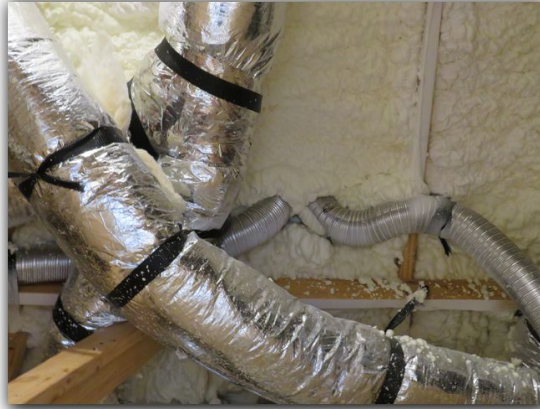
Bathroom and utility room exhaust fans were observed to be operational and vented to the exterior.

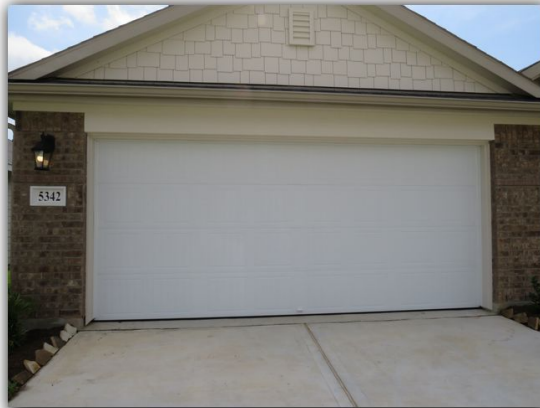
The **manual** 16x7 garage door was observed to be functional at the time of the inspection.

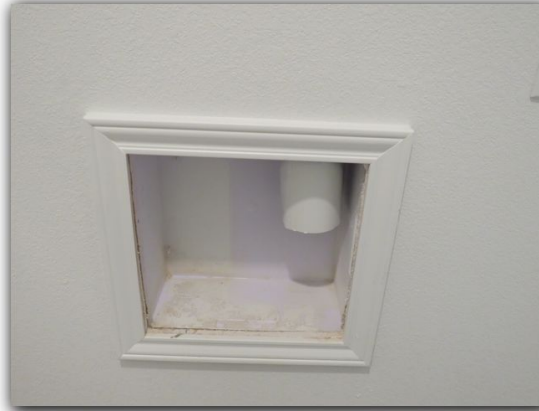
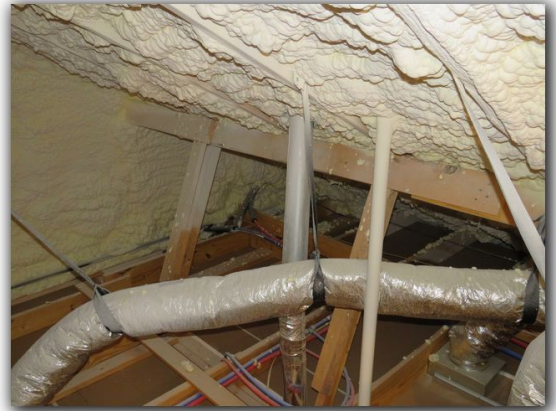
Dryer exhaust duct was installed and routed to the exterior for discharge.

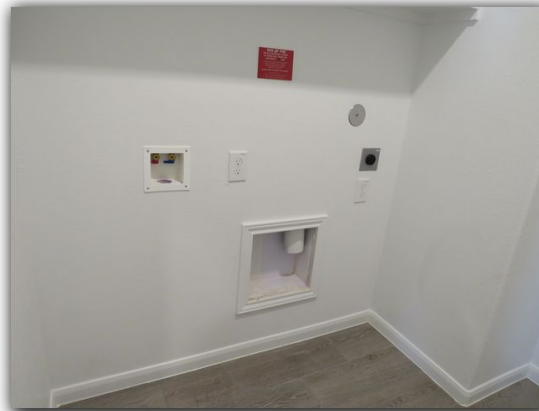
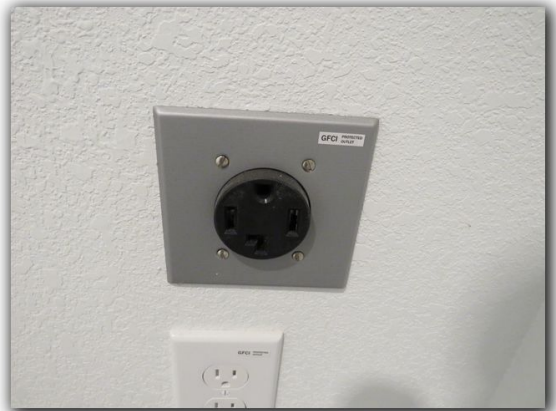
**UTILITY ROOM:** 120-240v electric supplied services.  
The utility room is equipped with a 4-prong 240v outlet.
