Property Inspection Report

**Jay Bertrand 23607
Noble Inspection LLC**

2202 Hilshire Trails Drive

Date of Inspection: 8/7/2023

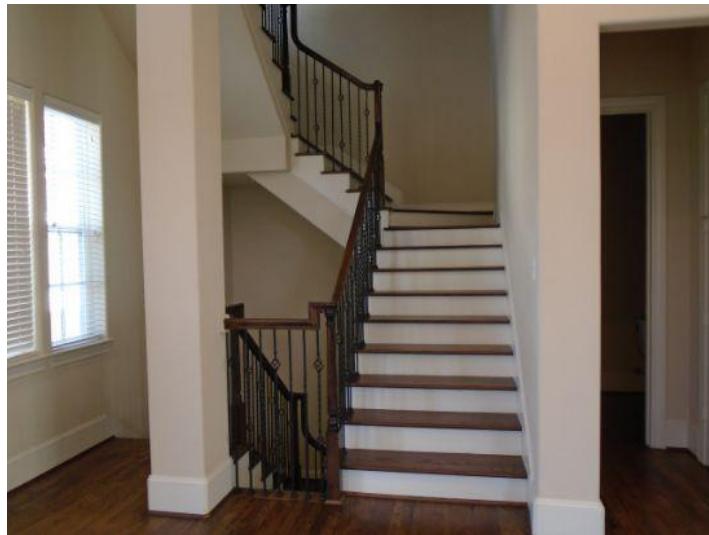
Stairway and steps leading to second, third and fourth floors were all working as intended.

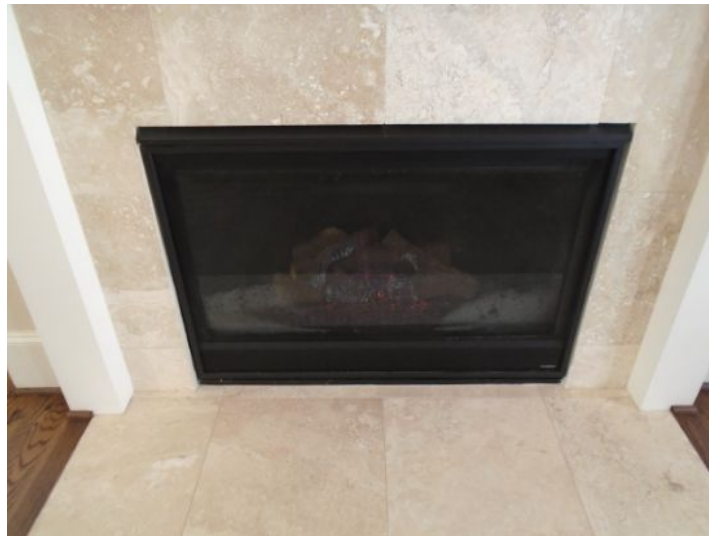
Gas Ignited Fire worked as intended during today's Inspection.

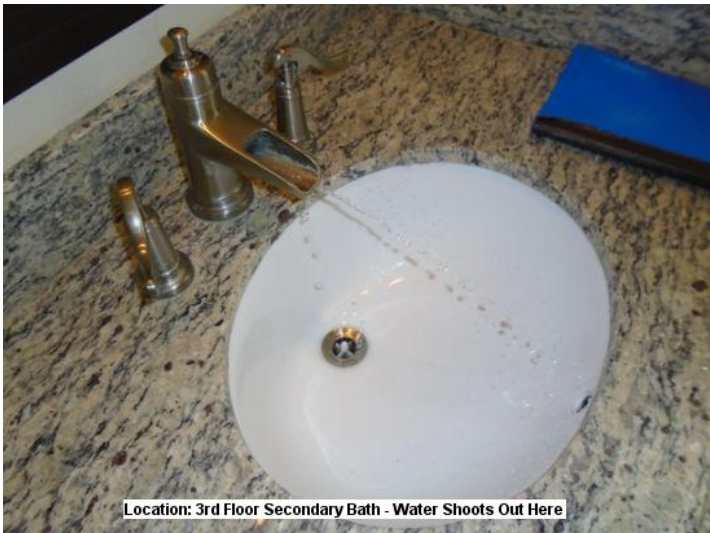
In one or more bathroom sinks, the pressure and angle of water flow exceeds the limits of the sink size.

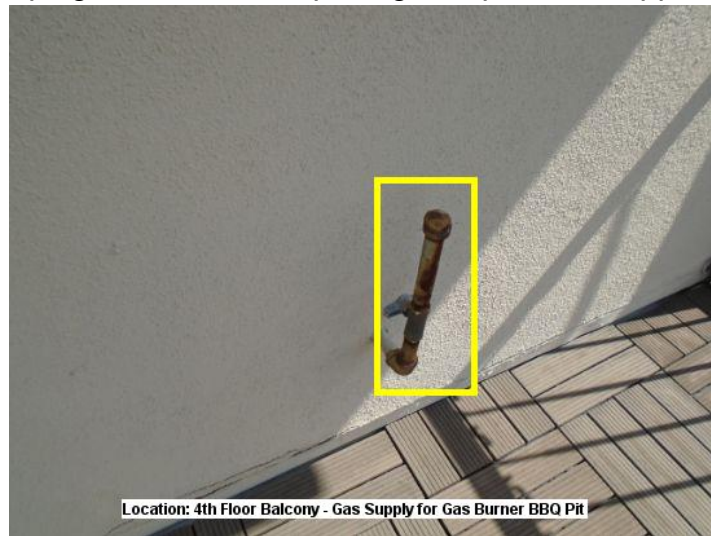
Gas Piping for the exterior patio grill is present, capped and ready to be used.

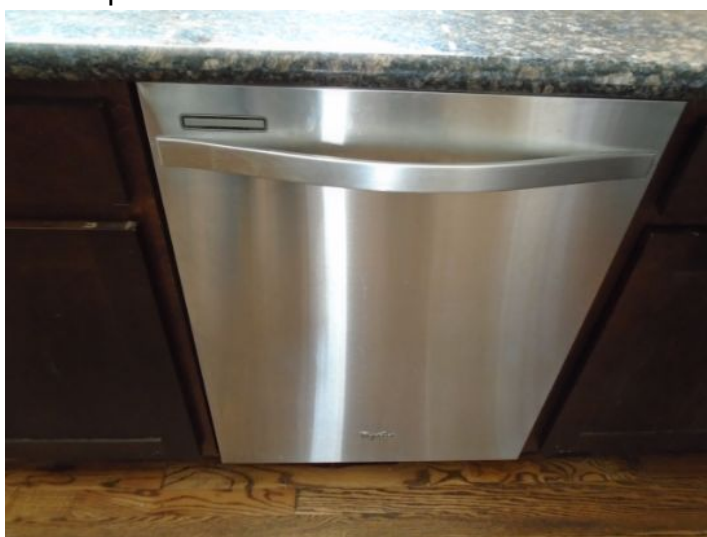
The dishwasher was found to be performing and in satisfactory condition at the time of the inspection.

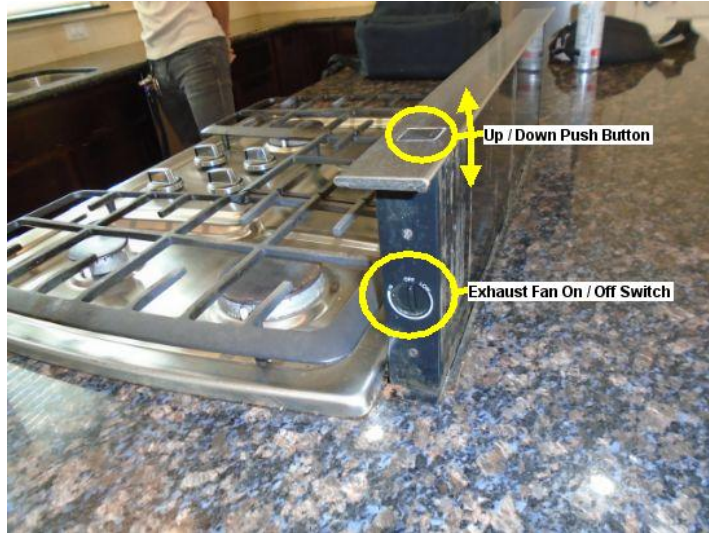
The range hood was functional at the time of the inspection.

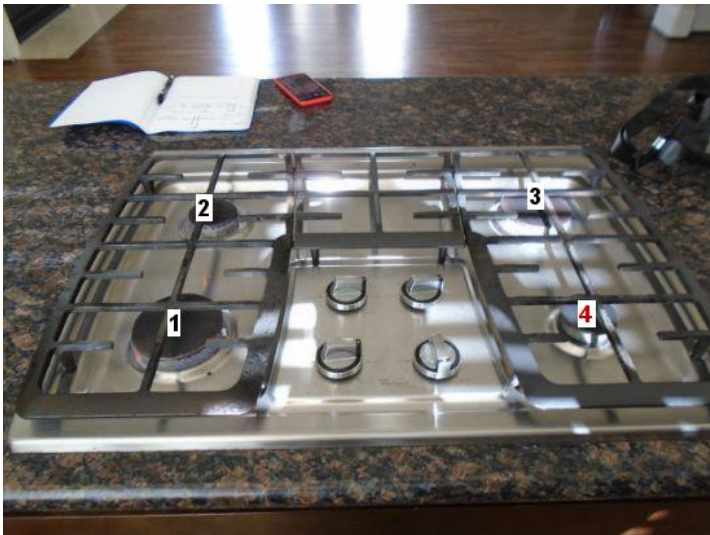
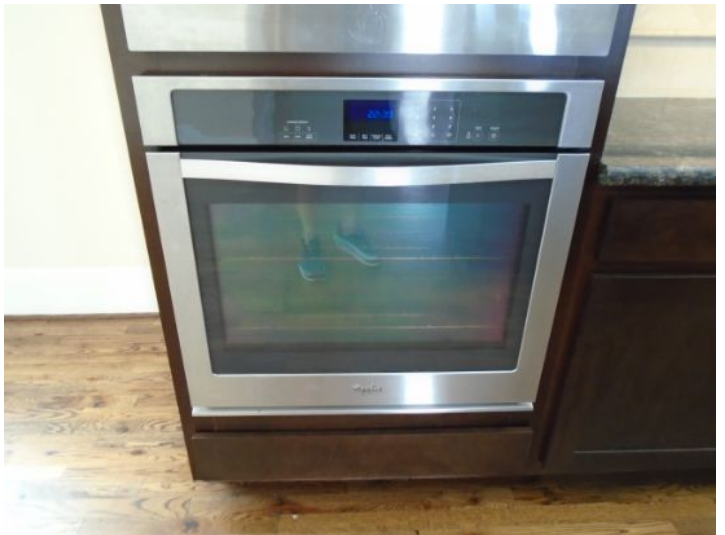
All (3 of 4) heating elements were functional at the time of the inspection.

Oven(s) was functional at the time of the inspection. (Electric)

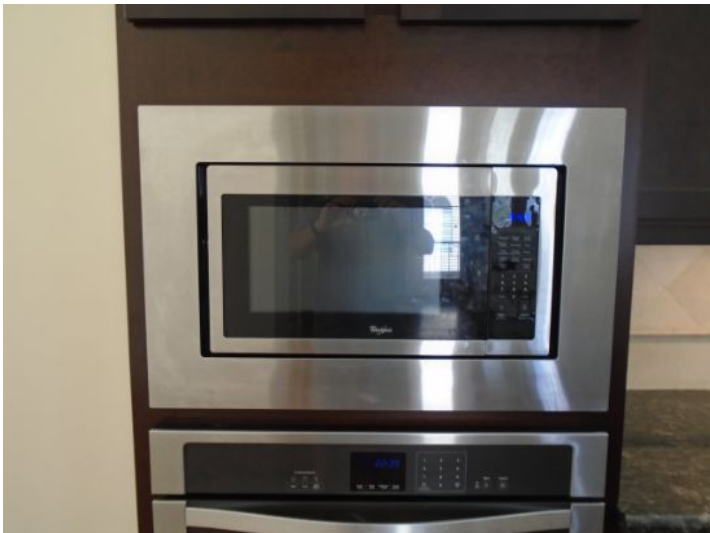
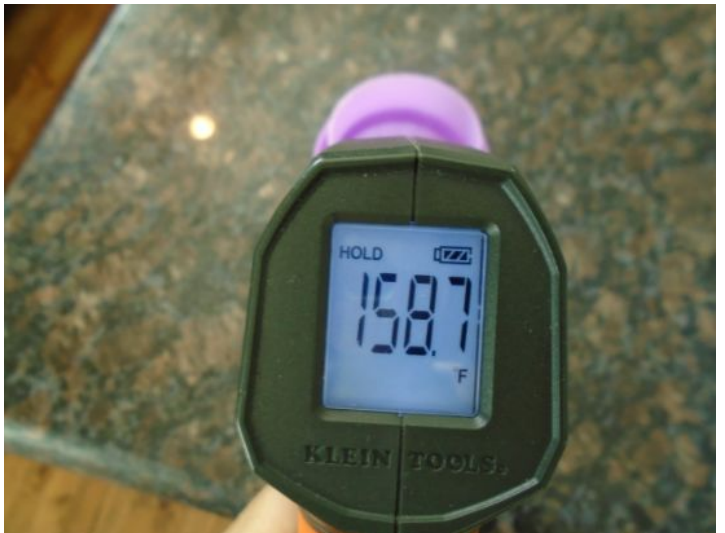
Microwave is a Whirlpool brand.

Microwave 30 second test indicated a 158.7 degrees temperature. Normal range is 125 -175 degrees.

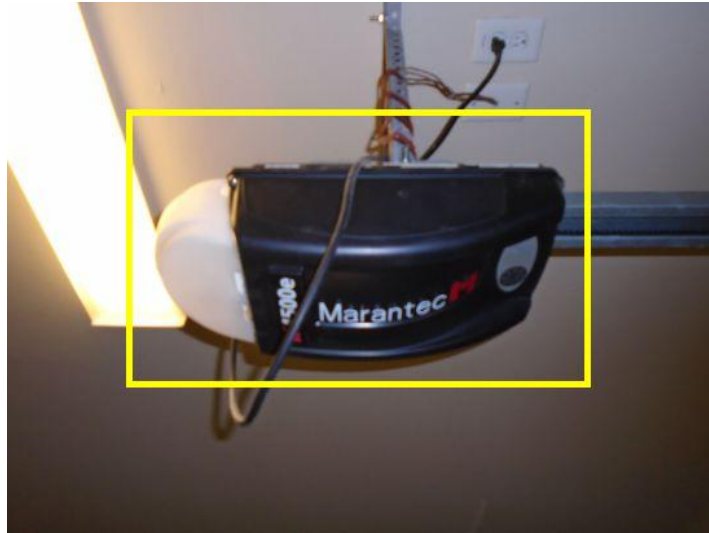
The overhead garage door{s} were functional at the time of the inspection.

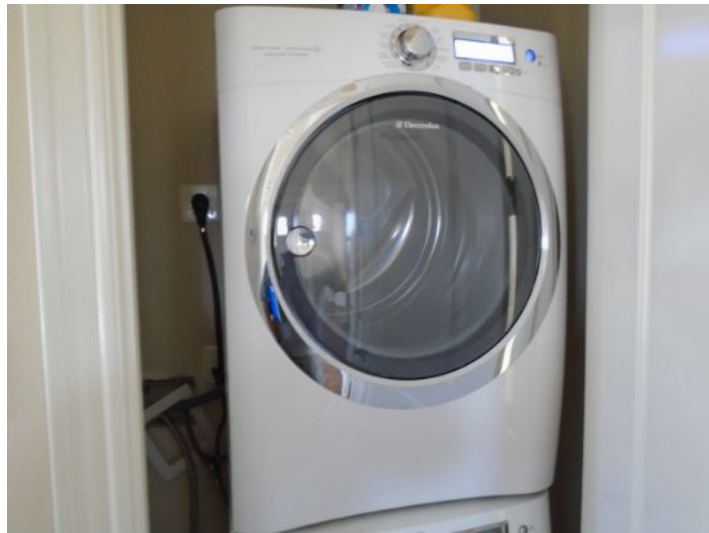
The dryer was present and inspector ran dryer for 10 minutes to ensure vent tube performed as expected.

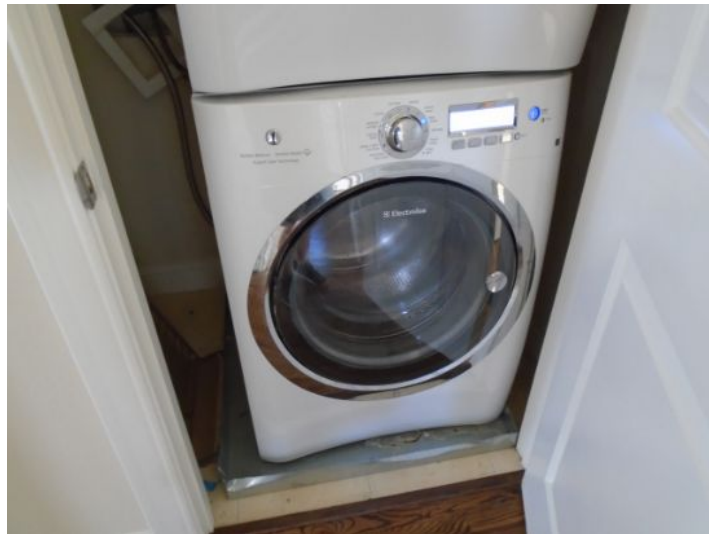
Washer was present and inspector ran the washer on a short cycle to ensure the drain pipe was not obstructed, washer drain worked as intended.
