GC Home Inspection

8106 Rhobell St
Houston, TX 77078

PROPERTY INSPECTION REPORT FORM

Elijah Adeniyi <i>Name of Client</i>	09/06/2023 <i>Date of Inspection</i>
8106 Rhobell St, Houston, TX 77078 <i>Address of Inspected Property</i>	
Chad Gregory Langston Jr. <i>Name of Inspector</i>	25839 <i>TREC License #</i>
Chad Langston <i>Name of Sponsor (if applicable)</i>	7946 <i>TREC License #</i>

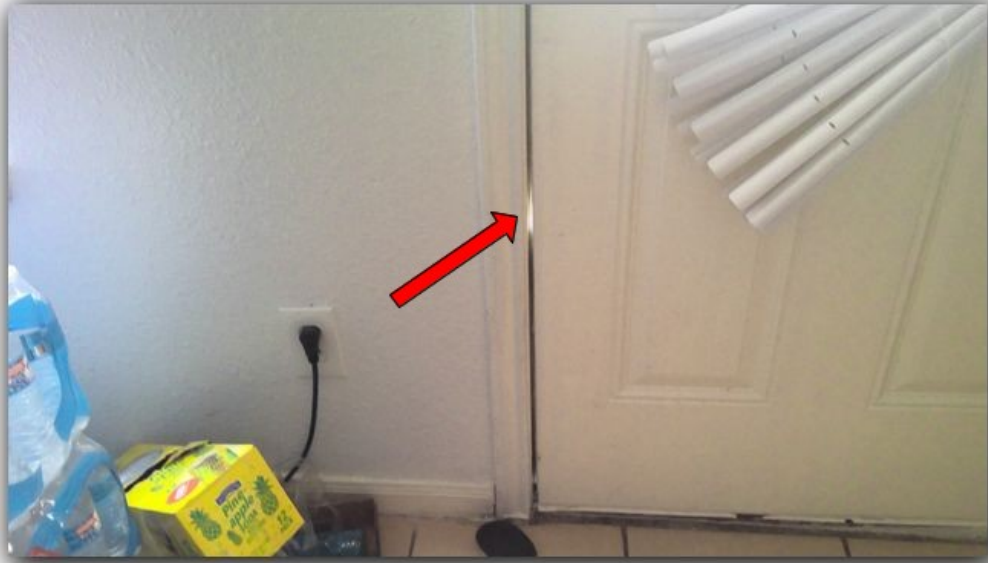
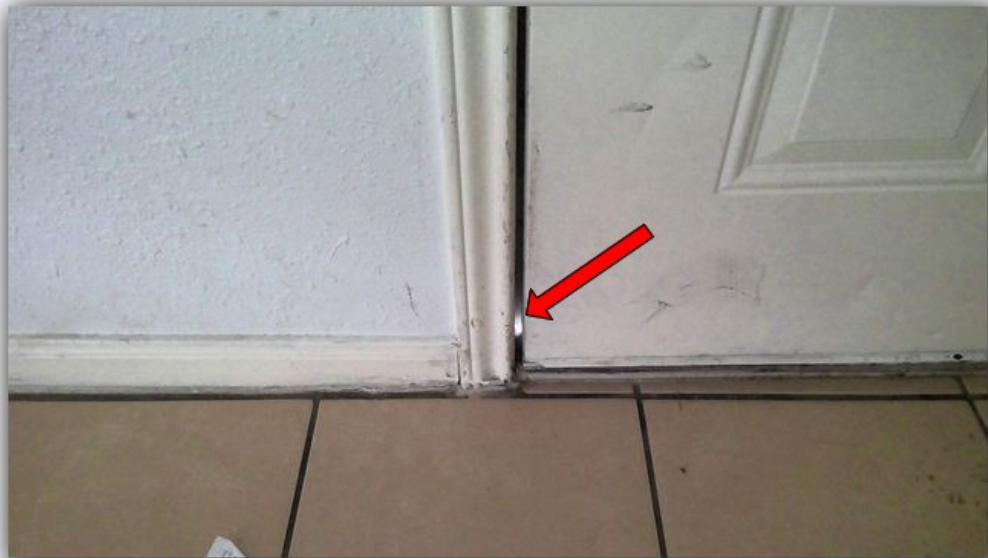
Doors in various locations should be trimmed or adjusted as necessary to work properly.

The exterior doors should be better sealed to promote energy efficiency.

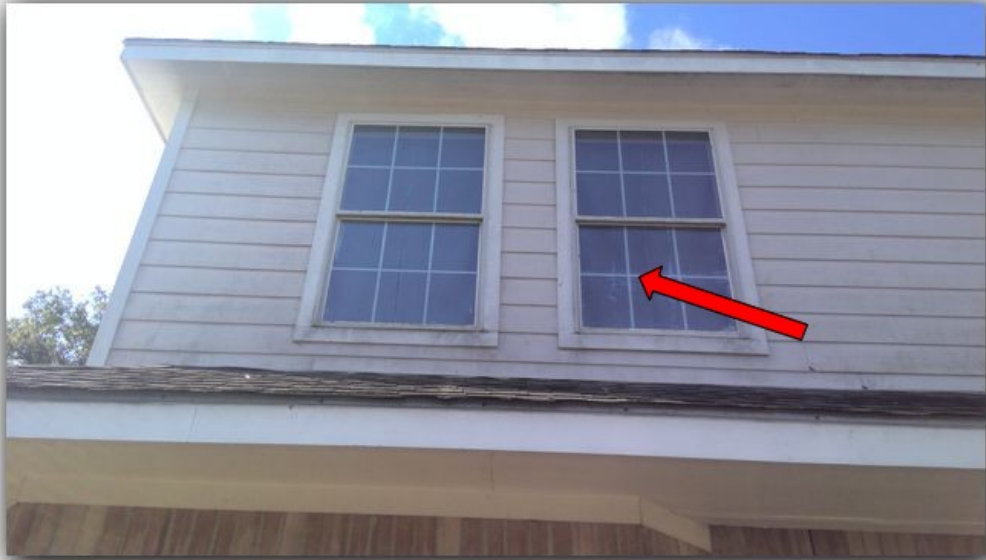
The window(s) have lost their seal in various locations. This has resulted in condensation developing between the panes of glass and can cause the glass to lose its insulating properties. The glass should be repaired or replaced.

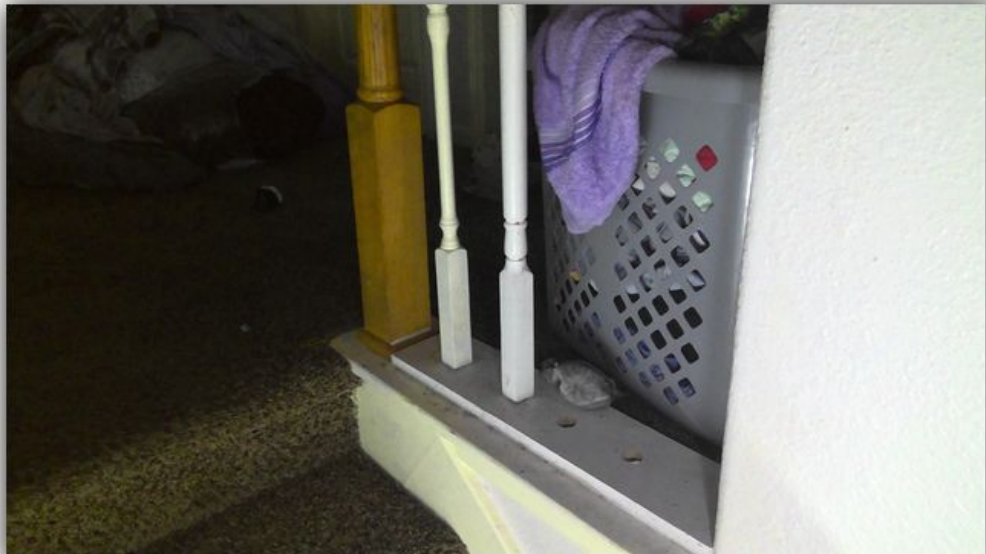
Unit A -

Missing balusters should be replaced.

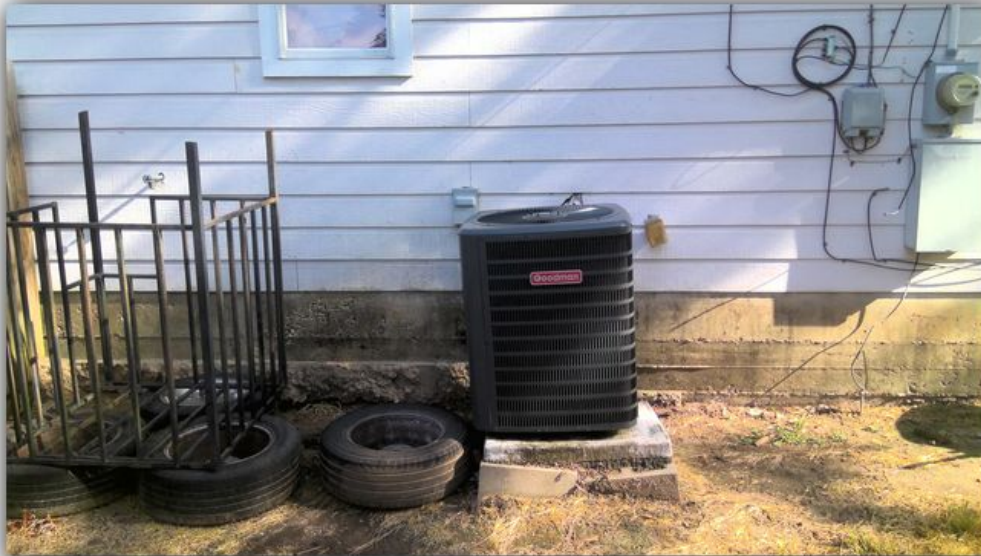
The outdoor unit of the air conditioning system is out of level. This should be improved.
